**Reclamation Plan for Rule 915.b.
Desert Eagle Operating/10797
Red Rocks 35-08
Location Number: 484359
3/15/2025**

**FIGURE A-1
RECLAMATION MAP
RED ROCKS 35-08
LAS ANIMAS COUNTY COLORADO
NE 1/4 SE 1/4 SEC. 35 T29S R55W 6TH P.M.
DESERT EAGLE OPERATING, LLC**

CONSTRUCTION LAYOUT - PLAN VIEW

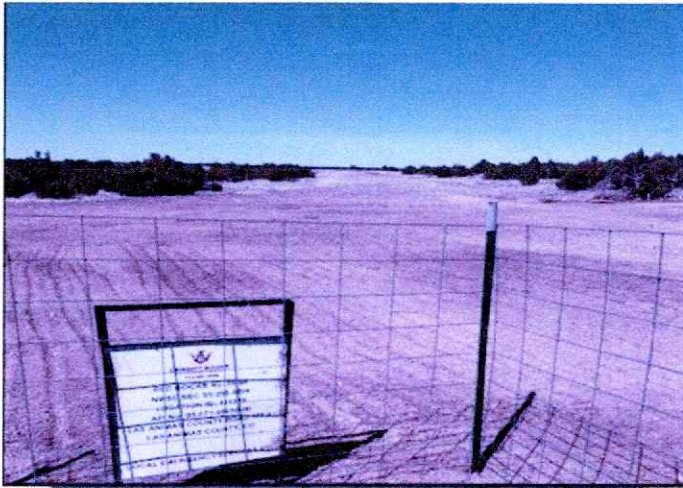
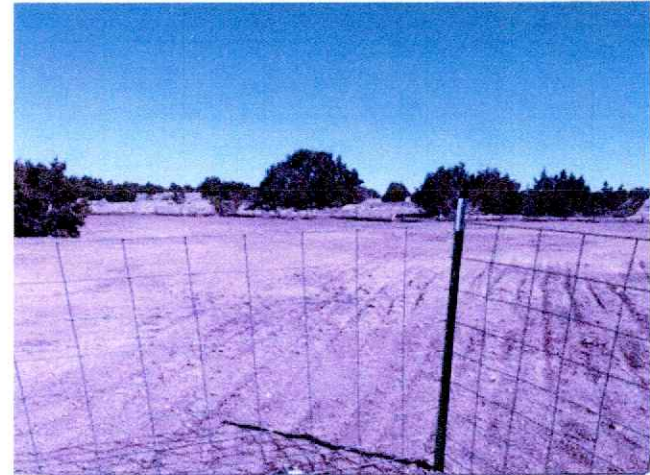
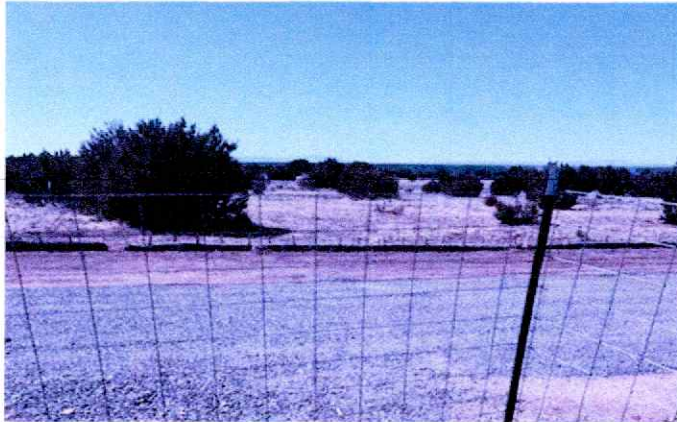
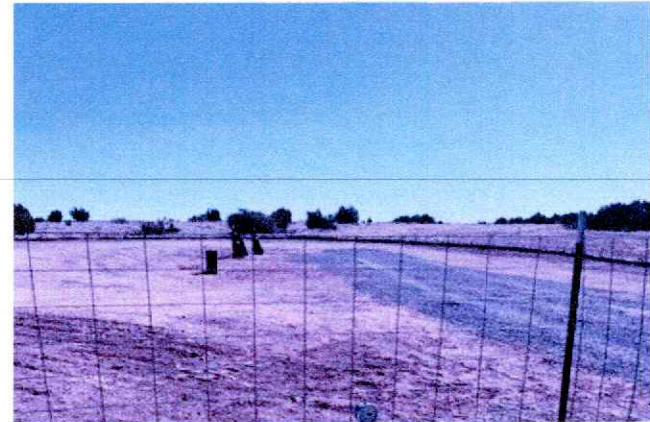
Operator: Desert Eagle Operating LLC
Location: Red Rocks 35-08
Photo Date: 3/10/25
Photo Time: 1:20 p.m.
Las Animas County
NE 1/4 SE 1/4 Sec. 35, T29S R55W 6th P.M

Looking North

Looking East

Looking West

Looking South

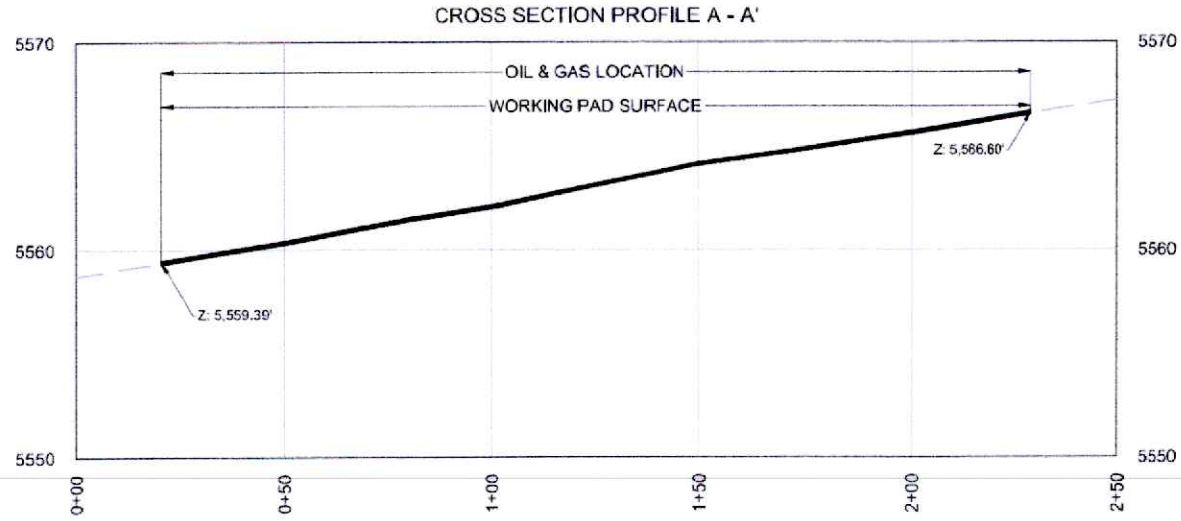
CONSTRUCTION LAYOUT - CROSS SECTIONS

- 1.) THERE IS NO DISTINCTION BETWEEN PRELIMINARY DRILL RIG LAYOUT AND WELL COMPLETION LAYOUT FOR THIS DEVELOPMENT.
- 2.) THERE IS NO STIMULATION LAYOUT FOR THIS DEVELOPMENT.
- 3.) THERE IS NO FLOWBACK FOR THIS DEVELOPMENT.
- 4.) THE WELL WILL BE DRILLED WITH AIR. THERE WILL BE NO HYDRAULIC FRACKING, STIMULATION, OR FLOWBACK. THE WELL IS NOT ANTICIPATED TO PRODUCE WATER. FRESHWATER WILL BE USED FOR SURFACE DUST CONTROL.

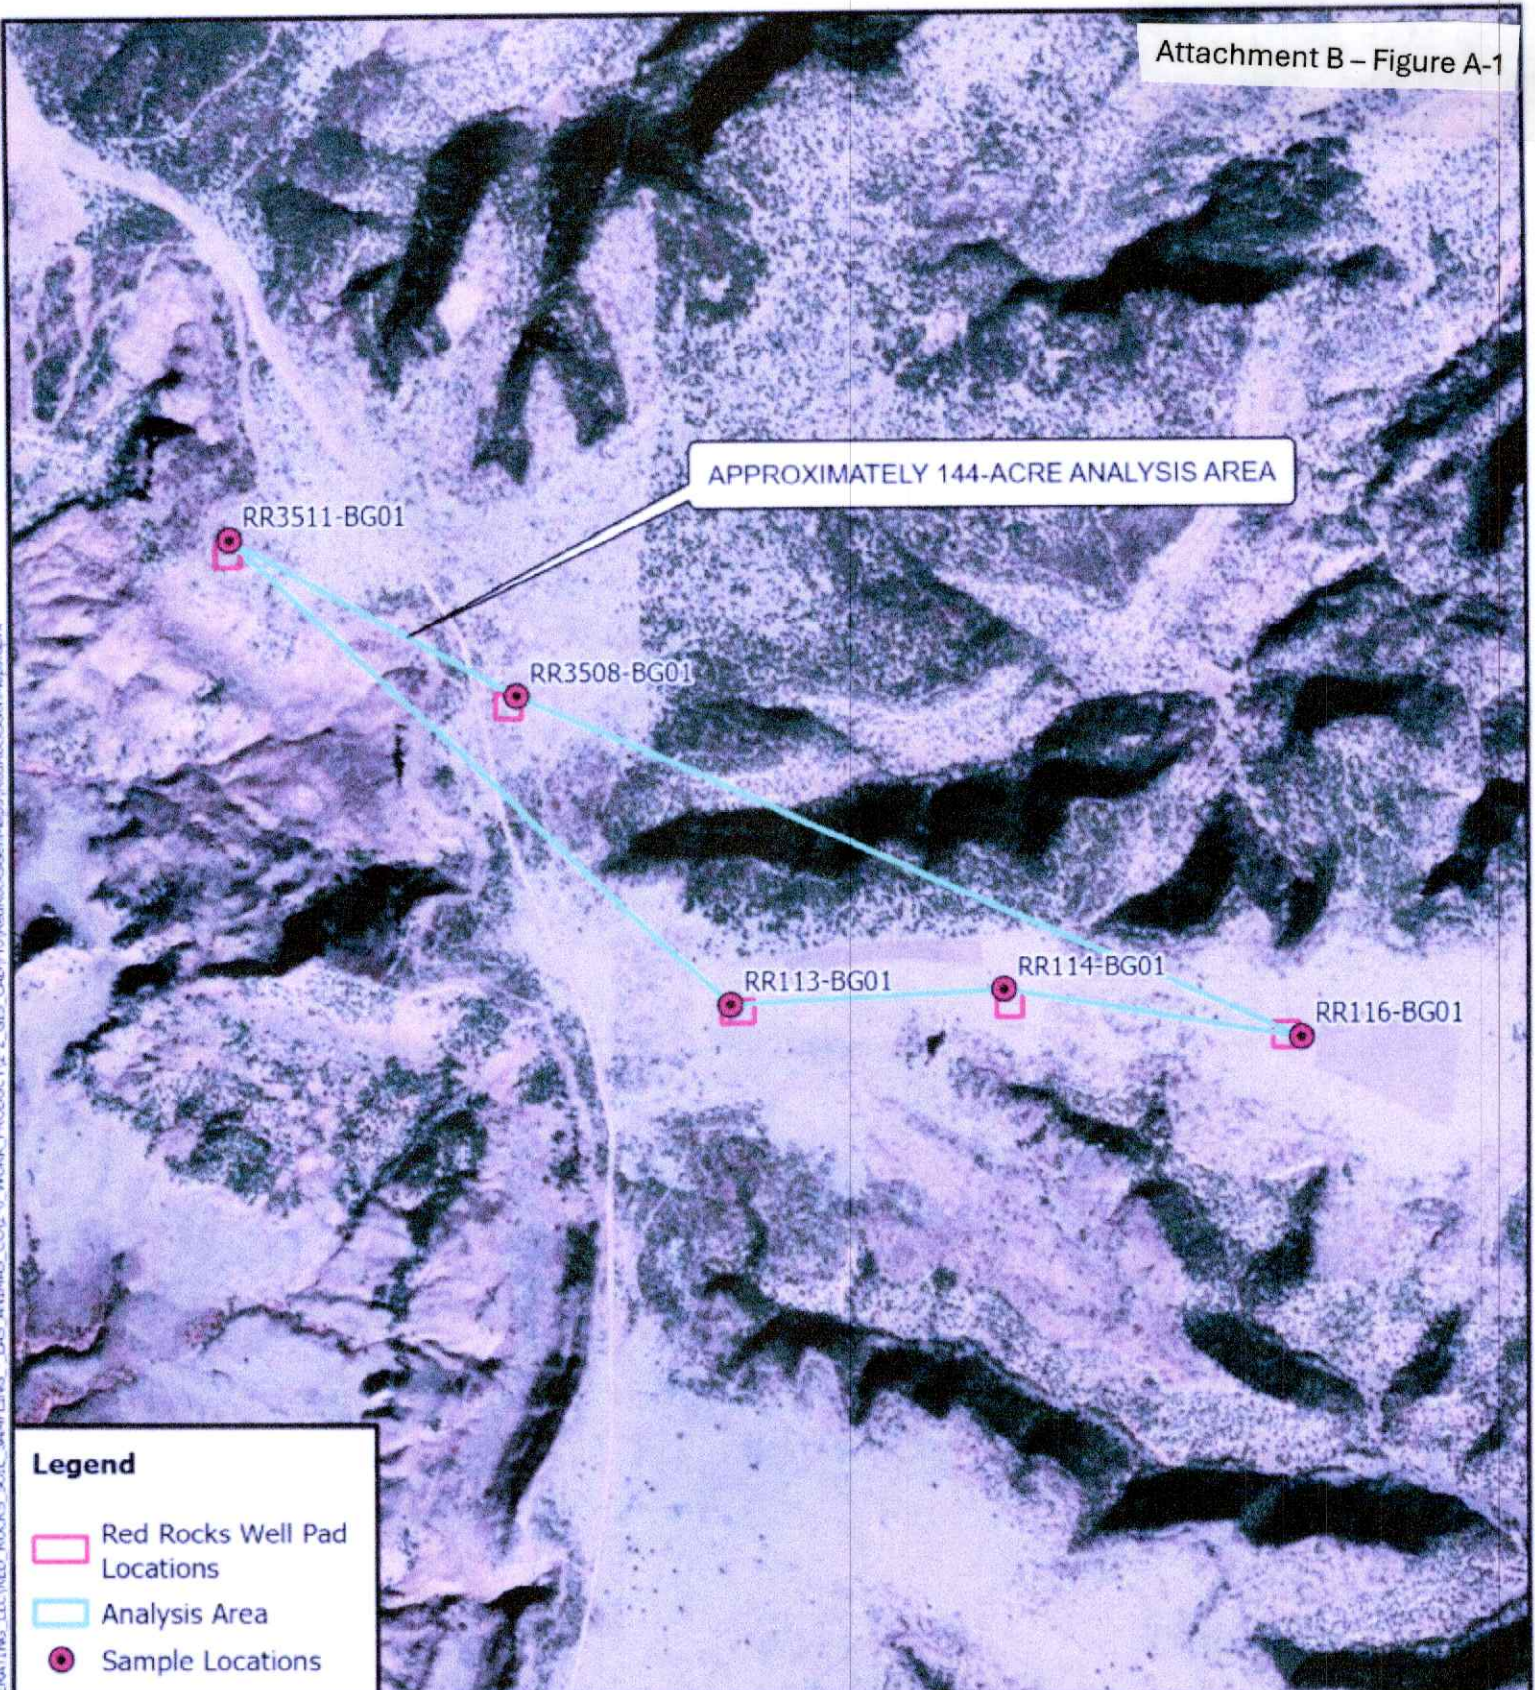
**FIGURE A-1
ANALYSIS AREA MAP
RED ROCKS WELL LOCATIONS
LAS ANIMAS COUNTY, COLORADO
DESERT EAGLE OPERATING, LLC**

As shown in **Figure A-1**, the Analysis Area spans approximately 144-acres, wherein pH values in undisturbed native soils range from 7.8 to 8.9. Analytical results for the sample series collected from Red Rocks 1-13 and Red Rocks 1-16 exhibit the highest pH concentrations in soils collected from the background sample locations (RR113-BG01 and RR116-BG01). As these samples were collected from undisturbed native soils it is reasonably assumed that the pH concentrations are representative of the greater 144-acre Analysis Area and are not the result of helium well drilling operations.

The naturally occurring pH levels across the Analysis Area exceed Table 915-1 Cleanup Concentration values. Given that the highest recorded pH values were from undisturbed background samples, further delineation is not warranted or feasible. It is the professional opinion of Topographic that additional investigation would not provide meaningful data, as native soils inherently exceed regulatory thresholds.

Per the Topographic report (Exhibit B, Figure A-1, Figure A-1, Figure A-3), the agronomic properties of the soil was not impacted by E&P activities. As reported, *the naturally occurring pH levels across the Analysis Area exceed Table 915-1 Cleanup Concentration values. Given that the highest recorded pH values were from undisturbed background samples, further delineation is not warranted or feasible. It is the professional opinion of Topographic that additional investigation would not provide meaningful data, as native soils inherently exceed regulatory thresholds.* Leaving the soil in-situ provides background levels of pH consistent with pH levels in the test area where the native grasses with root depth of up to 3' survive. The location is not immediately upgradient of surface water or riparian areas. The nearest mapped features are field verified gullies lacking an ordinary high water mark. There are no water wells within 0.5 miles of either location. The estimated depth to groundwater is greater than 1,200 feet, based on previous helium well drilling for Red Rocks 1-13 (API #05-071-09920) and other Red Rocks wells. The location is not within a Sensitive Area for water resources. There will be no cumulative impacts to water wells or surface water because of the distances to water wells and surface water, the depth to groundwater, well development without use of pits or ponds, and no liquids storage during production. There will be minimal air and noise pollution from the trucks and equipment for seeding and potential watering, less native ground will be disturbed, and more area of undisturbed ground will be available for wildlife. Leaving the soil in-situ and completing the reclamation plan in this arid, sparsely vegetated rangeland will not harm public health, safety, welfare, the environment and wildlife resources.

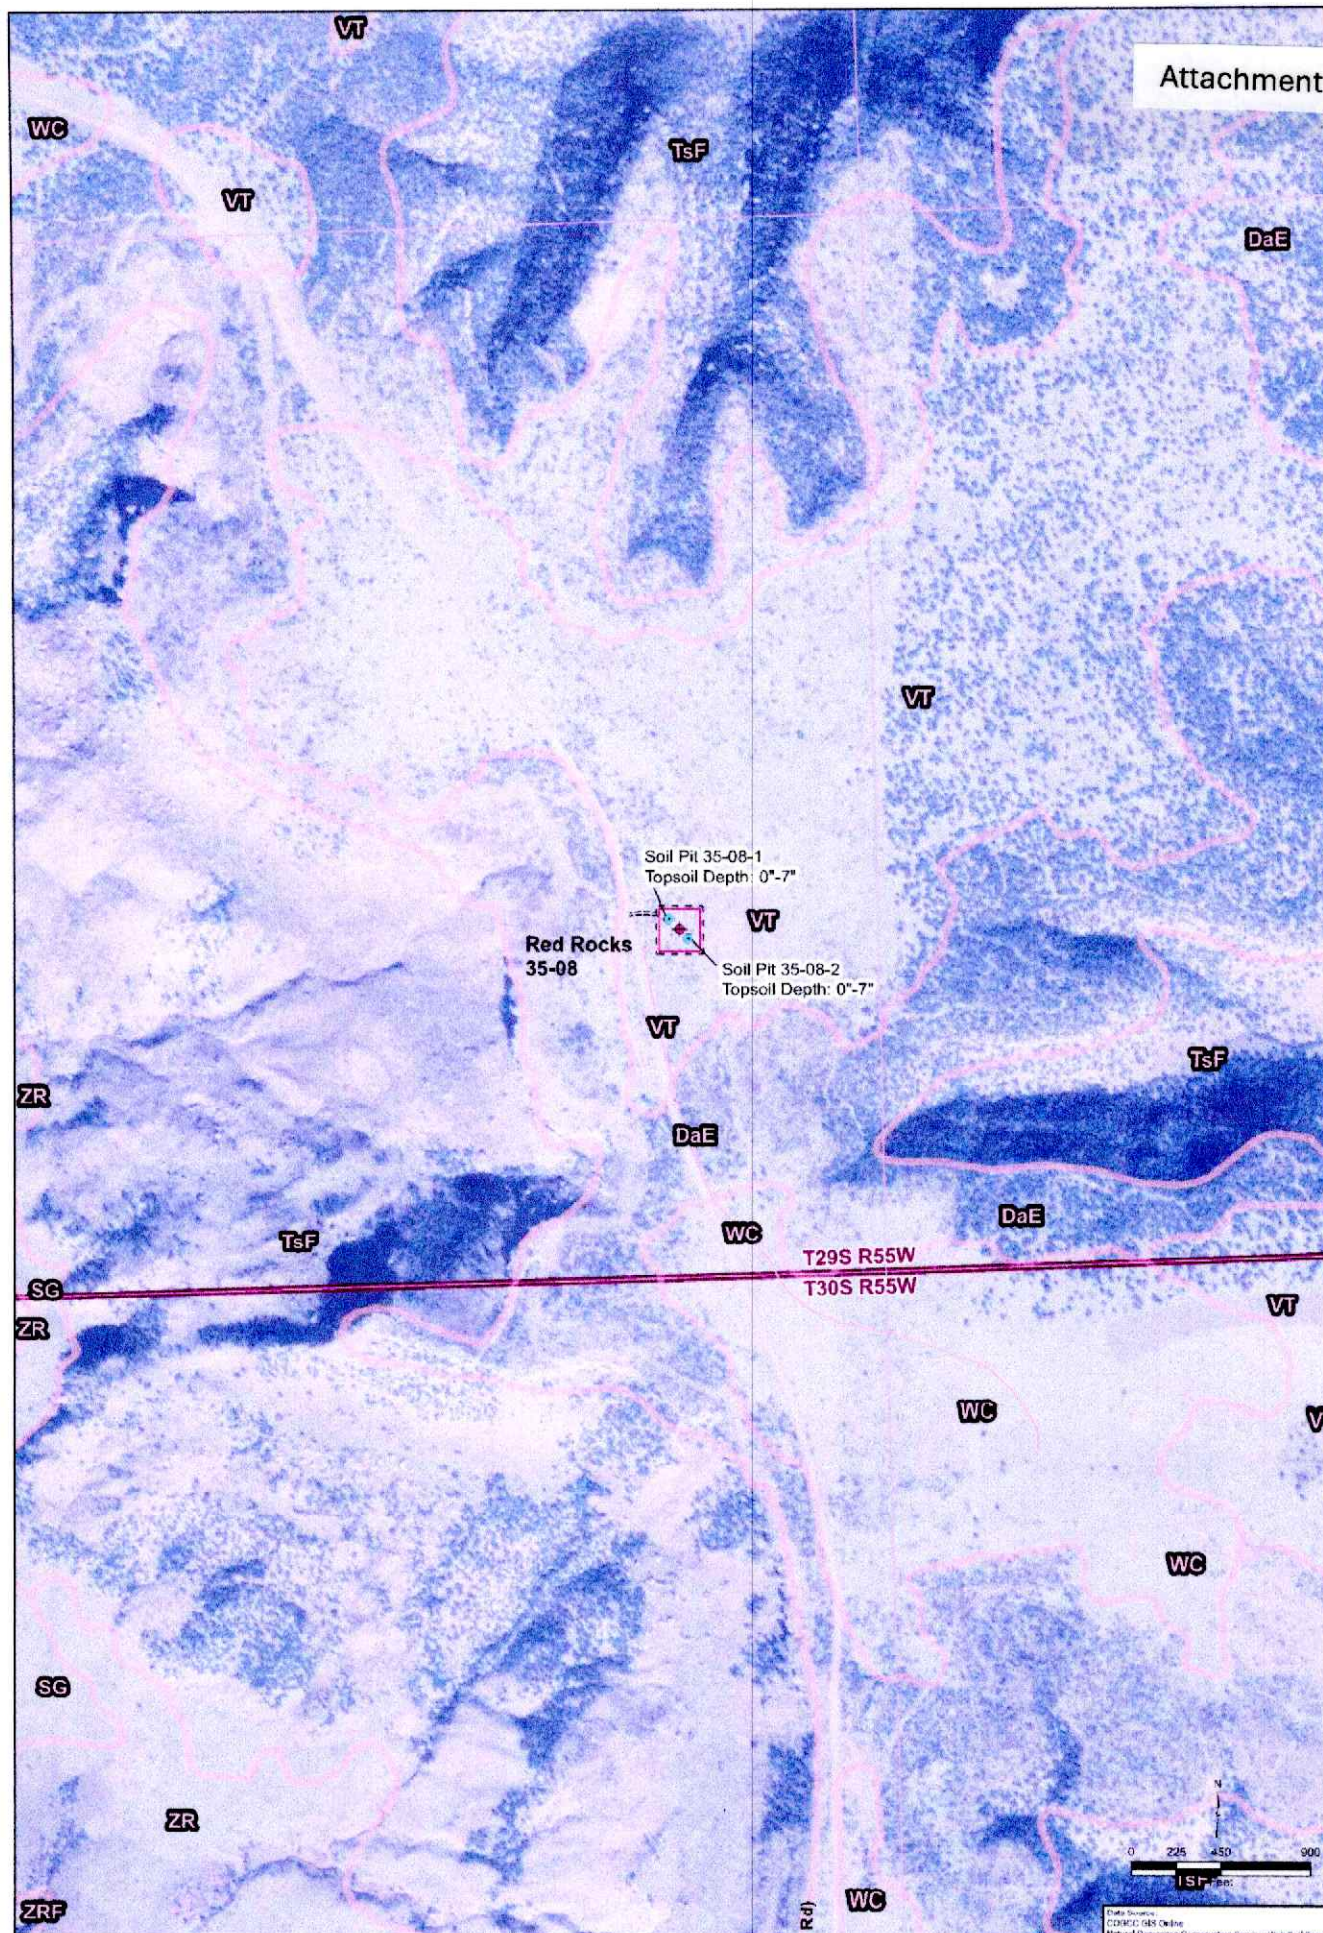
Soil at the Oil and Gas Location is Soil Unit VT - Villedry-Travessilla complex according to the Natural Resources Conservation Service Map Unit Descriptions. The typical profile for this soil type is silt loam and sandy loam with 1 to 8 percent slopes. The A-horizon is 0 to 5 inches of silt and sandy loam overlaying 4 to 15 inches of silt loam silty clay loam, and sandy loam. The soil type is well drained. The depth to the restrictive feature is alternately 20 to 40 inches and 6 to 20 inches. The NRCS soil unit descriptions are provided on the attached Custom Soils Resources Report (Attachment C). The soil map unit and its boundary are shown on the attached Soil Unit Map (Attachment D). The soil unit is listed below in Table 2.
