Inspection Photos

Loc: 307595

Operator: EVERGREEN NATURAL
RESOURCES LLC

Inspection Date: 3/17/2025

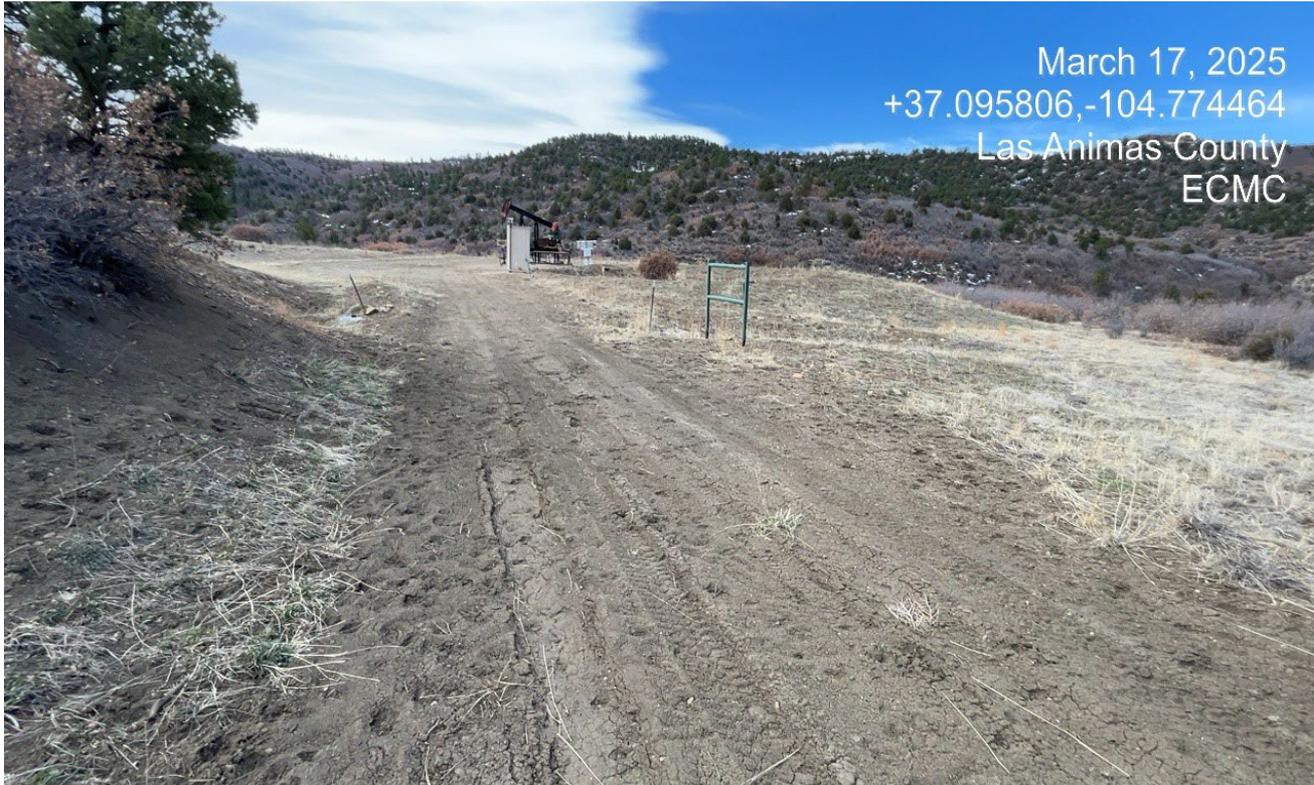
Photo 1. Facing southeast along the access road toward the wellsite.

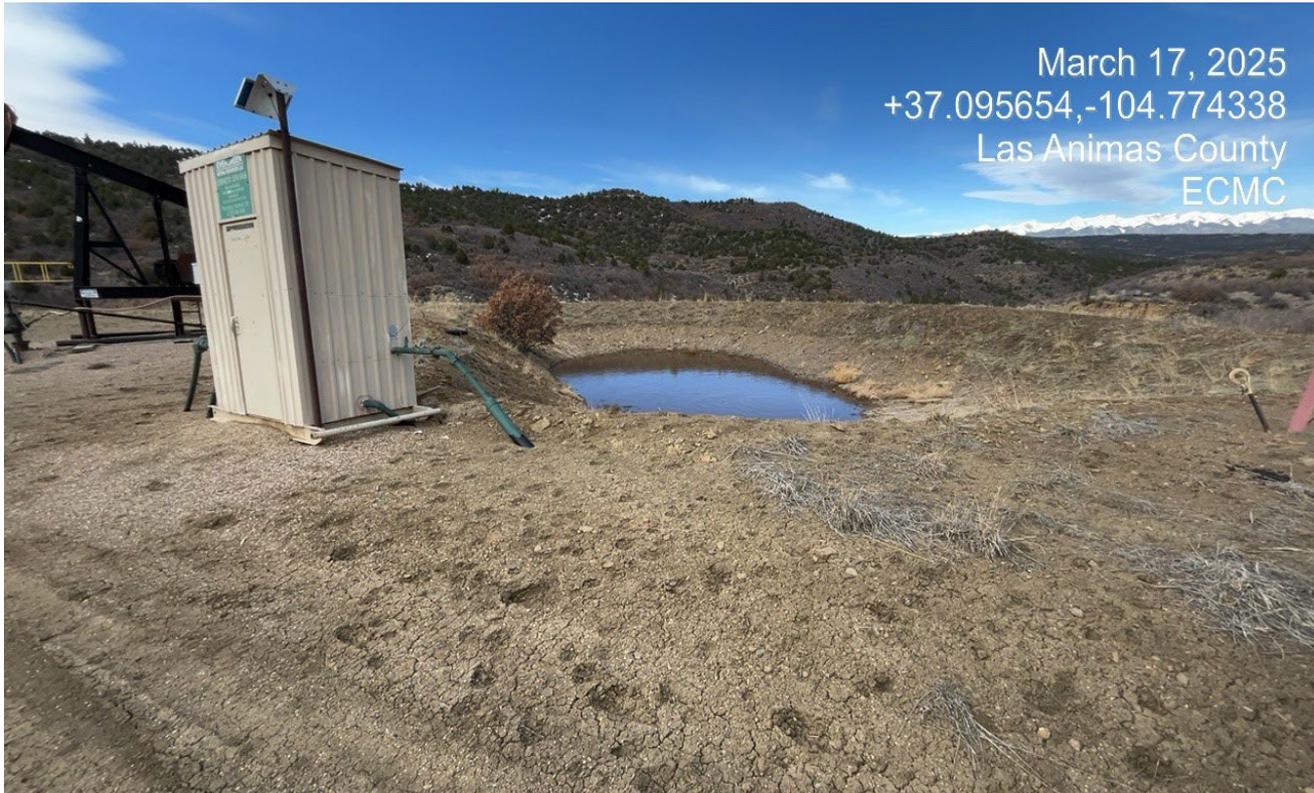
Photo 2. Facing southwest toward the produced water pit.

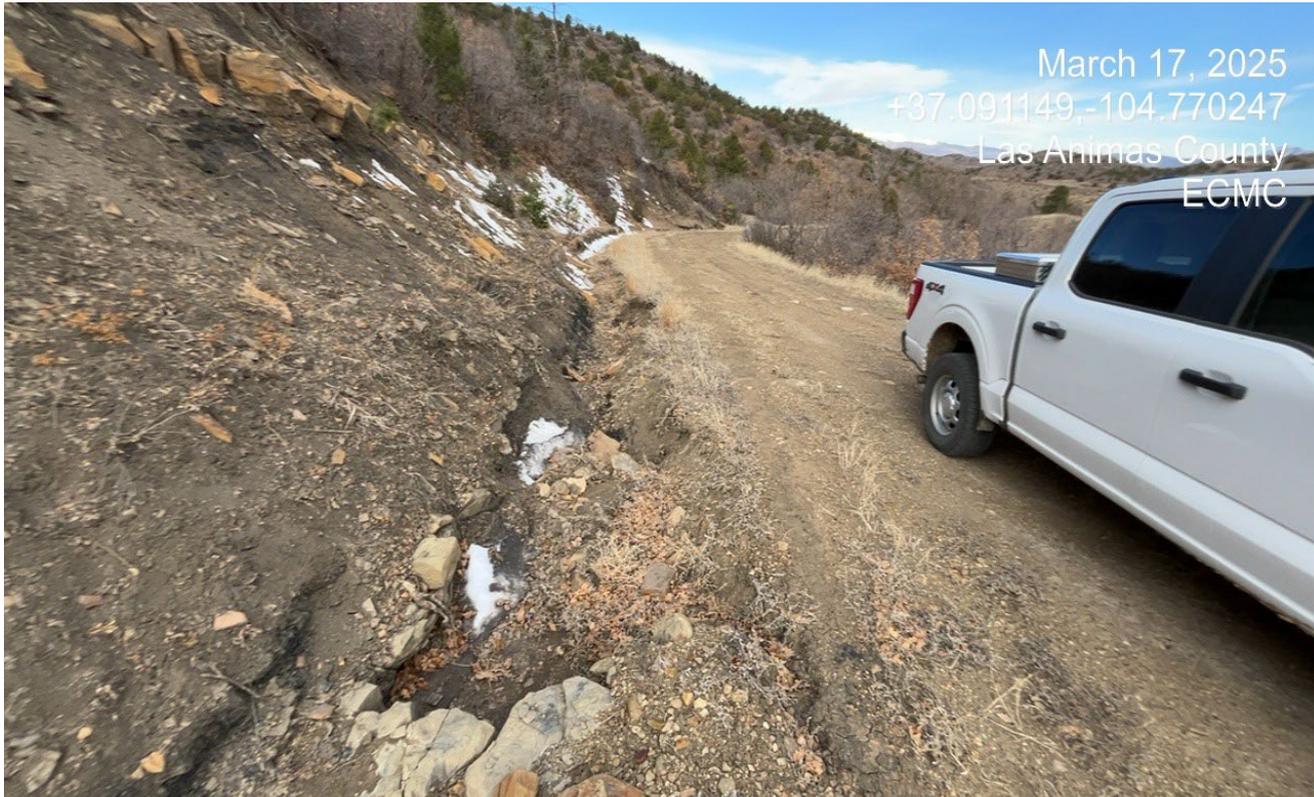
Photo 3. Facing west along the access road traveling east from the wellsite. This area along the road side has eroded and will need BMP's such as check dams, culverts, ect. to further prevent erosion.

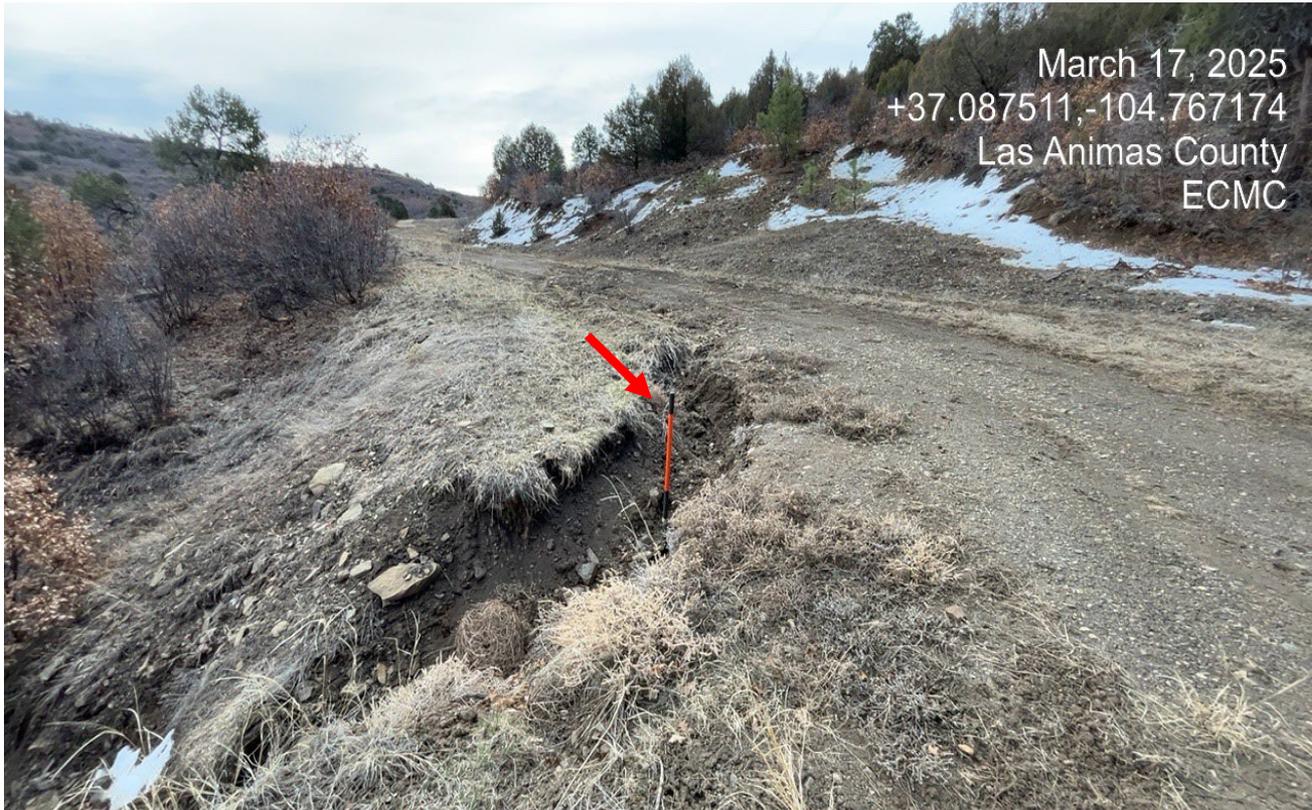
Photo 4. Facing east further along the road. This area has eroded and will need to be repaired and stabilized. Red arrow points to 4.5 ft shovel in the erosion gully.

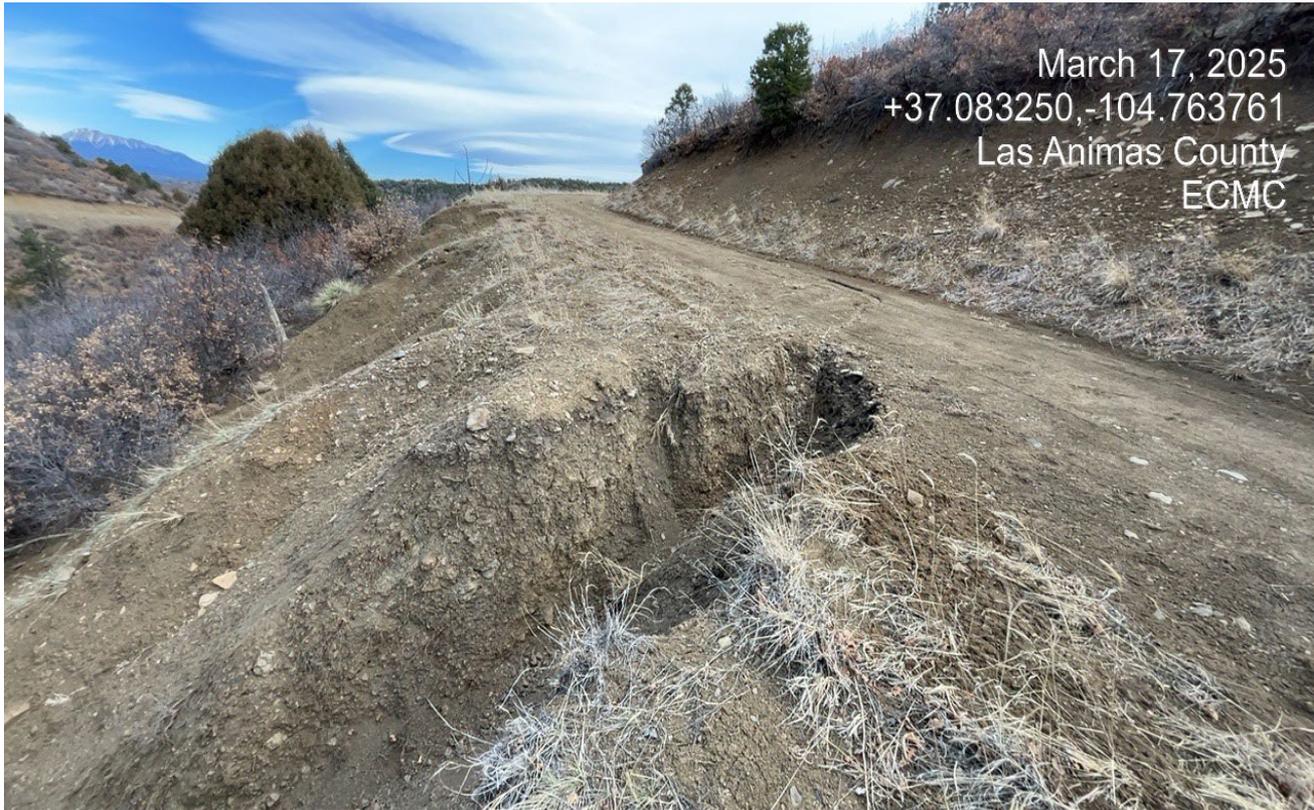
Photo 5. Facing north toward the fill slope of the road. This area has eroded and will need to be repaired and stabilized.

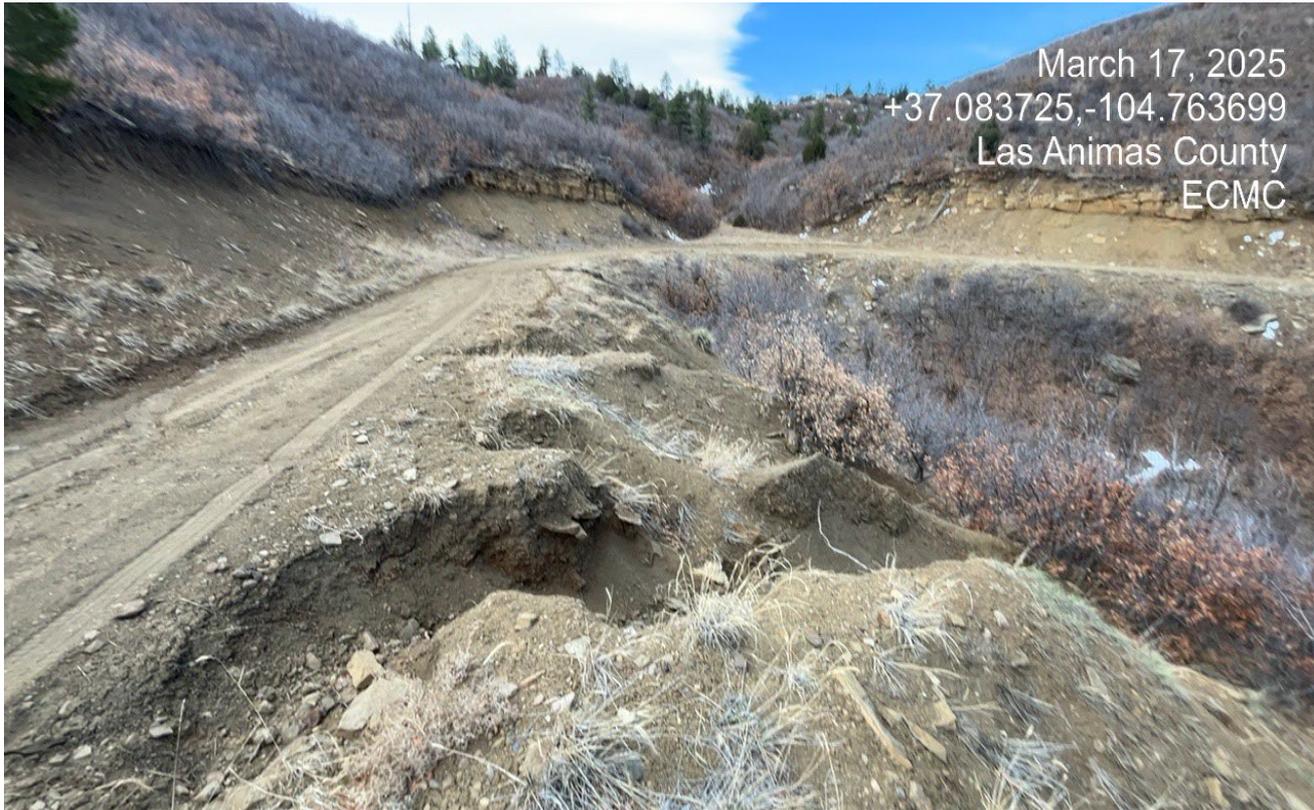
Photo 6. Facing back south at the same area as the previous photo. This area has eroded and will need to be repaired and stabilized.
