Final Reclamation and Stormwater Inspection

Location ID: 320476

Well Name: LINNEBUR #42-1

Inspection Document #: 718600412

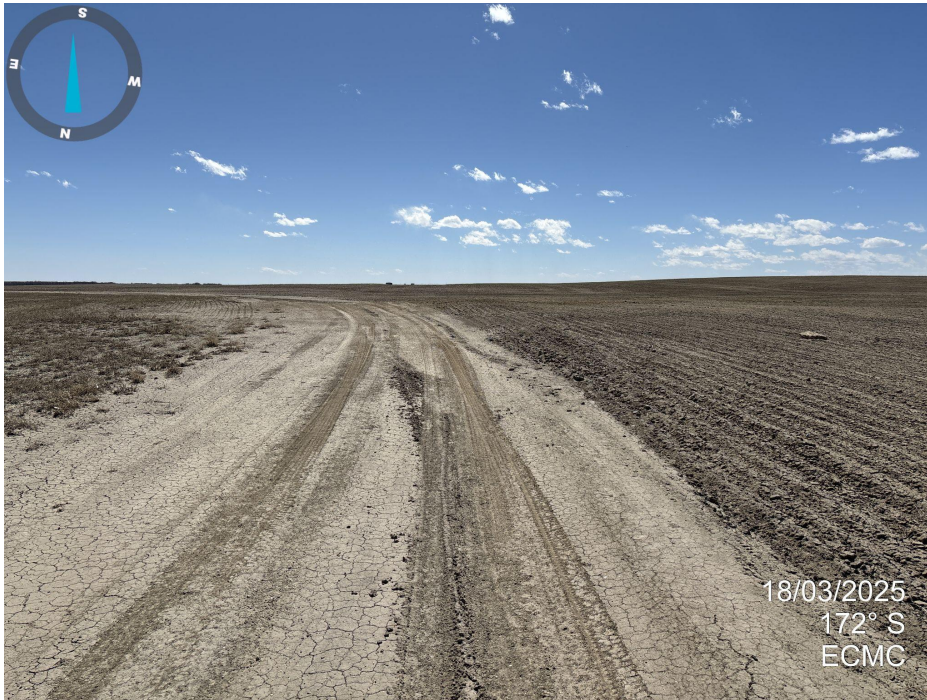
Photo 1. Looking south across well location. No oil and gas equipment remains. Access road appears to be in use for oil and gas access.

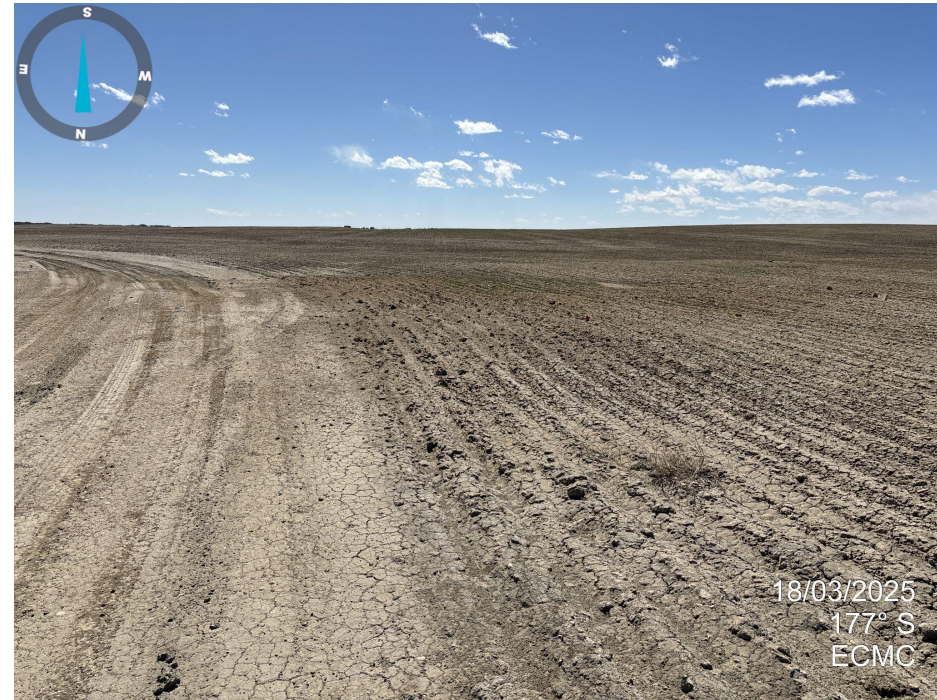
Photo 2. Looking across the wellbore area. Cropland appears to have been seeded, germination was visible at time of inspection.

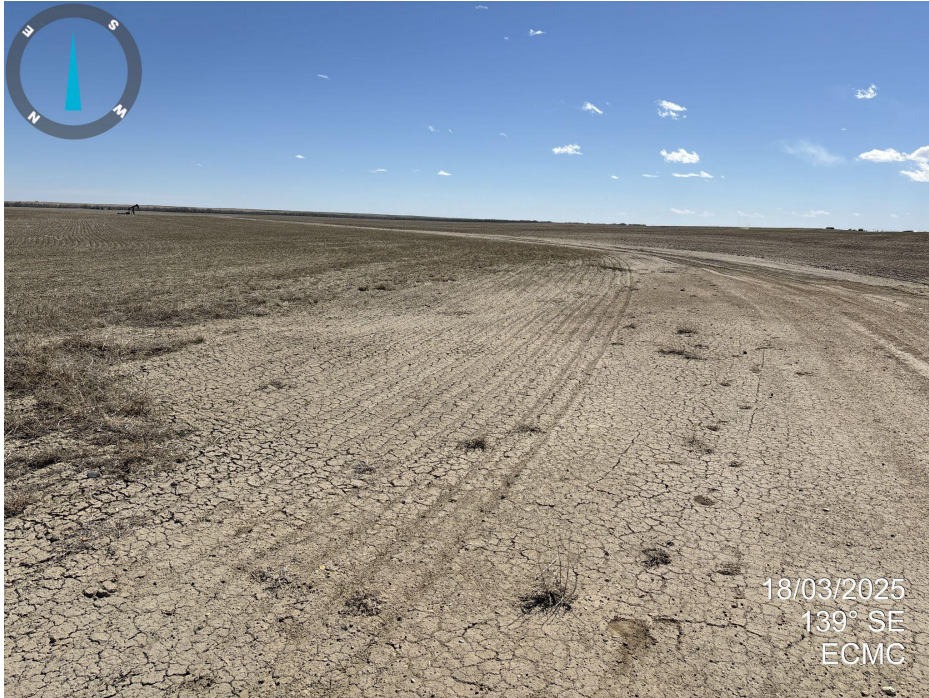
Photo 3. Picture taken looking at location east of the access access road. This portion appears to have been seeded.

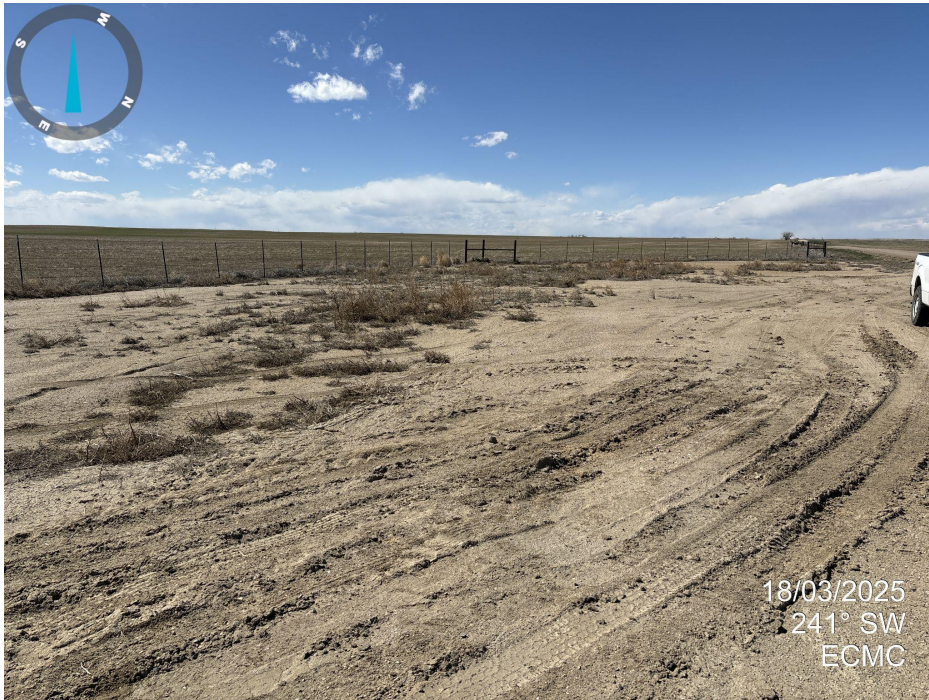
Photo 5. Looking west across former tank battery. All equipment has been removed. Tank battery is fenced out from field. Undesirable weeds (Kochia, Russian thistle) are present on tank battery.

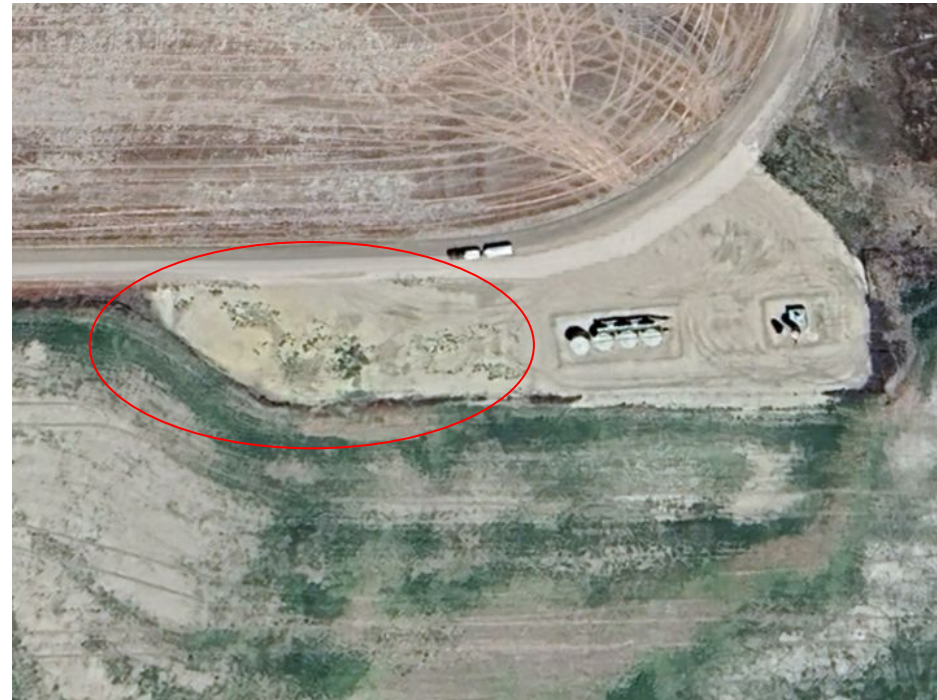
Photo 6. Google earth imagery 6/24, former tank battery location (red circle). This area should be returned to crop/pasture.
