Final Reclamation Inspection

Operator: MENDELL NIOBRARA LLC- 10435

Location ID: 322649

Inspection Document #: 697505878

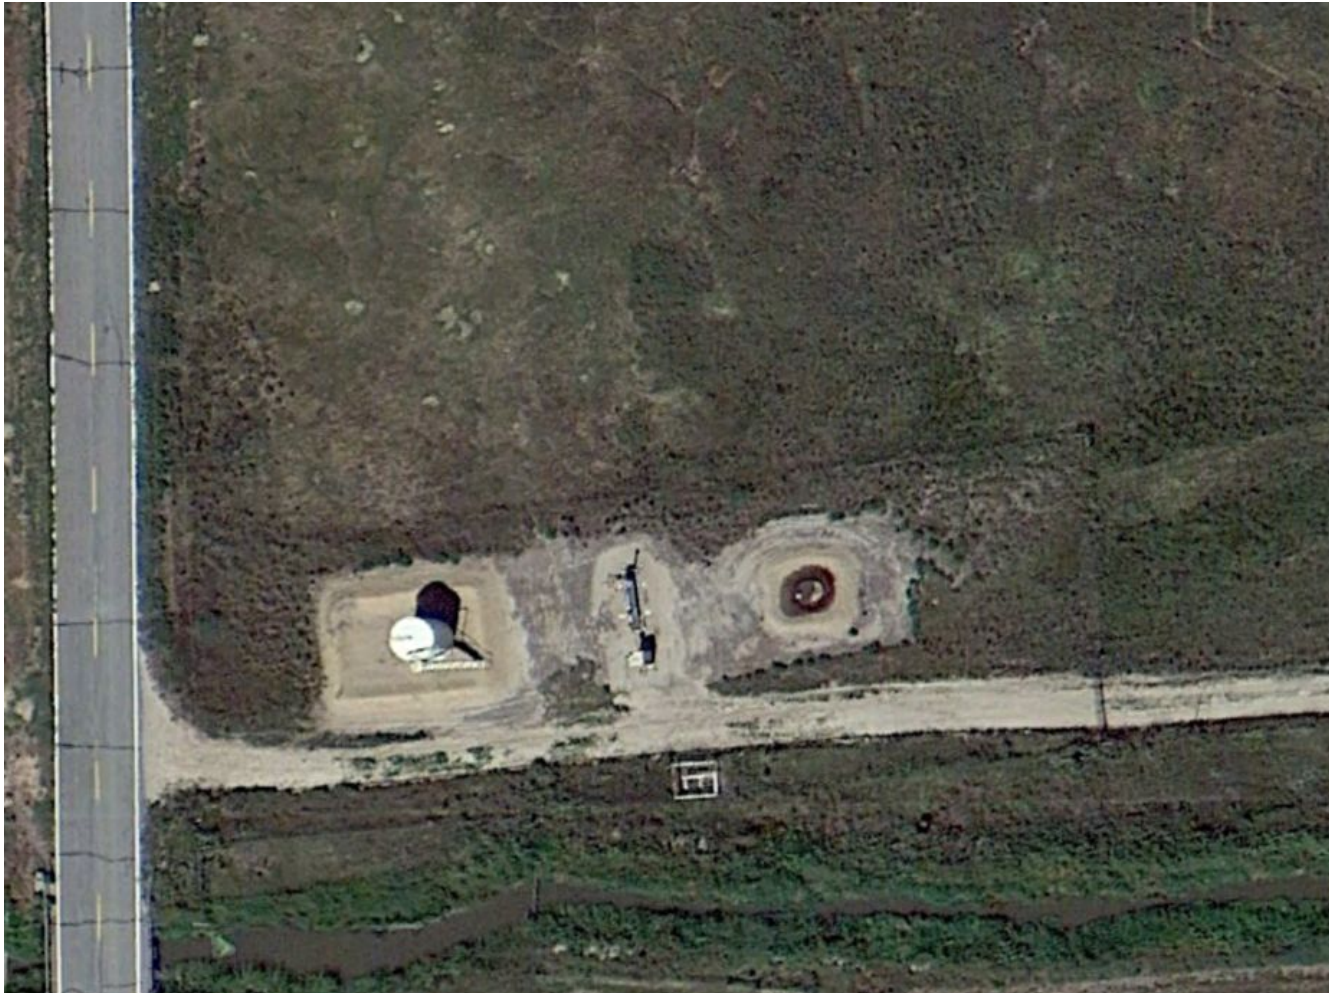
Photo 1. Google Earth aerial imagery taken September 6, 2013 during active operations.

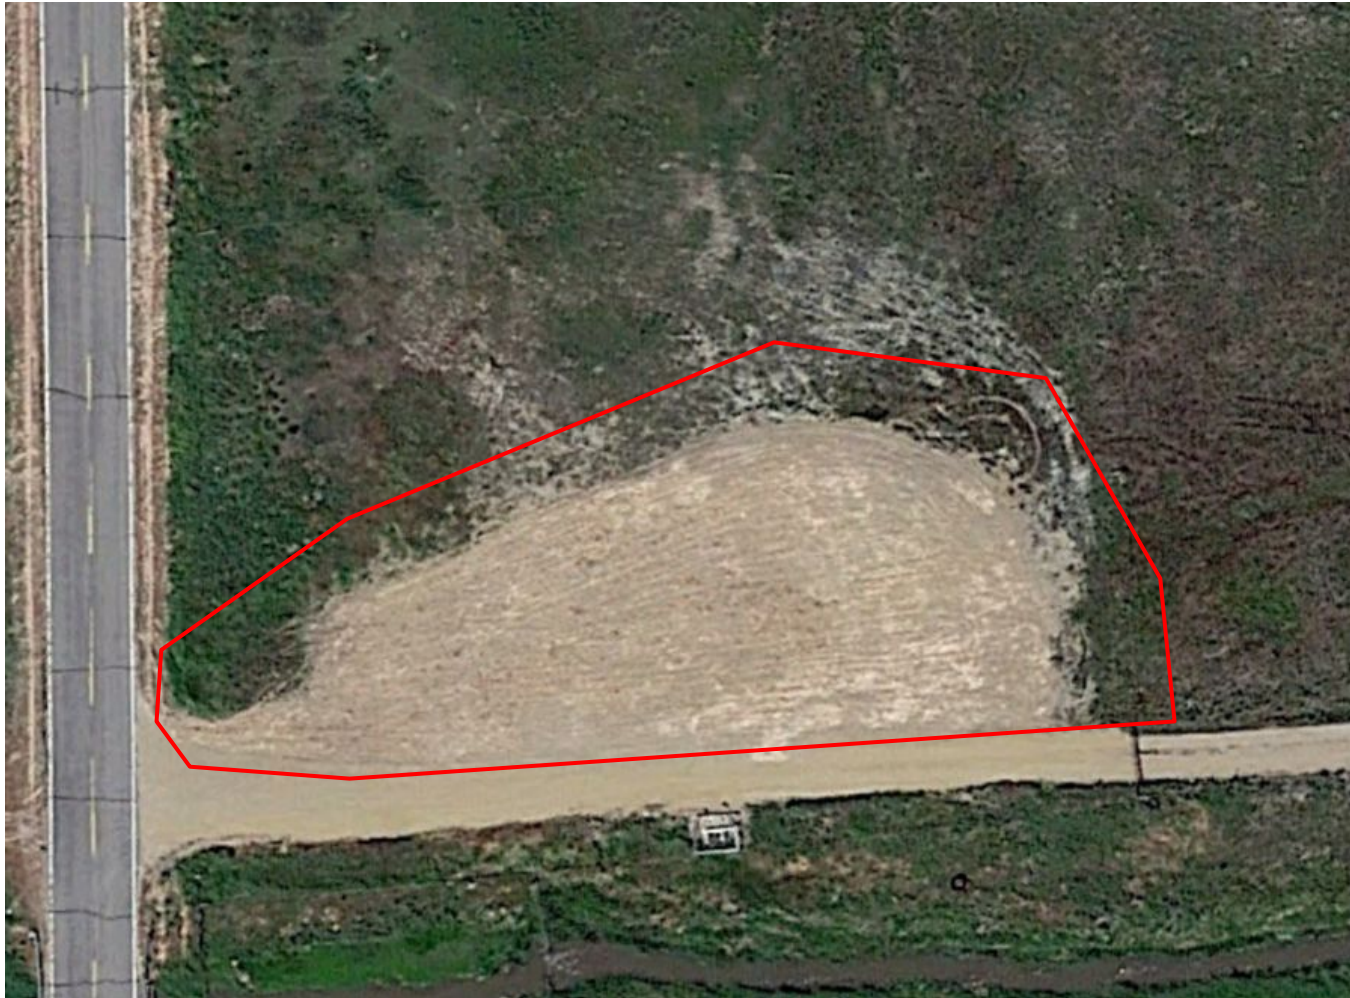
Photo 2. Google Earth aerial imagery taken June 14, 2016 shortly after final reclamation activities were completed.

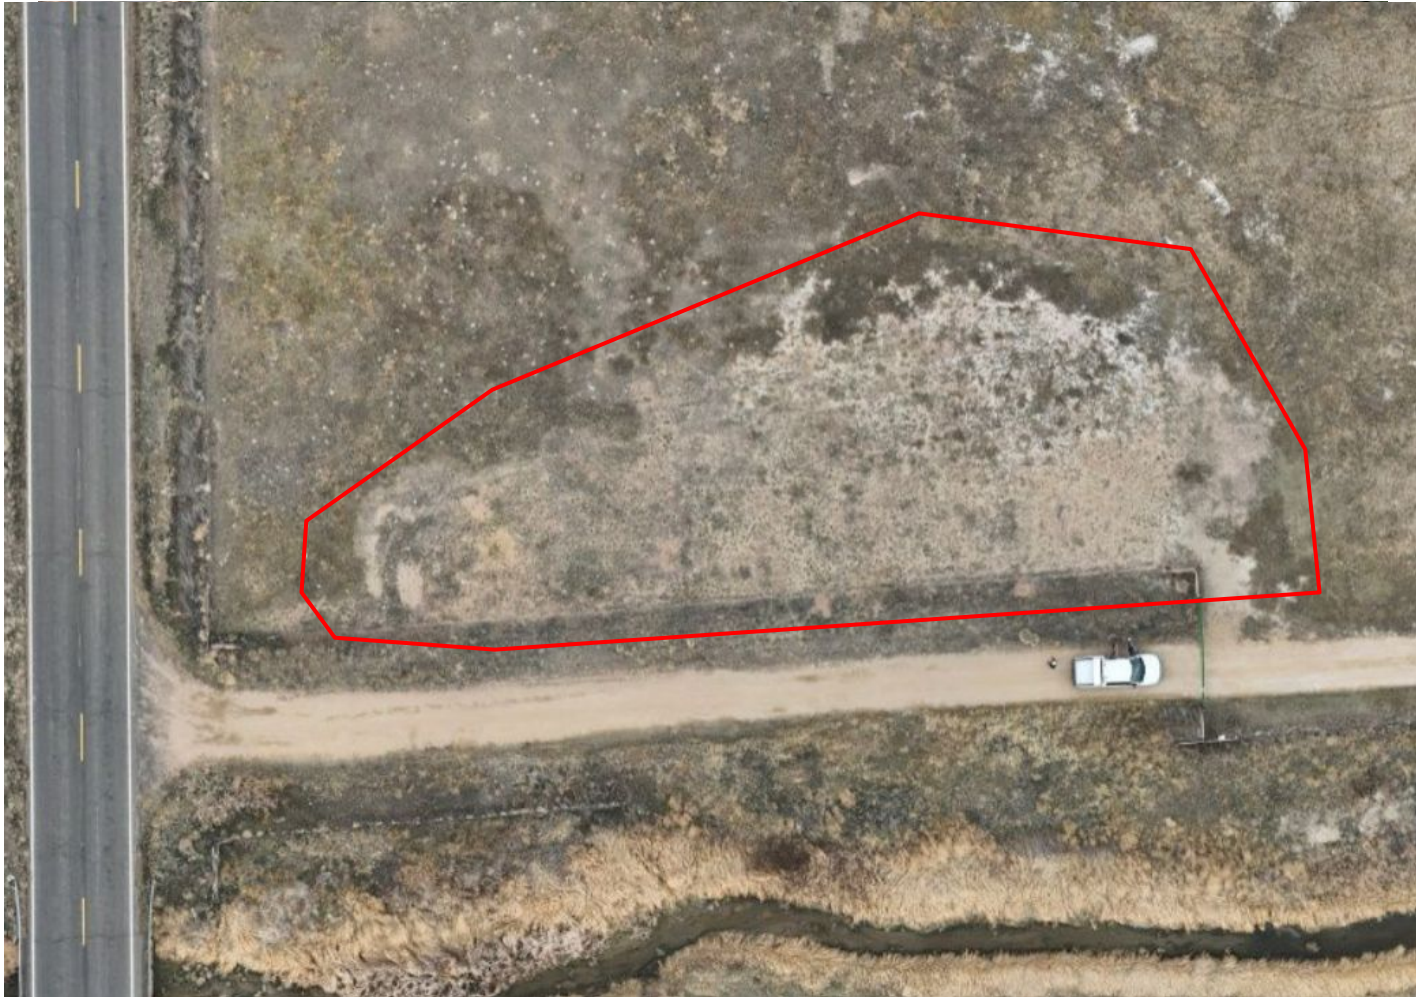
Photo 3. ECMC drone imagery taken March 25, 2025. Photo illustrates the tank battery location is evident due to the lack of vegetation establishment, which is not reflective of reference areas.

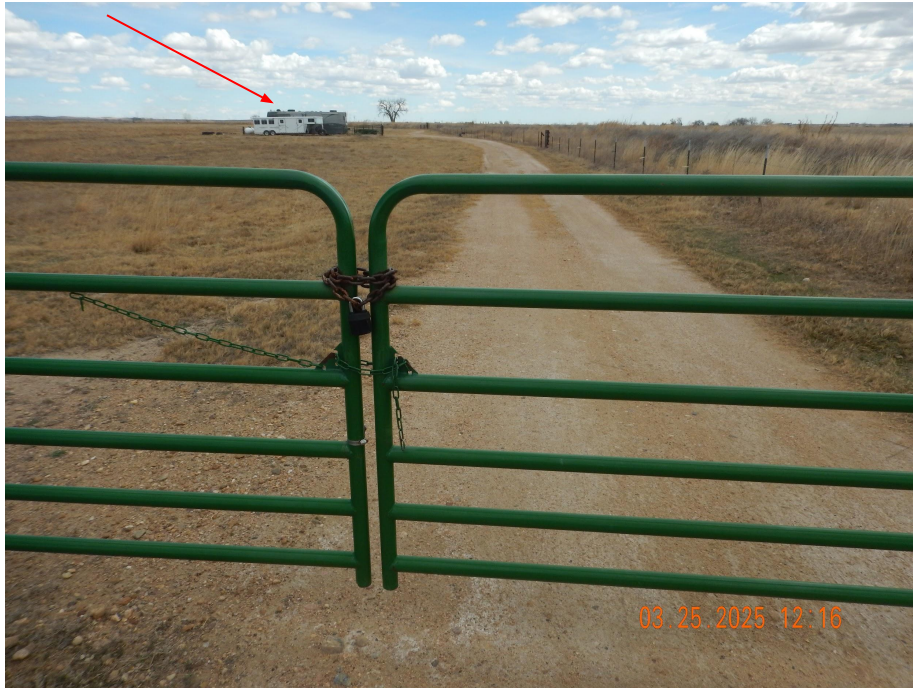
Photo 4. Photo taken from the entrance of the location, facing East. Photo illustrates the location has a locked, gated entrance.

Note- the access road and well location (red arrow) have an approved variance not to reclaim per Rule 1004 and leave it stabilized with gravel.

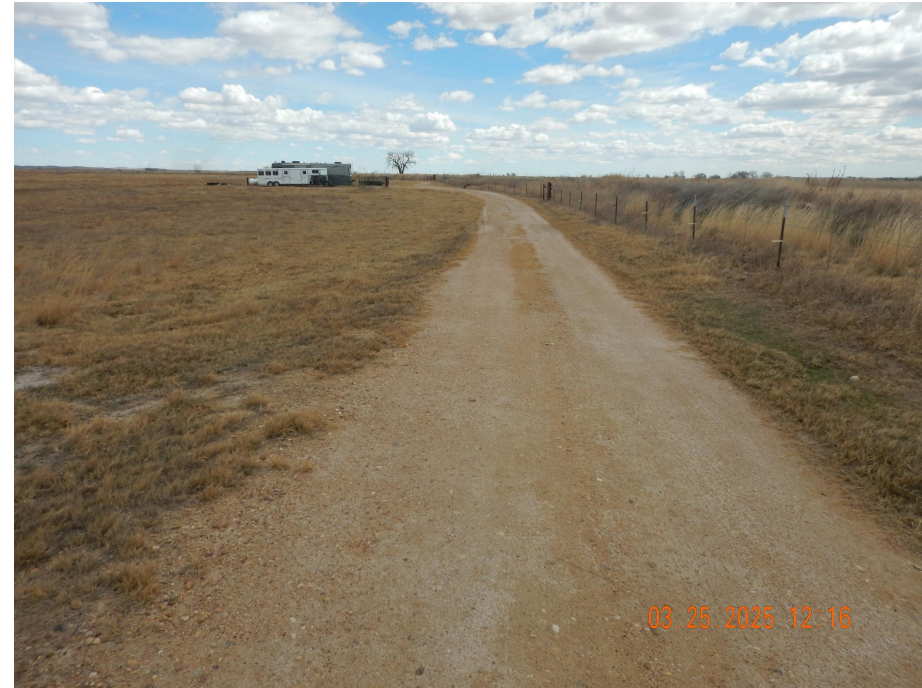
Photo 5. Photo taken from a portion of the western access road, facing West. Photo illustrates the access road has been left graveled and stabilized. At the time of this inspection, there were no stormwater erosion issues.

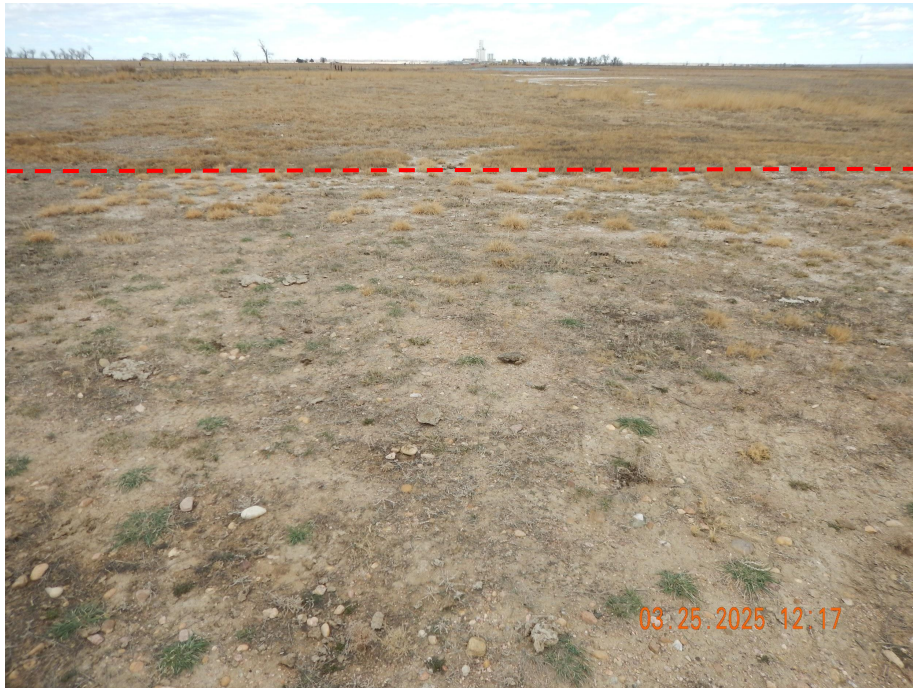
Photo 6. Photo taken from the central tank battery, facing North. Photo illustrates there is some establishment of grass species but predominantly bare ground.

Reference area vegetation is above the red-dashed line.

Note- it does not appear the grass species seeded is reflective of reference vegetation. It appears that introduced grass species were seeded.

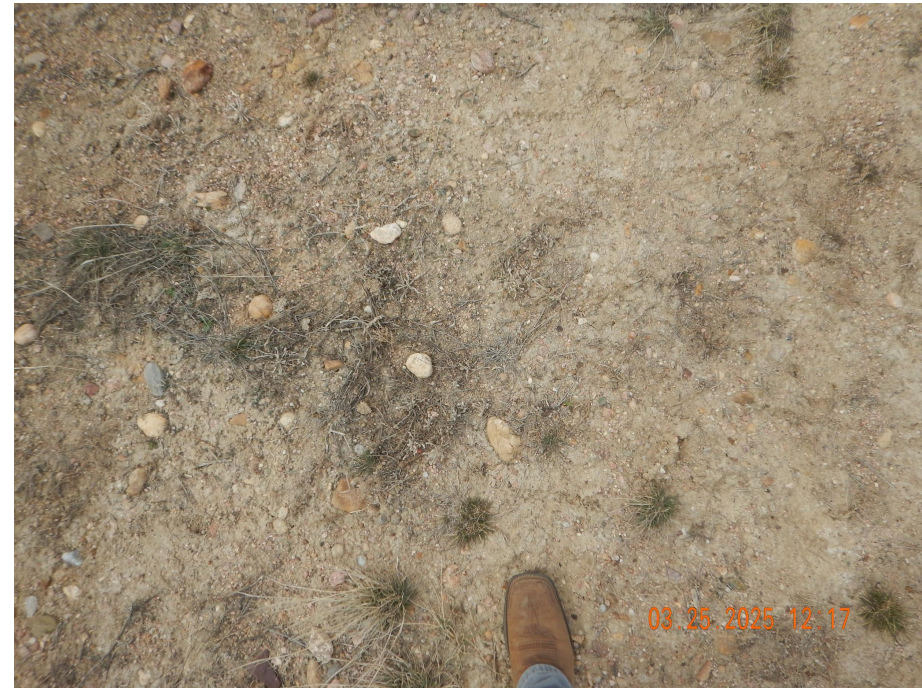
Photo 7. Close up photo taken from a portion of the tank battery illustrating what appears to be introduced grass species (small green bunch grasses) and bare ground.

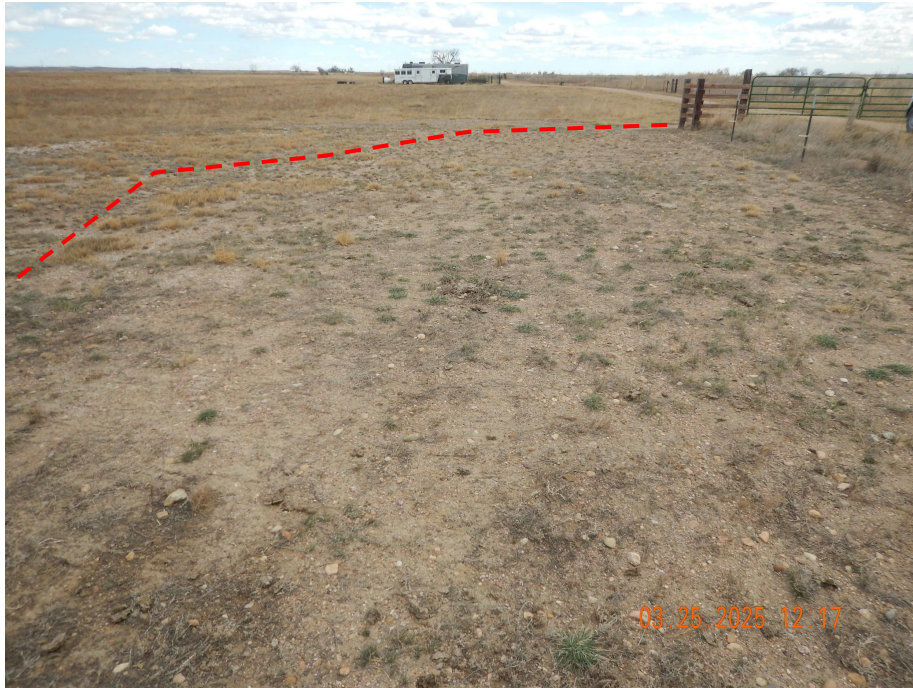
Photo 8. Photo taken from the central tank battery, facing East. See comments under Photo 6.

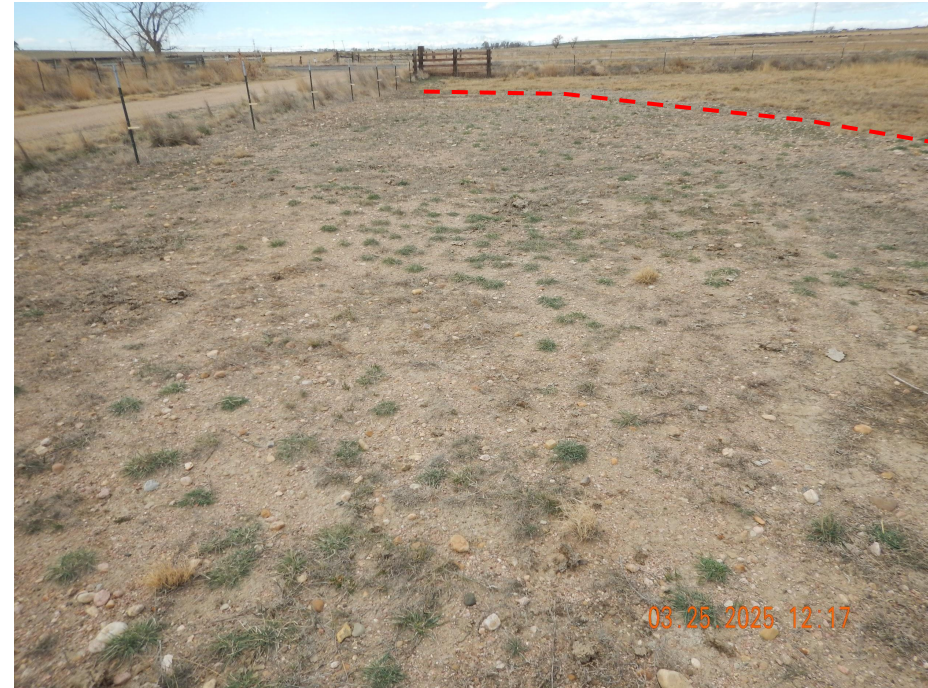
Photo 9. Photo taken from the central tank battery, facing West. See comments under Photo 6.

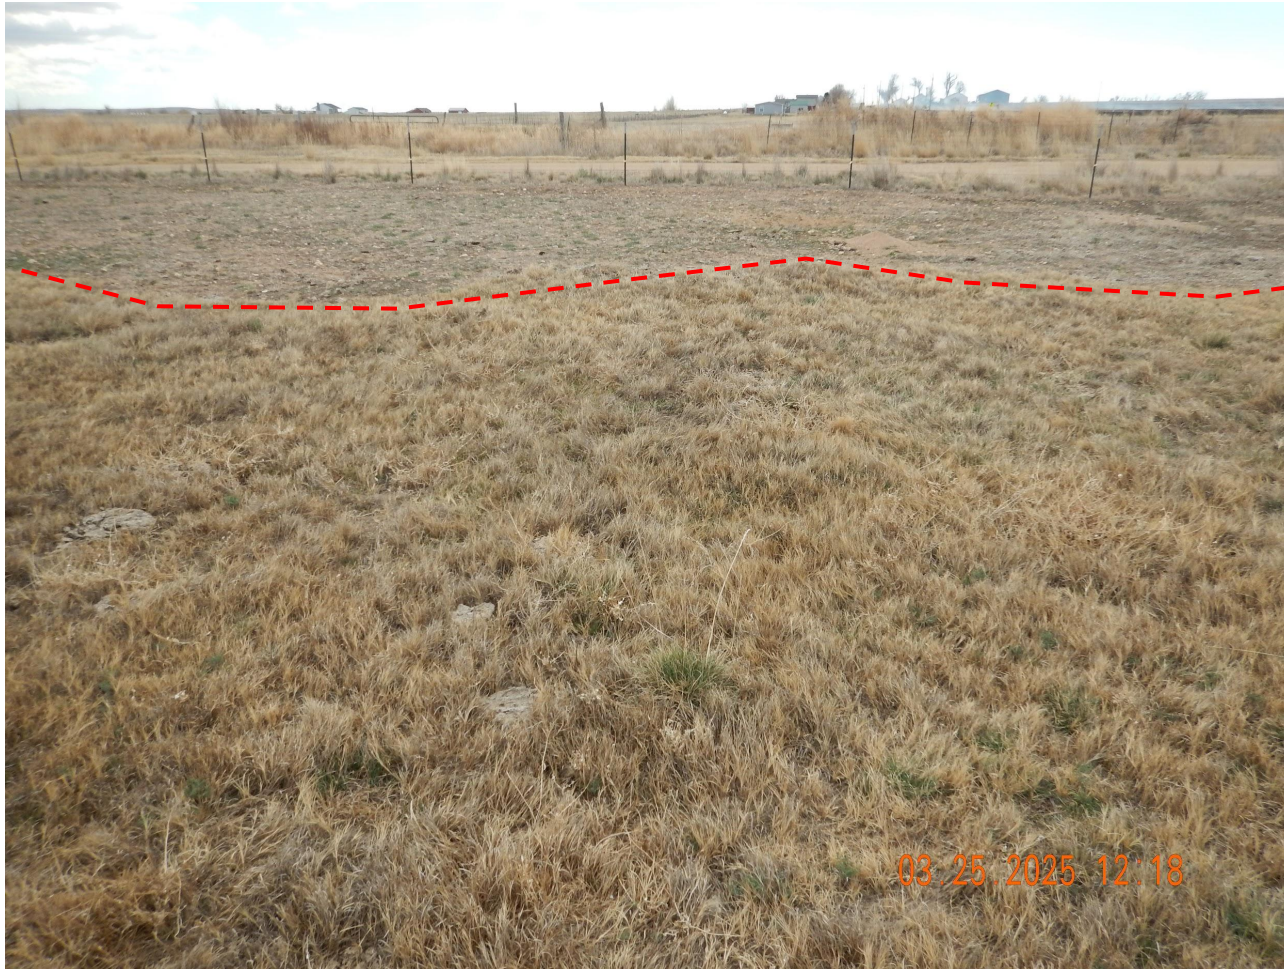
Photo 10. Reference vegetation photo taken north of the tank battery, facing South. Reference area vegetation is below the red-dashed line, which consists primarily of Saltgrass (*Distichlis spicata*).
