Inspection Photos

Operator: Highpoint Operating - 10071

Location ID: 313612

Inspection Photos
Location Name: Koskie Brumley Draw 15H
Location ID: 313612

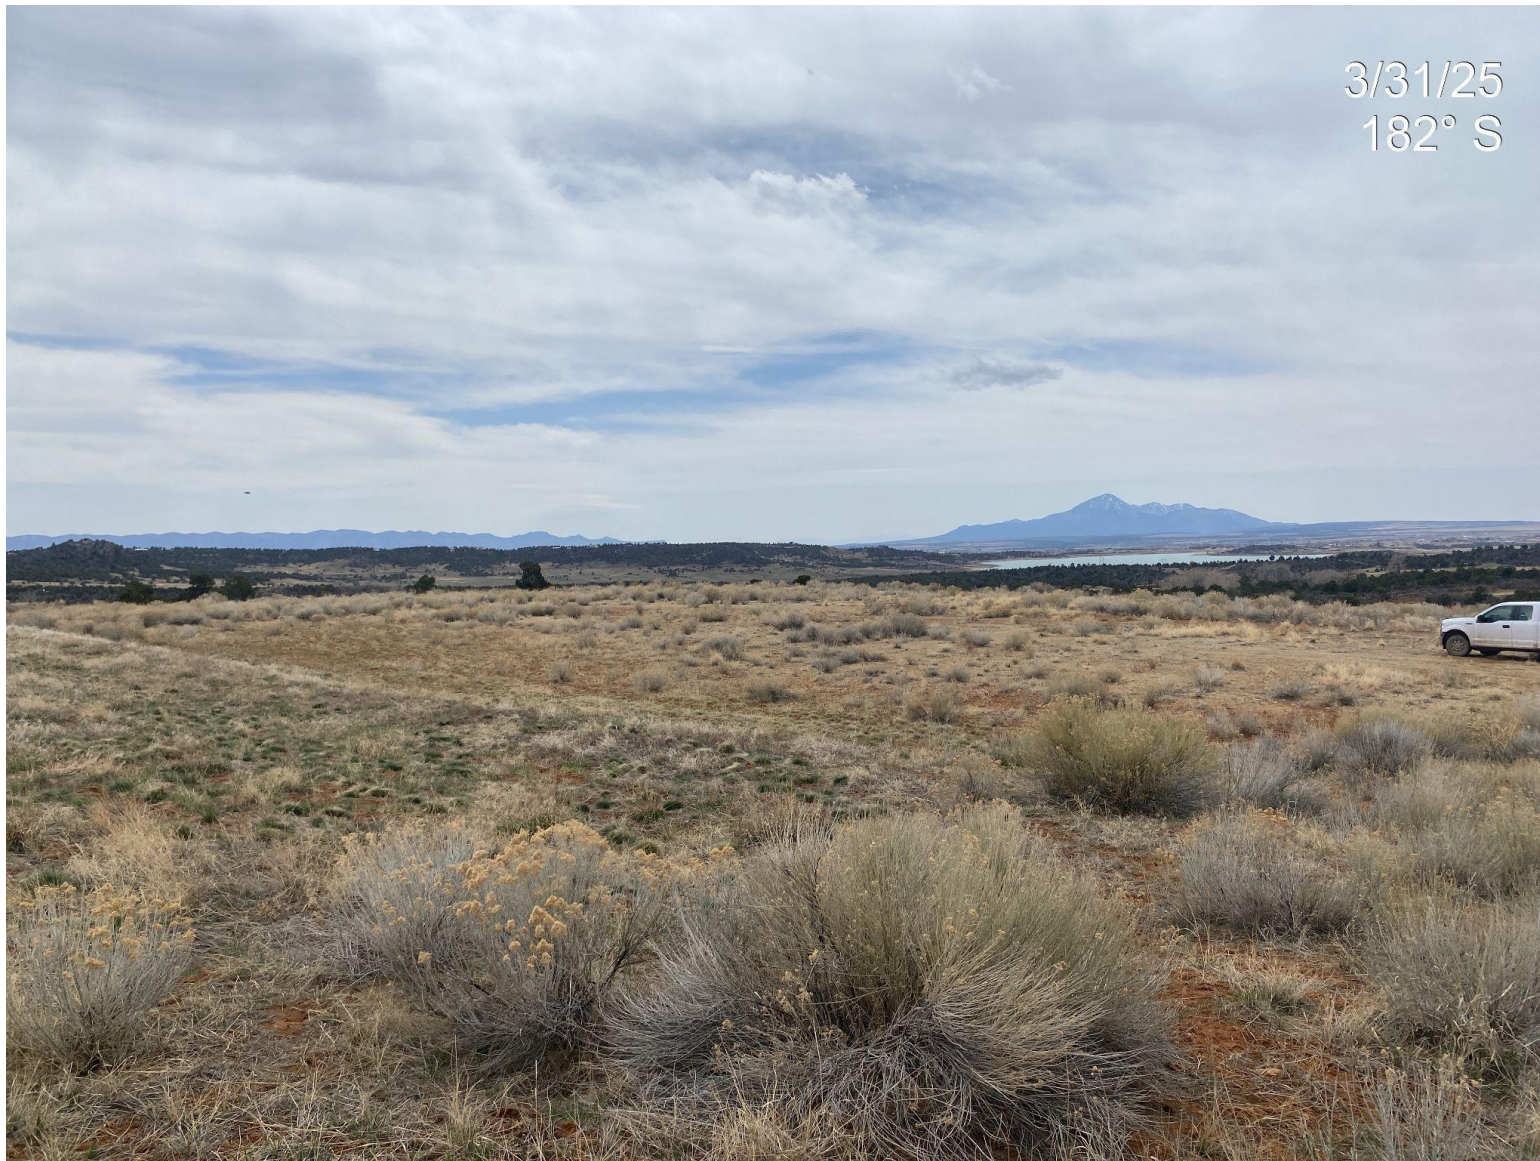
3/31/25
182° S

Photo 1. View of project area taken from the northern edge facing center. Note: location has pad, fill and cut slope have not been recontoured per 1004 reclamation standards.

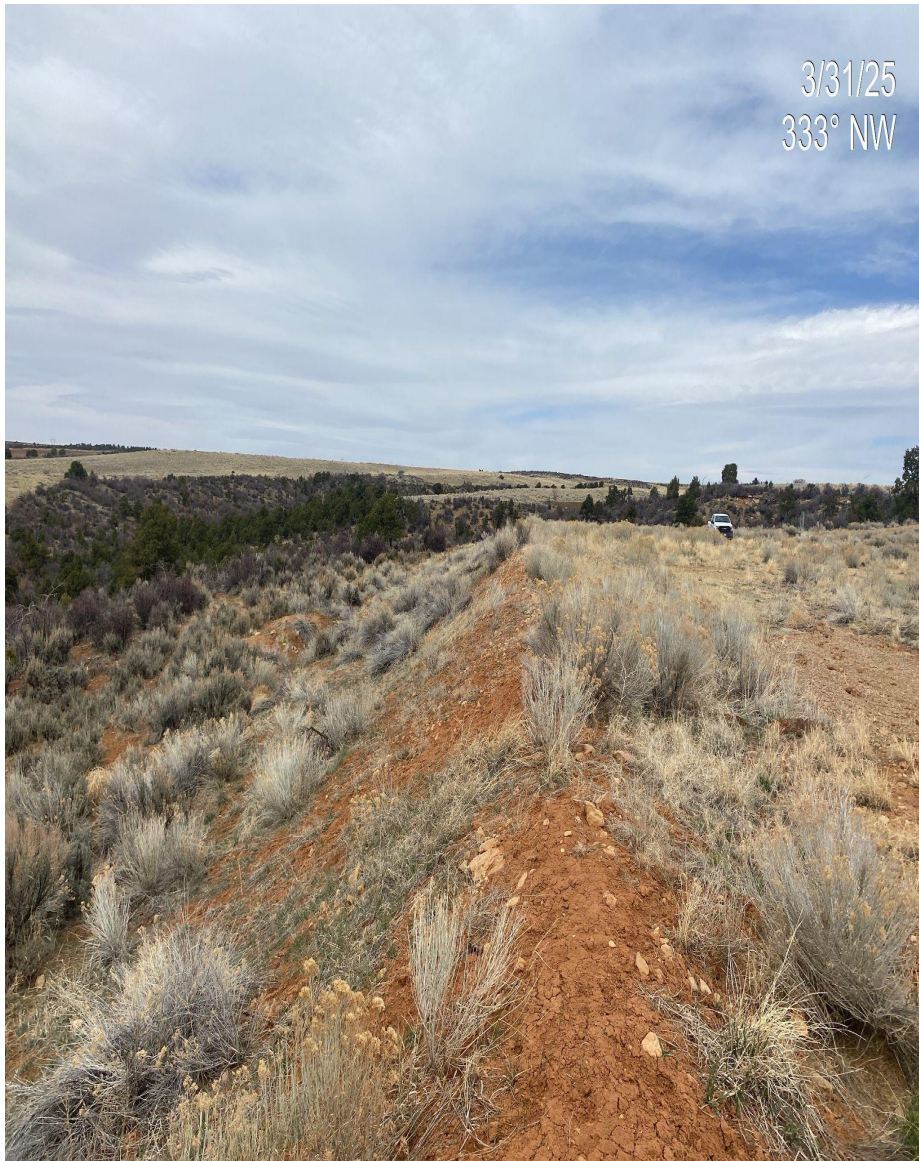
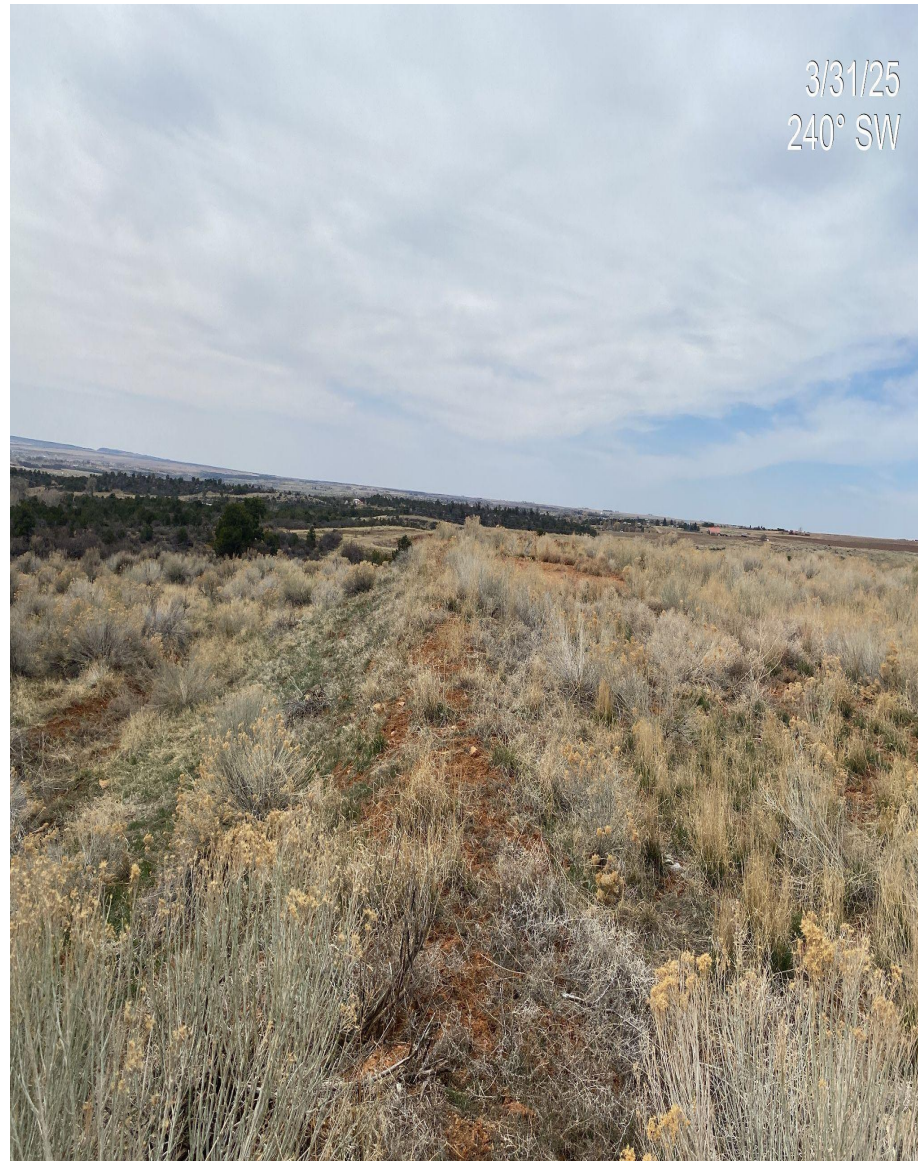
Photo 2. View of location fill slopes. Slopes have establishment of desirable vegetation including but not limited to Crested Wheatgrass, Sand Dropseed and Rabbitbrush.

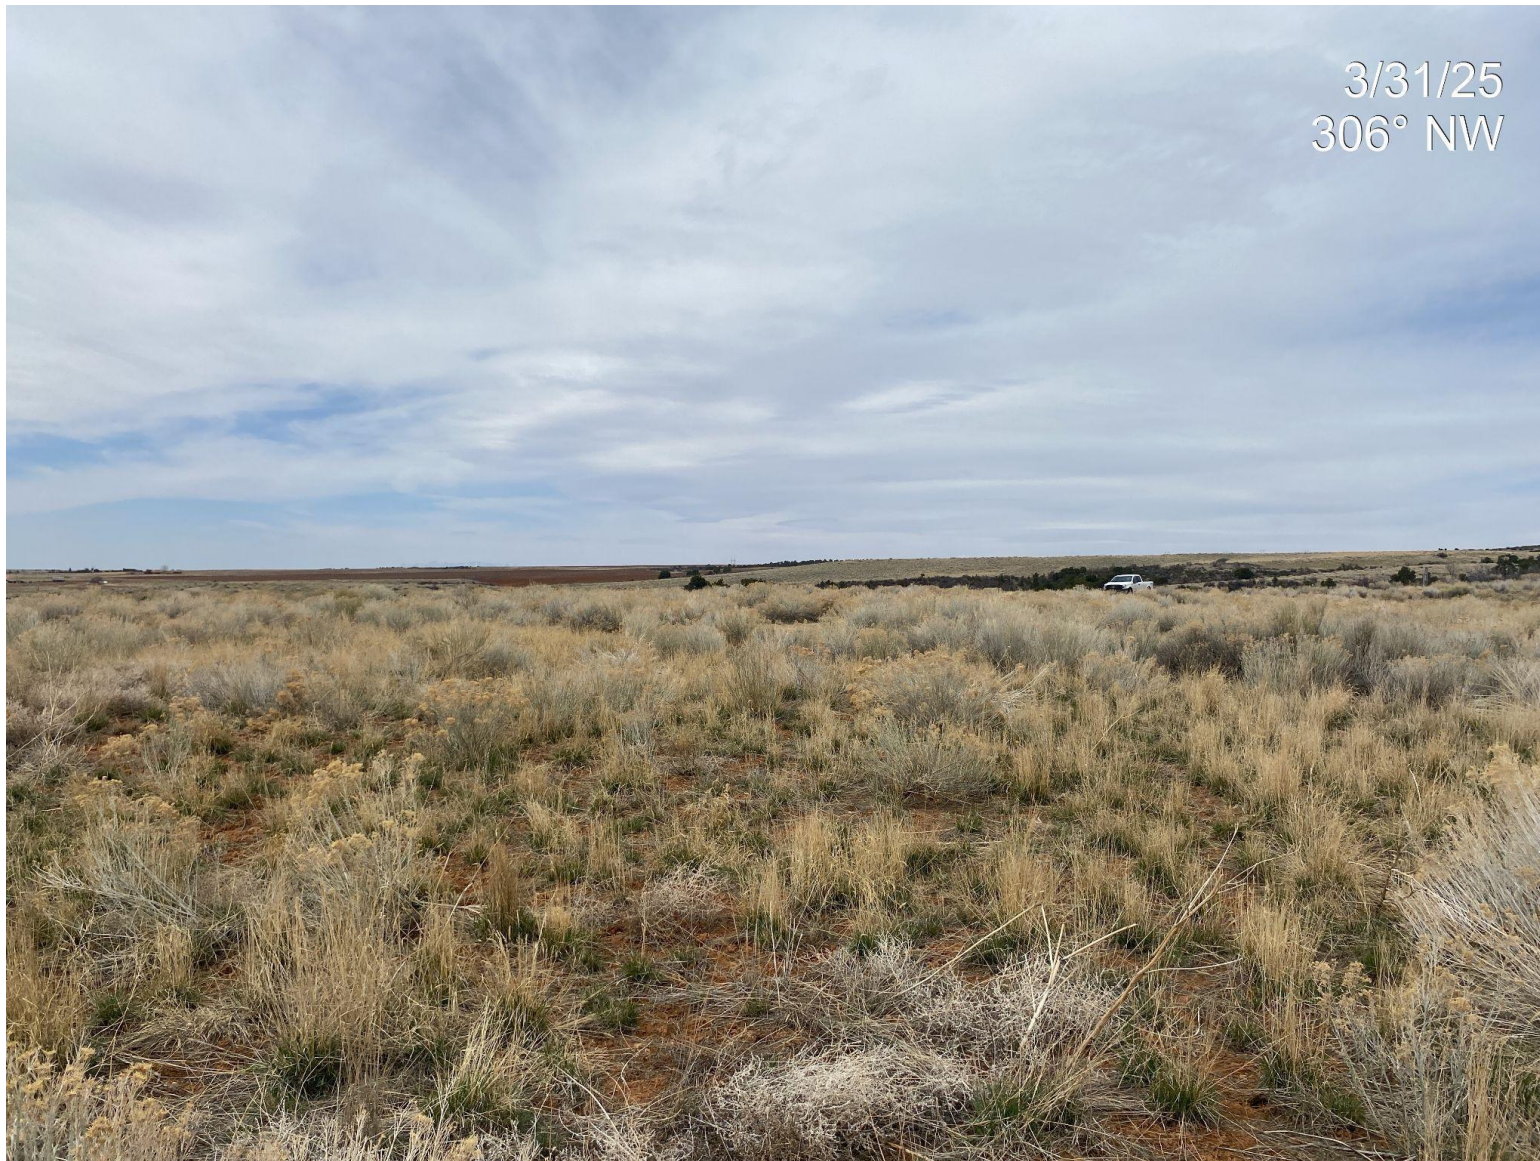
3/31/25
306° NW

Photo 3. View of flat portion of project area/pad taken from the southern edge facing center. Note: flat portion of project area has been revegetated with desirable vegetation including but not limited to Sand Dropseed, Crested Wheatgrass and Rabbitbrush.

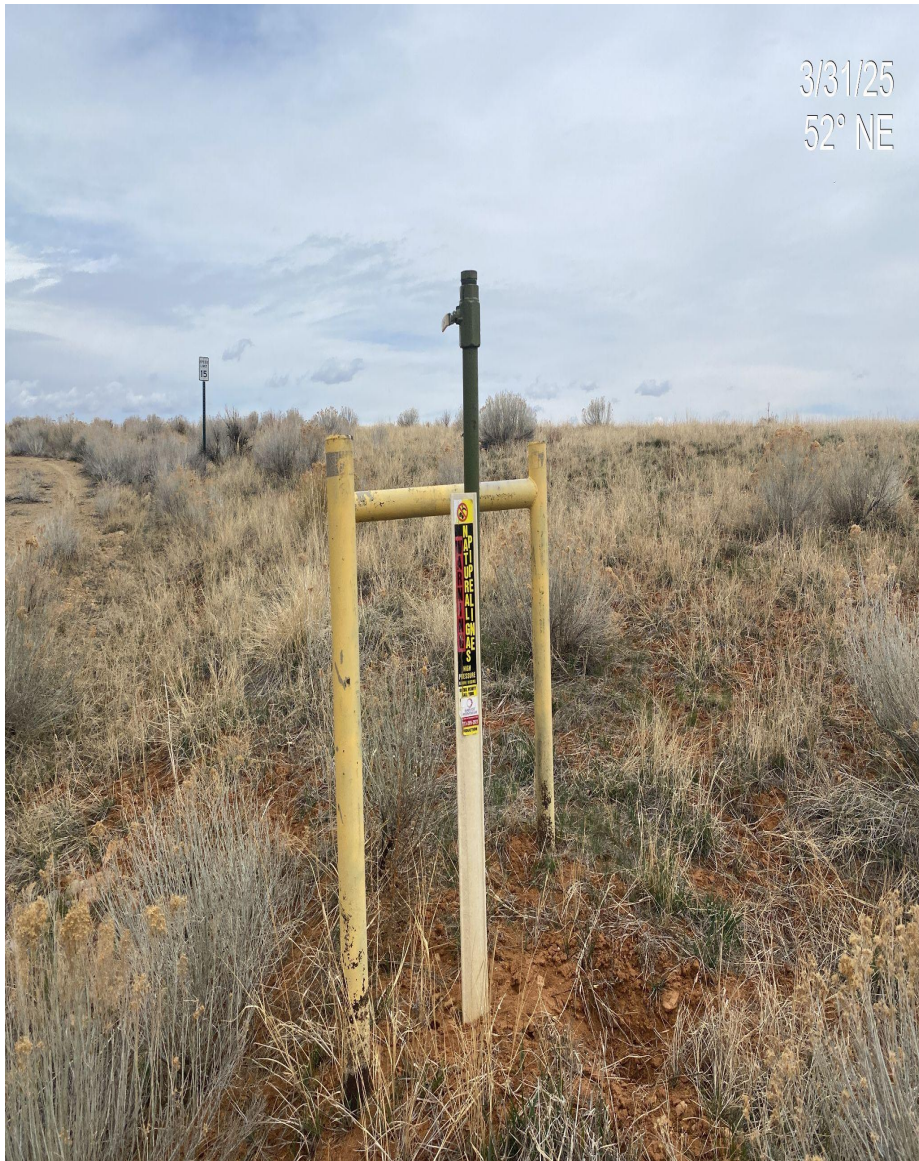
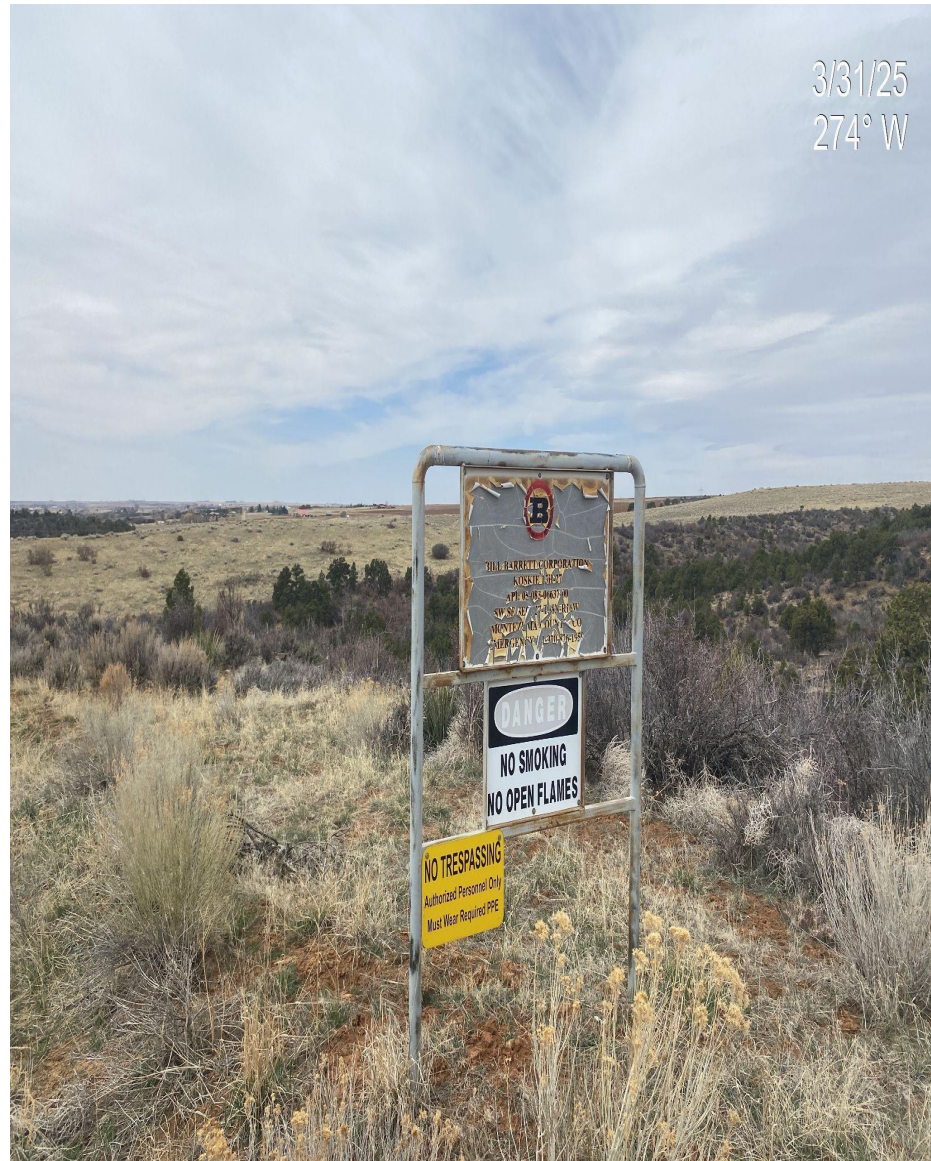
Photo 4. View of riser and location sign that remain at the access point of the location.
