Inspection Photos

Operator: CAERUS PICEANCE LLC - 10456

Location ID: 314334

Inspection Doc: 718100394

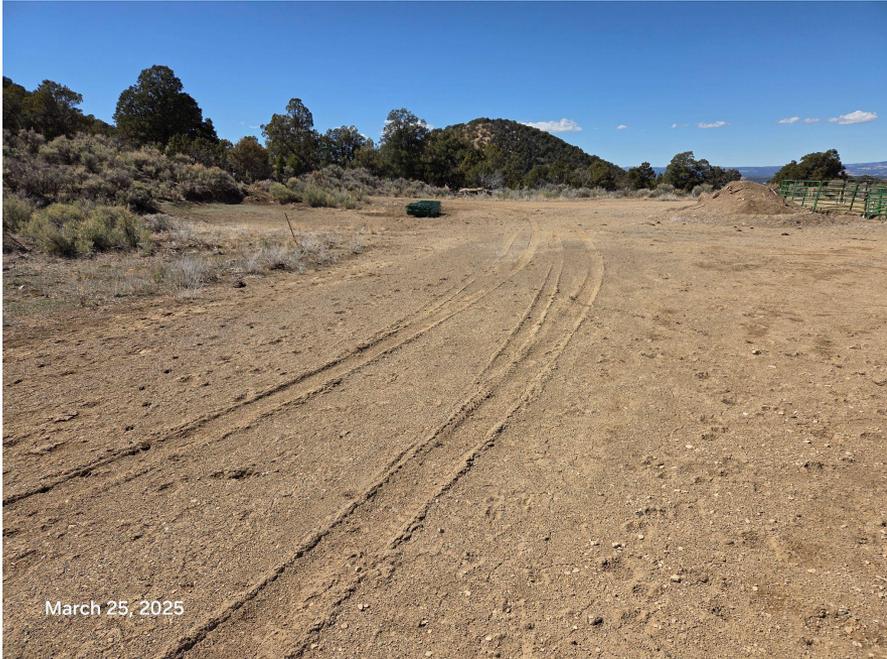
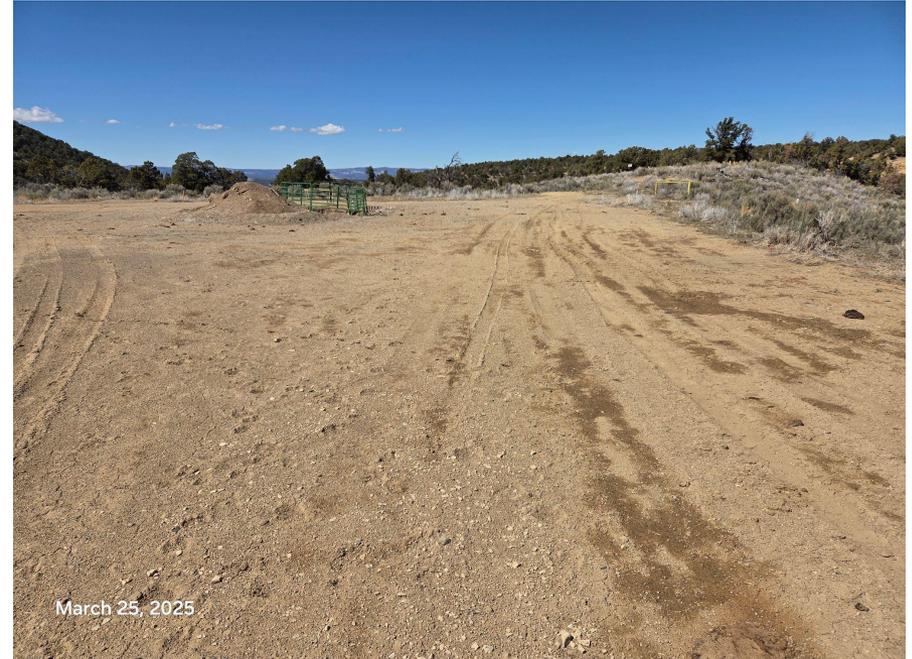
Photo 1: Photos taken from the east end of the Location, facing southwest and northwest. Photos provide an overview of the Location.

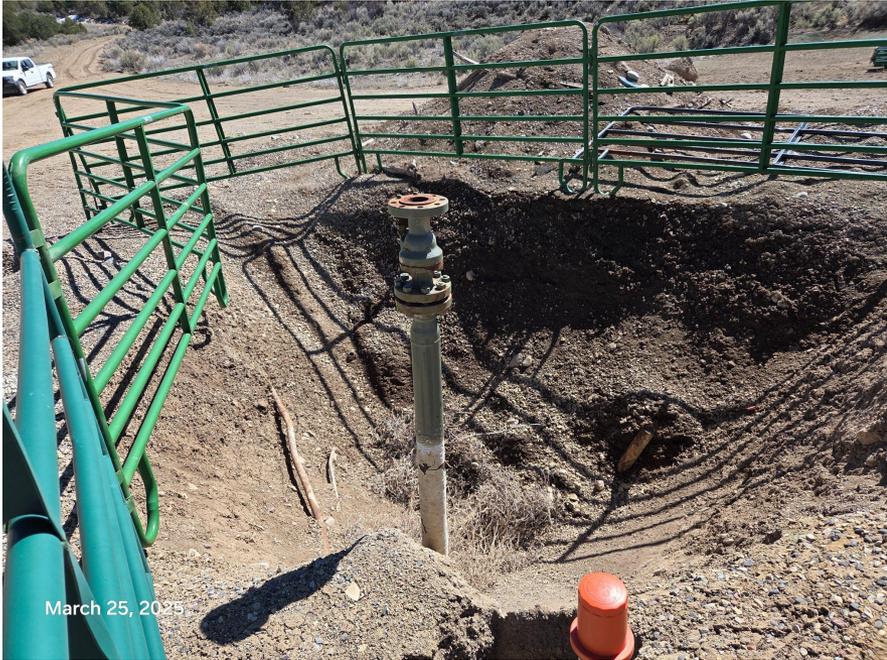
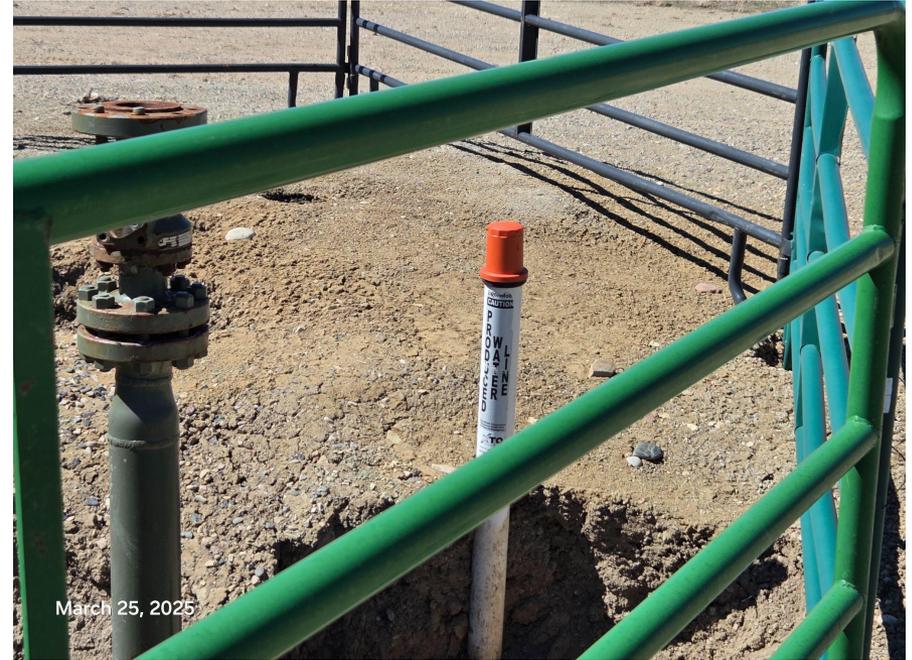
Photo 2: Photo taken from the well. Pursuant to Form 6(s), well was cut/capped 10/24/2023. Pursuant to Rule 1004.a, surface equipment was required to be removed by 1/2024. Photo shows riser equipment remaining on the Location. Risers require removal.

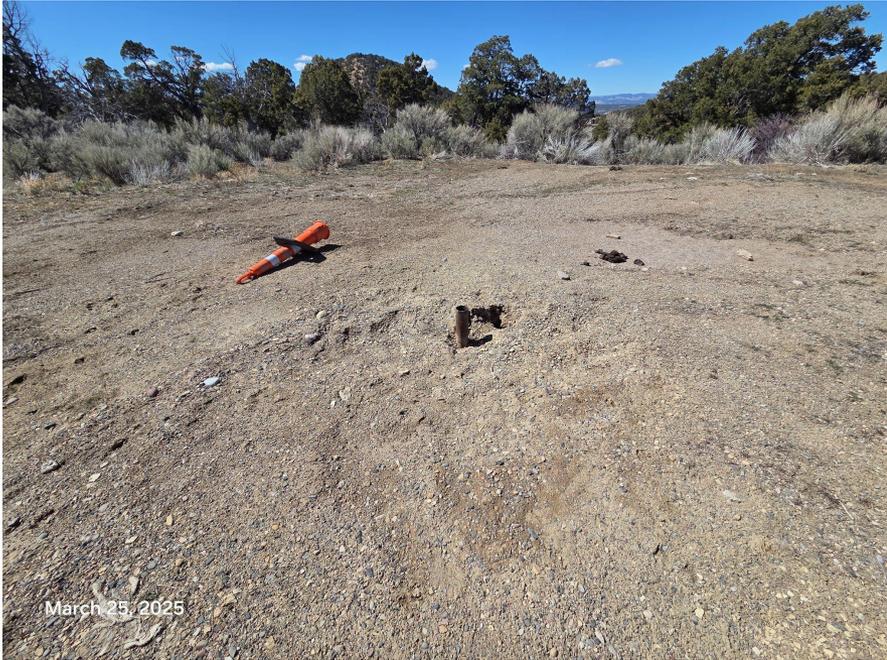
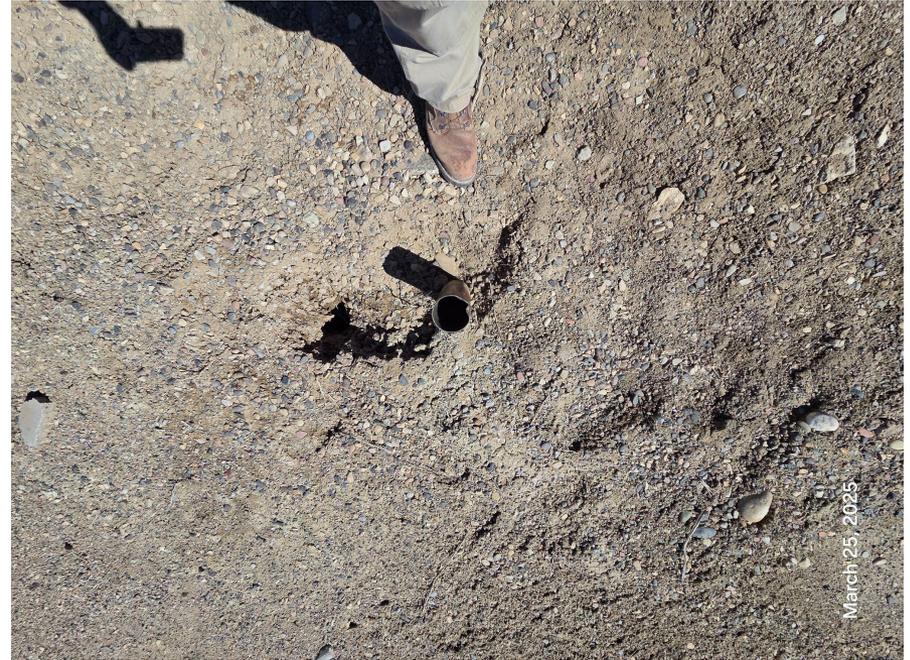
Photo 3: Photo taken from the west end of the Location. Photo shows pipe riser remaining on the Location. BMPs to prevent wildlife access to the pipe are missing. Pipe requires removal.

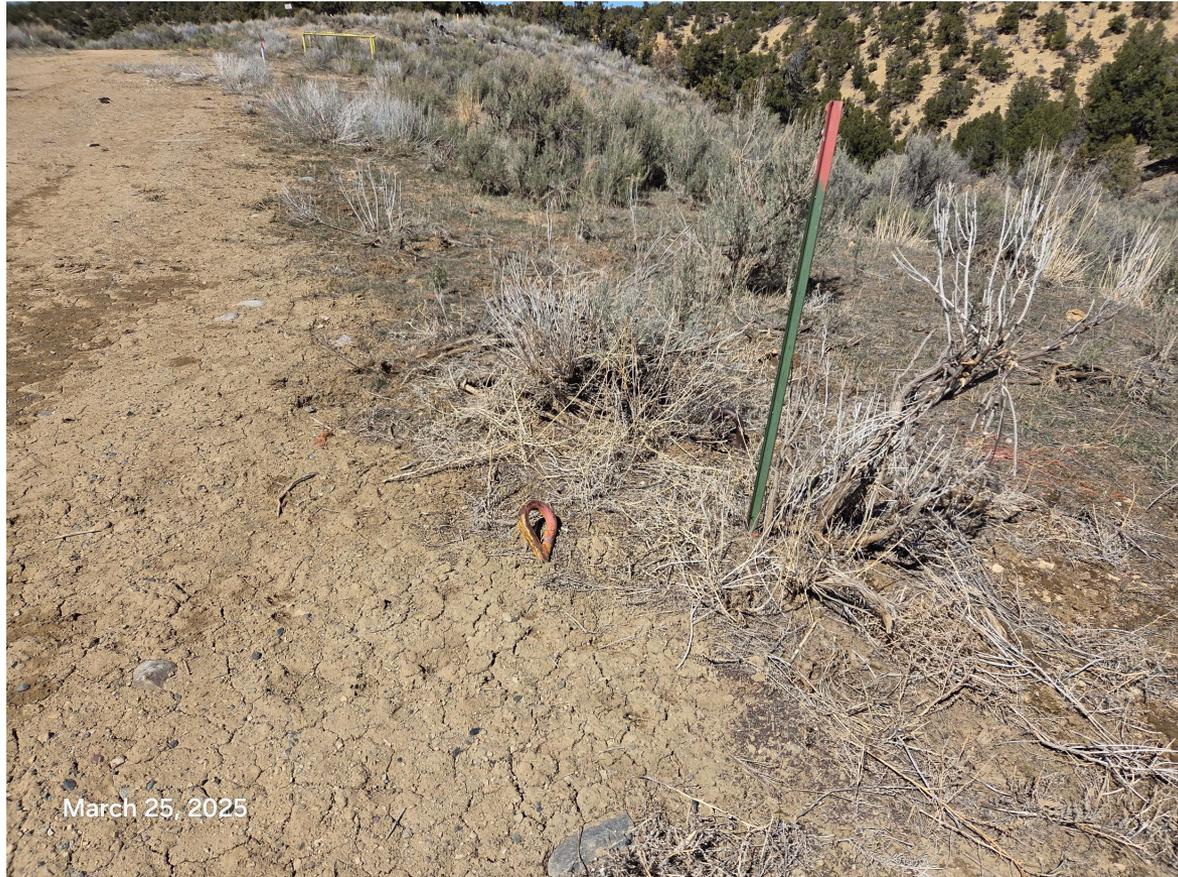
Photo 4: Photo taken from the northeast end of the Location. Photo example showing anchor equipment remaining.

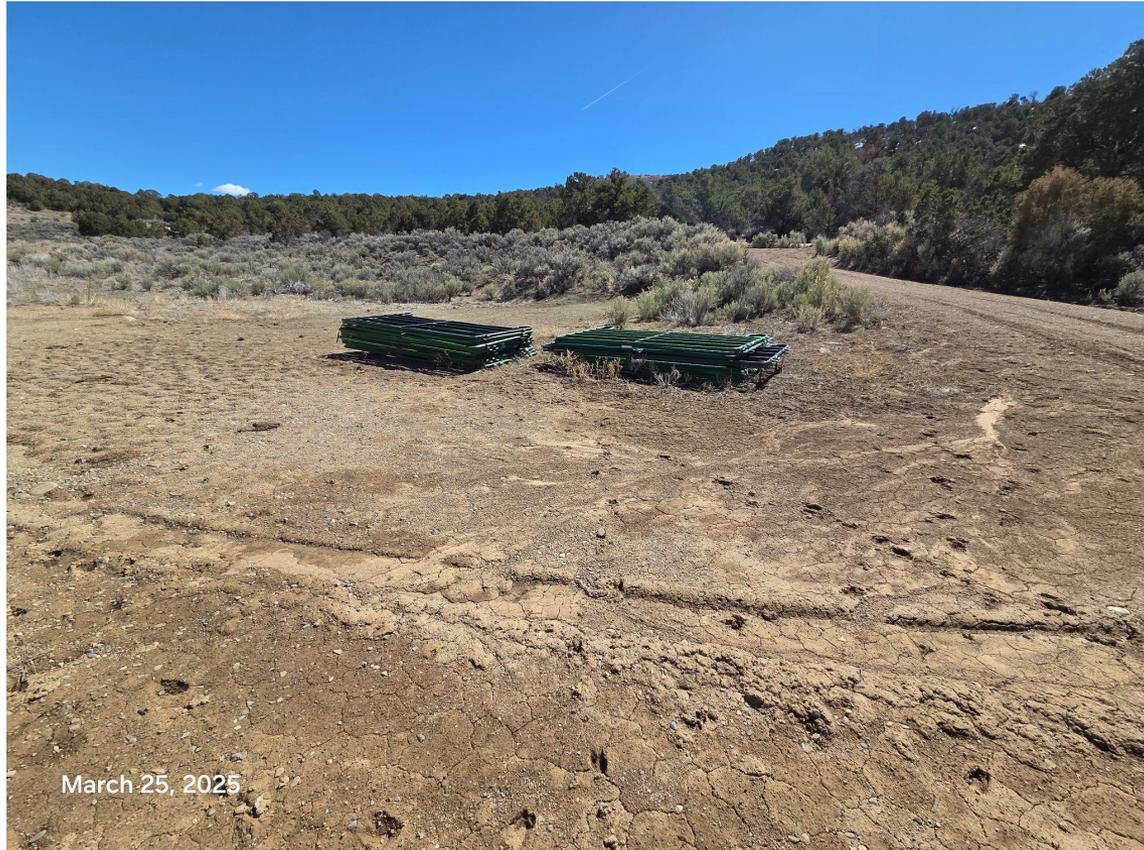
Photo 5: Unused cattle panels stored on the south end of the Location.

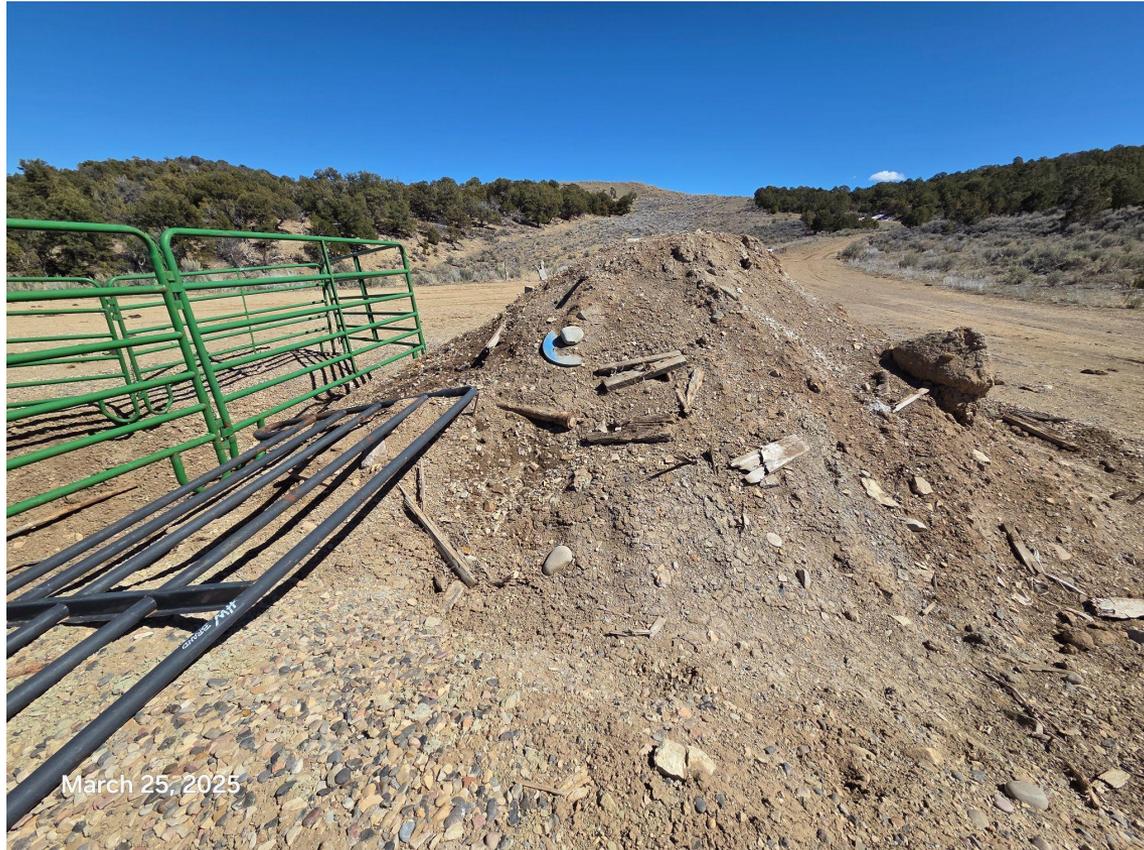
Photo 6: Photo shows the soil stockpile adjacent to the well. Photo also shows various trash/debris/rubbish mixed with the stockpile.
