Inspection Photos

Operator: CAERUS PICEANCE LLC - 10456

Location ID: 315260

Inspection Doc: 718100397

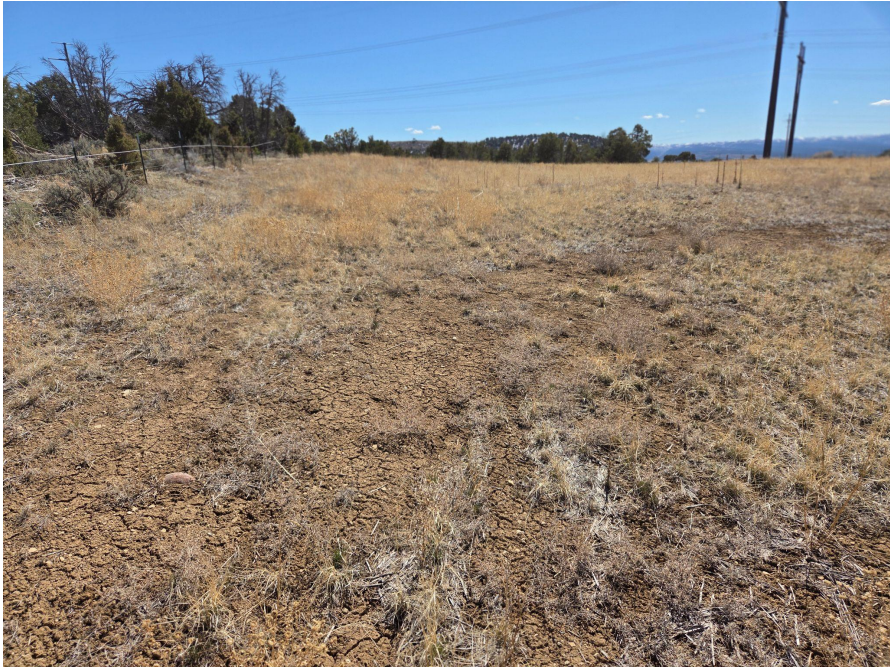
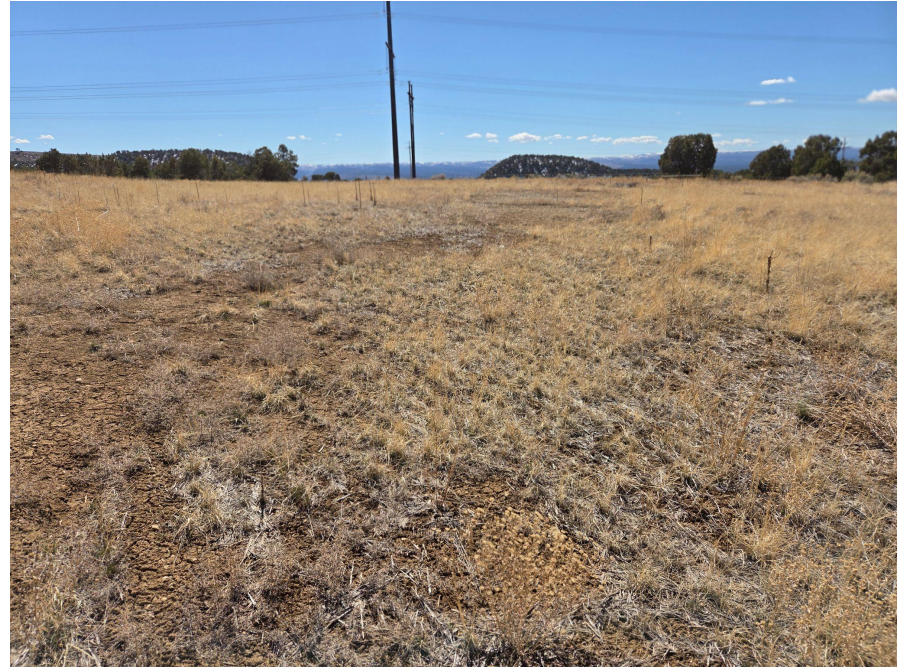
Photo 1: Photos 1-2 taken from the former Location entrance, on the north end of the Location. Photos provide an overview of the Location from south, southwest, to west.

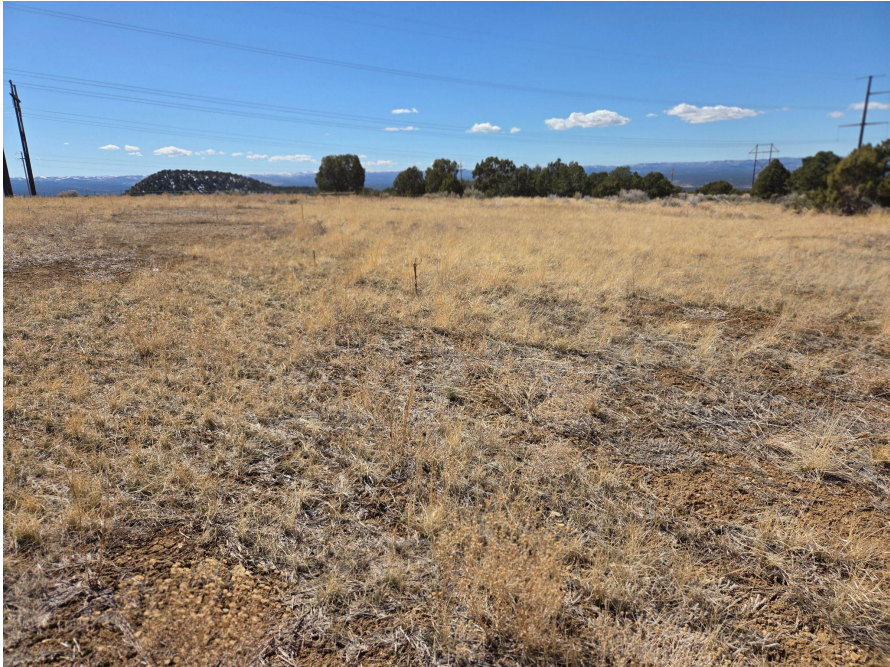
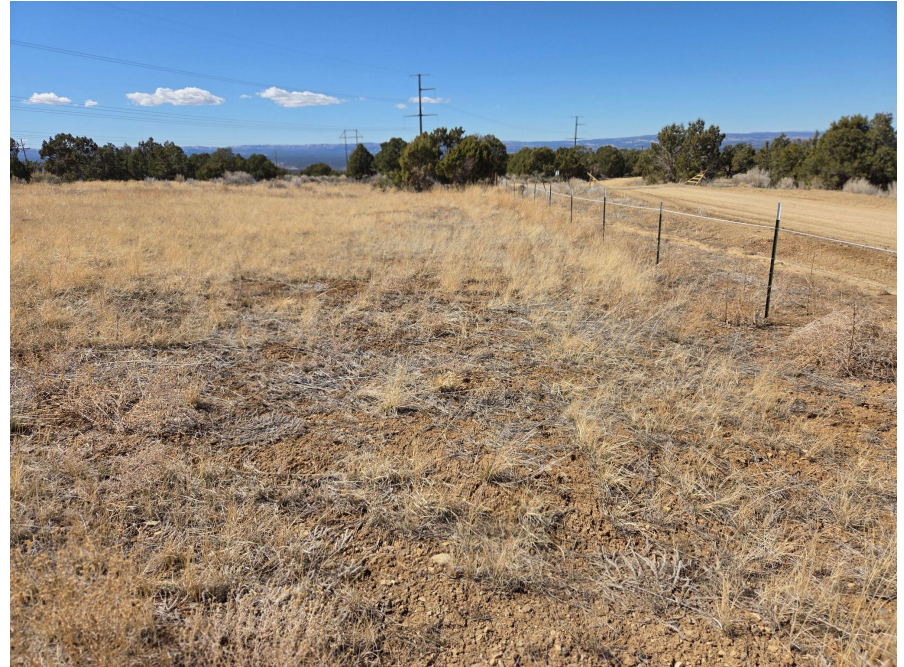
Photo 2: See comments under photo 1.

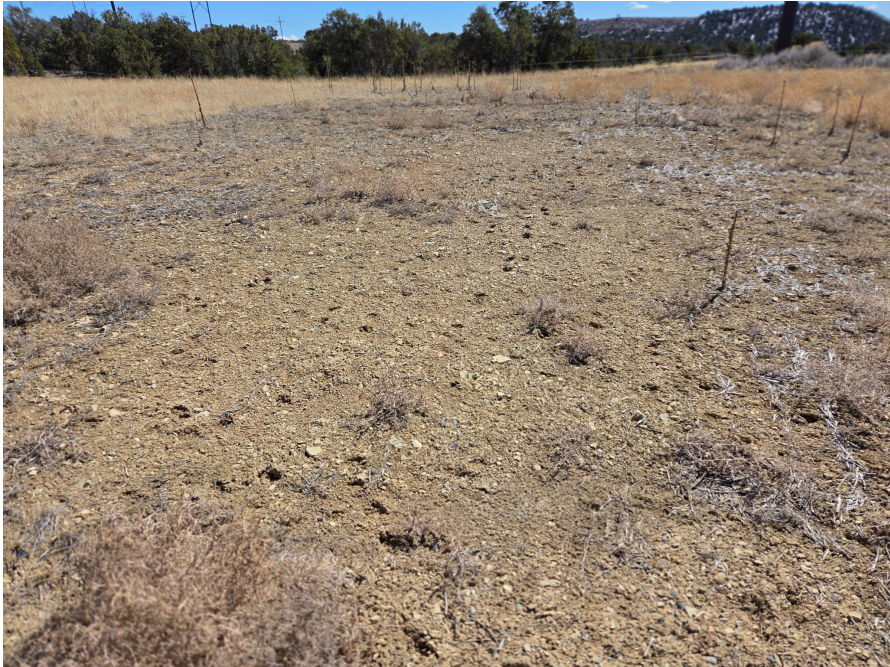
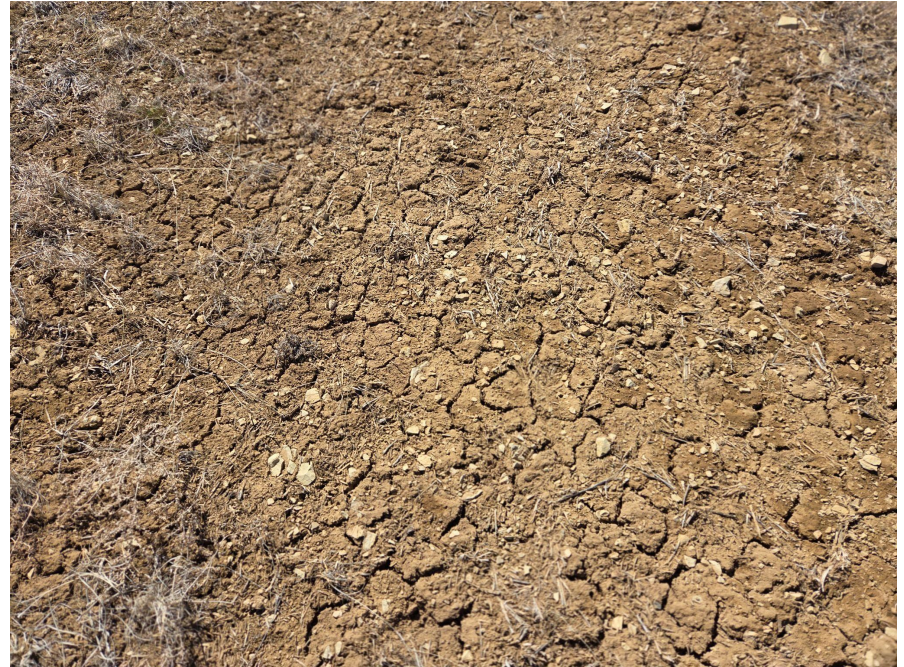
Photo 3: Photos 3-4 taken from the central areas of the Location. Photos examples of areas where desirable, perennial plant establishment is not progressing towards ECMC 1004 uniform standards.

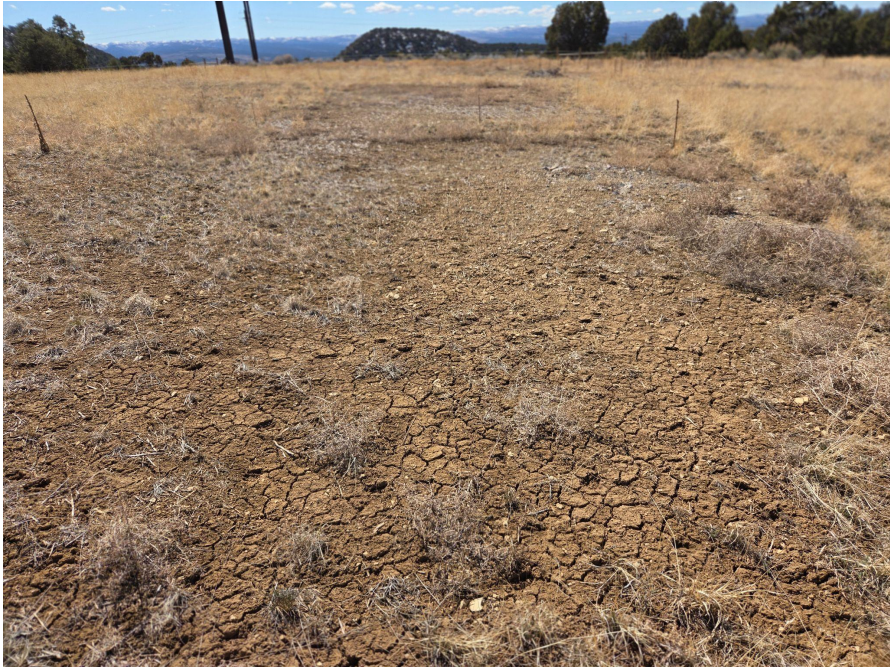
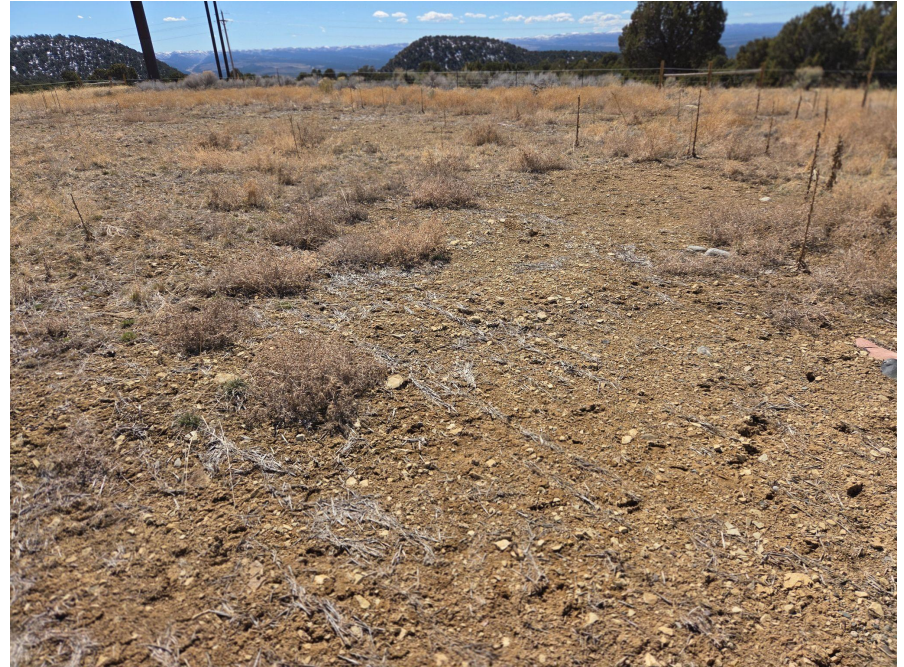
Photo 4: See comments under photo 3.

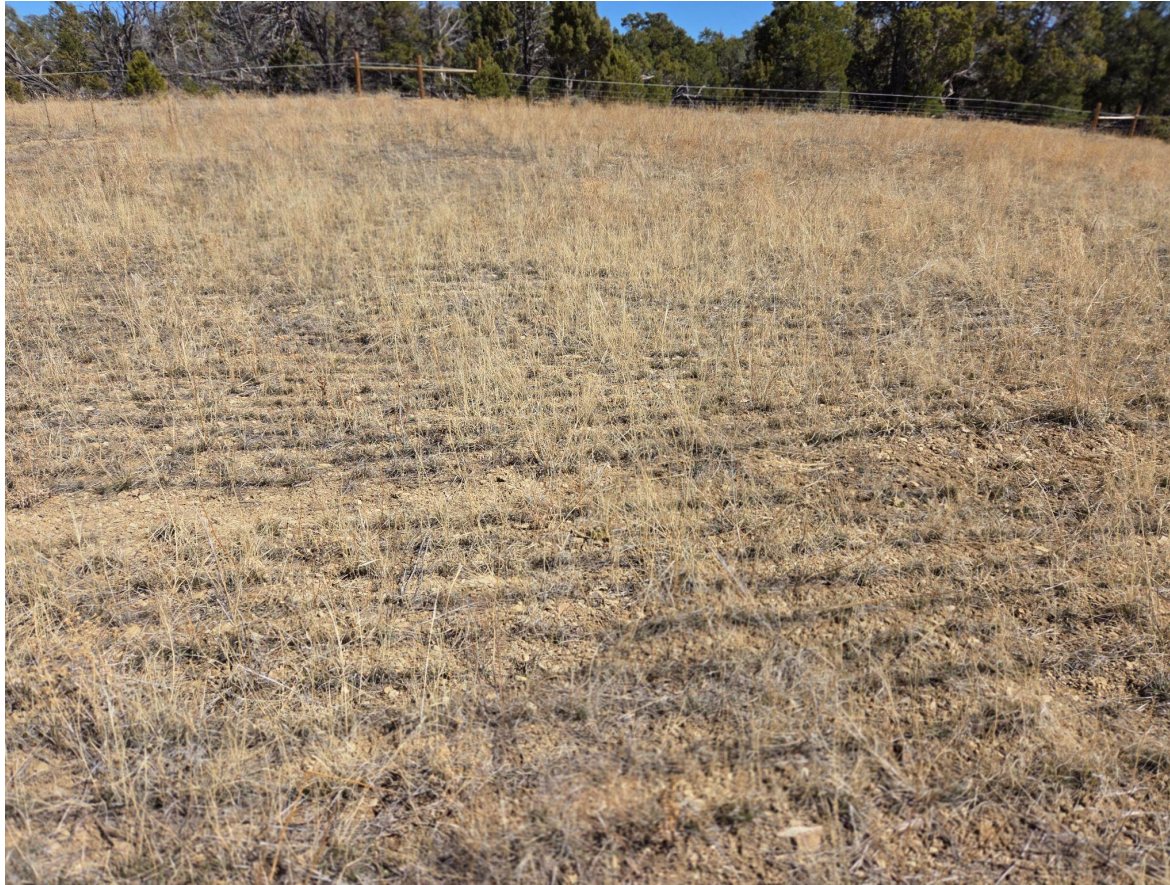
Photo 5: Photo taken from the southern areas of the Location, facing east. Photo example showing outer areas of the Location that are progressing towards 1004 standards.

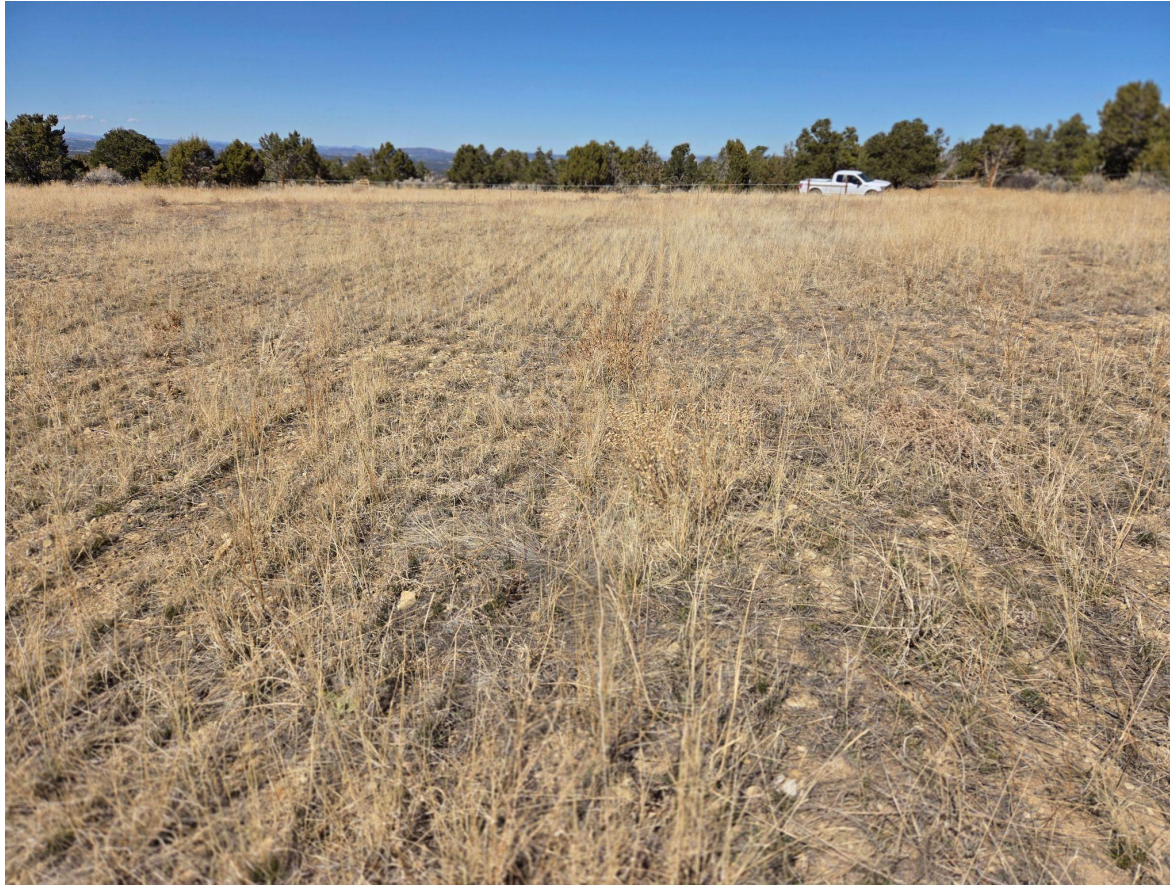
Photo 6: Photo taken from the east end of the Location, facing north. Photo example showing outer areas of the Location that are progressing towards 1004 standards.

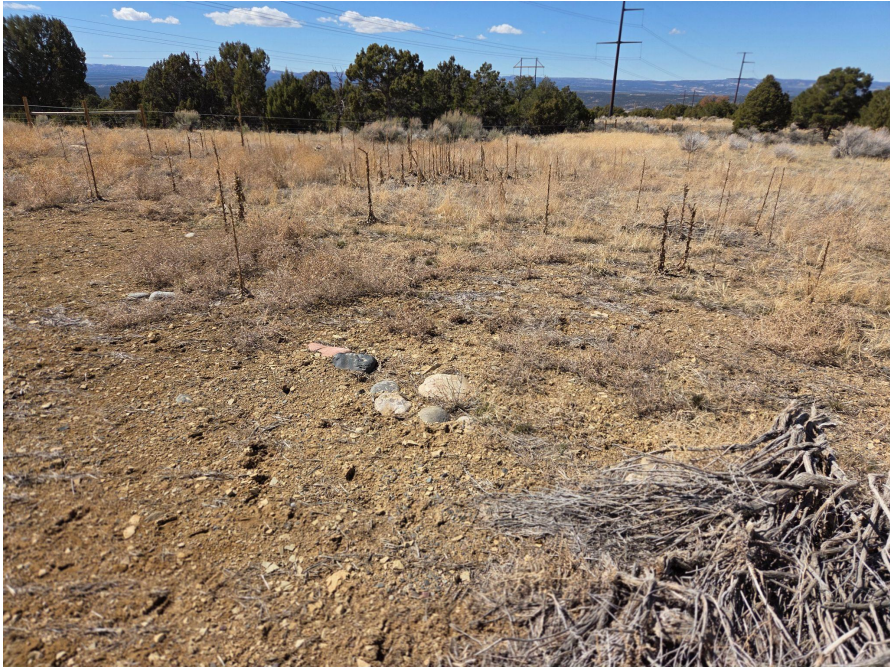
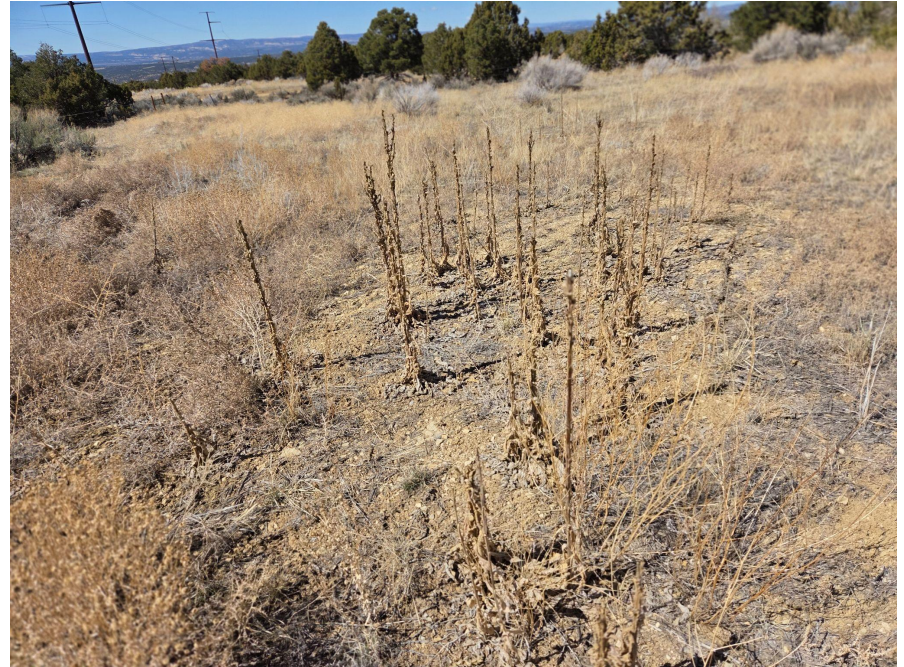
Photo 7: Photo example showing Noxious weed establishment (Common Mullein) observed throughout the Location. Additional weed management efforts required to prevent the further spread and establishment of Noxious weeds on this Location.
