# Final Reclamation Inspection

Location ID: 320486

Inspection Document #: 718800109

Inspection Photos  
Location Name: HSR STATE #6-16  
Location ID: 320486

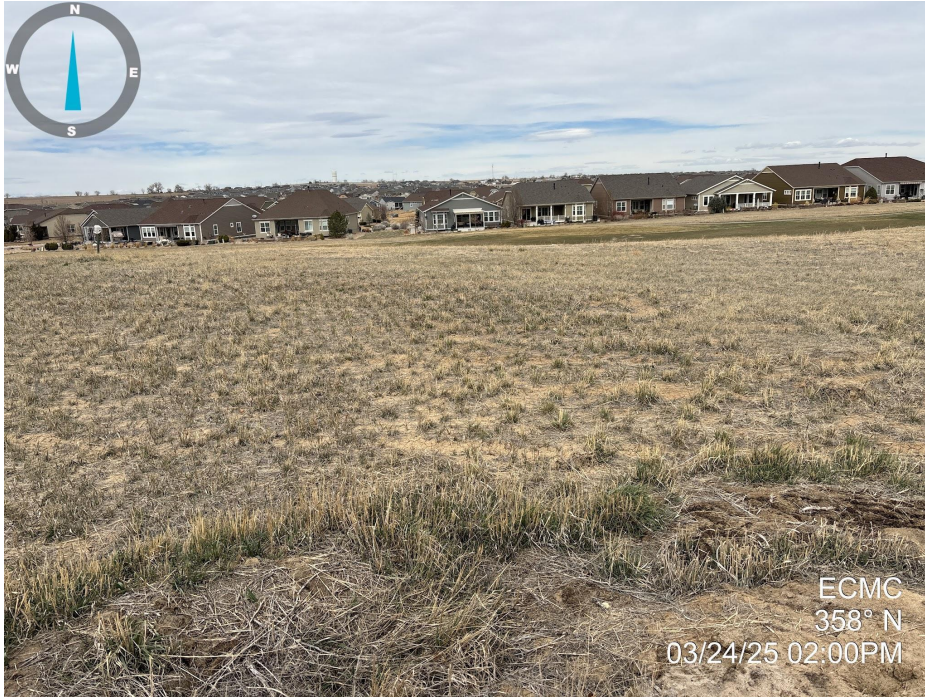
**Photo 1.** Photo taken from the well location, facing North. Photo illustrates that reclamation has taken place, but evidence of disturbance remains on site, and site does not meet Rule 1004 Reclamation standards for revegetation.

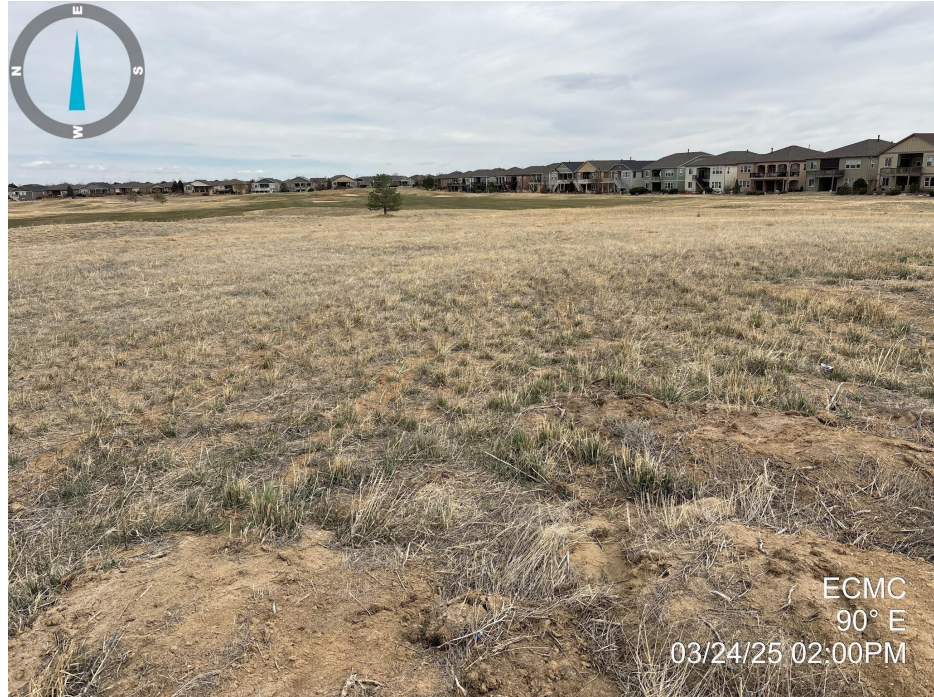
**Photo 2.** Photo taken from the well location, facing East. See comments under Photo 1.

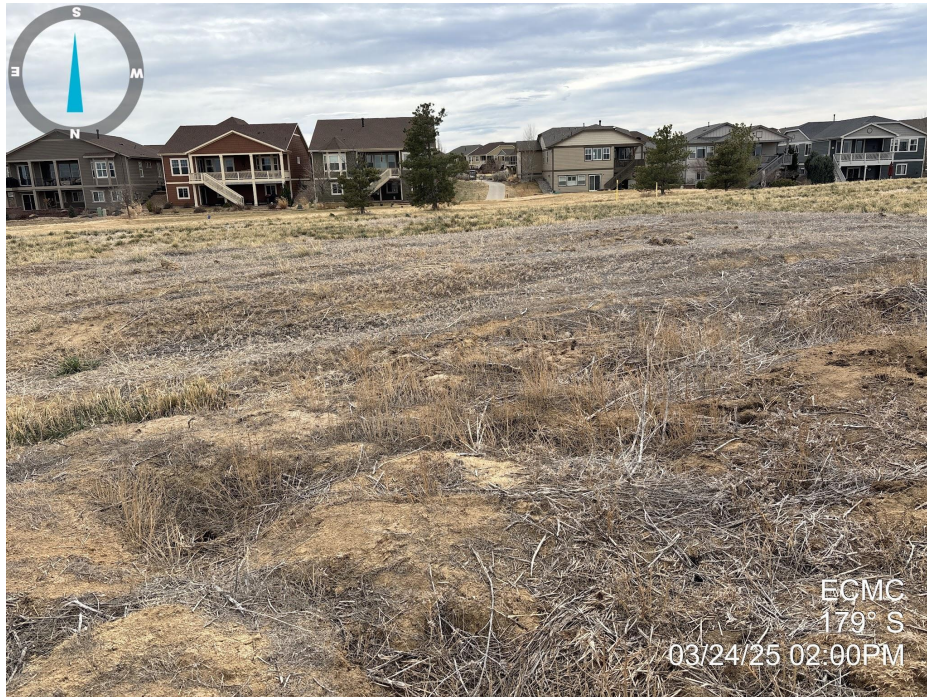
**Photo 3.** Photo taken from the well location, facing South. Photo illustrates disturbance with weedy growth and bare soil patches.

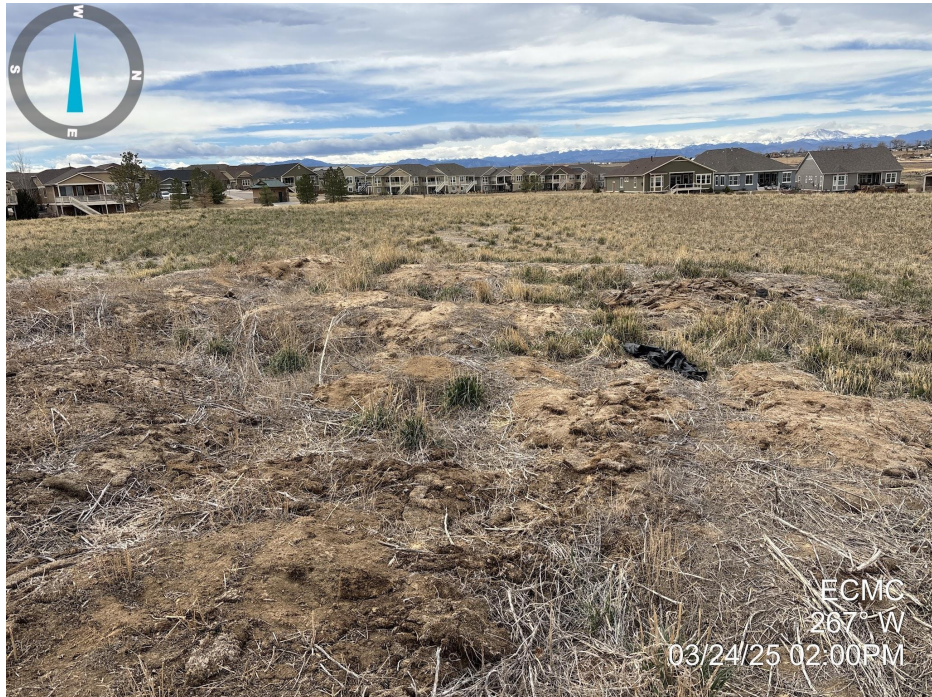
**Photo 4.** Photo taken from the well location, facing West. See comments under Photo 3.

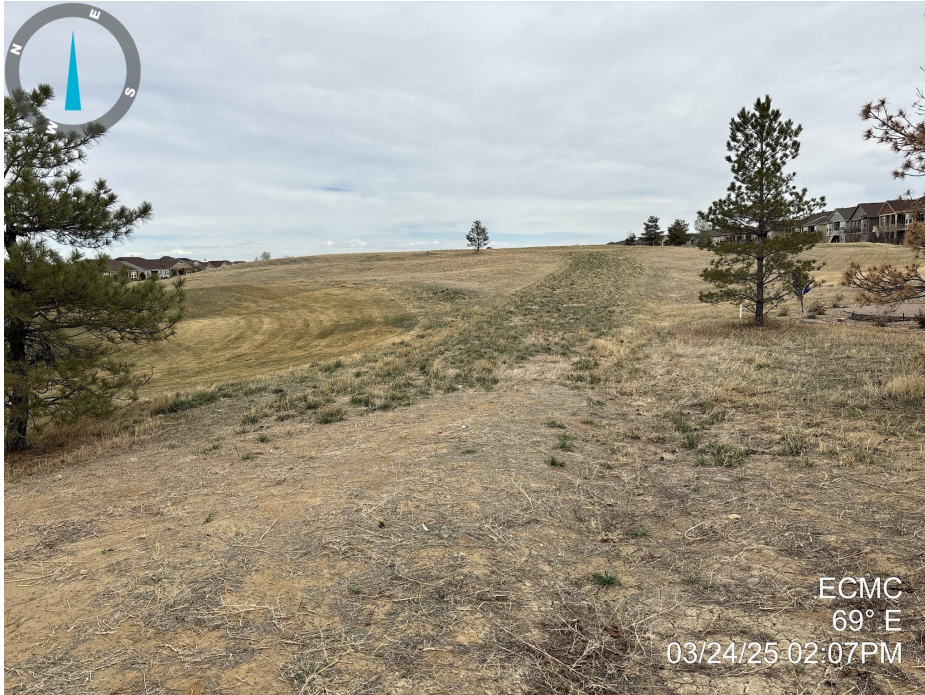
**Photo 5.** Photo taken from the start of the access road, facing East. Photo illustrates that the access road has been reclaimed, but at the entrance to the access road, bare soil patches remain.

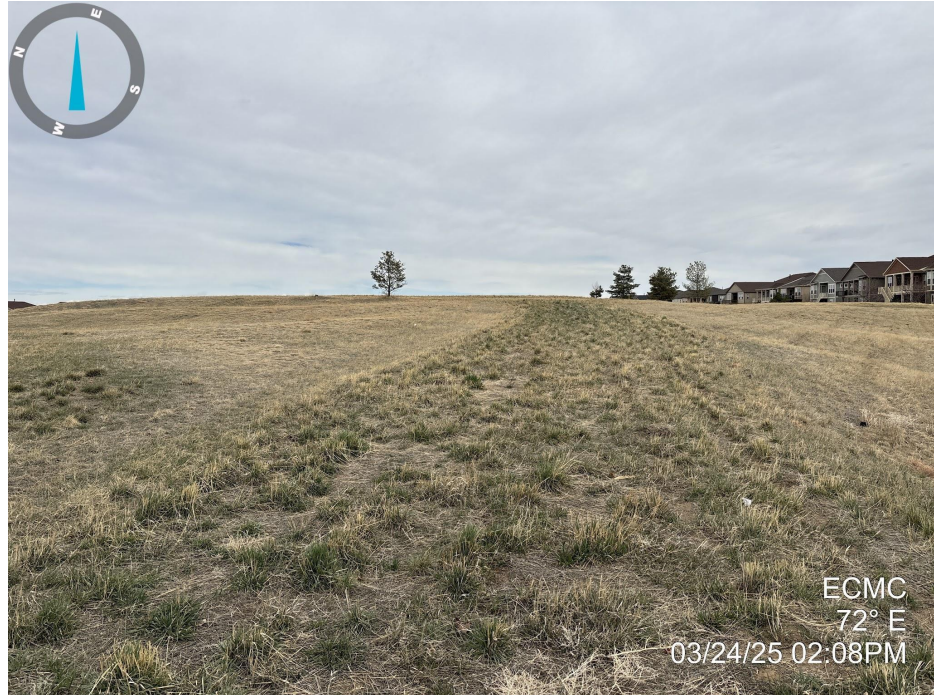
**Photo 6.** Photo taken from the access road, facing East. Photo illustrates that the access road has been reclaimed.

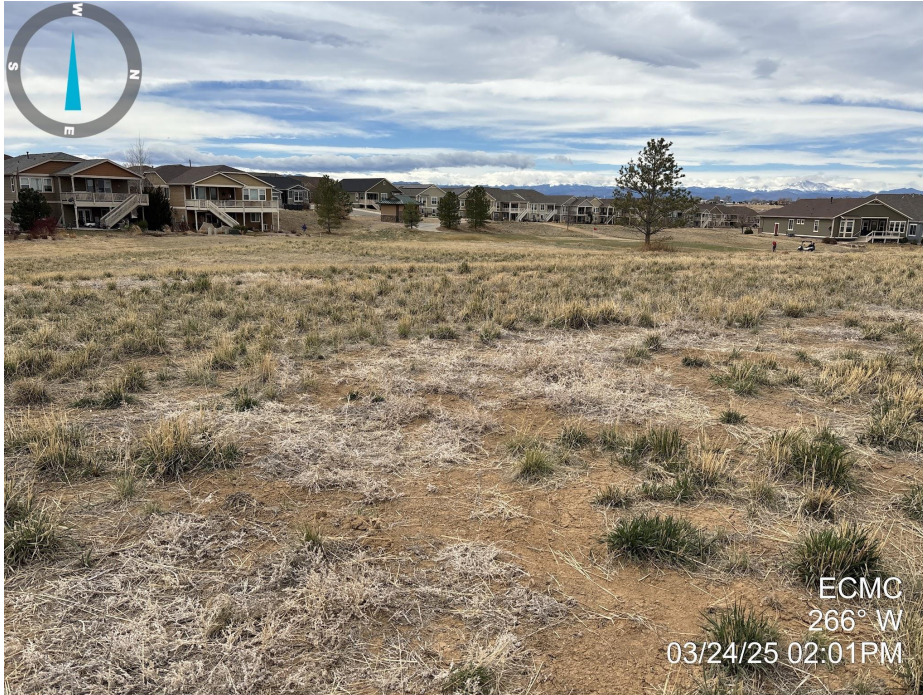
**Photo 7.** Photo taken from the tank battery location, facing West. Photo illustrates evidence of bare soil patches and kochia.

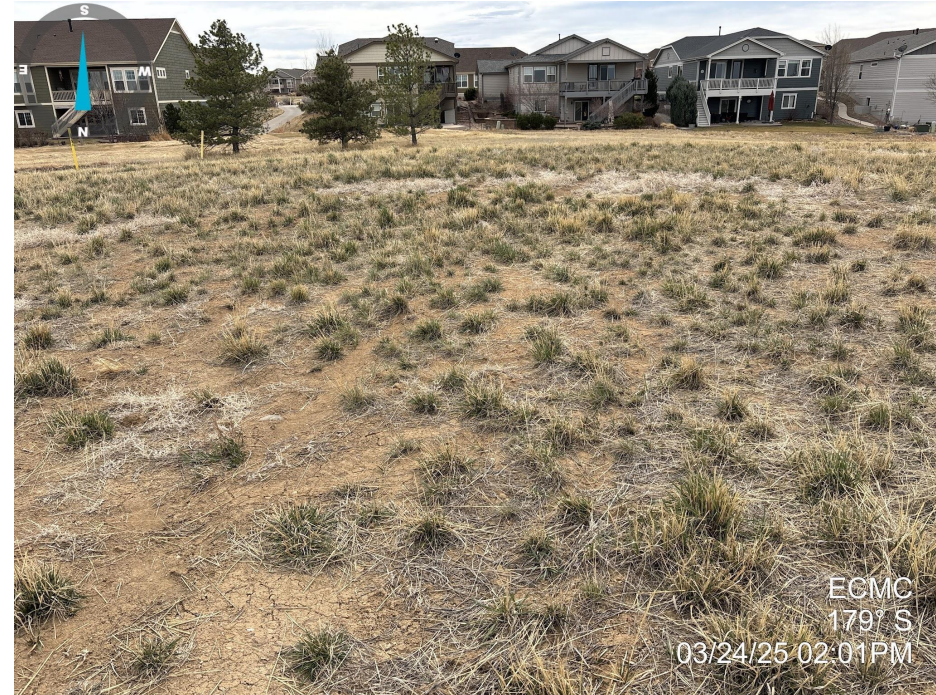
**Photo 8.** Photo taken from the tank battery location, facing South. See comments under Photo 7.

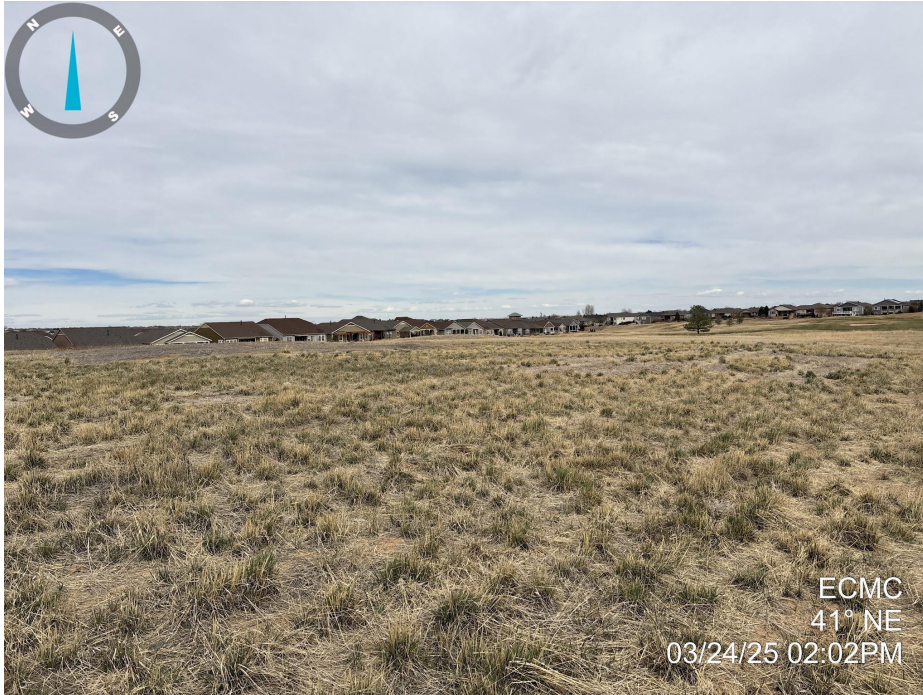
**Photo 9.** Photo taken from the reference area, southwest of the location, facing Northeast towards the location. Photo illustrates perennial grass vegetation.

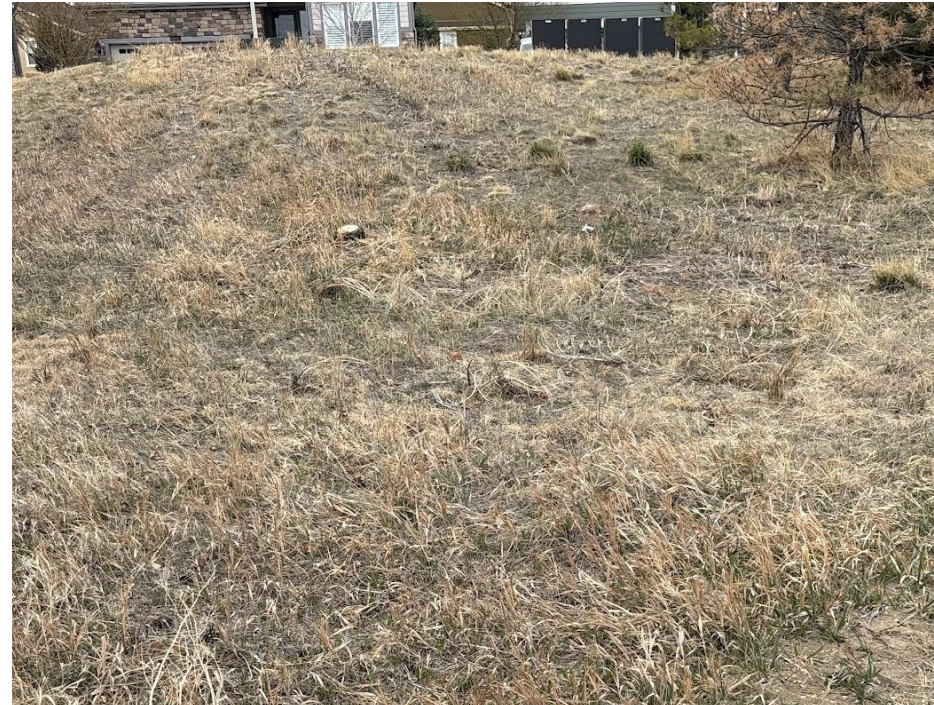
**Photo 10.** Photo taken from the reference area, west of the access road, facing southwest. See comments under Photo 9.
