Final Reclamation and Stormwater Inspection

Location ID: 320012

Well Name: COLORADO STATE #32-12

Inspection Document #: 718600447

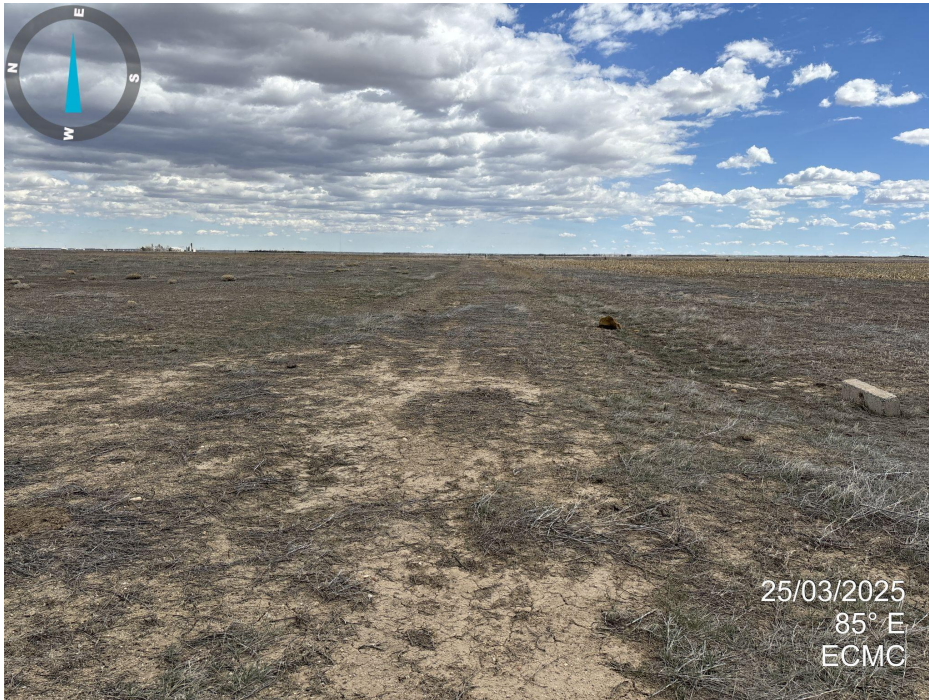
Photo 1. Looking east down access road from well API 001-07450. Vegetation coverage on road is lower than surrounding area and primarily undesirable weedy vegetation.

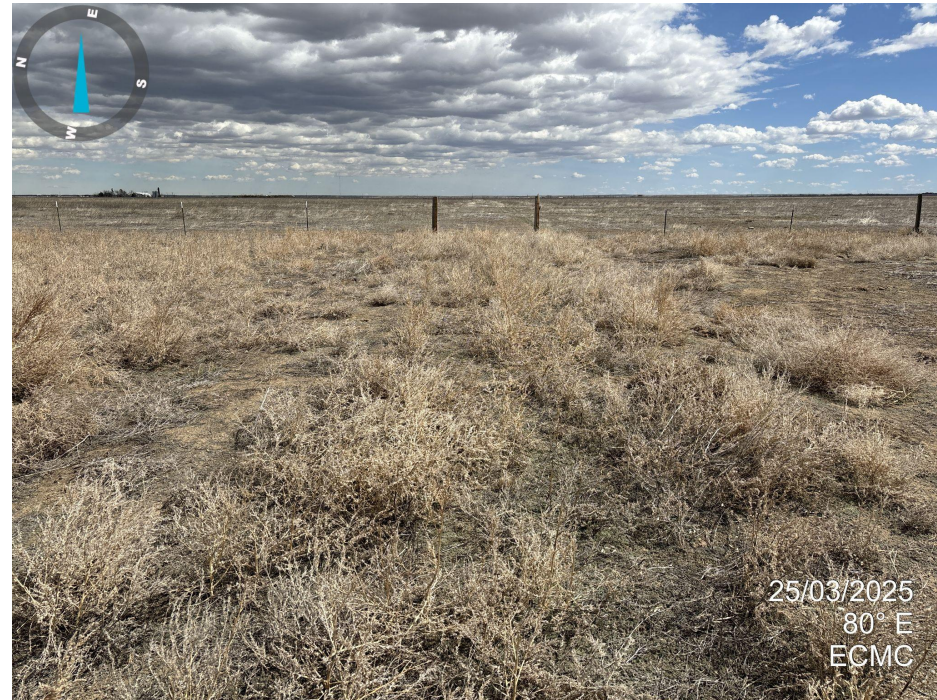
Photo 2. Looking east down access road from west side of fence junction. Undesirable weed Kochia is present on access road.

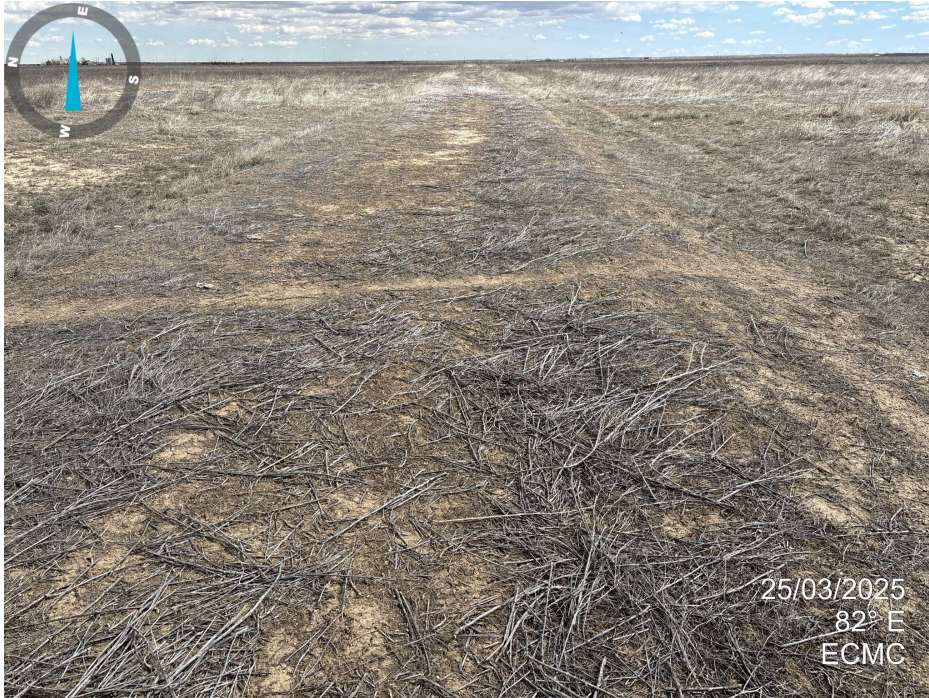
Photo 3. Looking east down access road near fence line. Very little desirable vegetation establishment on access road, especially towards the west side. The crown of the road is visible in this picture, the road is elevated above the surrounding area and ditches are present on both sides.

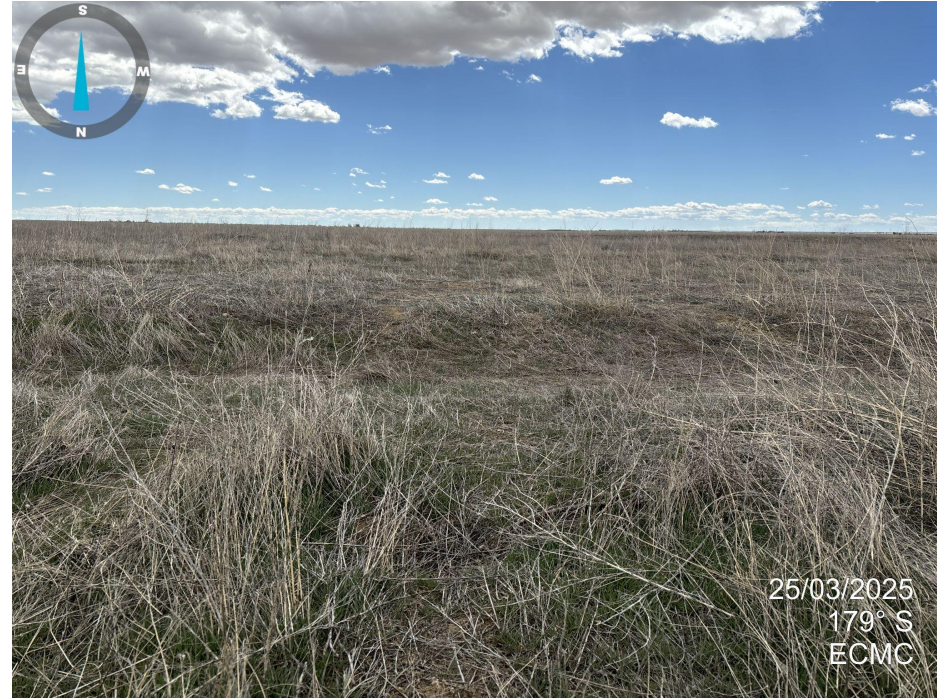
Photo 4. Side profile of access road. Access road and ditches have not been recontoured flat.

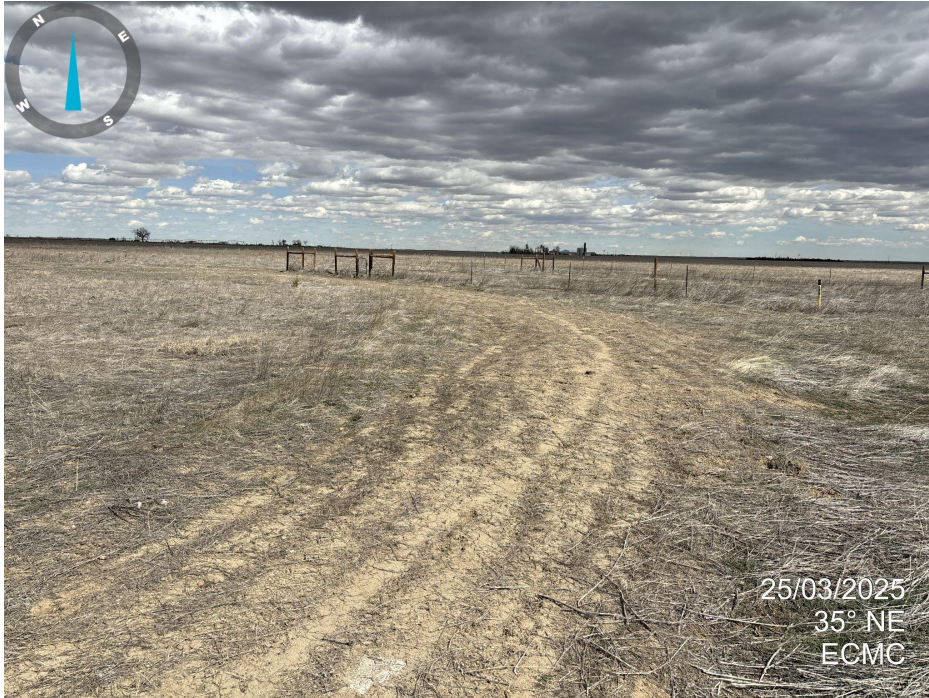
Photo 5. Looking across the turn around loop at the end of the road. Some desirable vegetation is present on the road but coverage is lower than surrounding area.

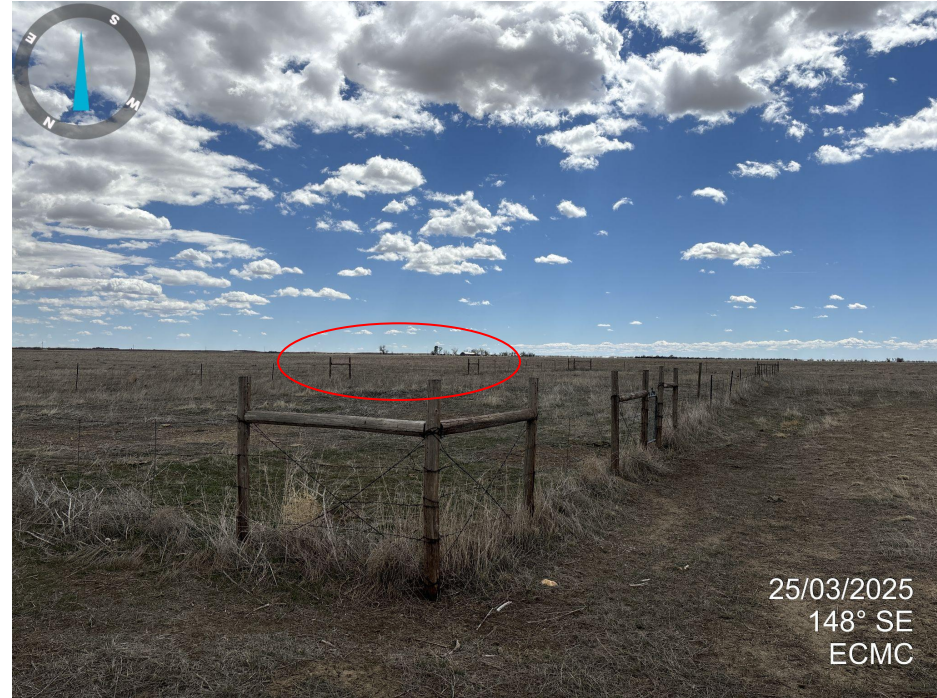
Photo 6. Picture taken at the northwest corner of location. Location is fenced. A large wire gate was down at time of inspection (red circle).

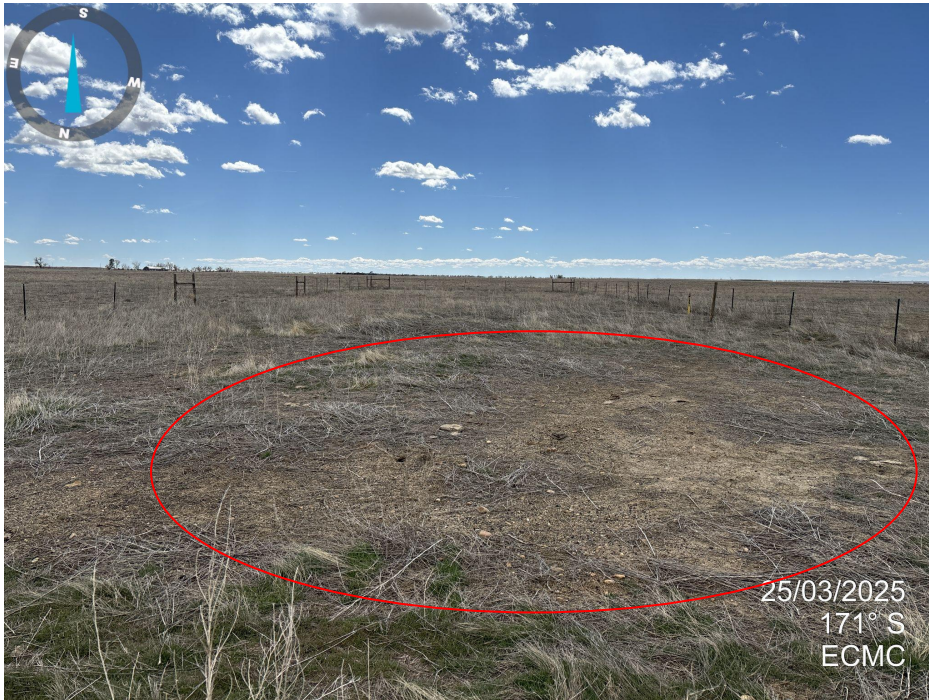
Photo 7. Looking south across location. A large bare patch is present on the north side of location (red circle). List C noxious weed Downy Brome and undesirable weeds such as Kochia are present on location. Desirable perennial vegetation has begun to establish on portions of the location.

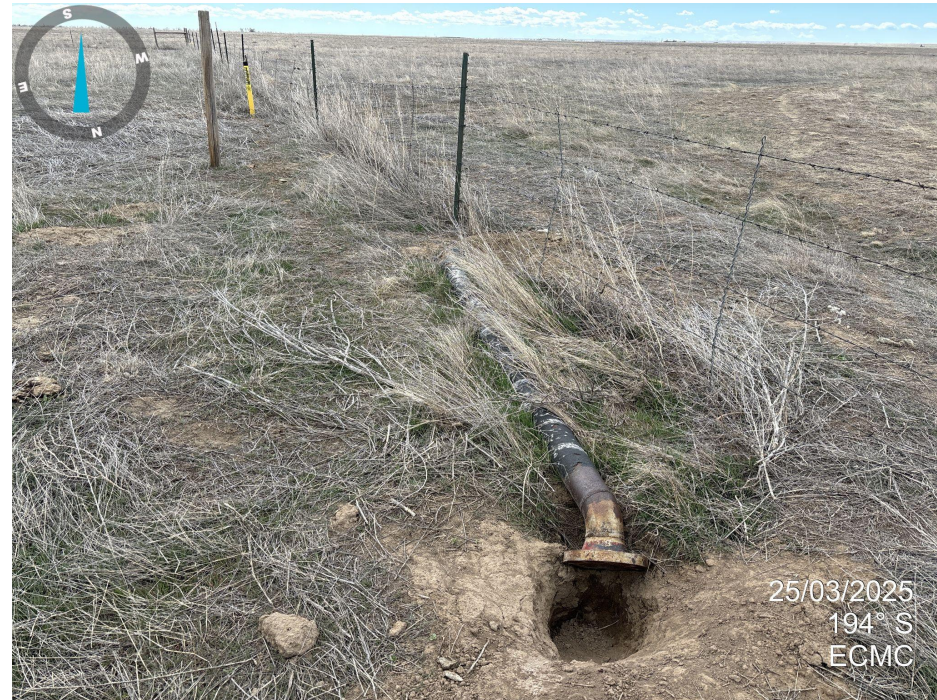
Photo 6. Picture taken on the west side of location, middle. Pipe remains on location.

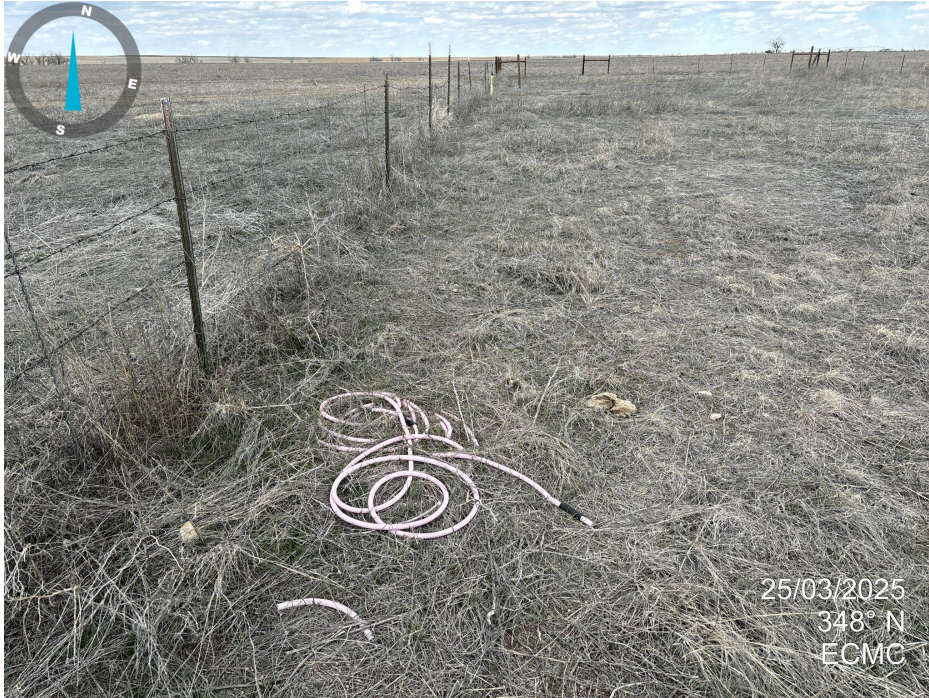
Photo 5. Picture taken on west side of location towards the south end. Debris on location (hose).

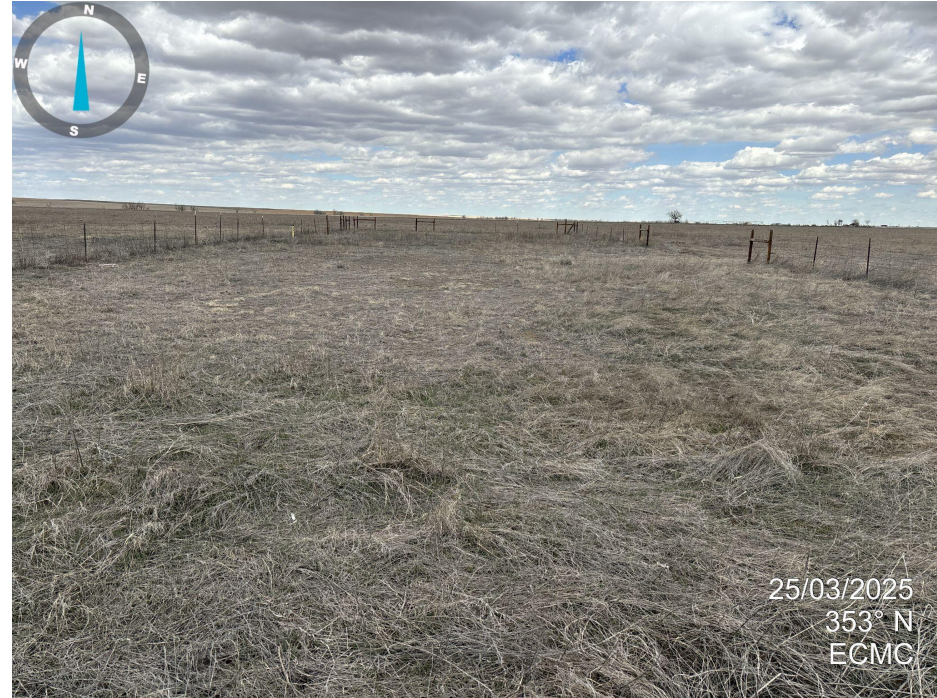
Photo 6. Overview of location looking north. There appears to be better desirable vegetation establishment on the south side of location.

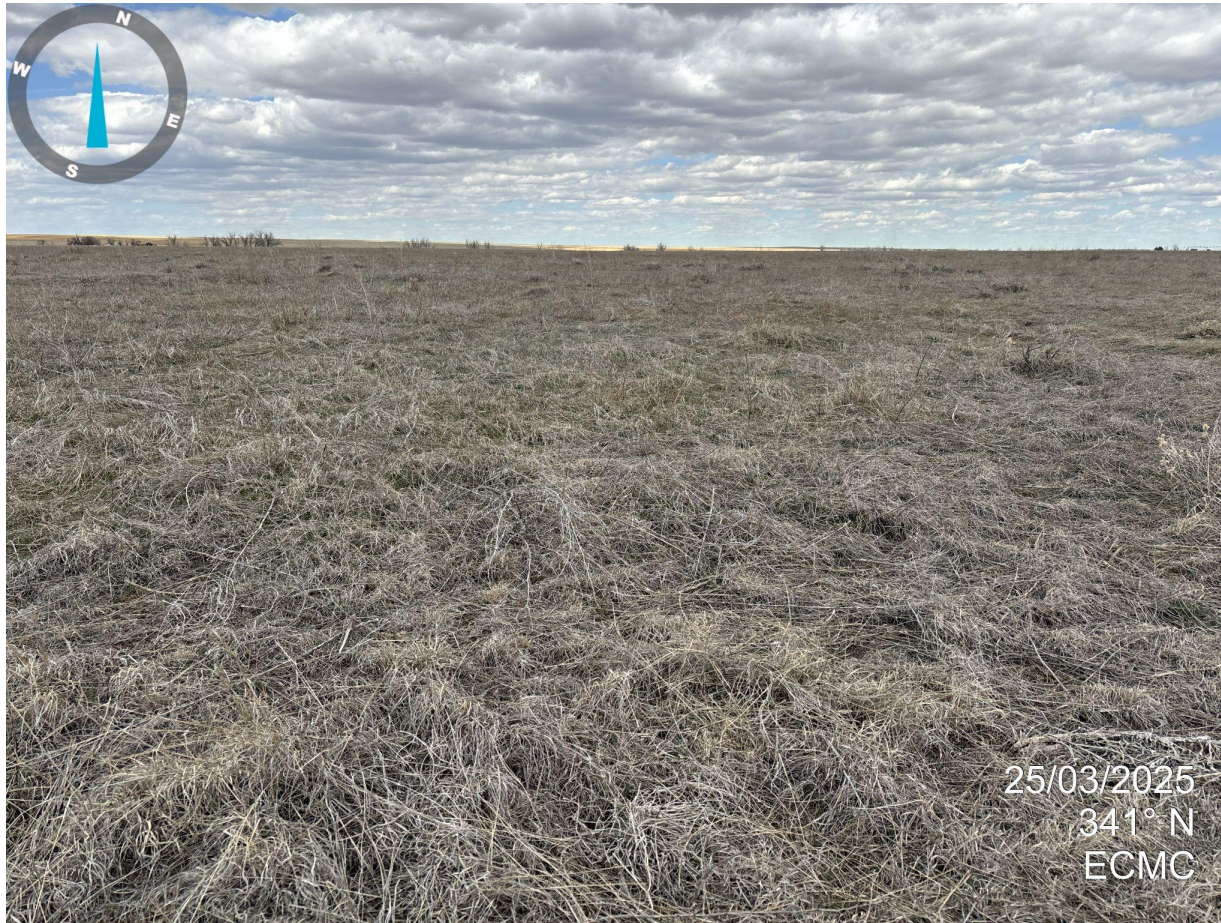
Photo 7. Reference vegetation to the north of location.
