# Final Reclamation and Stormwater Inspection

Location ID: 460821

Well Name: BULLARD 6 (Tank Battery)

Inspection Document #: 718600457

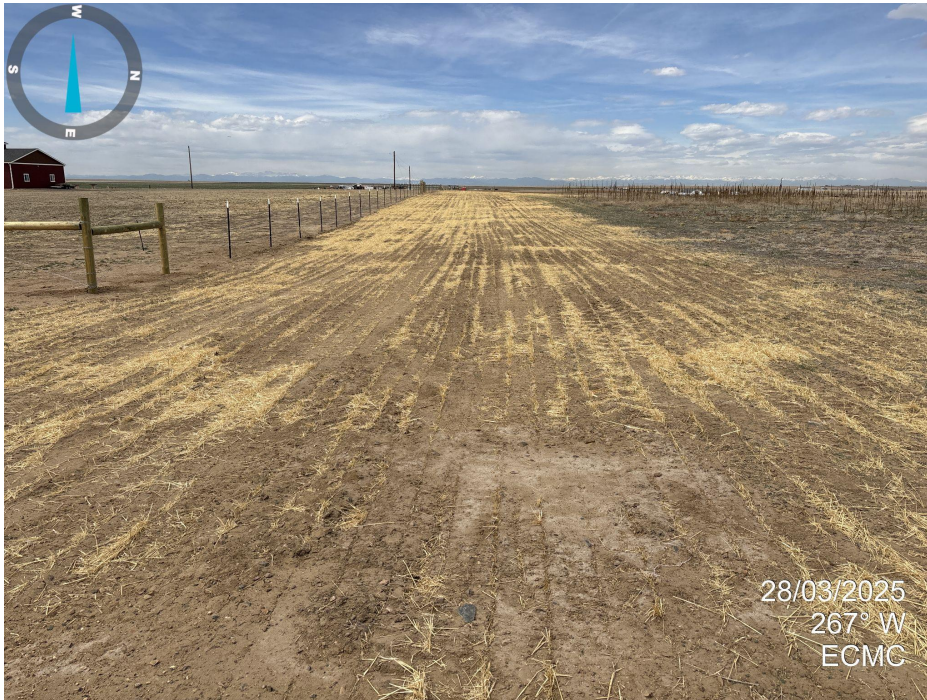
**Photo 1.** Looking west down access road. It appears that reclamation has been conducted with evidence of crimped straw.

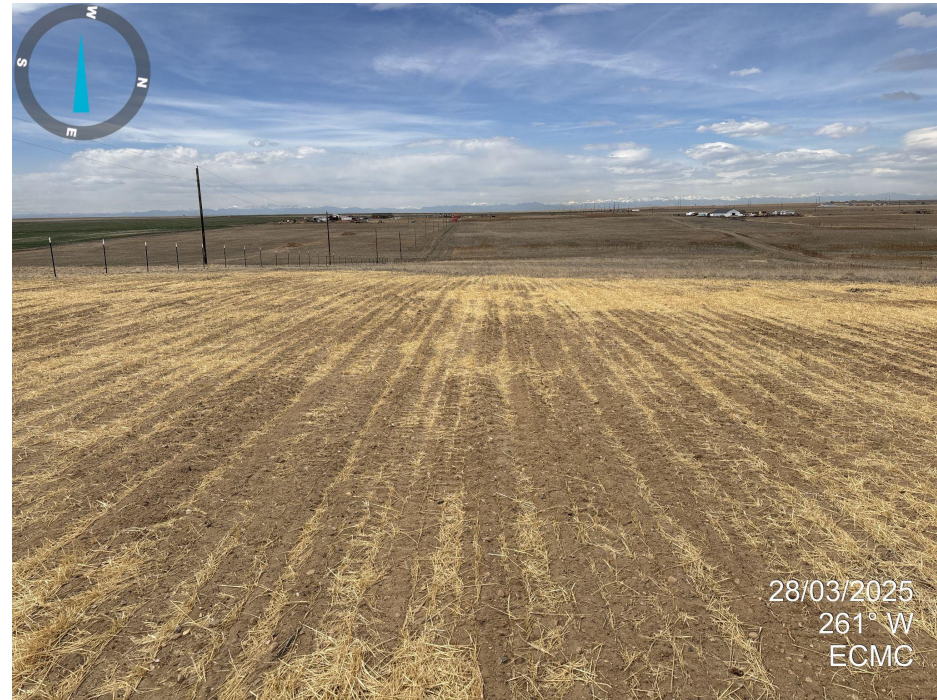
**Photo 2.** Looking west from the center of tank battery. No oil and gas equipment remains. It appears that reclamation has been conducted with evidence of crimped straw.

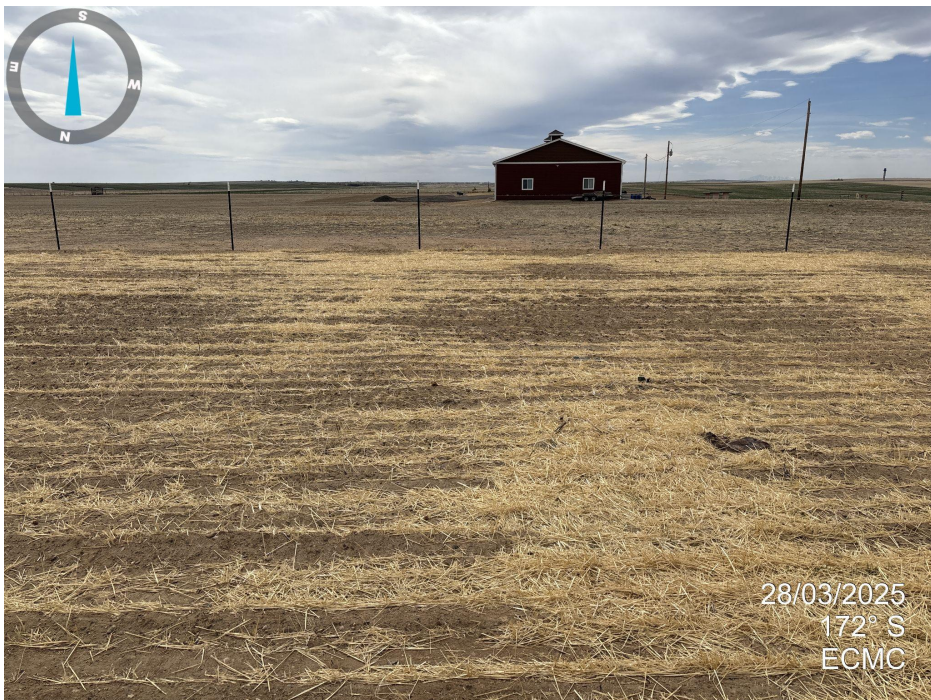
**Photo 3.** Looking south from center of tank battery. Crimped straw stops at fence line.

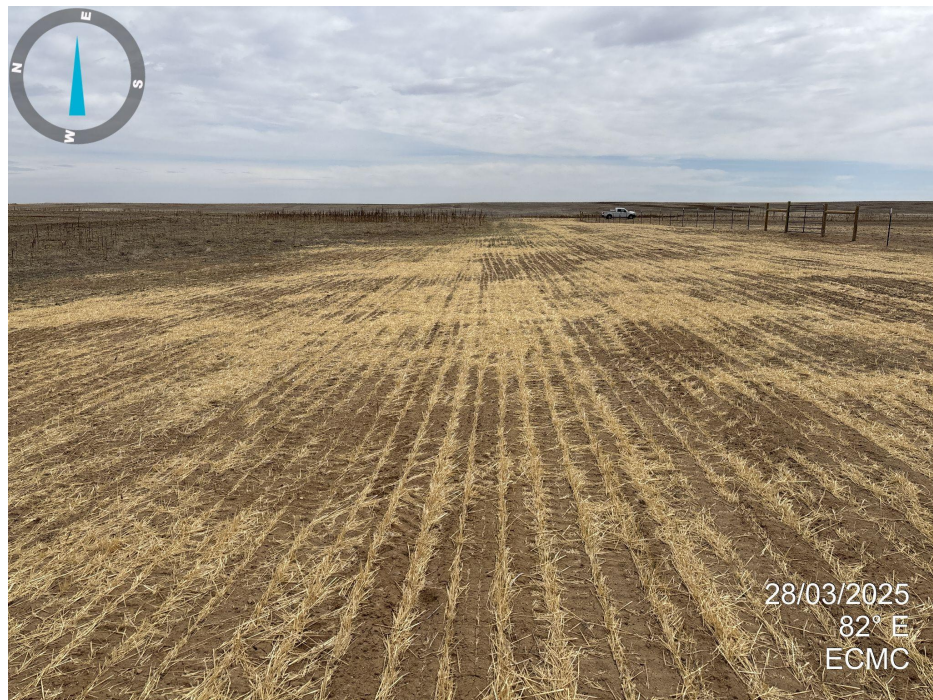
**Photo 4.** Looking east from center of tank battery. See photo 2 comments.

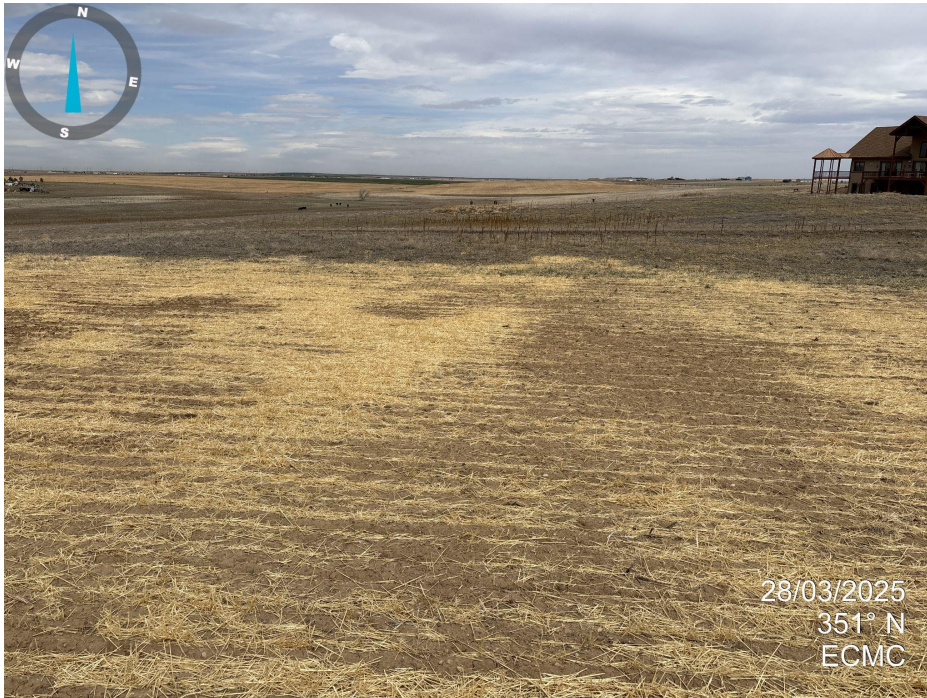
**Photo 5.** Looking north from center of tank battery. See photo 2 comments.

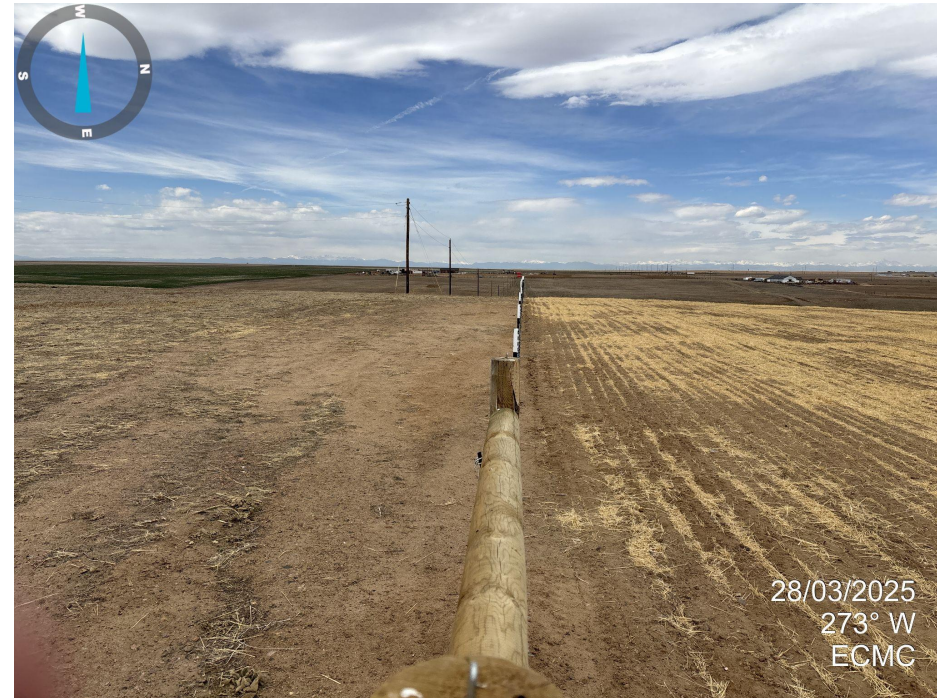
**Photo 6.** Looking west down fence line. It appears that this fence was installed after the location and tank battery was constructed and it appears the tank battery extended south beyond the fence.

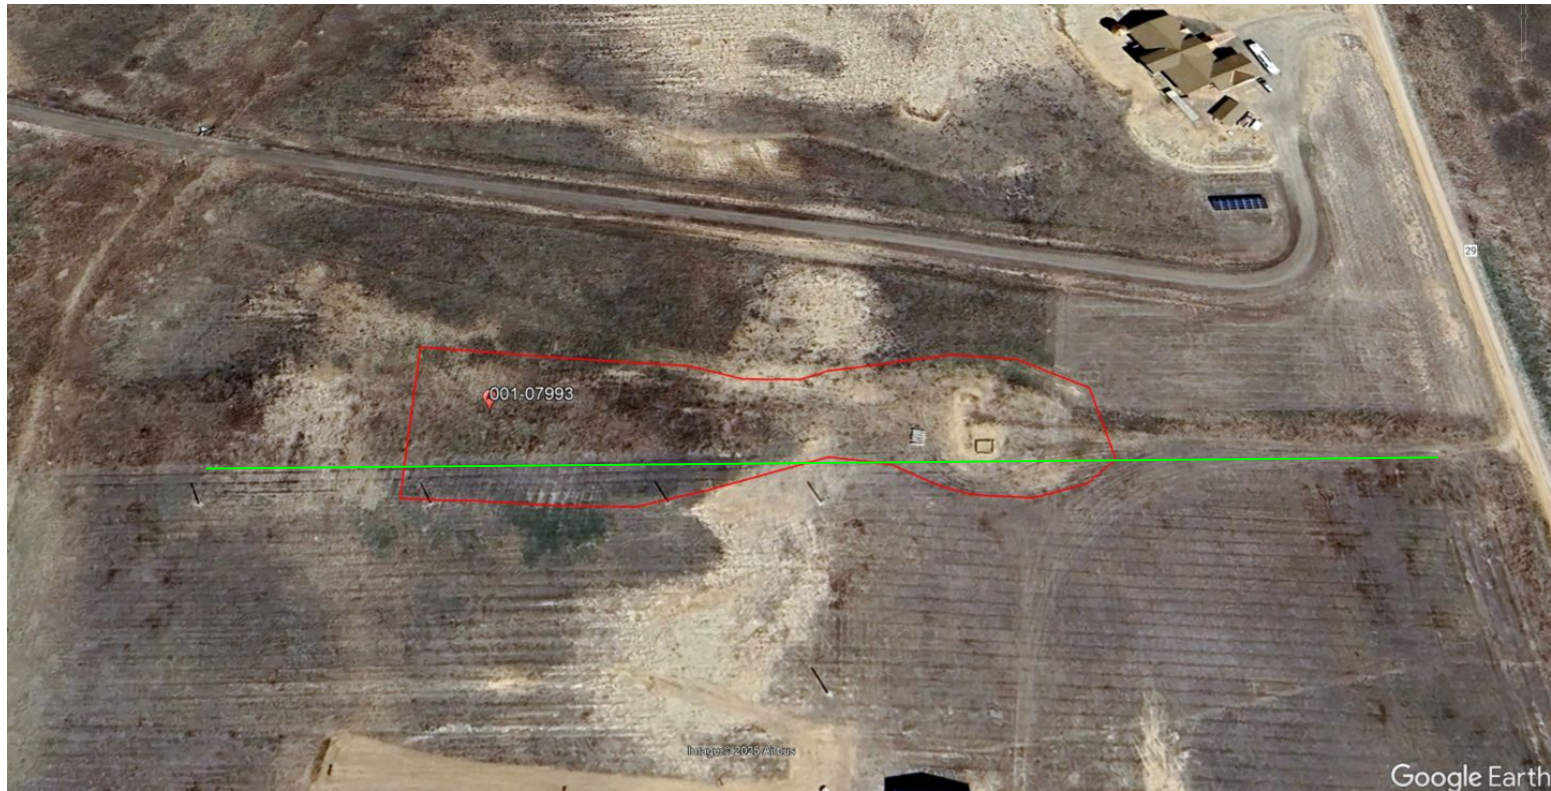
**Photo 7.** Google earth aerial imagery taken 04/2024. It appears that the footprint of the well location and tank battery (red circle) extends over the fence line (approximate green line).
