Flowline Closure Checklist										
COGCC Rule 911.a.(4) Environmental Site Closure Assessment Field Form										
Additional Attachments:		Tank Battery Closure		Wellhead Closure			Pit Closure		Partially Buried Vault Closure	
Site Name & COGCC Facility Number: Shelton 18-25XX				Date: 09/08/23					Remediation Project #: 28440	
Associated Wells:				Age of Site:					Number of Photos Attached: 1	
Starting point: (GPS coordinates and descriptions) 40.286651/-104.615773										
End point: (GPS coordinates and descriptions) 40.287119/-104.613564										
USCS Soil Type: SW						Estimated Depth to Groundwater: > 3'				
Hydrocarbon Impacted Soils / Spills : (Note estimated size and if impact appears to be surficial or extends to an unknown depth) None observed										
Salt Crusted Soils or Impacted Vegetation: (Note estimated size and if impact appears to be surficial or extends to an unknown depth) None observed

Noble Energy, Inc. – DJ Basin
Shelton 18-25XX
SENW, Section 25, Township 4 North, Range 65 West
Weld County, Colorado

Flowline Closure & Soil
Analytical Results Map
(09/08/2023)

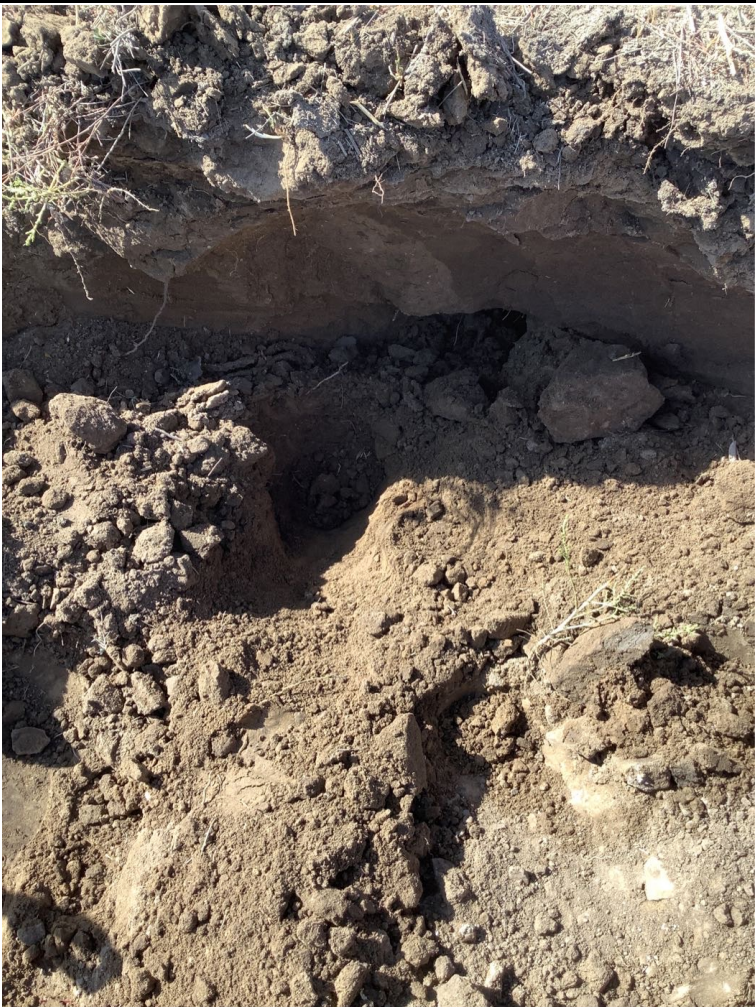
Flowlines										
Flowline type		Oil/ Gas / Water								
Depth		3'								
Age										
Length		639'								
Construction Material		steel								
Were flowlines pulled?		yes								
Visual Integrity of lines		good, see observation below								
Visual impacts if trenched		none observed								
PID Readings if trenched		0.2								
Sample taken? Location/Sample ID#		yes, see below								
Photo Number(s)		1								
Other observations regarding on loction flowlines: Flowline was fully removed. A grab sample was collected on the flowline path (FL01-C@3'). The A-point of the flowline was sampled during the wellhead decommissioning. The B-point sample was collected during decommissioning of the associated facility (REM #28542).										
Summary										
Was impacted soil identified? <div>No</div> Yes - less than 10 cubic yardsYes - more than 10 cubic yards										
Total number of samples field screened: 1						Total number of samples collected: 1

Equipment ID: FL01-C@3'		Equipment Type: Flowline			
						Material: Steel	Volume:	Contents: Oil/Gas/Water	Equipment ID:	Equipment Type:	
						Notes/Conditions: Facing South			Notes/Conditions:

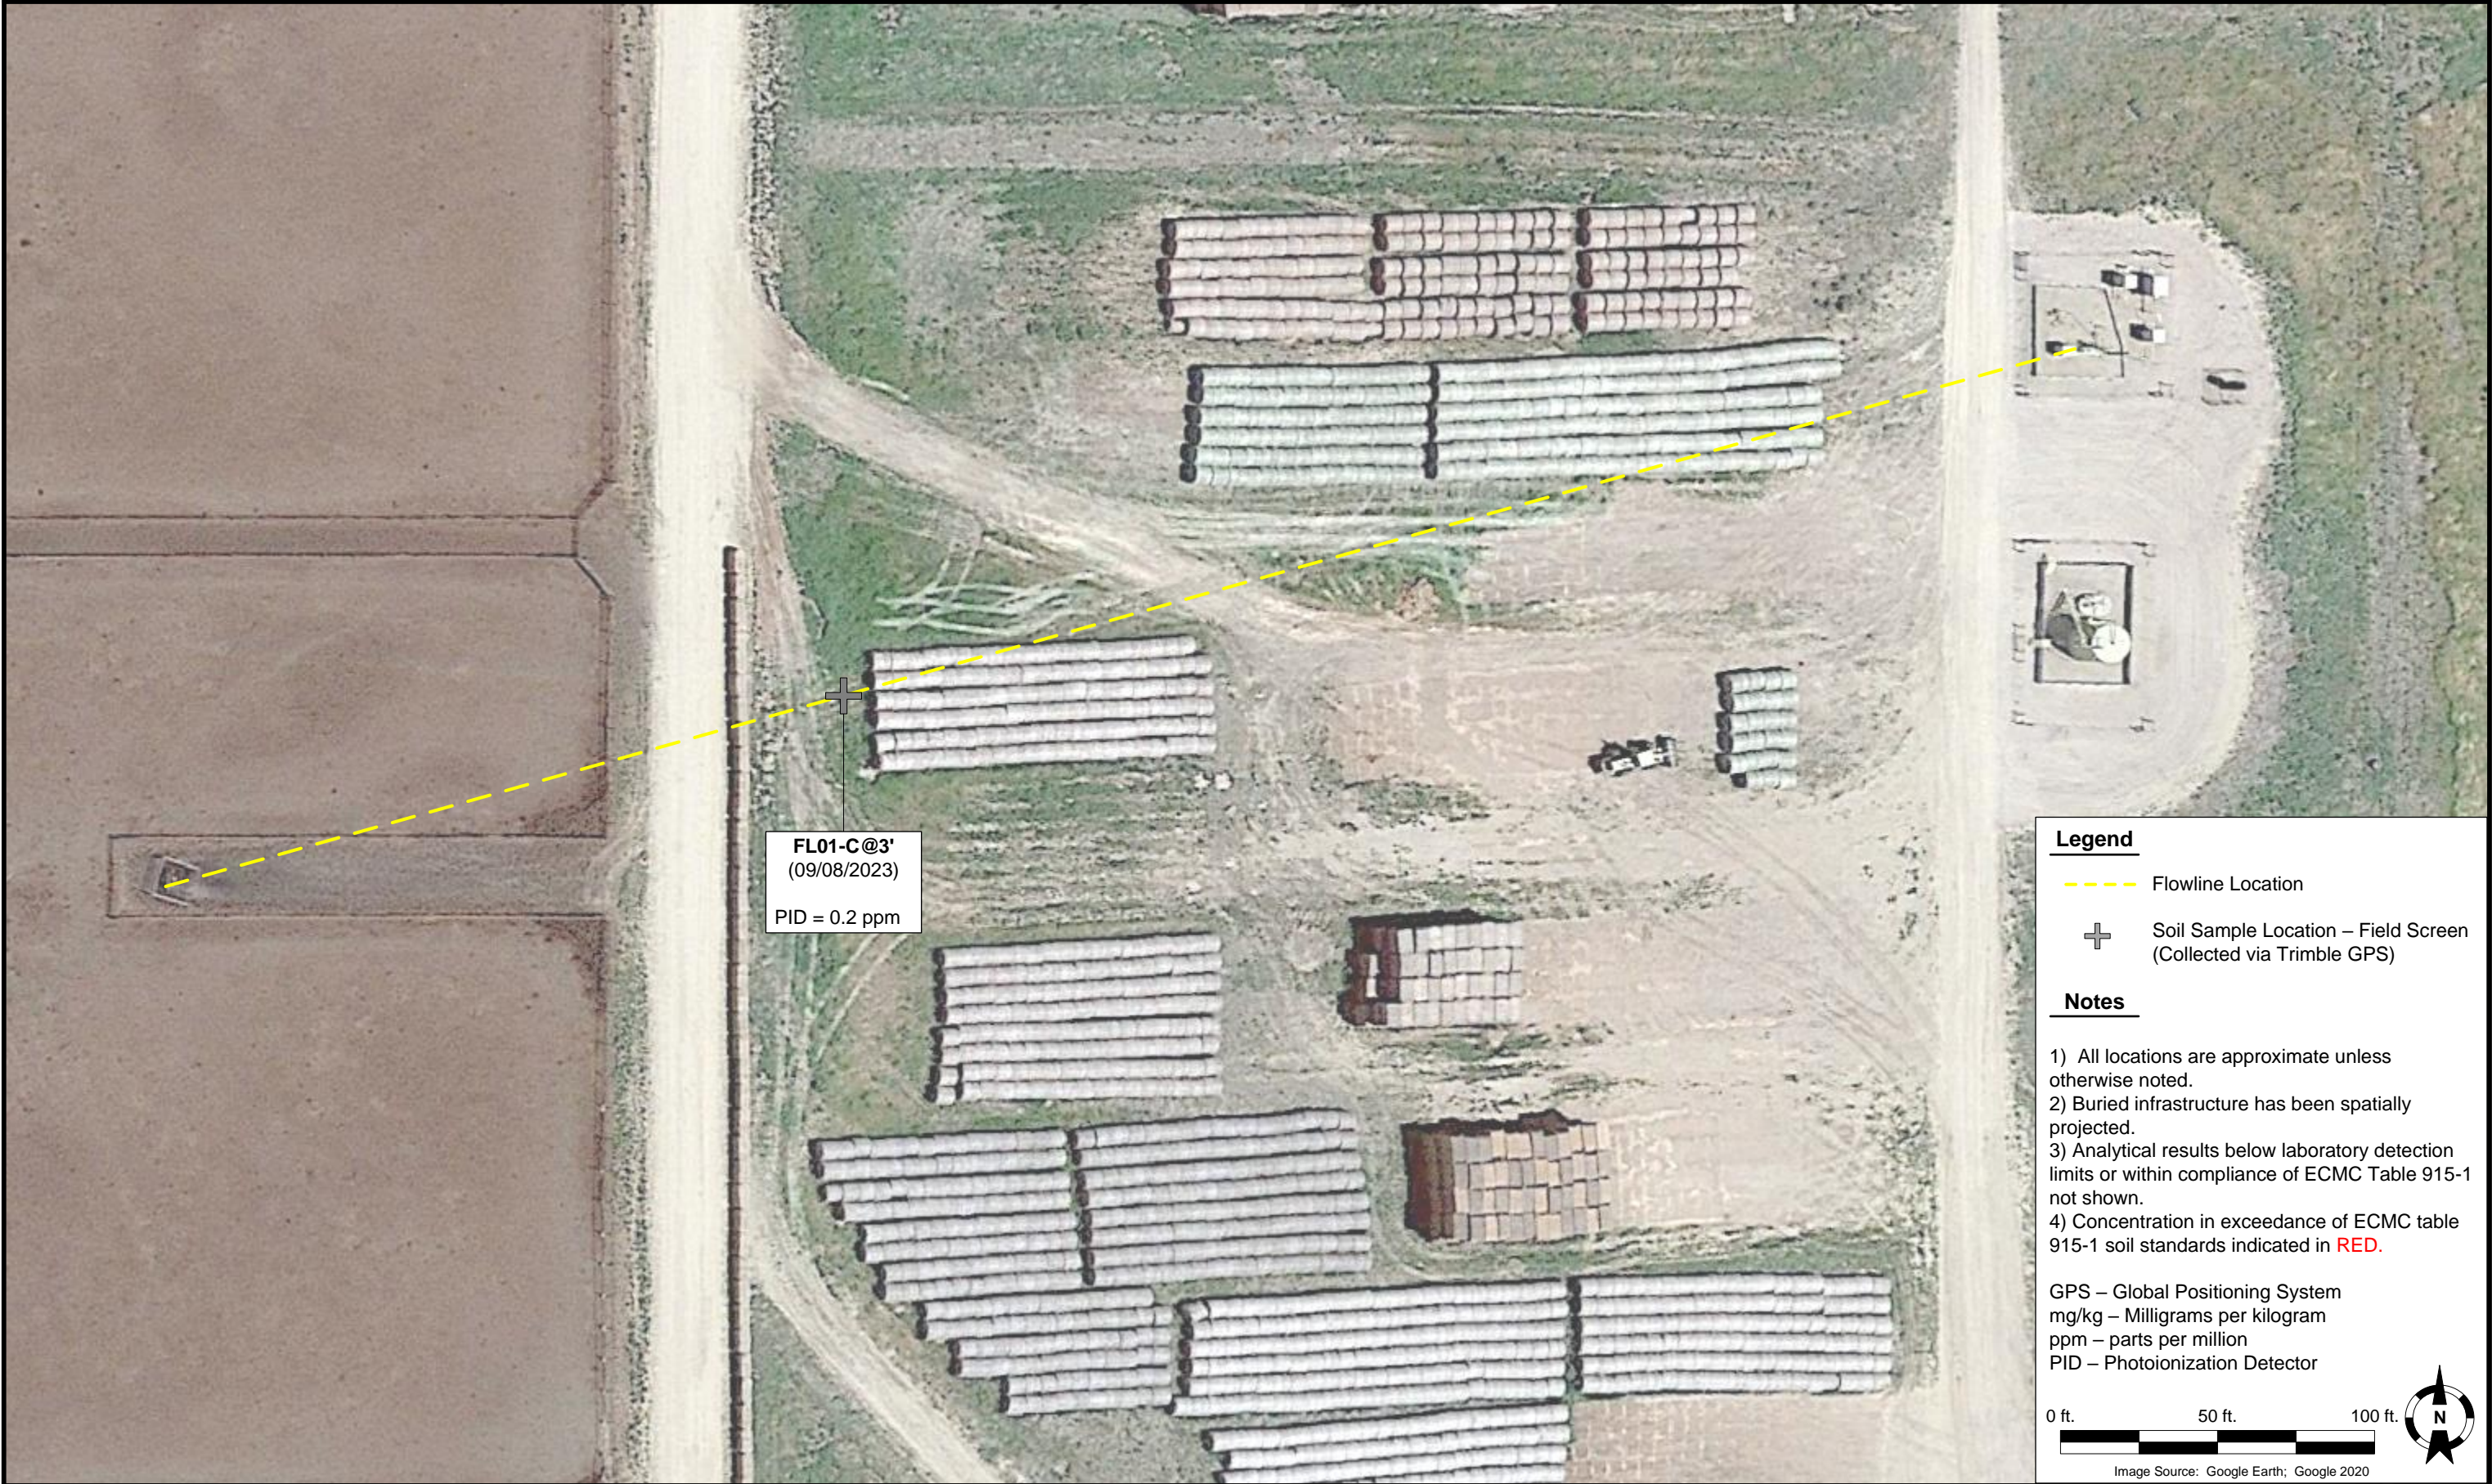
FIGURE
1

Soil Sample ID	Date	PID (ppm)	Visual	Olfactory	Sample Type (Grab/Lab)	Latitude ¹	Longitude	PDOP
FL01-C@3'	09/08/23	0.2	No Staining	No Odor	Grab	40.286804	-104.614993	0.8
