Inspection Photos

Operator: TEP ROCKY MOUNTAIN LLC #96850

Location ID: 324113

Inspection Doc: 718100408

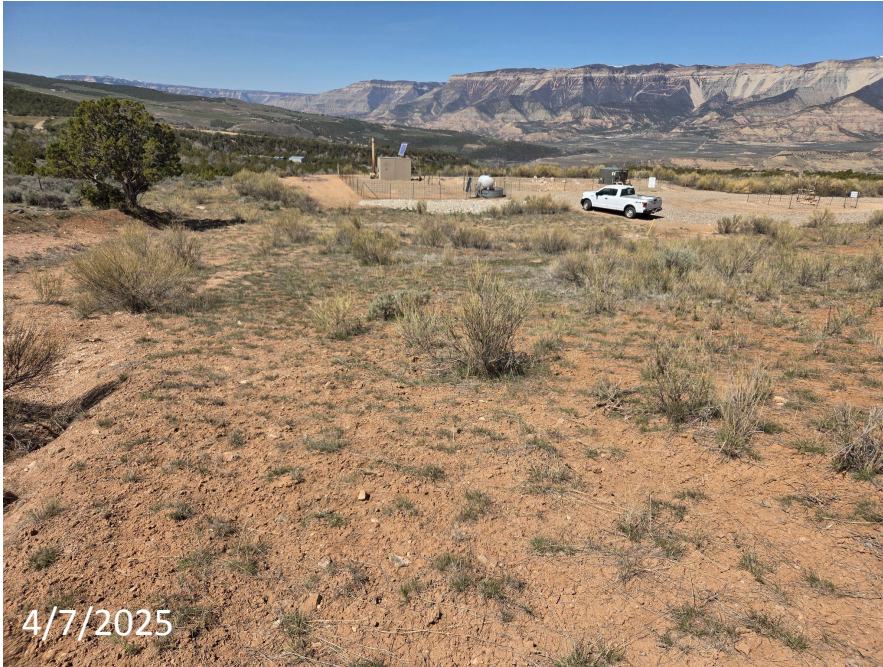
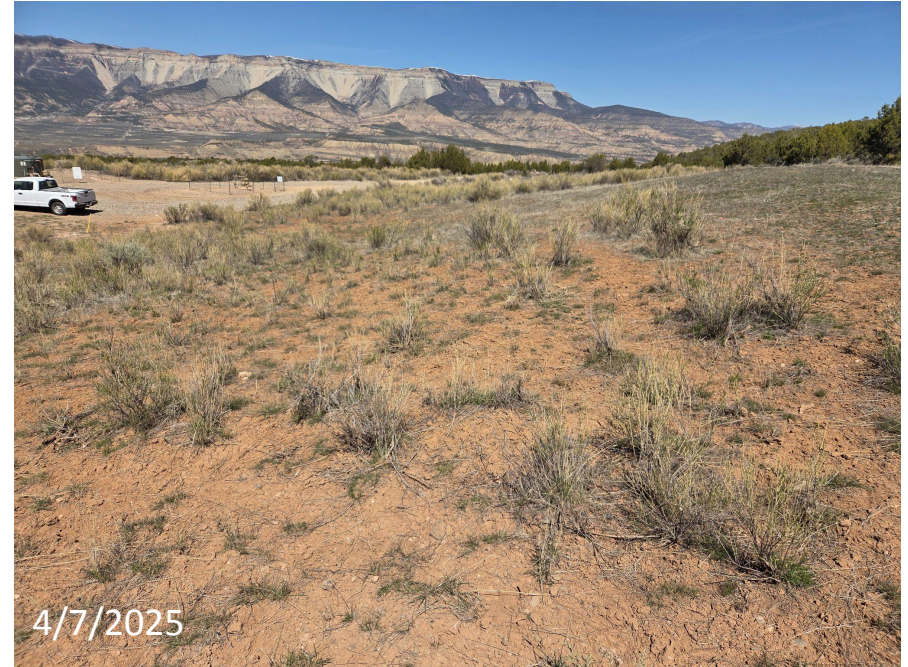
Photo 1: Photos taken from the southeast end of the Location, facing west and northwest. Photos provide an overview of the Location.

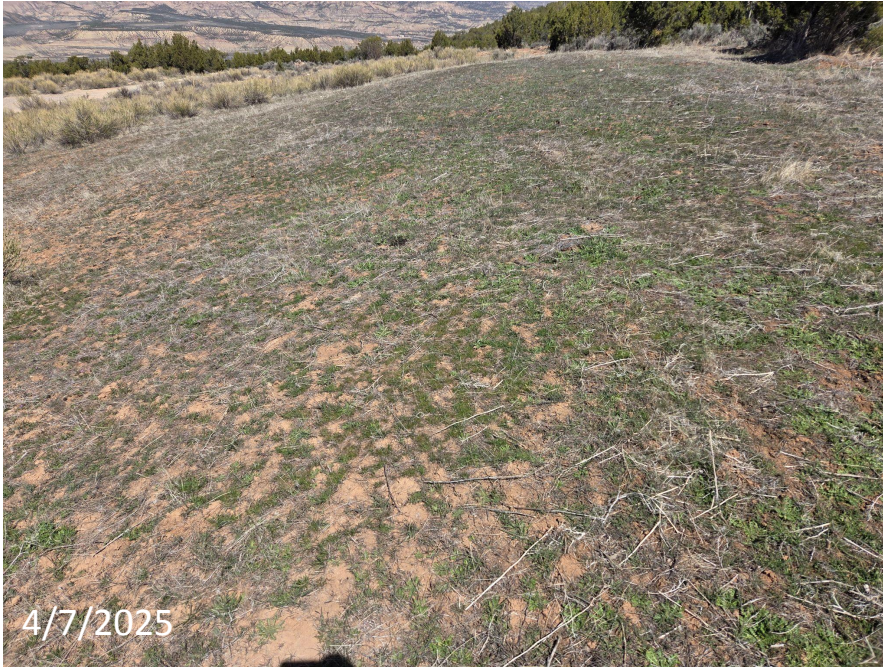
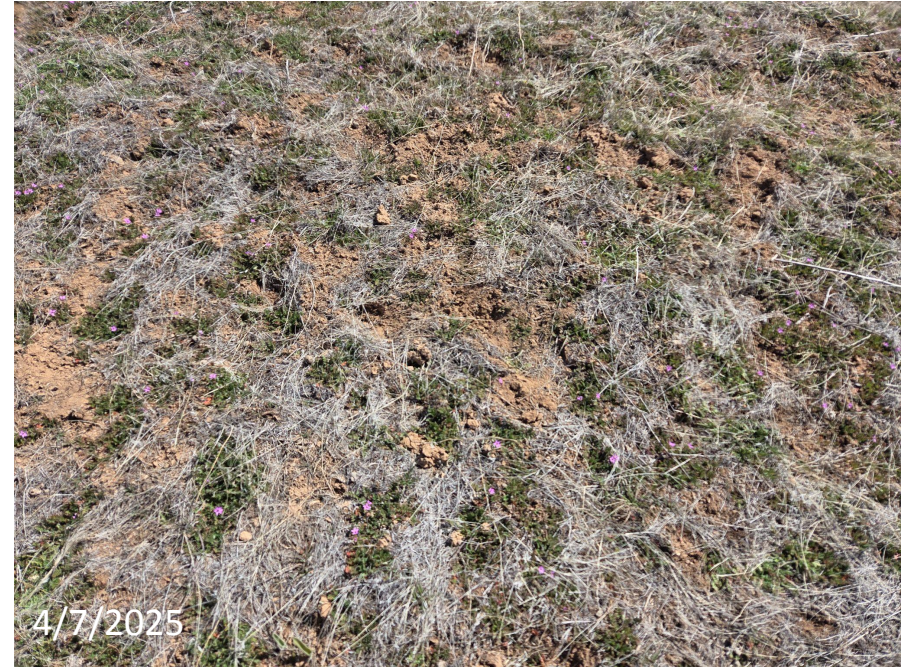
Photo 2: Photos taken from the eastern interim areas of the Location. Vegetation observed within photo appears to be predominantly cheatgrass. Desirable perennial vegetation is sparse within these areas.

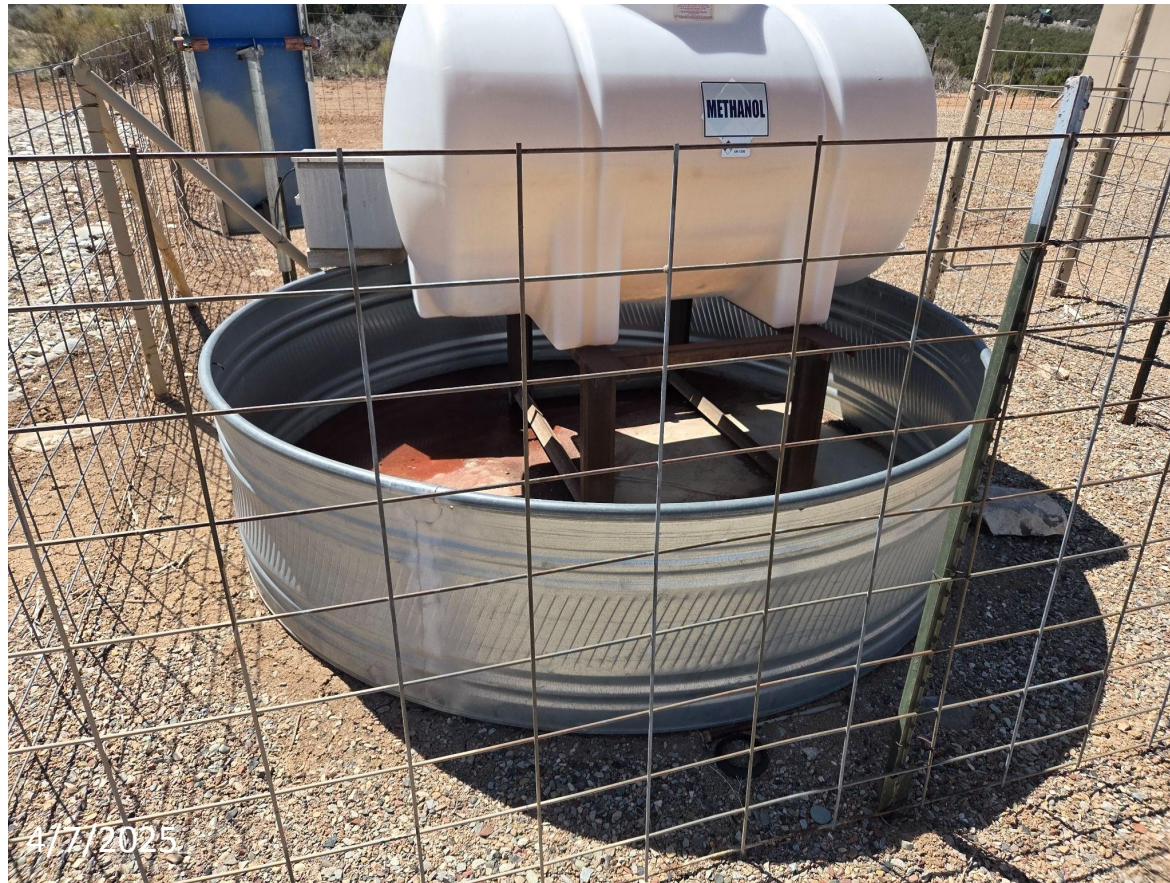
Photo 3: Wildlife protection BMPs missing or insufficient at secondary containment.

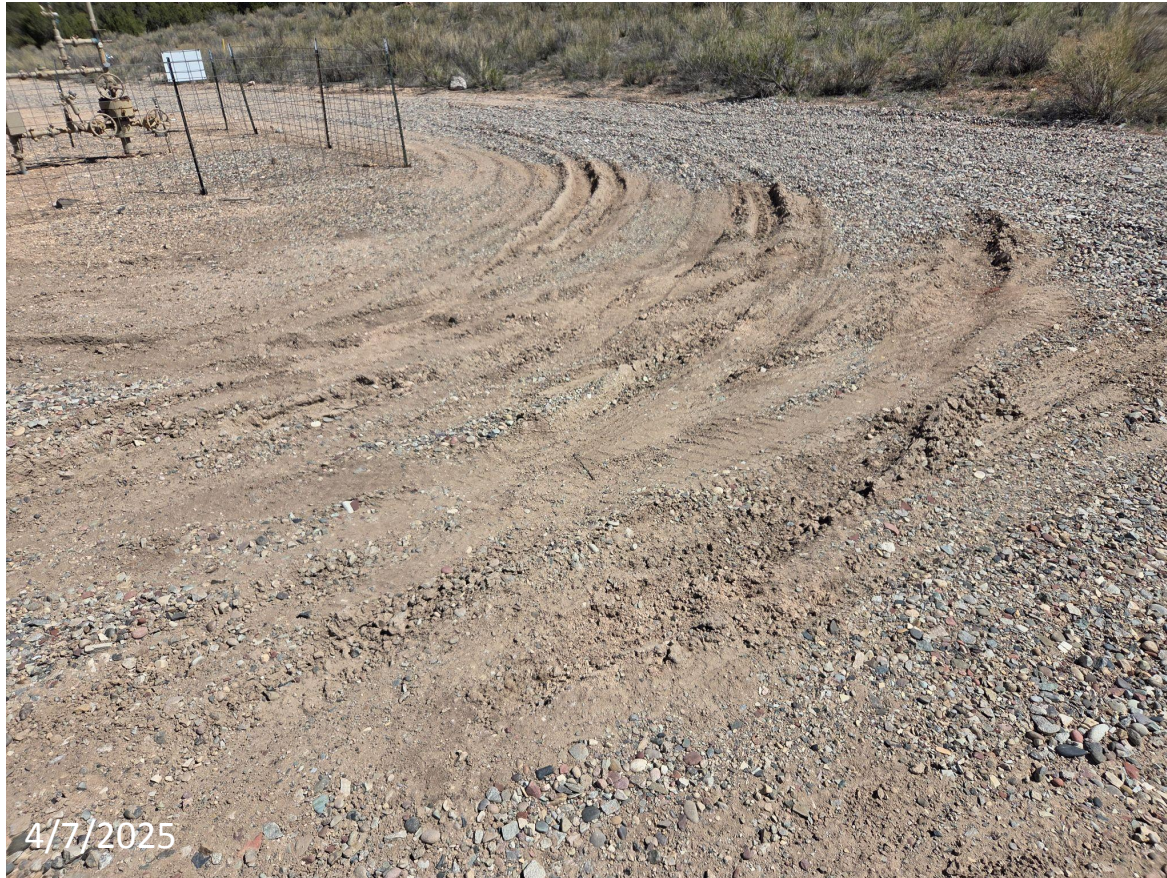
Photo 4: Vehicle tracking controls do not appear to be sufficient to minimize erosion, degradation and vehicle tracking during wet condition; BMPs show signs of disrepair and tracking/rutting is becoming evident.
