SITE NAME: STROH H12-16 FLOWLINE							DATE: 8/29/2024	REM. PROJECT #: 34390	WEATHER: SUNNY, 70s	
SITE DIRECTIONS: Cr 49 & Cr 34, N 0.1, W 0.1 into							CLIENT: Noble			
LEGALS AND LAT/LONG: 40.23380971, -104.604270							TASMAN PERSONNEL: MW, JB			
SOIL TYPES:							SURFACE GRADIENT:			
SOIL SAMPLING							FACILITY INFRASTRUCTURE			
Date/Time	Soil Sample ID	PID (ppm)	Visual	Olfactory	Photo?	Grab or Lab Sample?	EQUIPMENT	Quantity	Photo?	
							Above Ground Storage Tank (AST)			
08-29-2024 11:10	FL01R-W@2'	0.5	No Staining	No Odor	Yes	Lab	Buried or Partially Buried Vessel			
							Separator			
							Emission Control Device (ECD)			
							Dump Line			
							Wellhead			
							Flowline	1	✓	
							Other:			
							Soil Loads Removed			
							IMPACTED SOIL IDENTIFIED?			
							ESTIMATED VOLUME OF IMPACTS:			
							Date	Number	CY	
							Total Removed	0	0	
							Disposal Facility:			
							Groundwater Recovery

TABLE 1
FIELD DATA SUMMARY TABLE
NOBLE ENERGY, INC. 100322
STROH H12-16 FLOWLINE, WELD COUNTY, COLORADO
REM # 34390

Noble Energy, Inc. – DJ Basin
Stroh H12-16 Flowline
SESE, Section 12, Township 3 North, Range 65 West
Weld County, Colorado

Flowline Closure & Soil
Anal

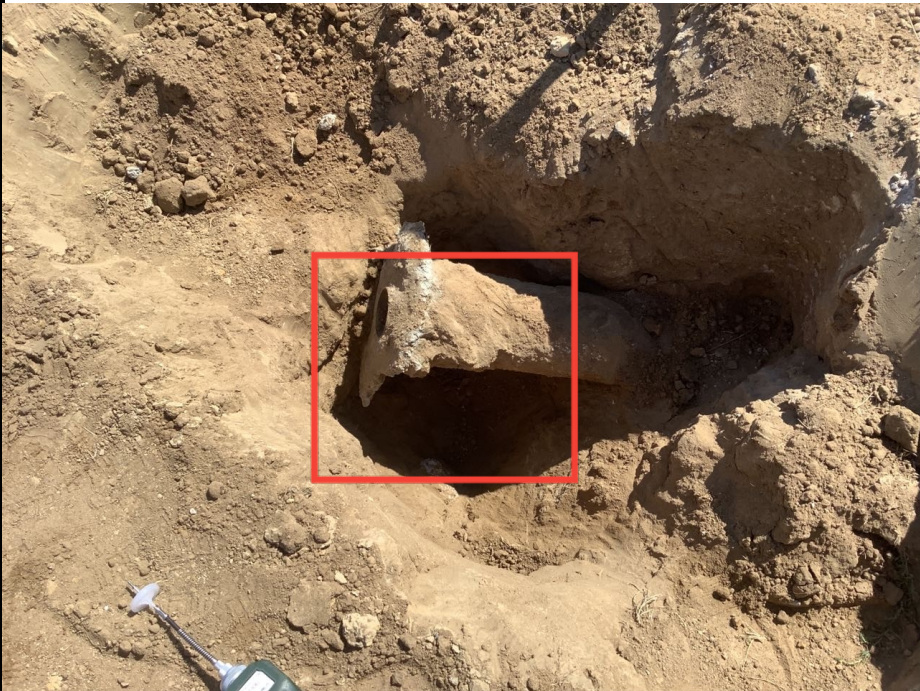
Equipment ID: FL01R-W@2'		Equipment Type:	Equipment ID:		Equipment Type:
Material:	Volume:	Contents:	Material:	Volume:	Contents:
Notes/Conditions: FACING E.			Notes/Conditions:

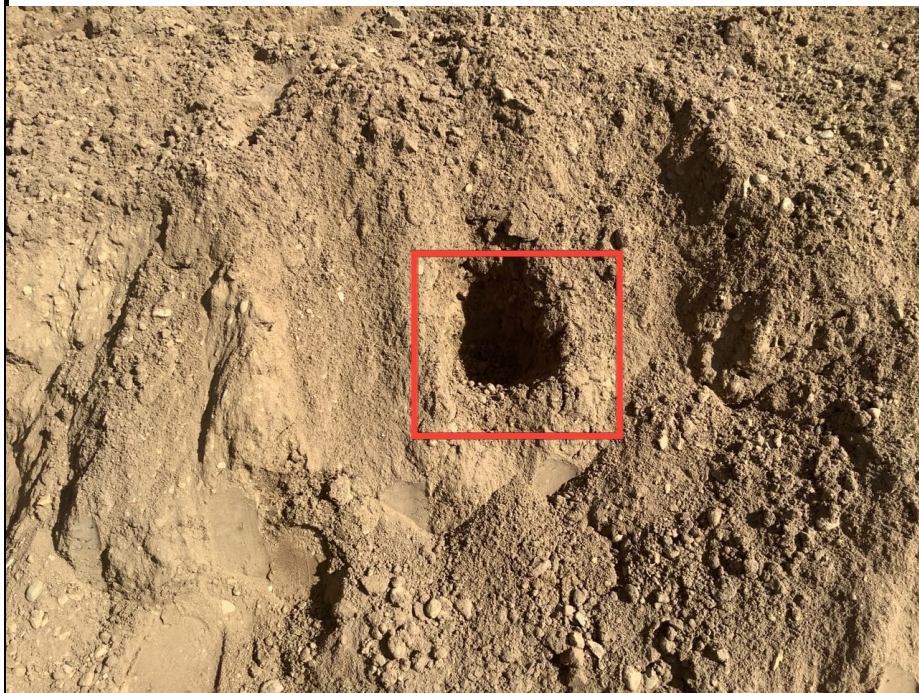
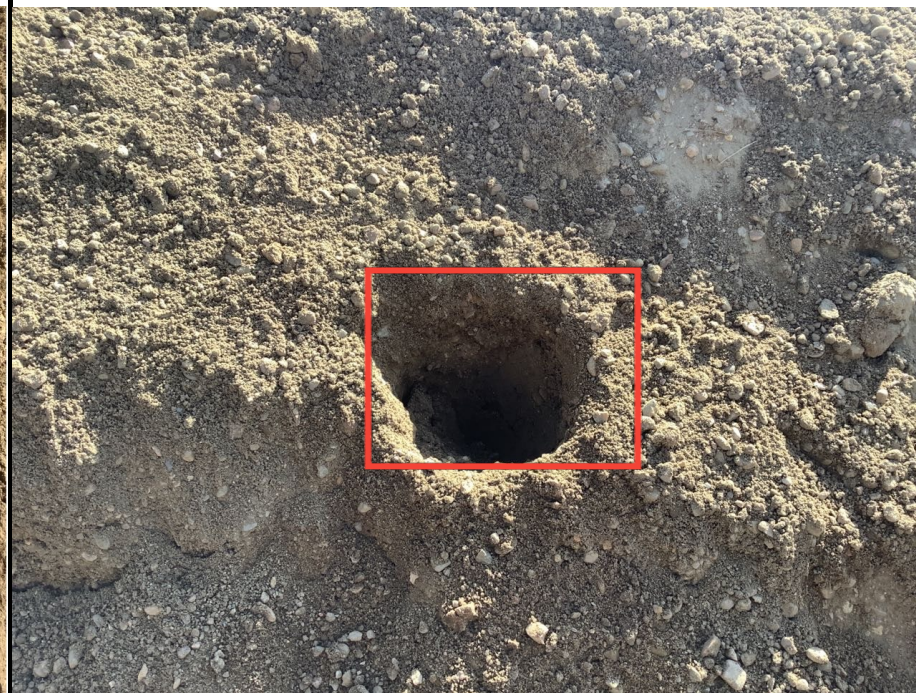
Equipment ID: PWV01-N@2'		Equipment Type:		Equipment ID: PWV01-E@2'		Equipment Type:					
Material:		Volume:		Contents:		Material:		Volume:		Contents:	
Notes/Conditions: FACING N.						Notes/Conditions: FACING E.

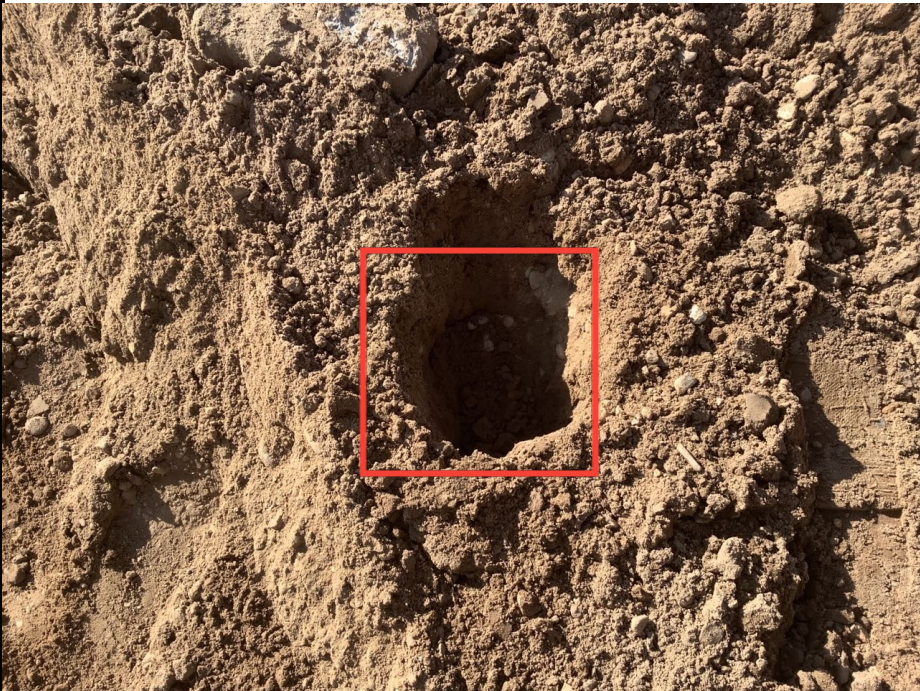
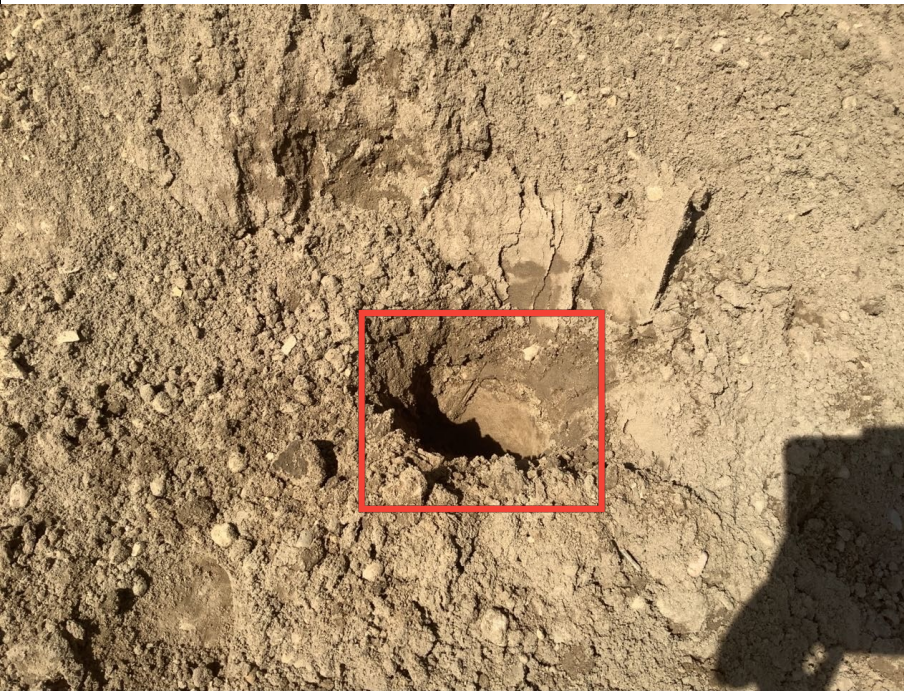
Equipment ID: PWV01-S@2'		Equipment Type:		Equipment ID: PWV01-W@2'		Equipment Type:					
Material:		Volume:		Contents:		Material:		Volume:		Contents:	
Notes/Conditions: FACING S.						Notes/Conditions: FACING W.

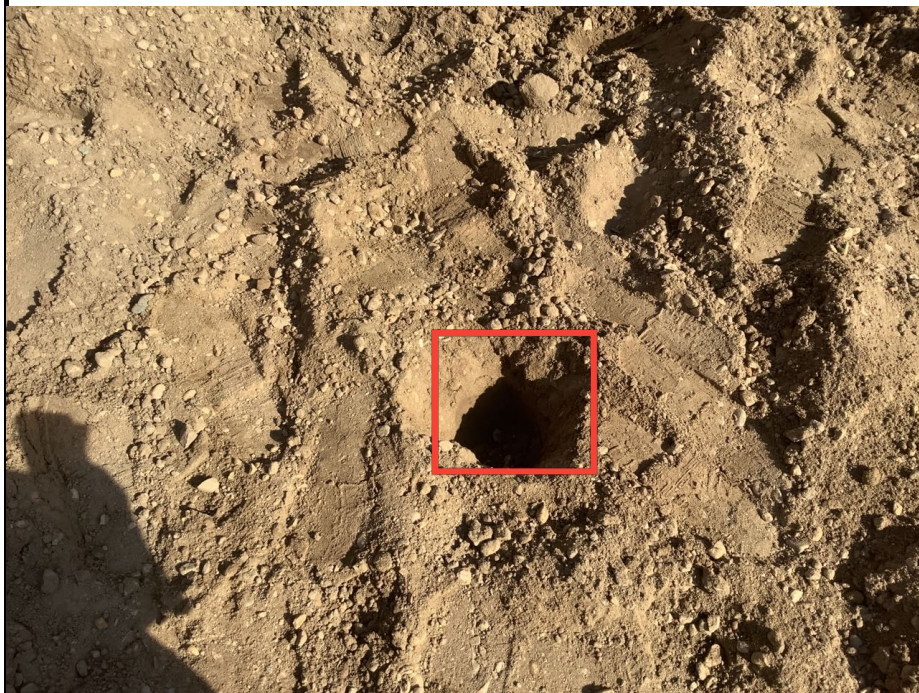
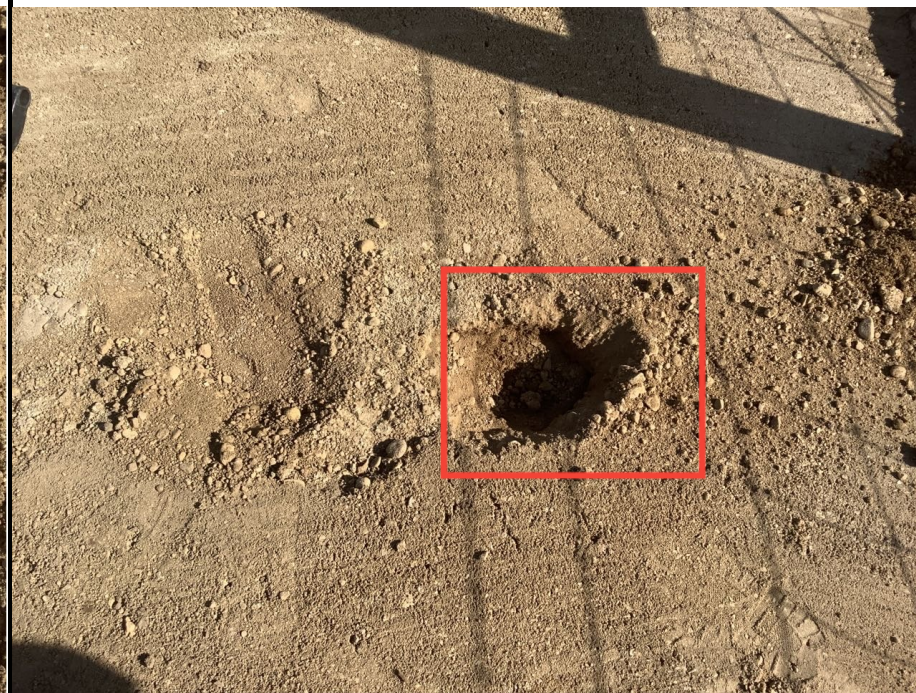
Equipment ID: PWV01-B@4'		Equipment Type:		Equipment ID: FLARE01@0-6"		Equipment Type:					
Material:		Volume:		Contents:		Material:		Volume:		Contents:	
Notes/Conditions: FACING N.						Notes/Conditions: FACING N.

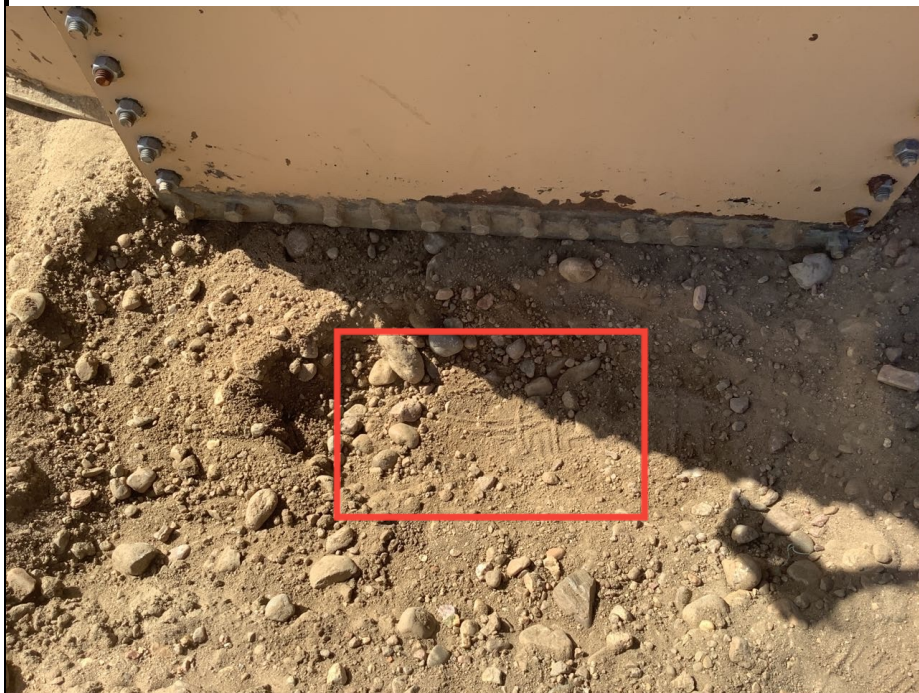
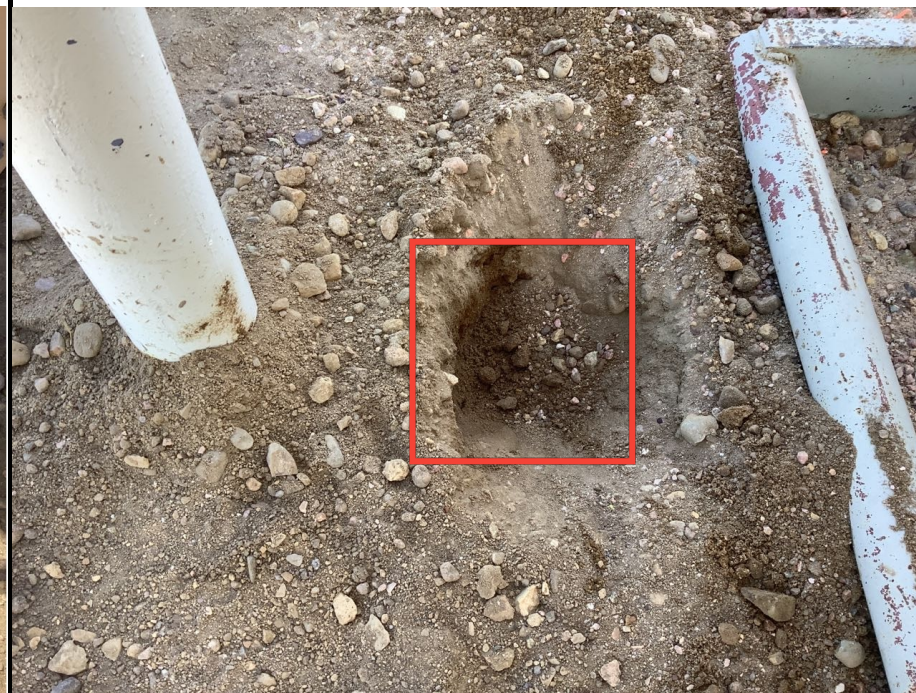
Equipment ID: AST01 @ 0-6"		Equipment Type:		Equipment ID: MH01 @ 0-6"		Equipment Type:					
Material:		Volume:		Contents:		Material:		Volume:		Contents:	
Notes/Conditions: FACING S.						Notes/Conditions: FACING N.

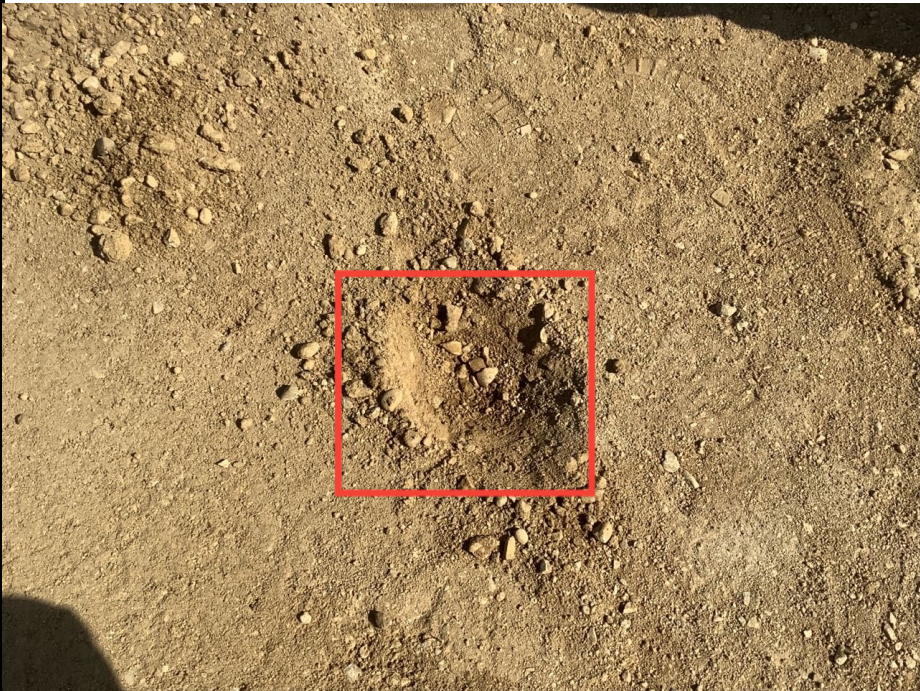
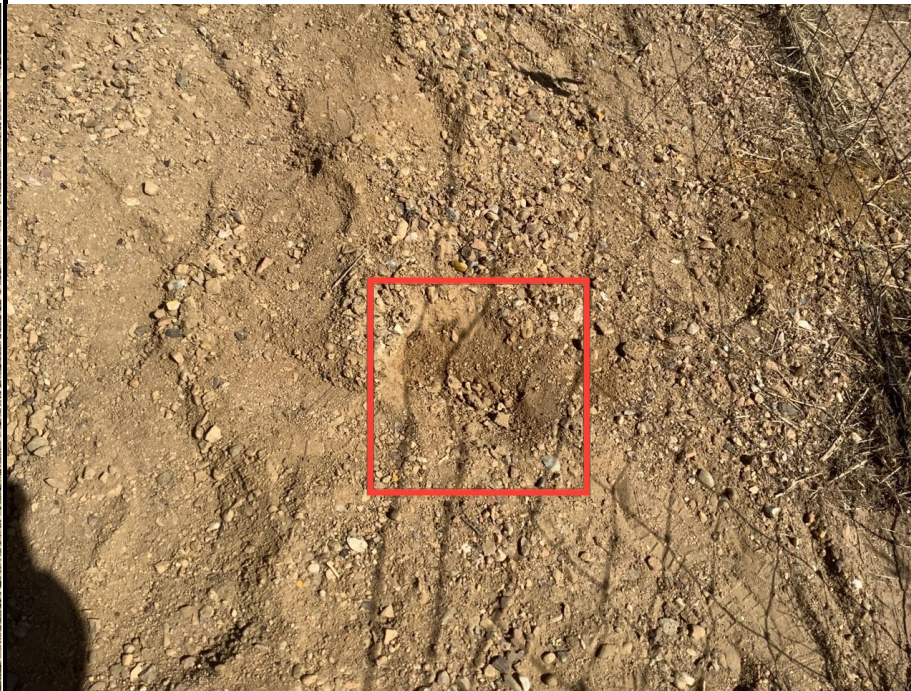
Equipment ID: FLARE02 @ 0-6"		Equipment Type:		Equipment ID: AUTO01 @ 0-6"		Equipment Type:					
Material:		Volume:		Contents:		Material:		Volume:		Contents:	
Notes/Conditions: FACING N.						Notes/Conditions: FACING N.

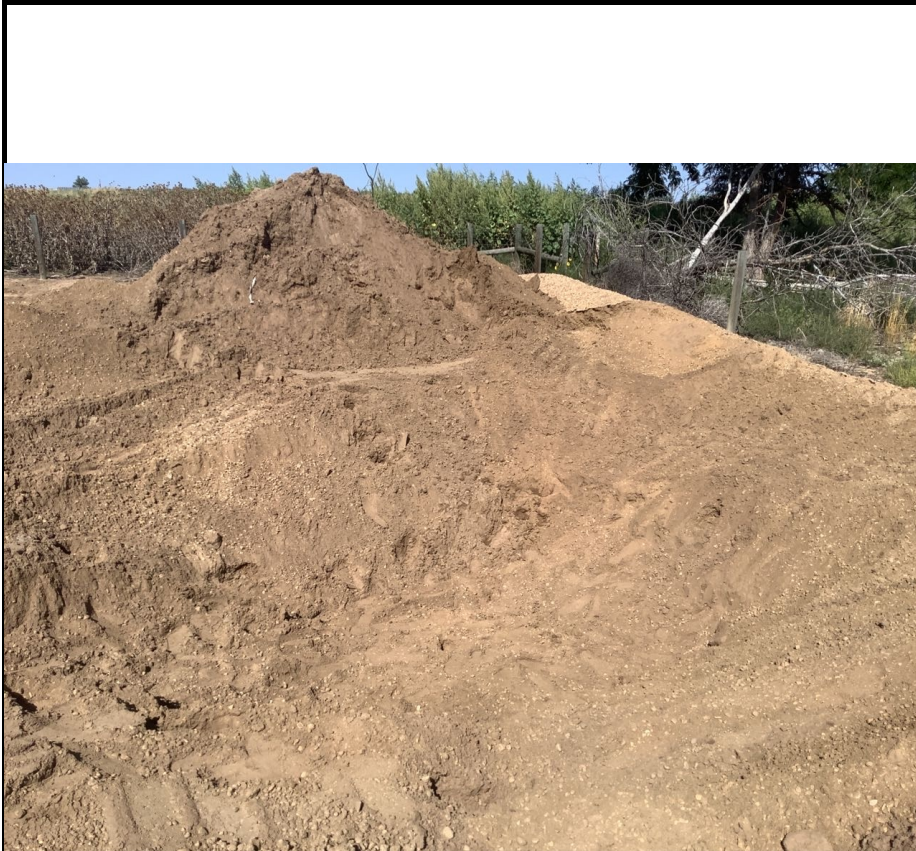
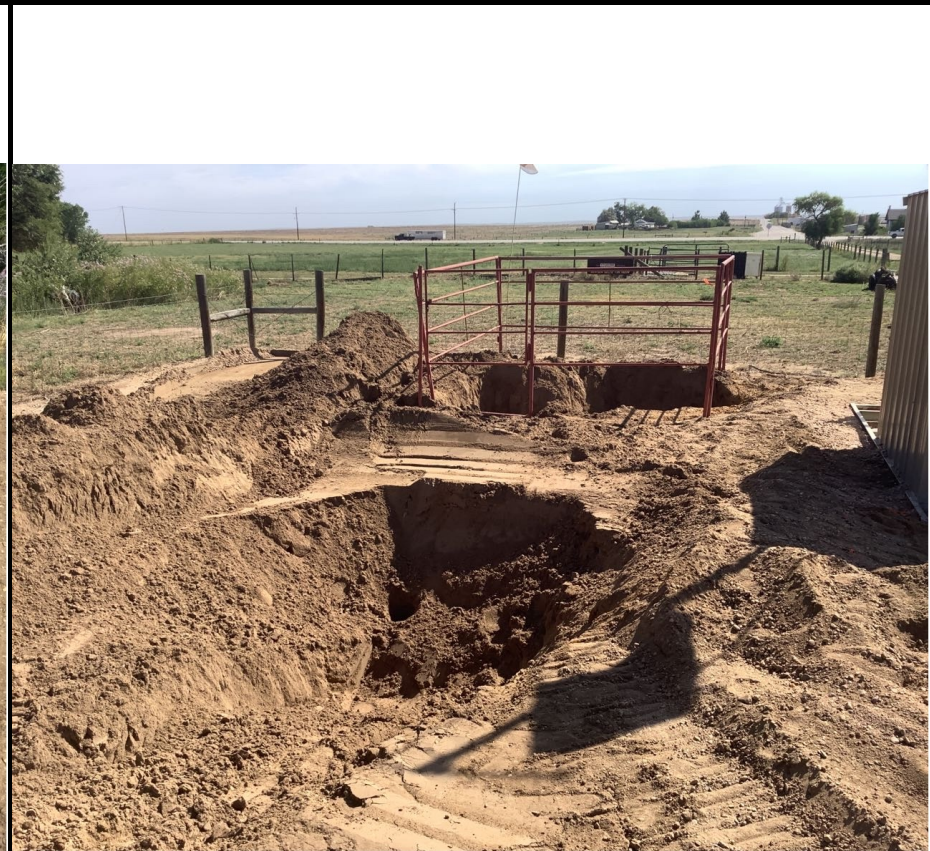
Equipment ID:PWV01

Equipment ID:SEPARATOR

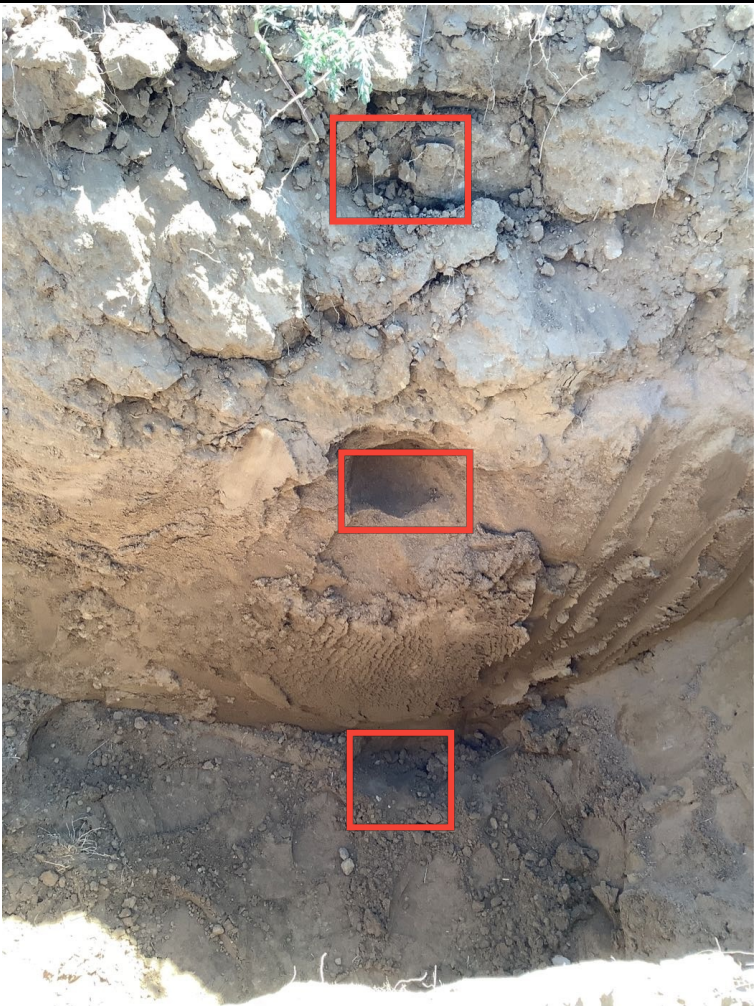
Equipment ID: BKG01		Equipment Type:	Equipment ID:		Equipment Type:
Material:	Volume:	Contents:	Material:	Volume:	Contents:
Notes/Conditions: FACING E.			Notes/Conditions:
