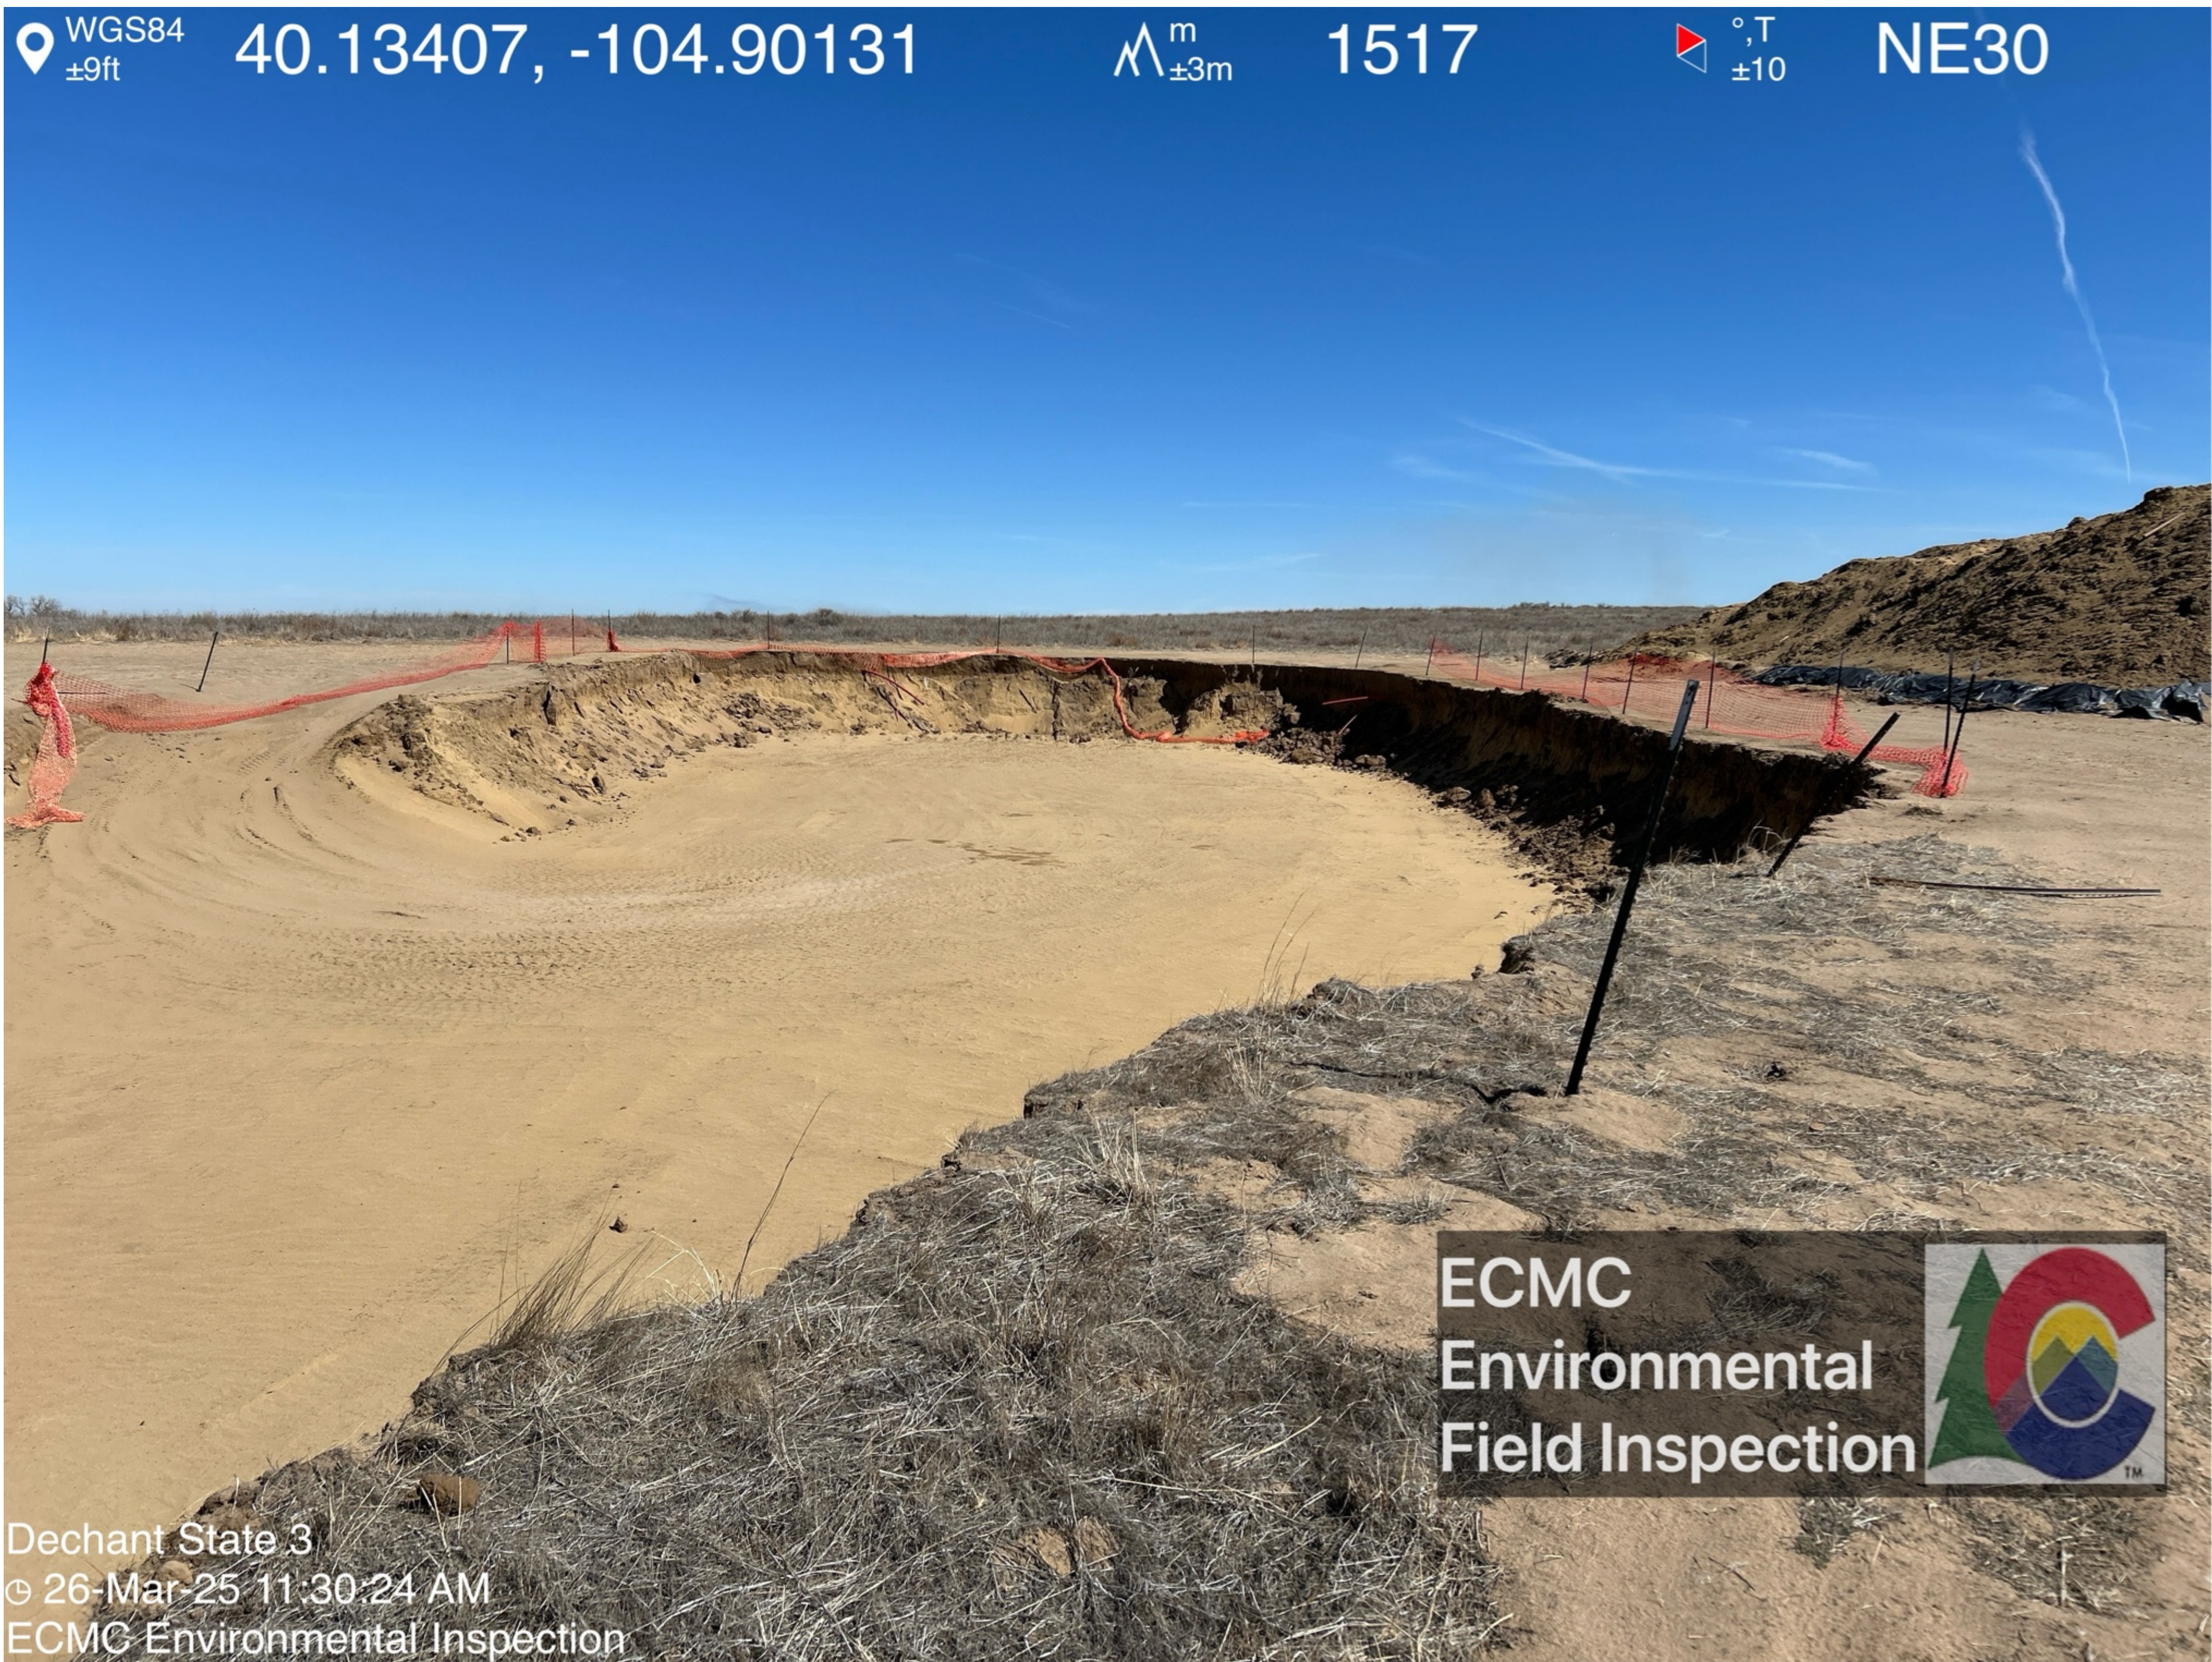
Orange construction fencing has been installed around portions of the excavation, but has fallen and does not fully encompass the excavation perimeter.

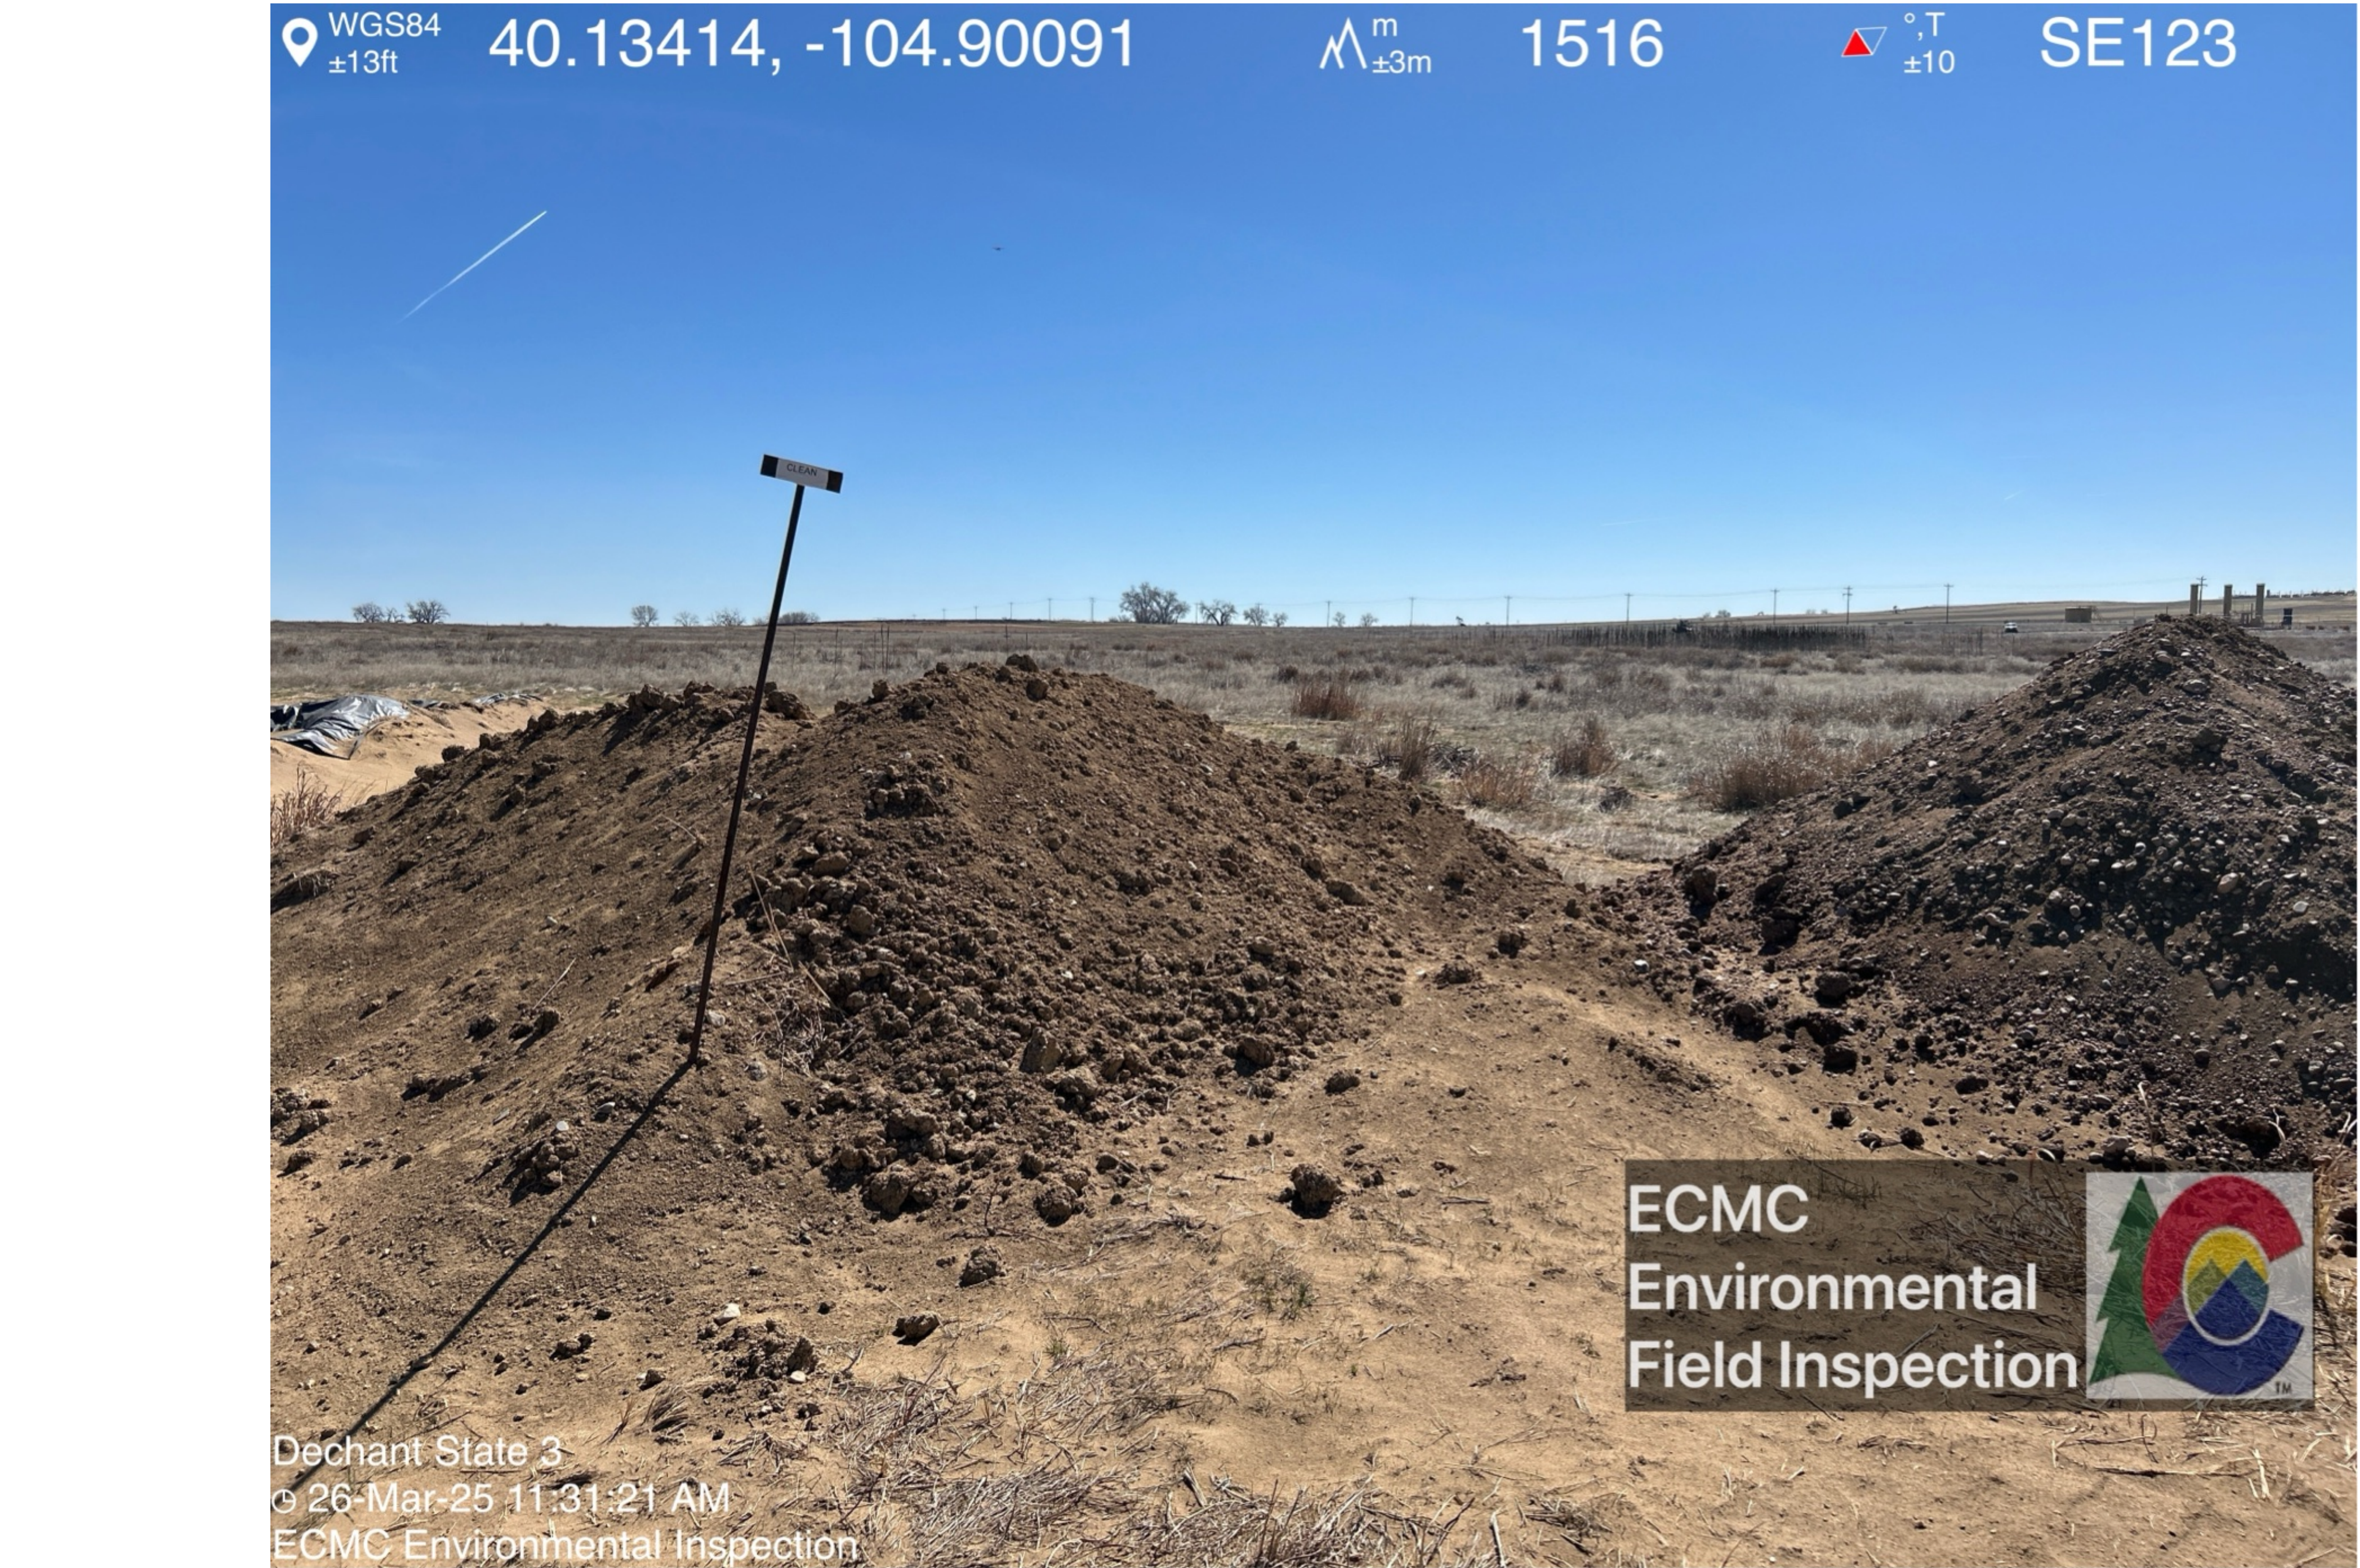
Two small soil stockpiles labeled "Clean" are visible immediately adjacent to stockpiled oily waste labeled "contaminated". The "clean" soil appeared to be mixed with topsoil and vegetation from the surrounding area. A portion of the liner of the soil stockpile marked contaminated is visible in the left side of the picture.

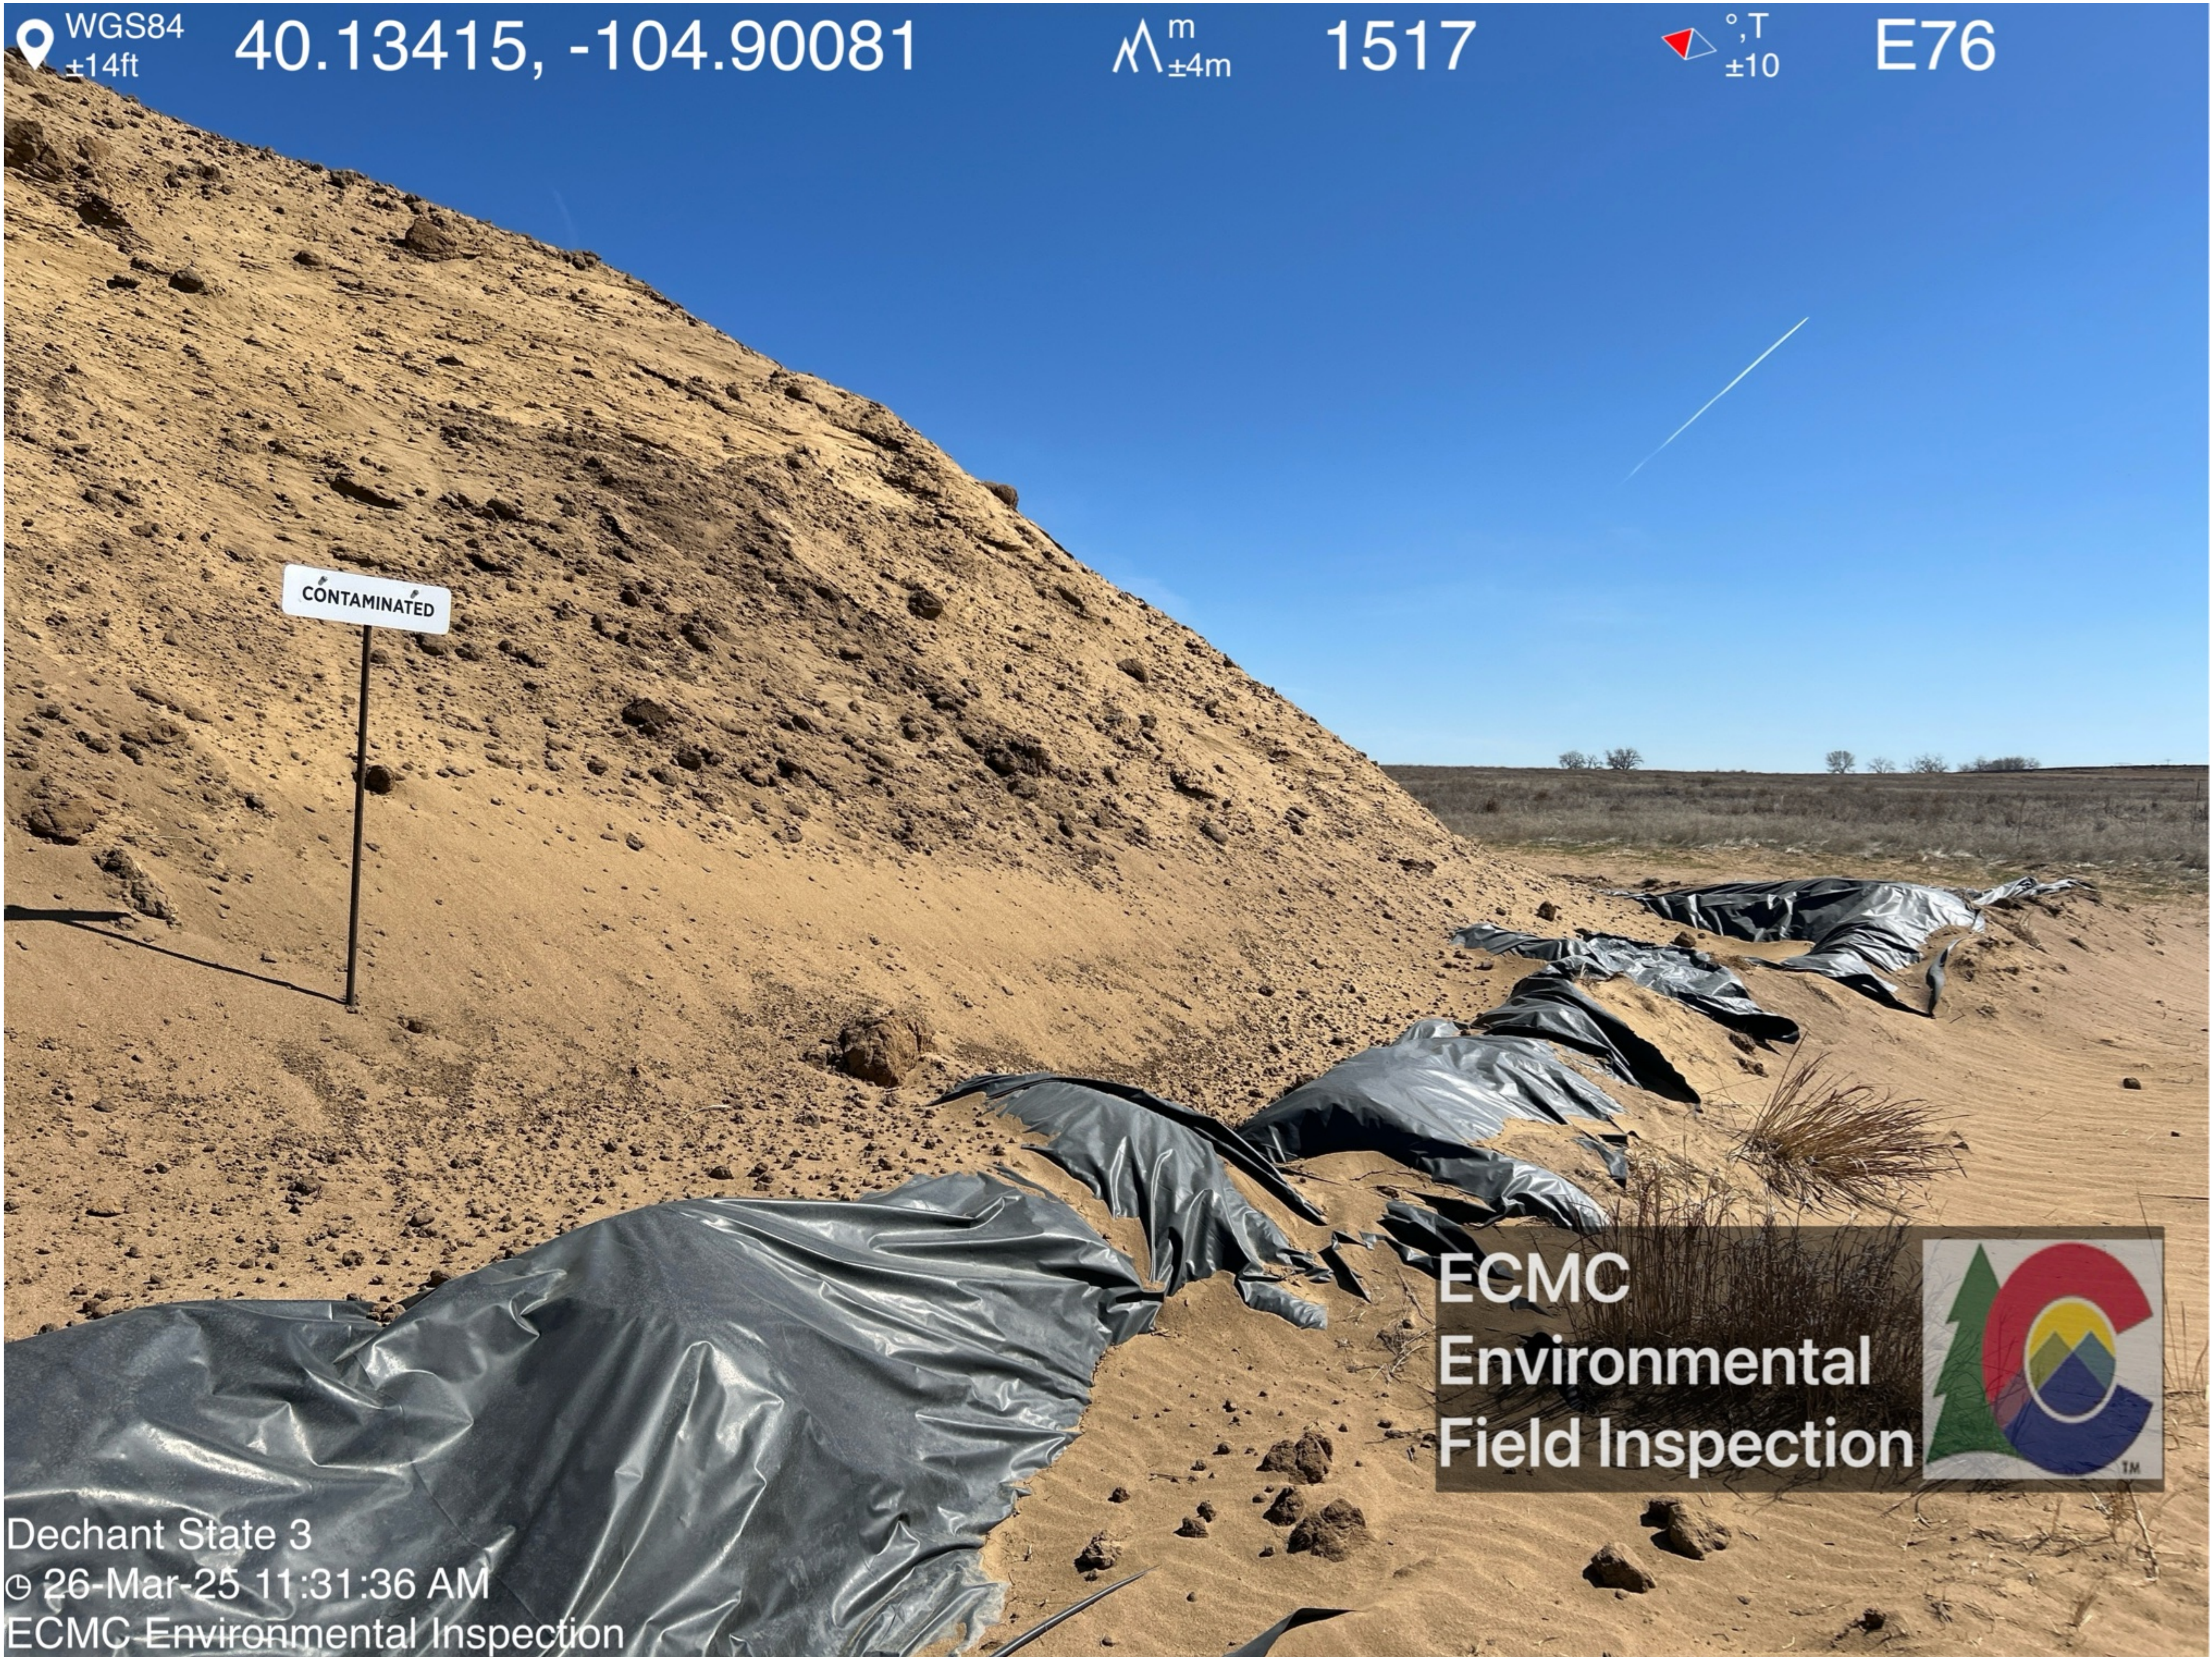
Oily waste labeled "contaminated" is stockpiled on location. The majority of oily waste is stockpiled on liner; however, oily waste has spilled and spread outside of the lined area. Asymmetrical ripples are visible.

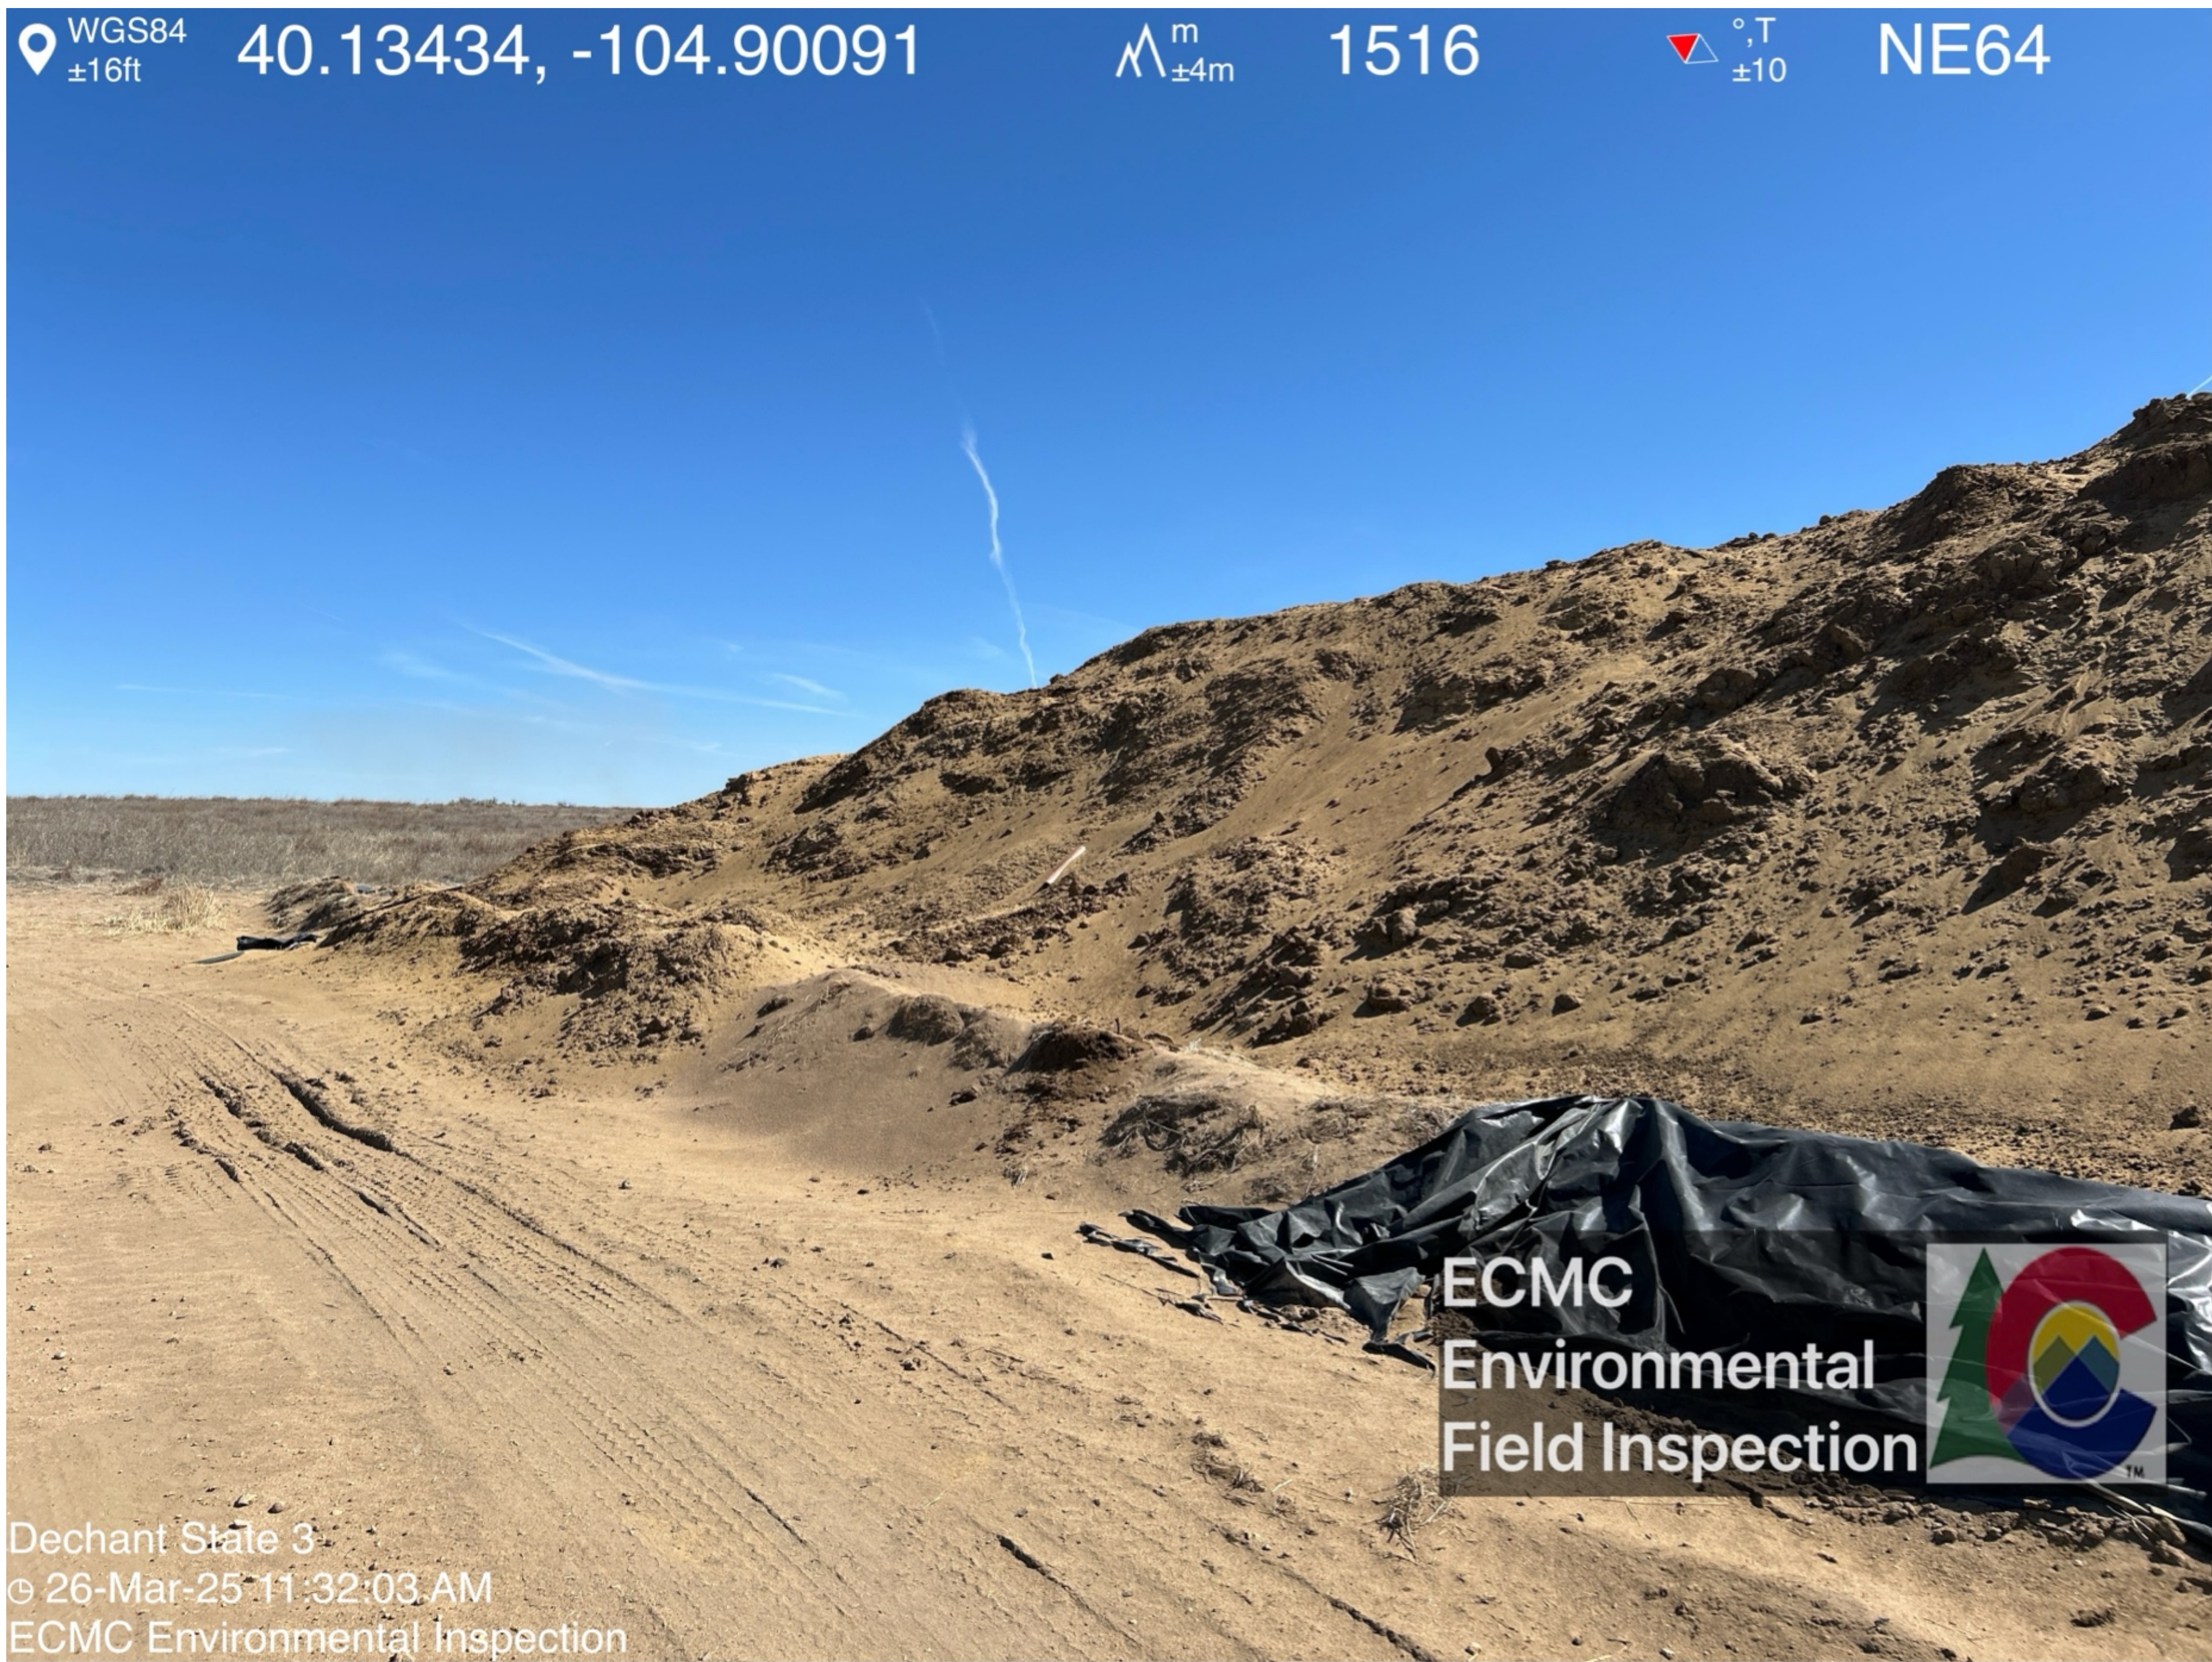
Oily waste labeled "contaminated" is stockpiled on location. The majority of oily waste is stockpiled on liner; however, the liner is discontinuous and oily waste has spread outside of the lined area.

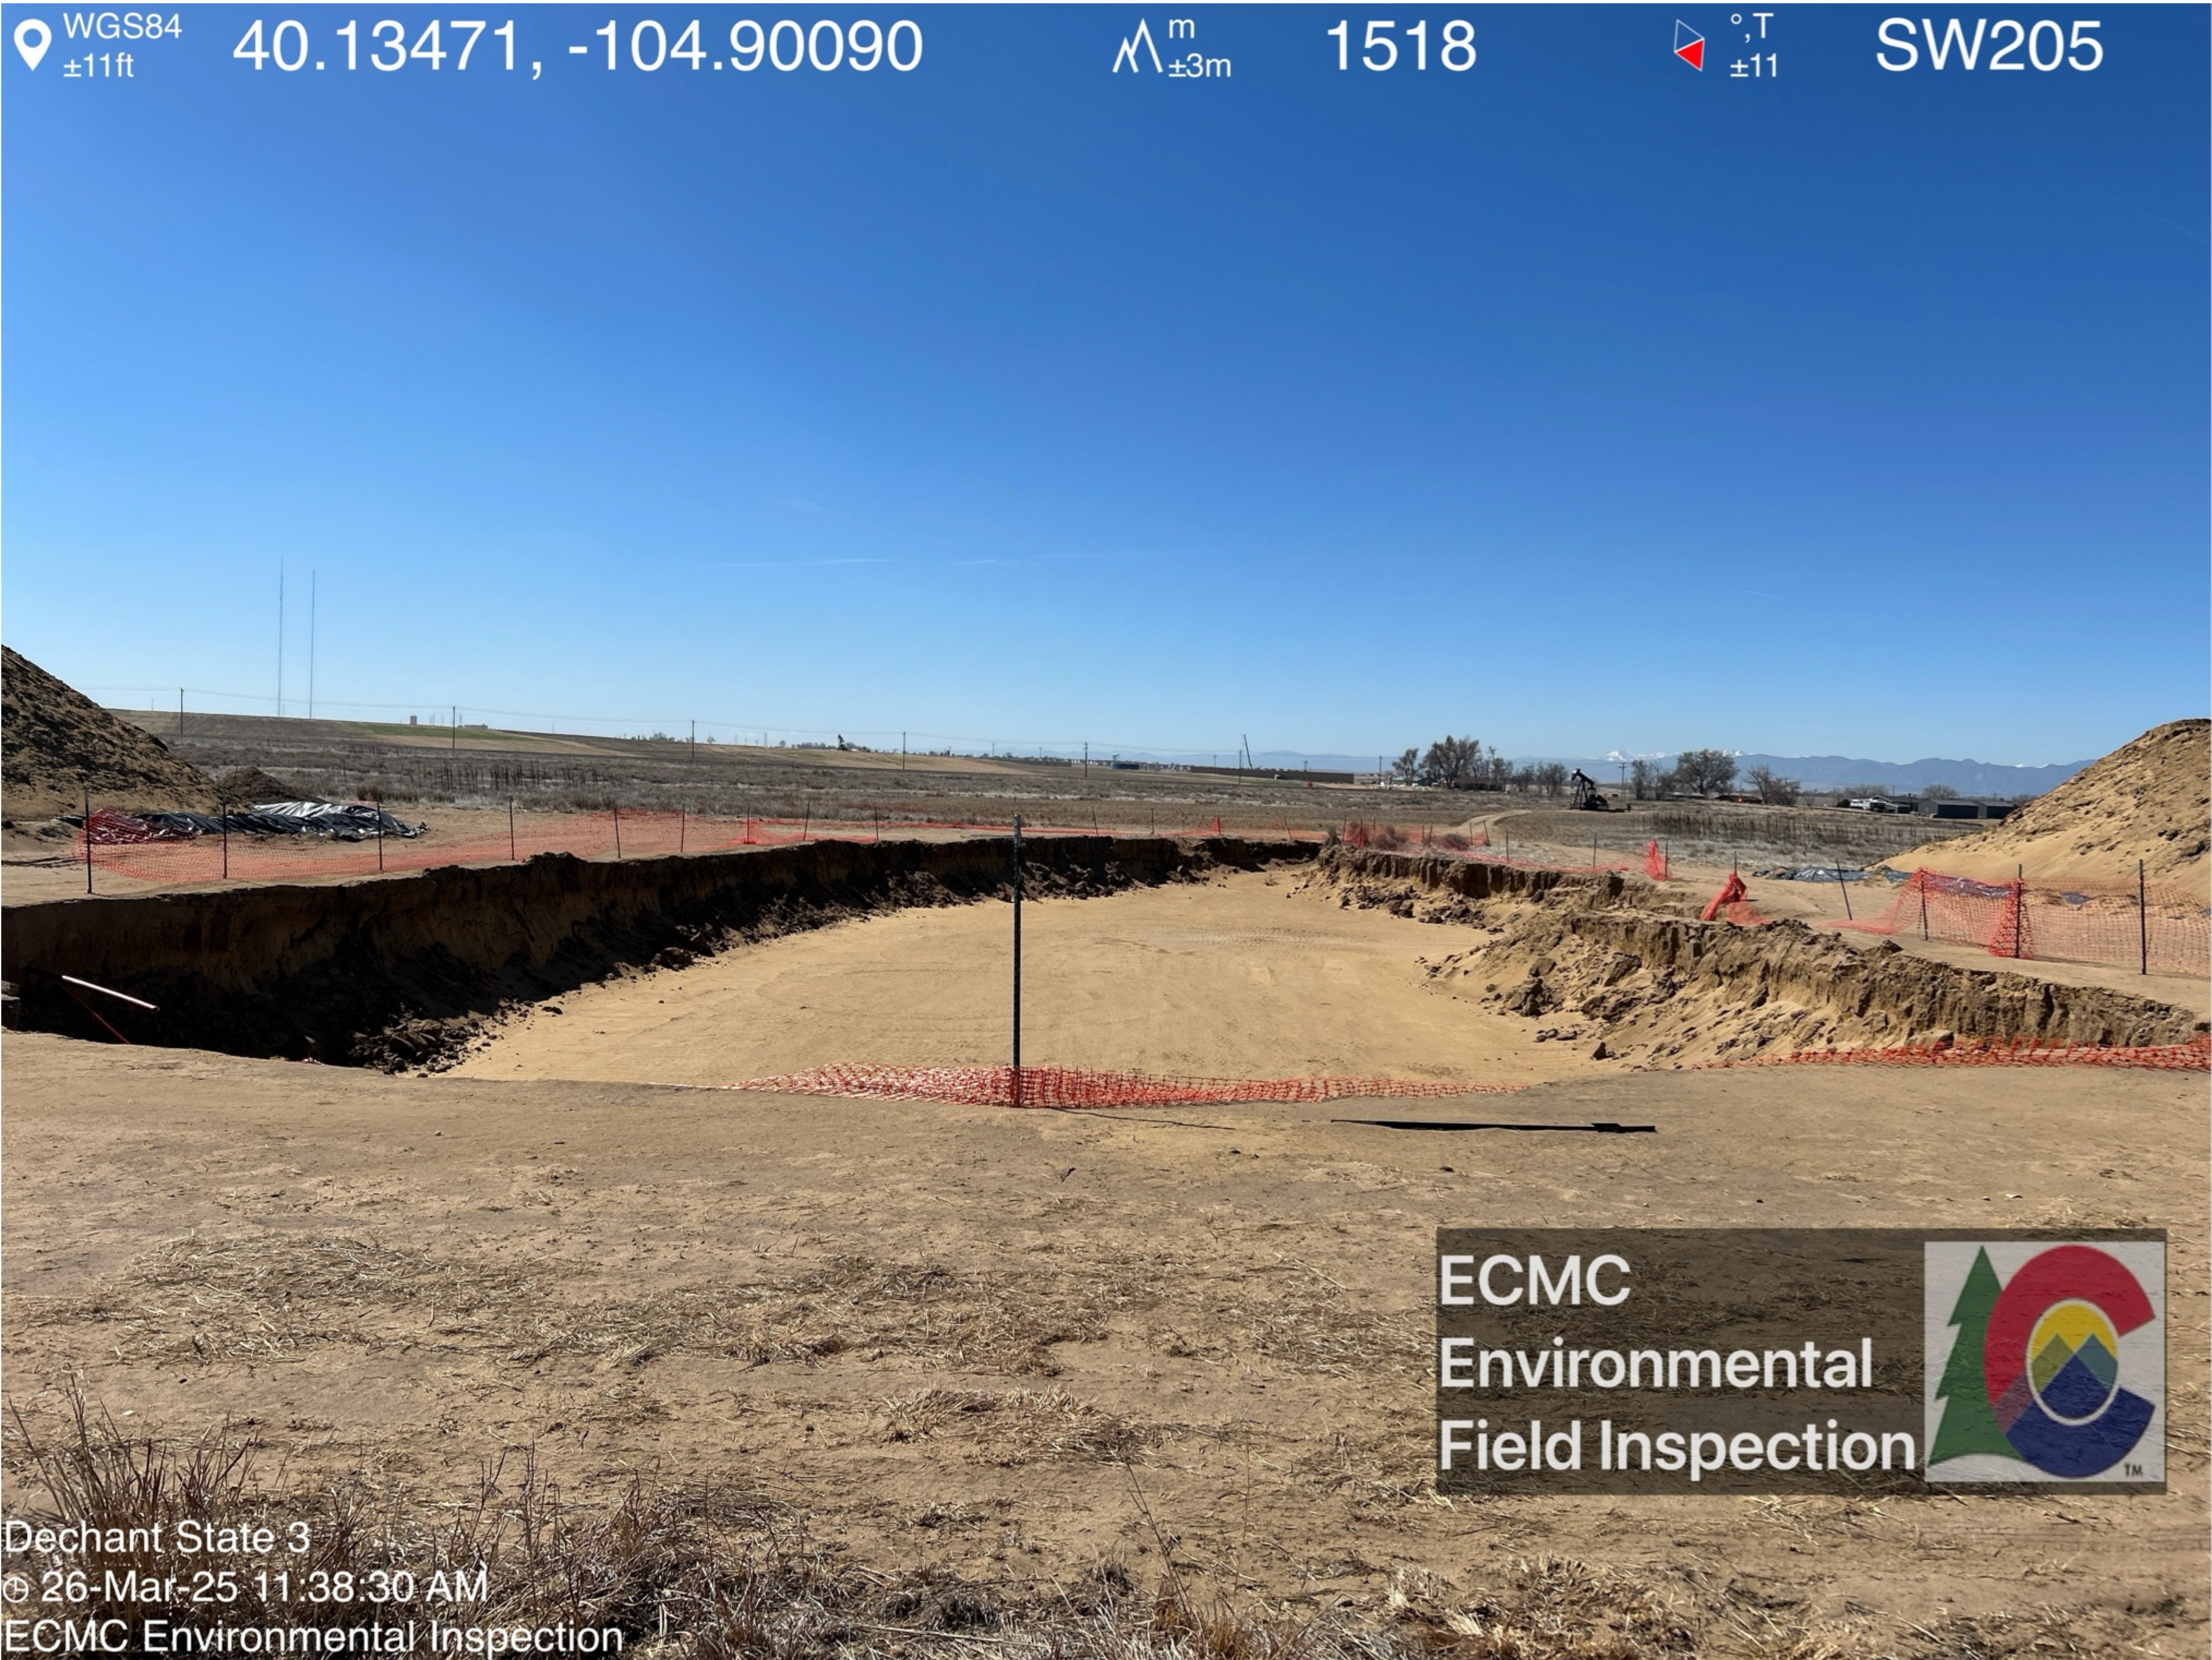
Open construction and soil stockpiles are visible on location.
