FREMONT ENVIRONMENTAL INC.

Subject: **Facility Closure Data Submittal**
31-4-64 SENE Tank Battery
SENE Sec. 31, T4N, R64W
Weld County, Colorado
Fremont Project No. C023-135
Facility # 467637, Remediation #26965

Tank Battery Closure Checklist

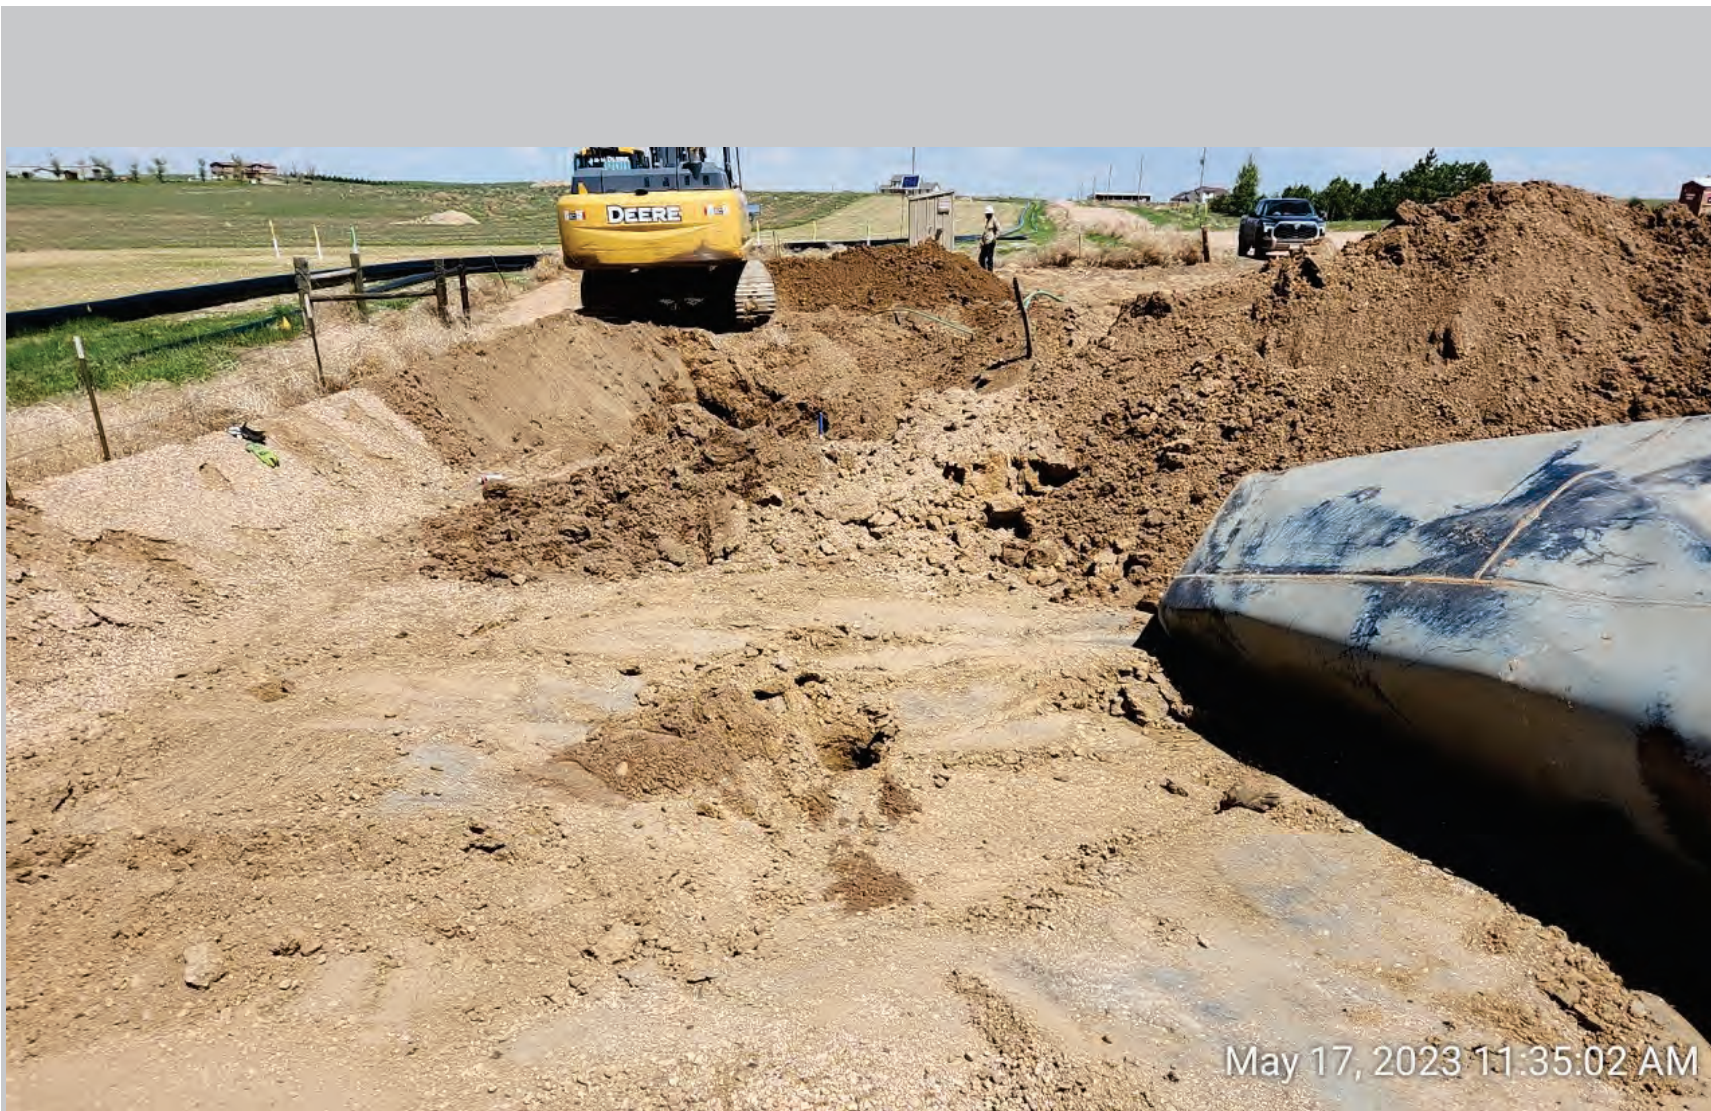
#1A - 31-4-64 SENE Tank Battery - Southern Above Ground Storage Tank (Oil) - AST01@6.0" - No Impacts Noted - PID 36.5ppm

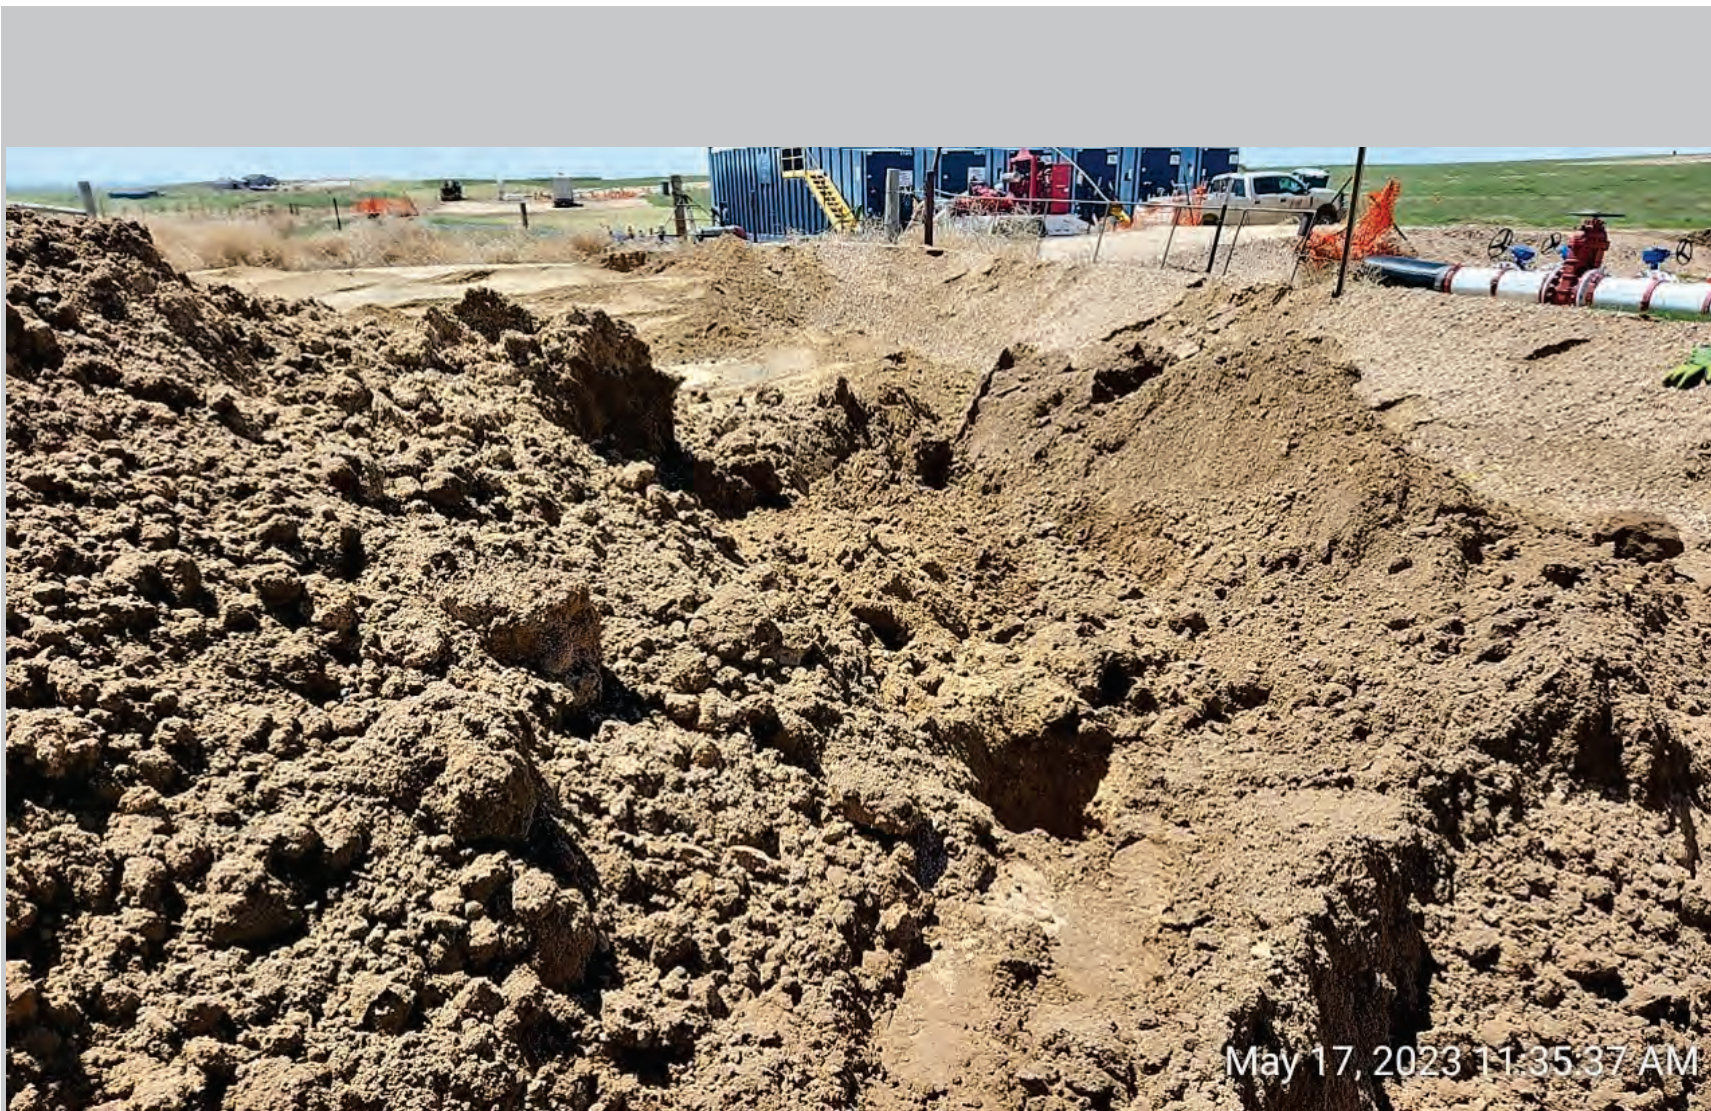
Tanks removed prior to sampling event. An exceedance in pH (5.56) was discovered at the northern above ground storage tank (AST02@6.0"). Refer to the inorganic soil chemistry table (Table 3) for reference.

#2A - 31-4-64 SENE Tank Battery - Northern Above Ground Storage Tank (Oil) - AST02@6.0" - No Impacts Noted - PID 37.9ppm

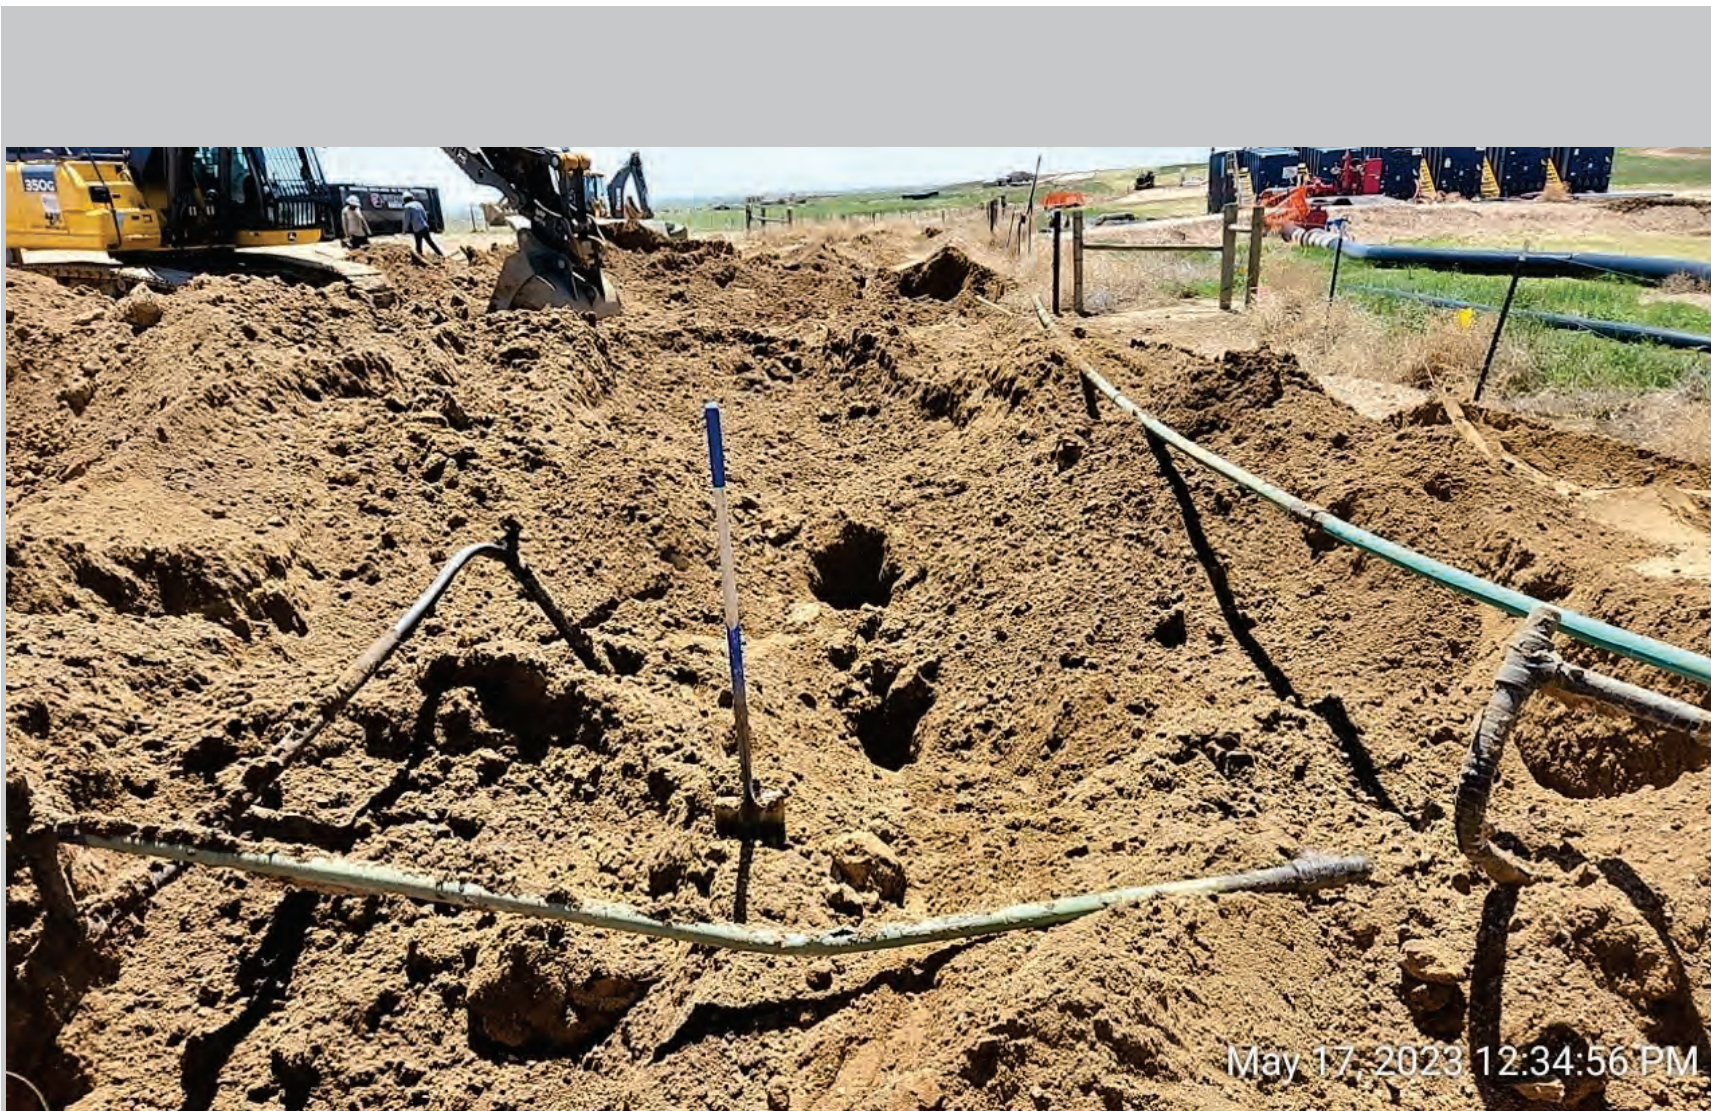
Impacts were discovered at the separator (SEP01@4.5'). Soil failed groundwater protection soil screening levels (GPSSLs) for Benzo (a) Anthracene. Refer to the volatile organic soil chemistry table (Table 1) for reference. Soil impacts were left in place. Further Investigation is required.

#3A - 31-4-64 SENE Tank Battery - Separator - SEP01@4.5' - No Impacts Noted - PID 12.9ppm

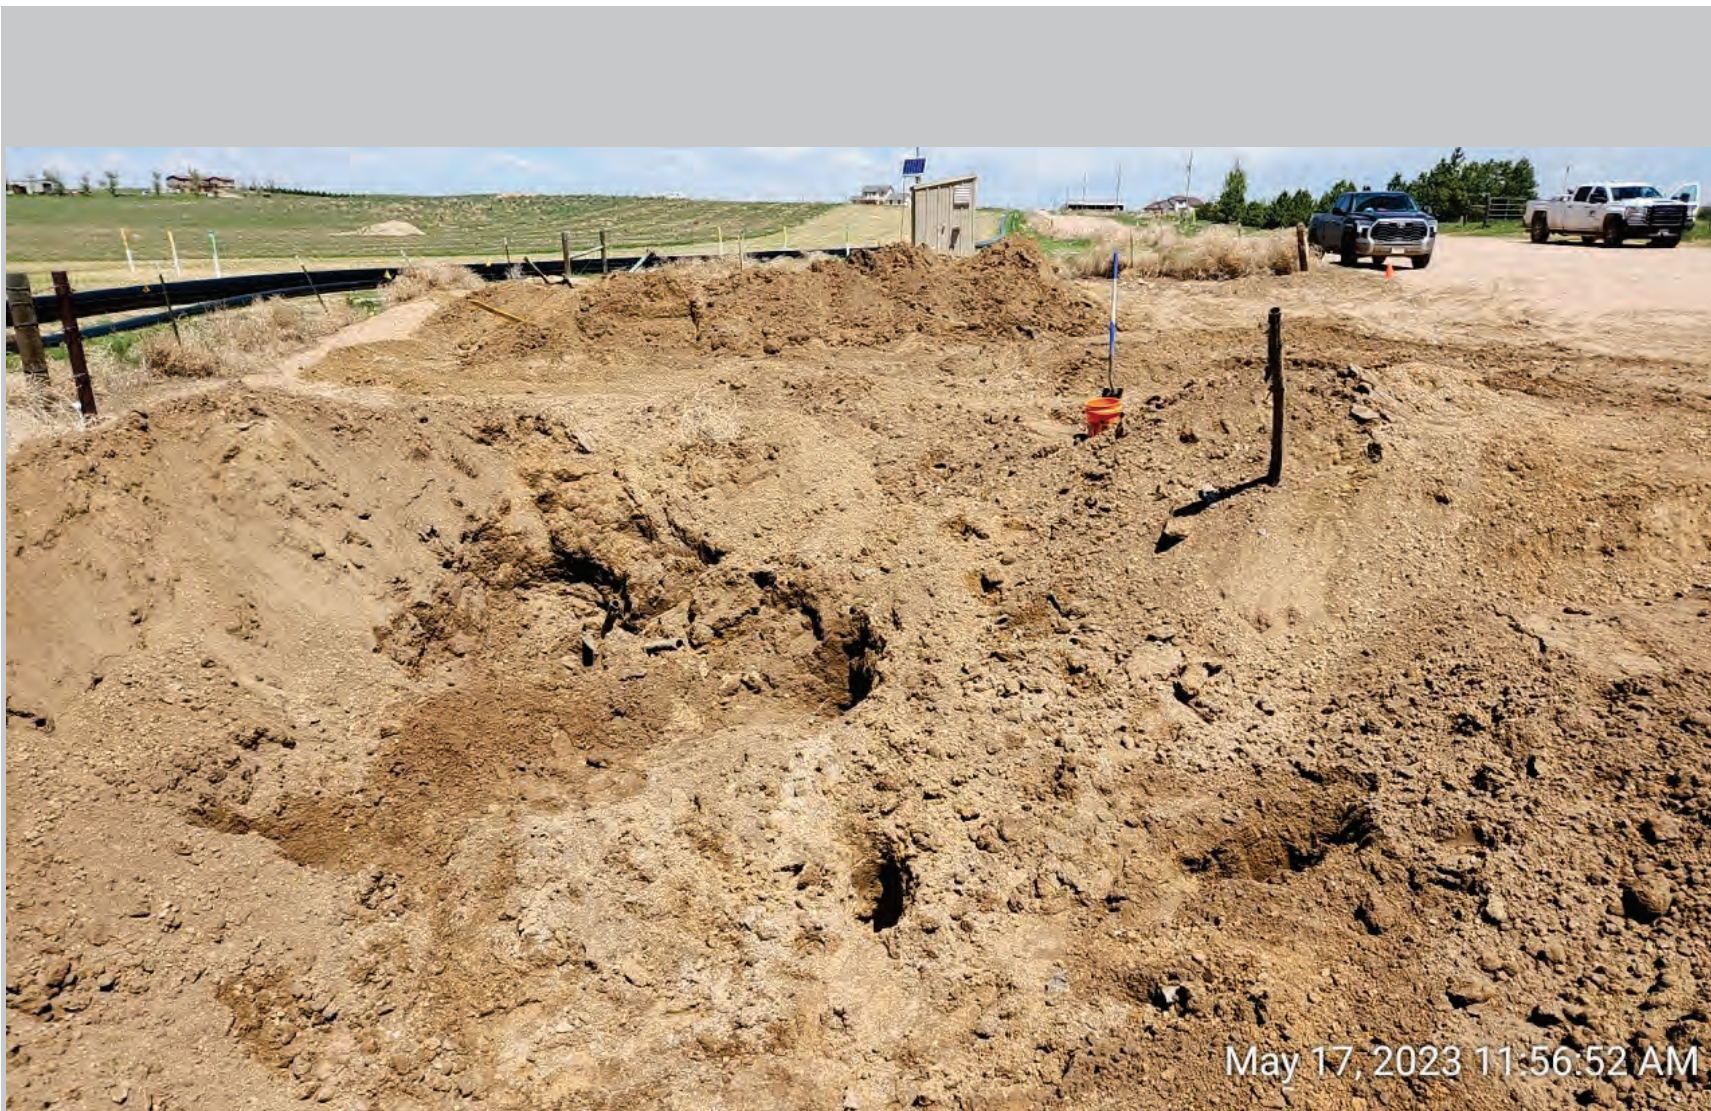
#4B - 31-4-64 SENE Tank Battery - North Sidewall of Produced Water Vault Excavation - PWVN01@5.0' - No Impacts Noted - PID 21.4ppm

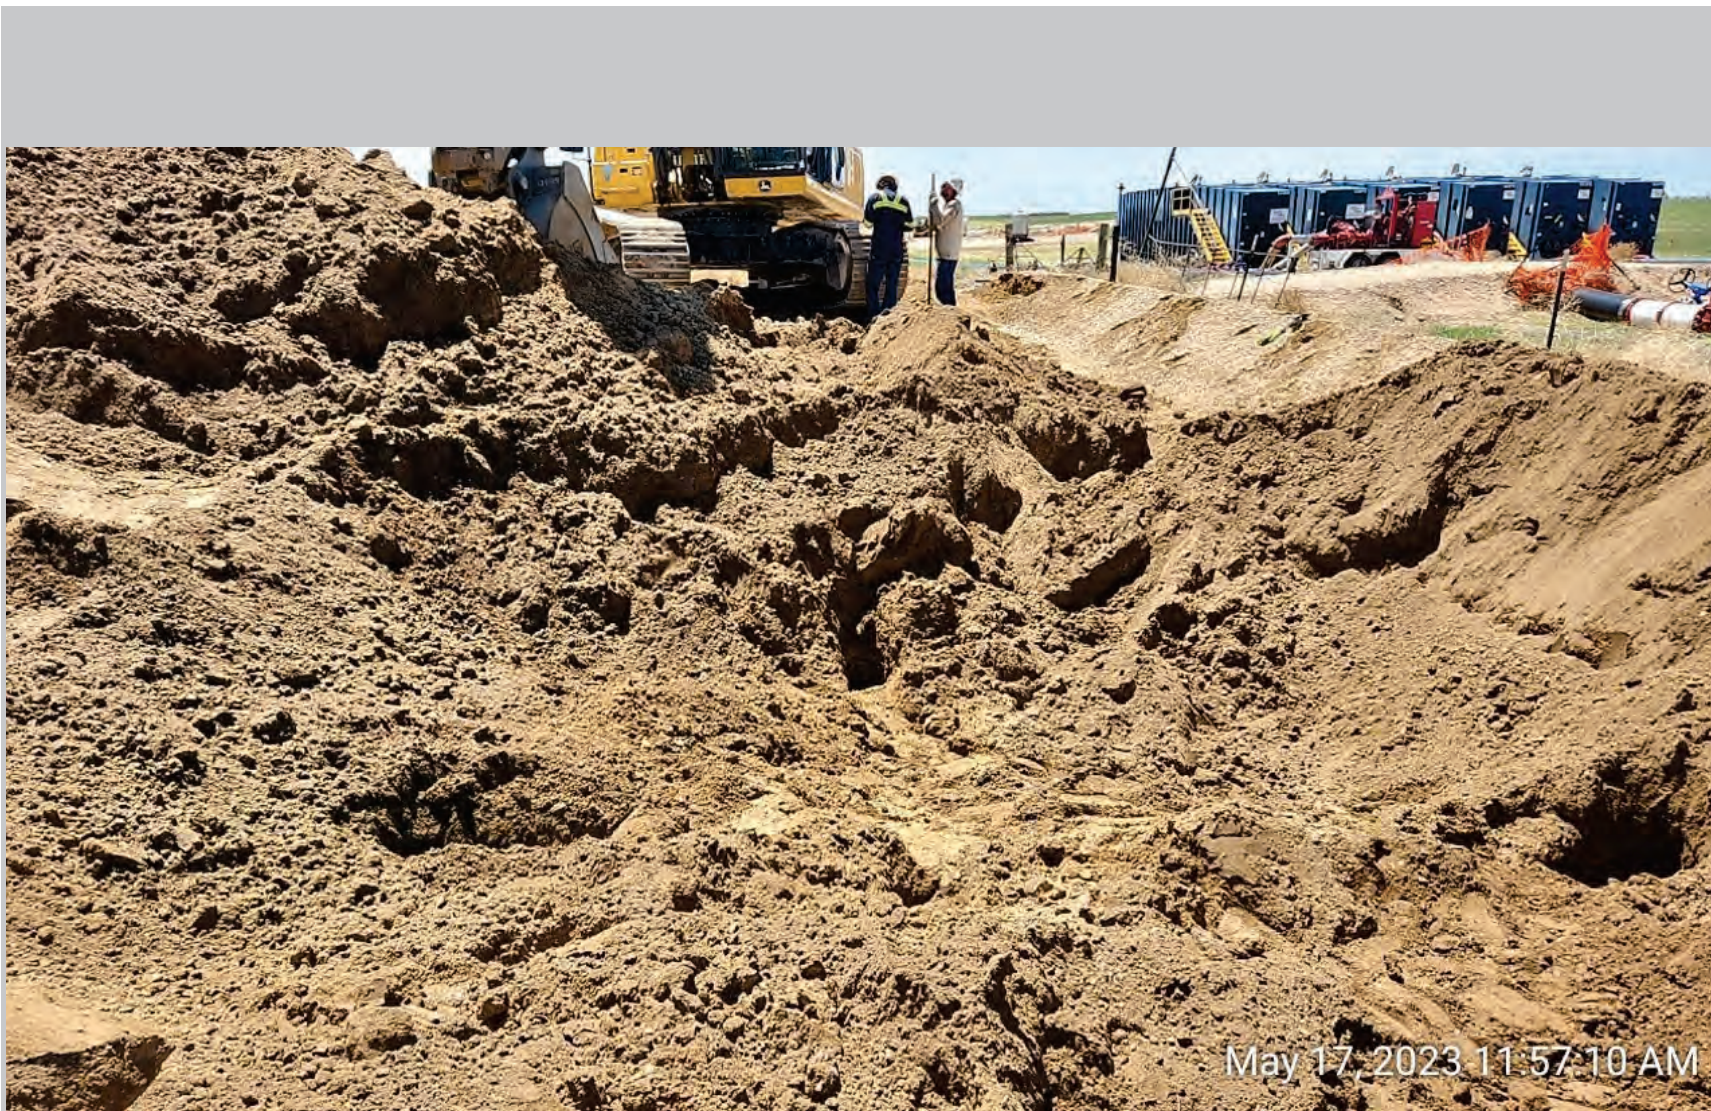
#4C - 31-4-64 SENE Tank Battery - South Sidewall of Produced Water Vault Excavation - PWVS01@5.0' - No Impacts Noted - PID 21.1ppm

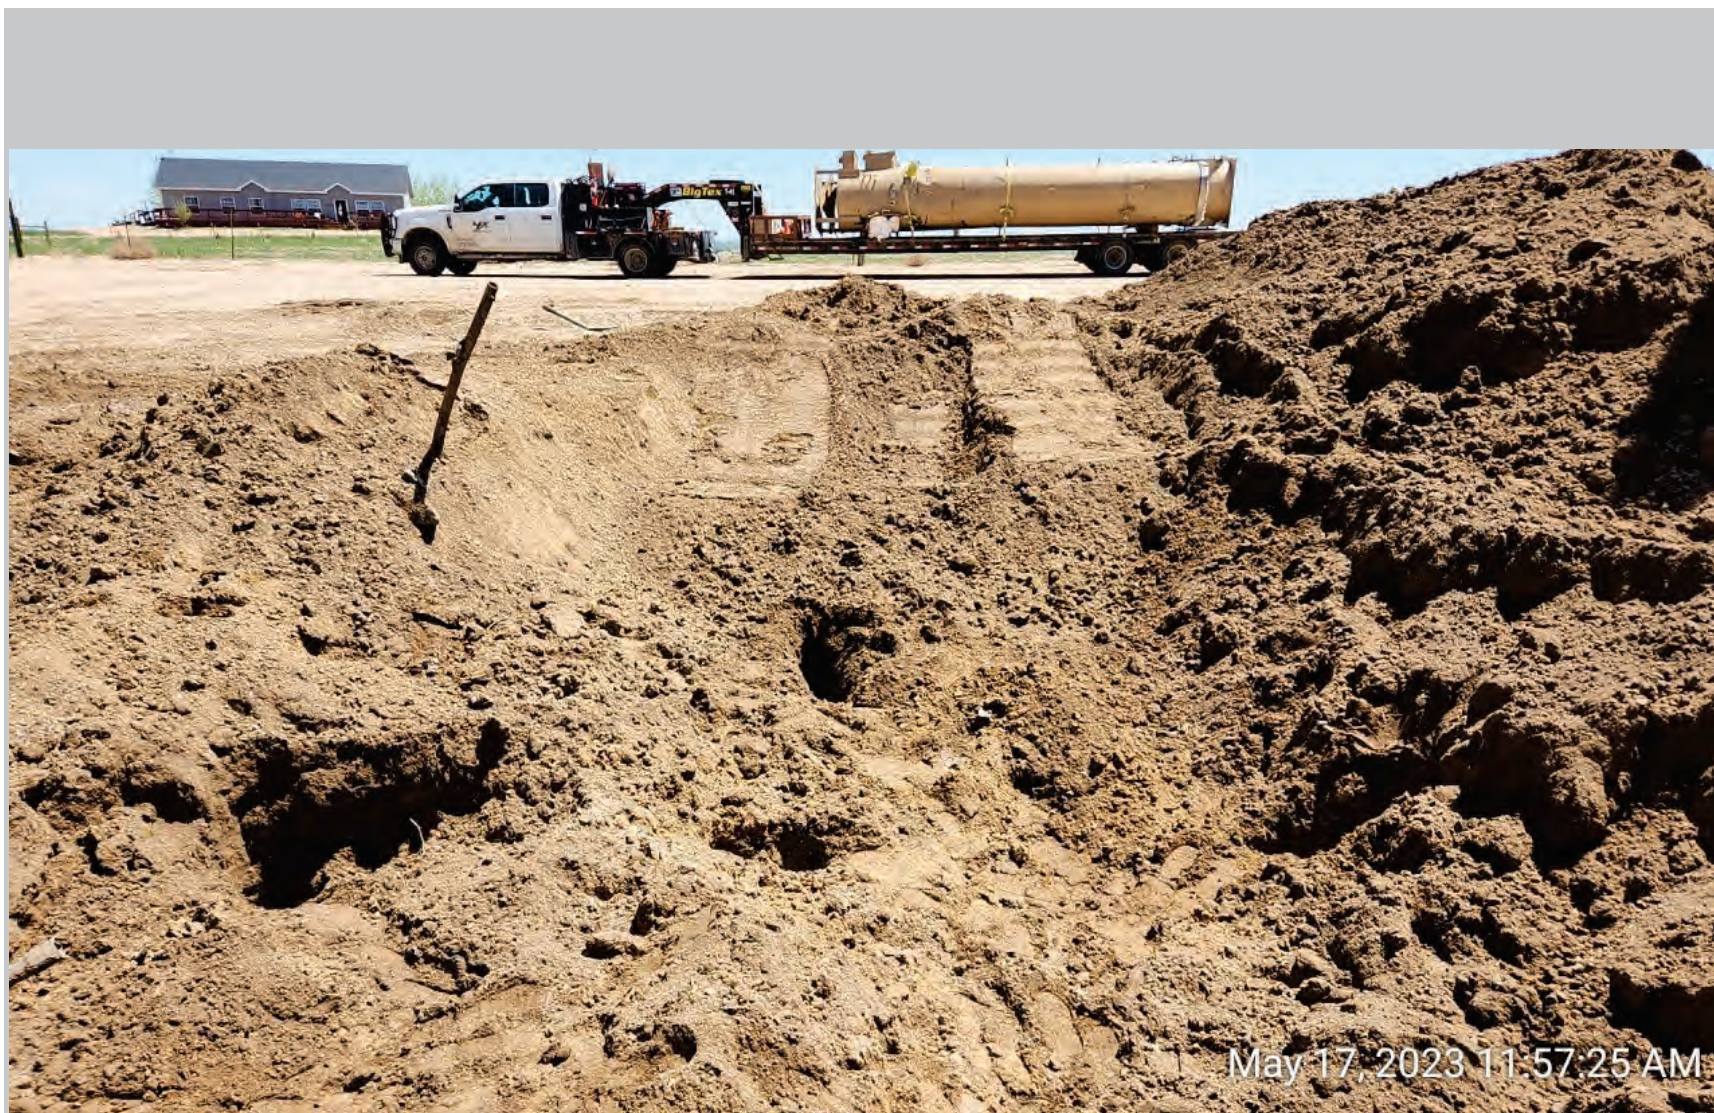
#4D - 31-4-64 SENE Tank Battery - East Sidewall of Produced Water Vault Excavation - PWVE01@5.0' - No Impacts Noted - PID 14.1ppm

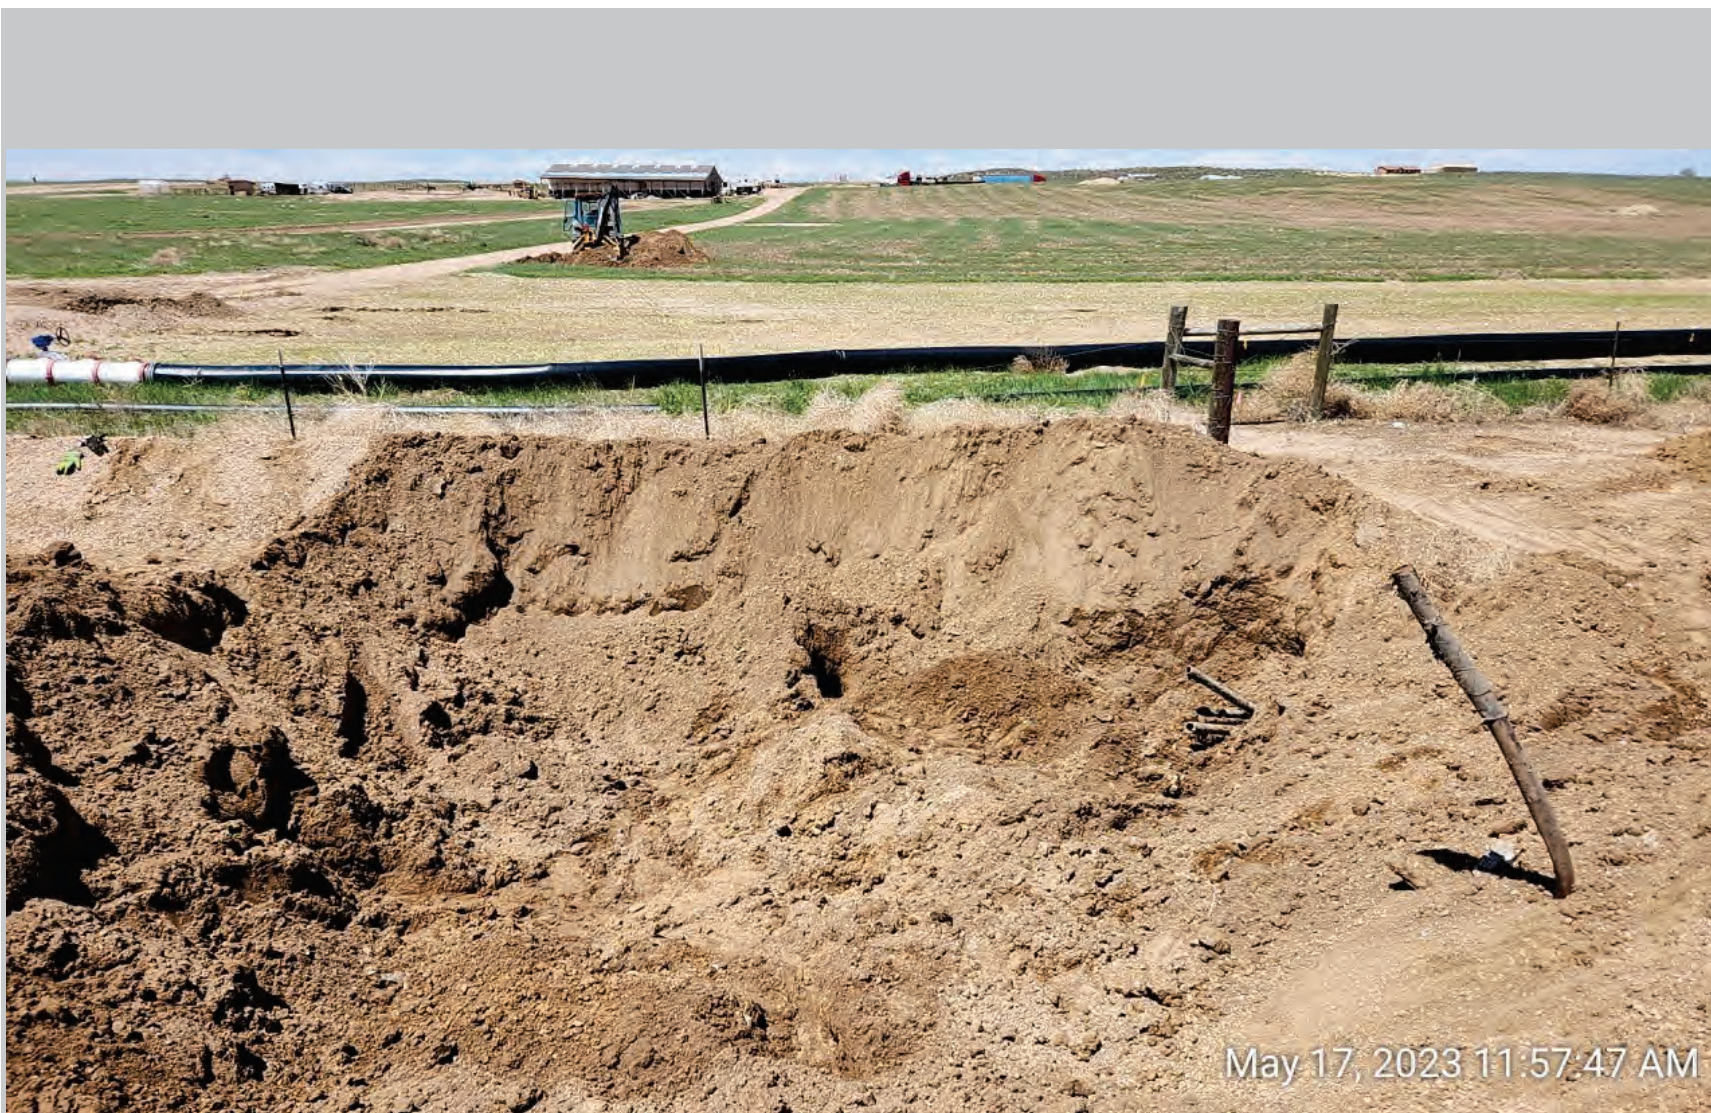
#4E - 31-4-64 SENE Tank Battery - West Sidewall of Produced Water Vault Excavation - PWVW01@5.0' - No Impacts Noted - PID 11.0ppm

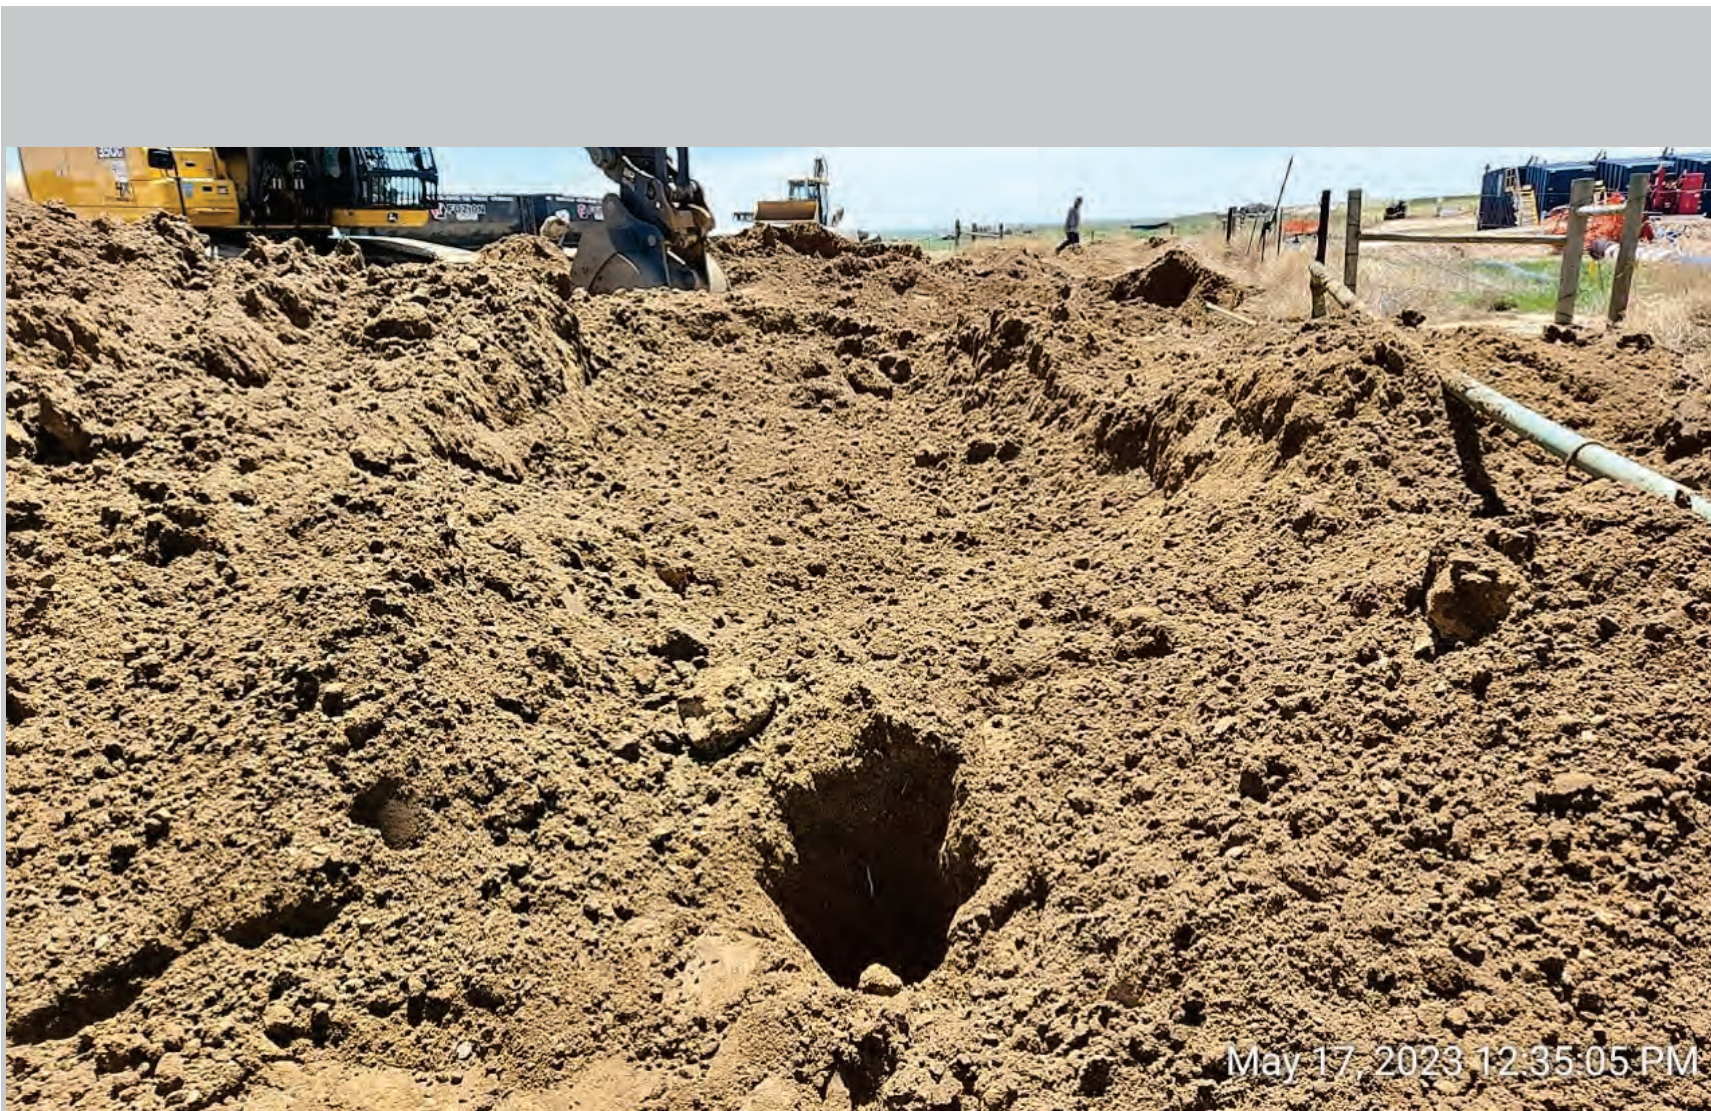
#5A - 31-4-64 SENE Tank Battery - Dumplines - Separator Tie-in - DL01@4.0' - No Impacts Noted - PID 10.1ppm

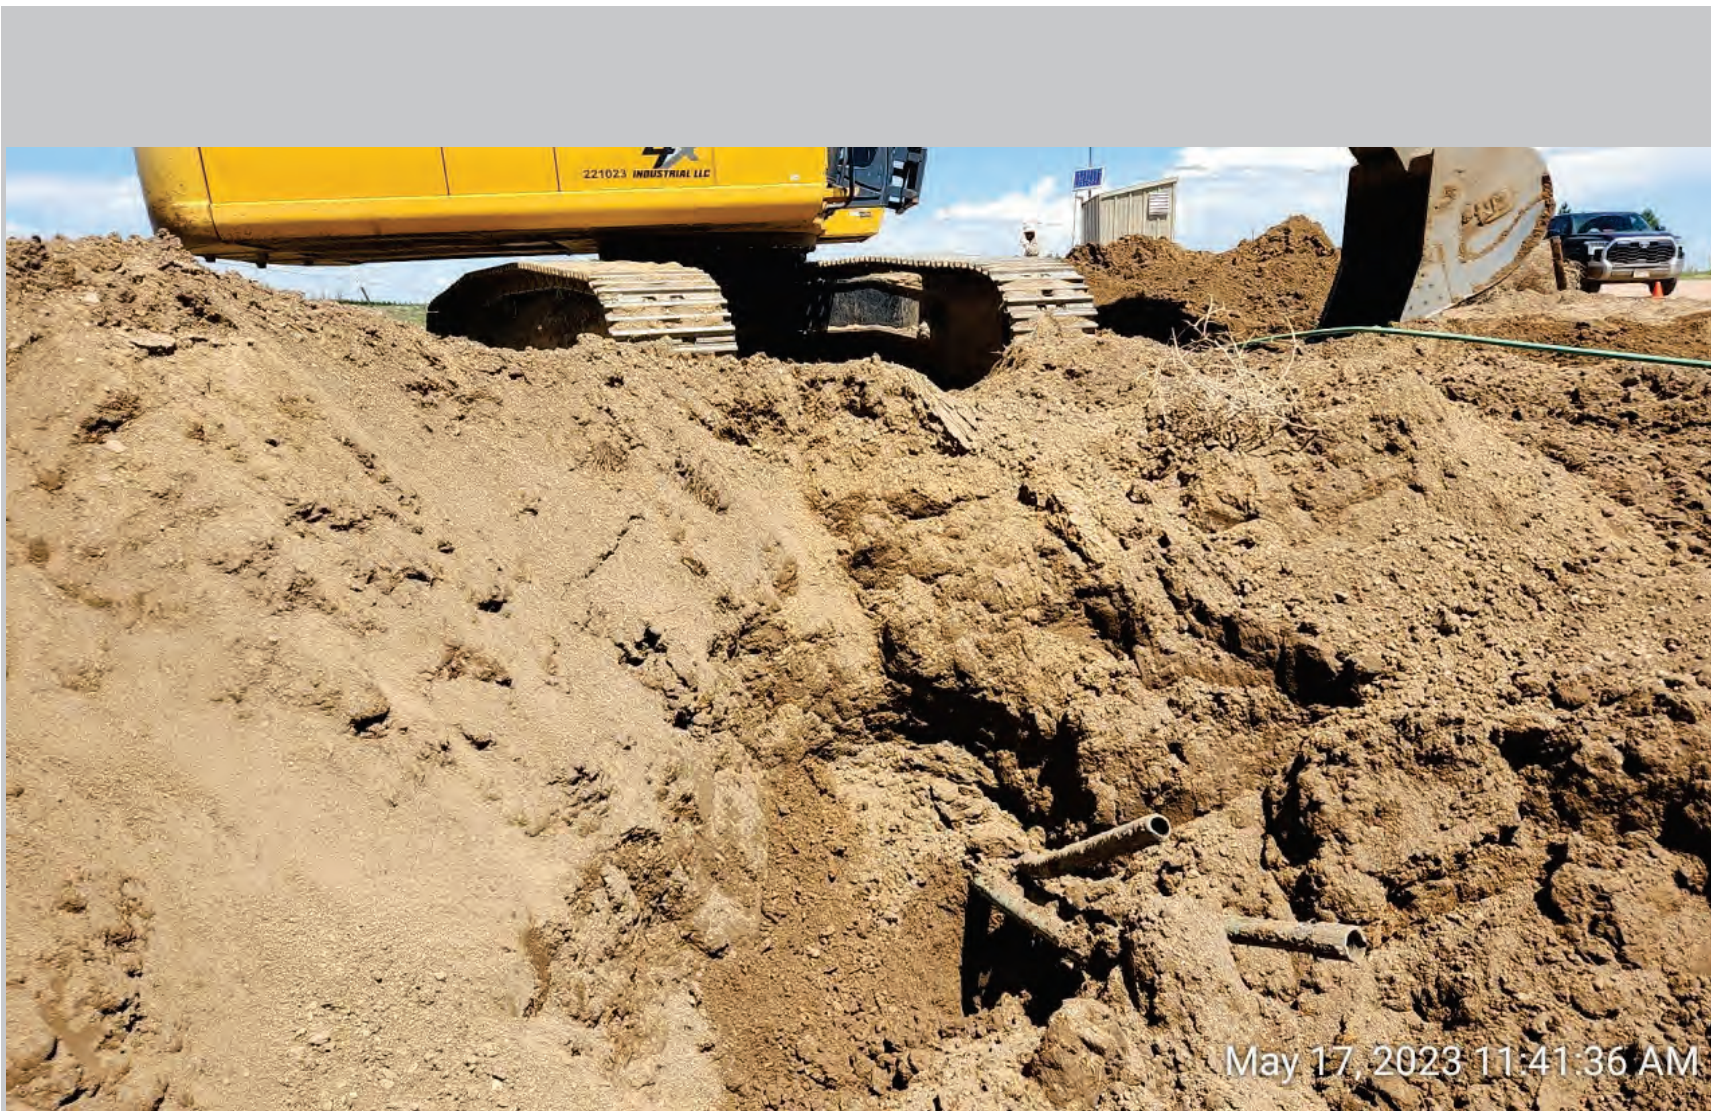
#5B - 31-4-64 SENE Tank Battery - Dumplines - Tanks Tie-in - DL02@5.0' - No Impacts Noted - PID 9.8ppm

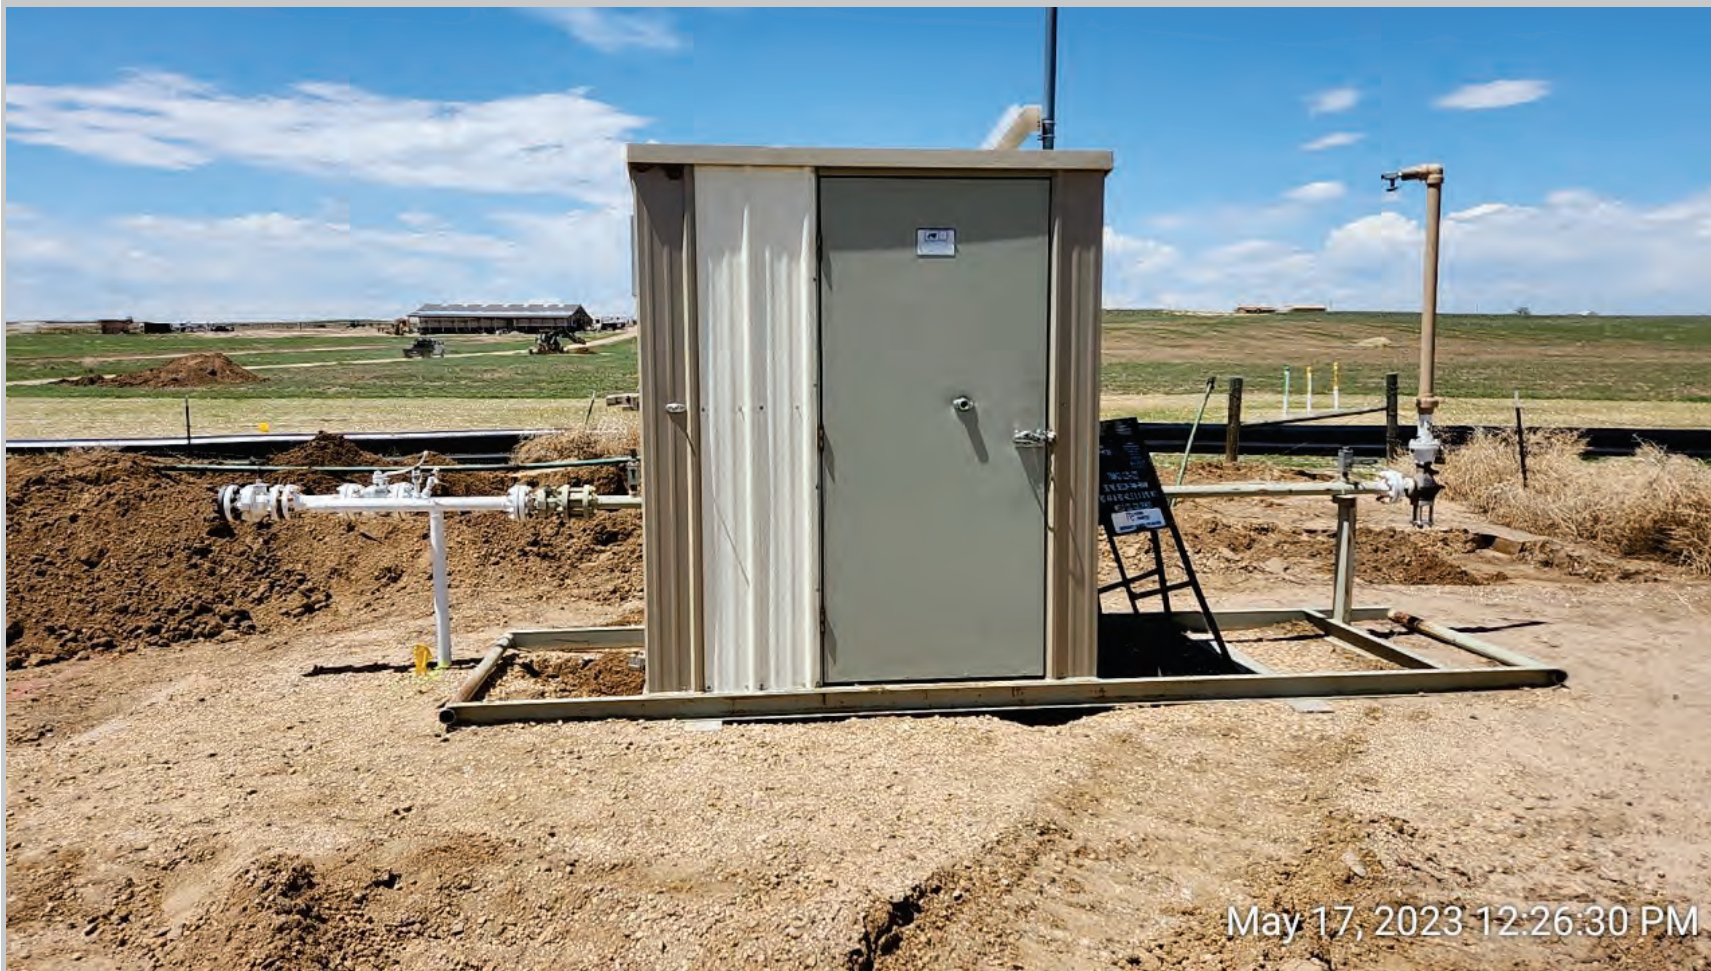
#6A - 31-4-64 SENE Tank Battery - Third Party Meter Shed - MET01@6.0" - No Impacts Noted - PID 0.4ppm

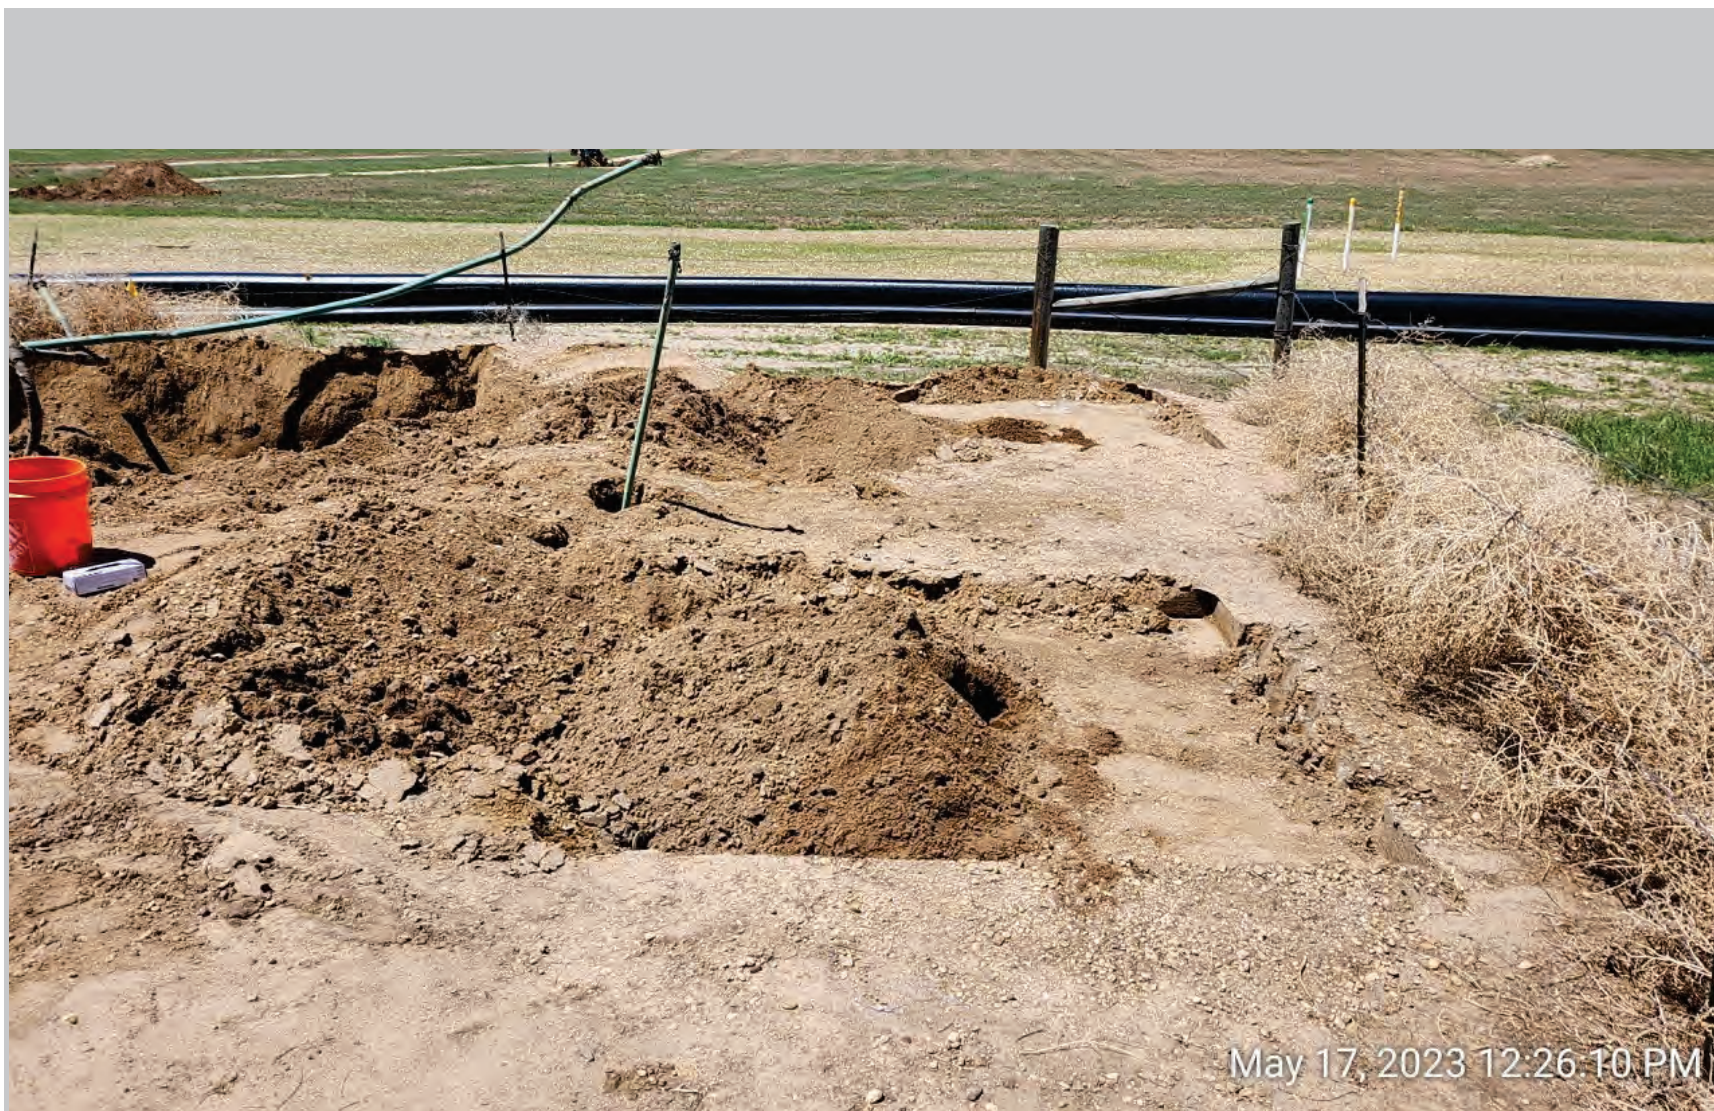
#7A - 31-4-64 SENE Tank Battery - Eastern Combustion Unit - ECD01@6.0" - No Impacts Noted - PID 0.0ppm

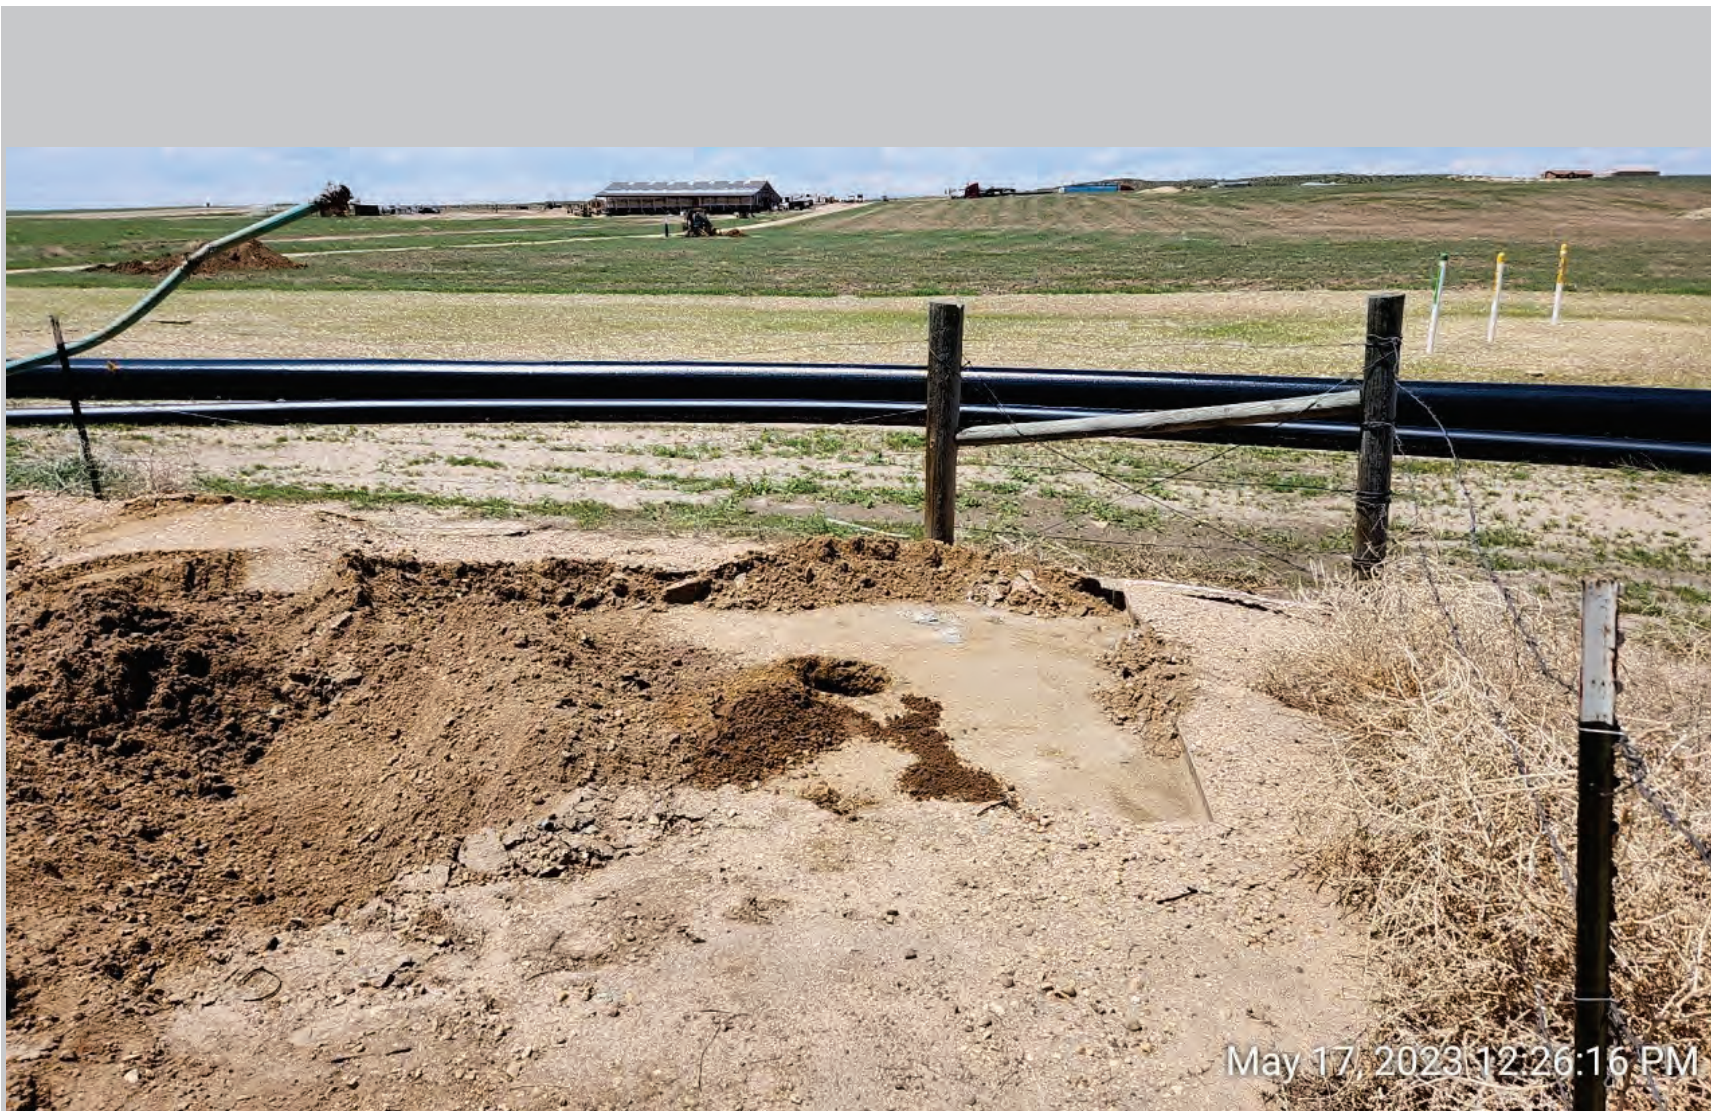
#8A - 31-4-64 SENE Tank Battery - Western Combustion Unit - ECD02@6.0" - No Impacts Noted - PID 0.2ppm
