FREMONT ENVIRONMENTAL INC.

Subject: **Facility Closure Data Submittal**
31-4-64 SENE Tank Battery
SENE Sec. 31, T4N, R64W
Weld County, Colorado
Fremont Project No. C023-135
Facility # 467637, Remediation #26965

Tank Battery Closure Checklist

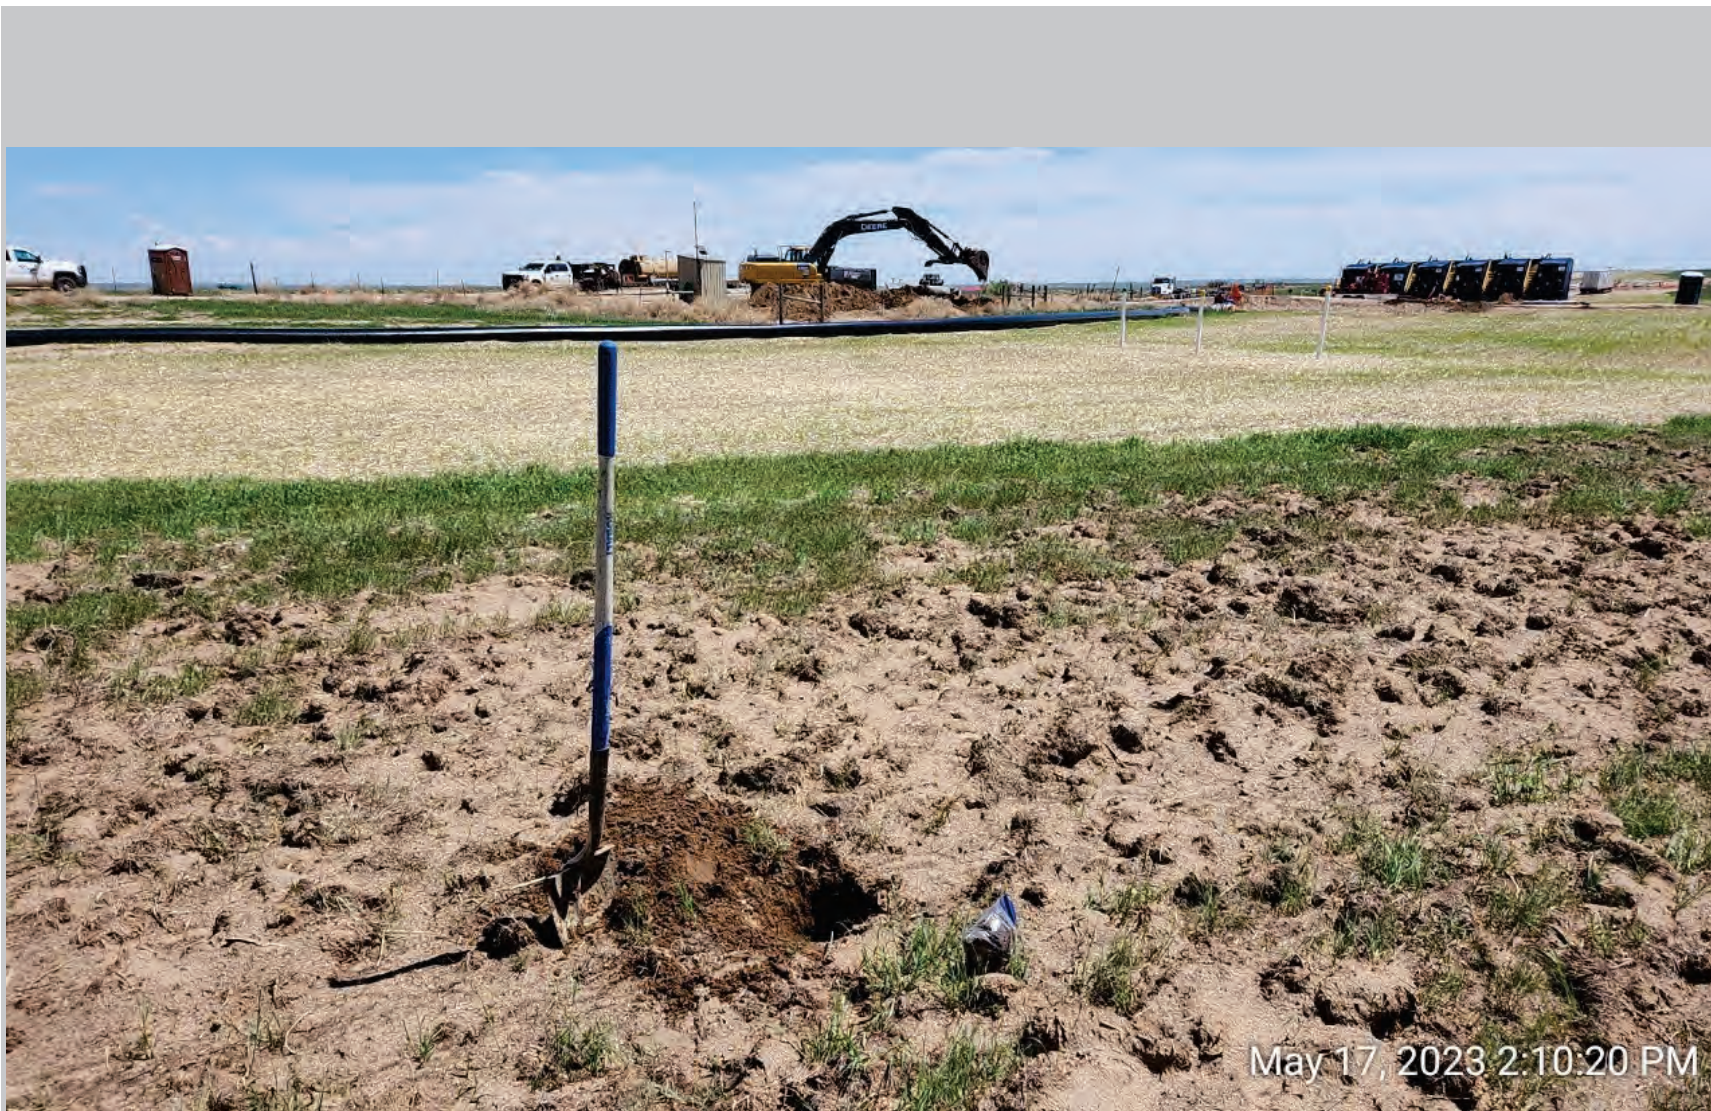
#9A - 31-4-64 SENE Tank Battery - Local Background Sample - BKG01@6.0" - No Impacts Noted - PID 0.0ppm
