Interim Reclamation and Stormwater Inspection

Location ID: 464350

Location Name: Lone Eagle/13-34

Inspection Document #: 718600503

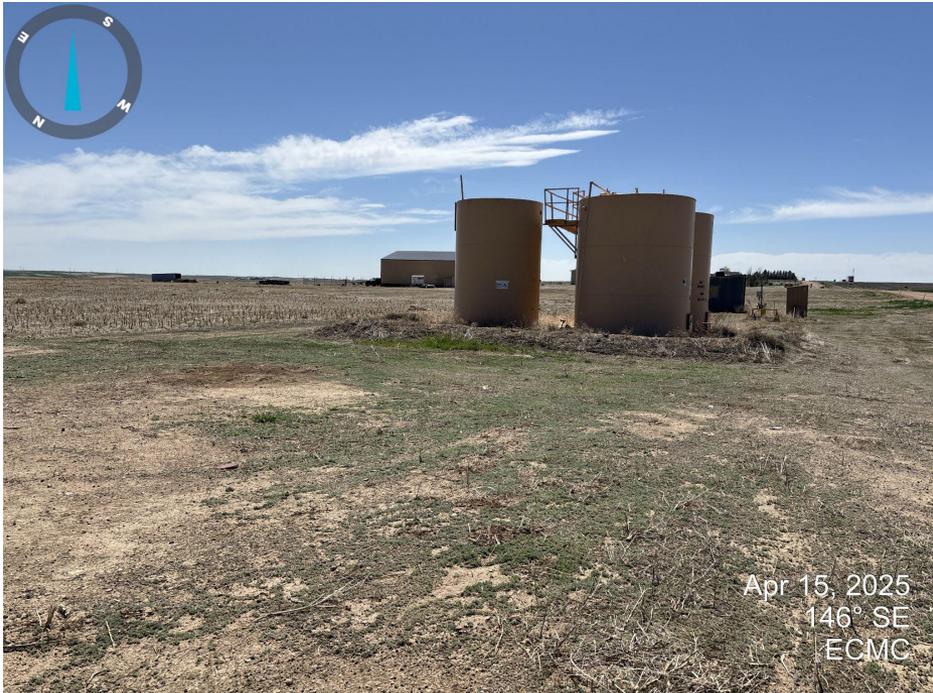
Photo 1. Looking south across the tank battery. Weeds outside secondary containment have been mowed.

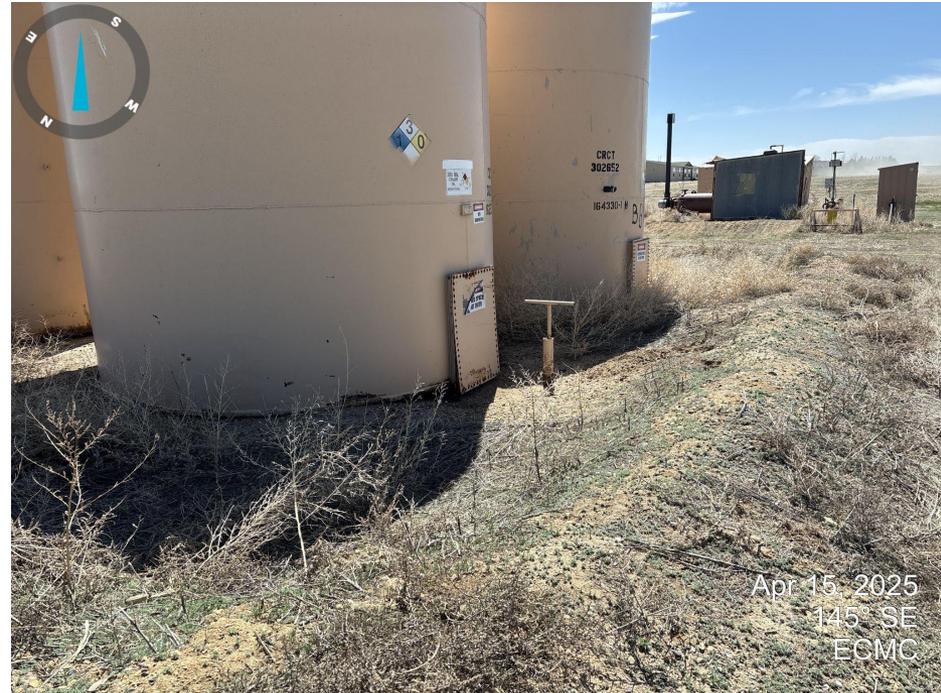
Photo 2. Looking south across the west side of the tank battery. Undesirable weeds such as Kochia and Russian Thistle are present inside of secondary containment.

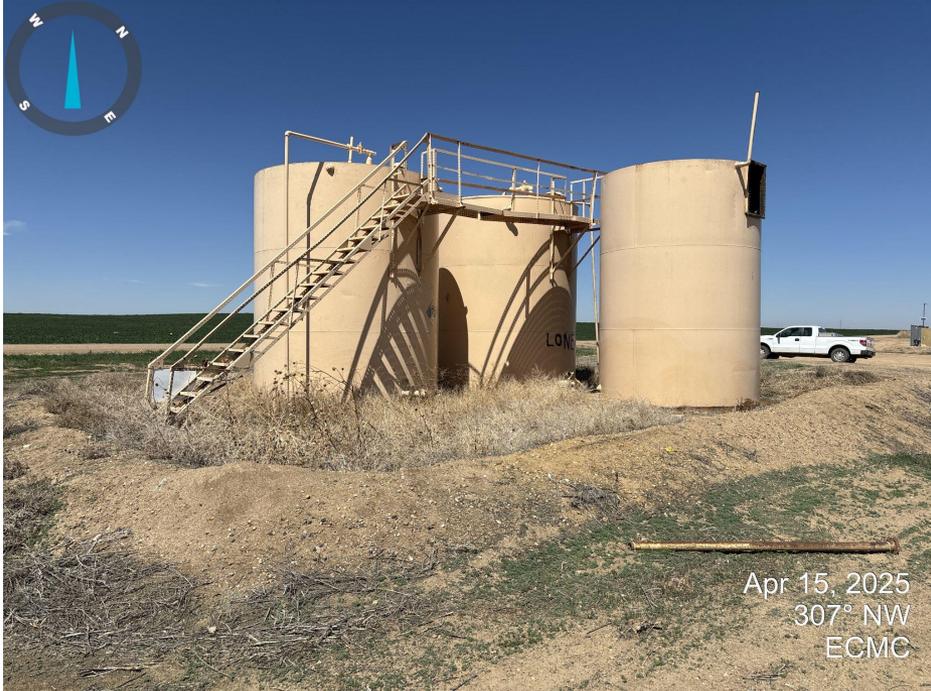
Photo 3. Looking northwest at the east side of the tank battery. Undesirable weeds inside of secondary containment. Unused equipment remains on site.

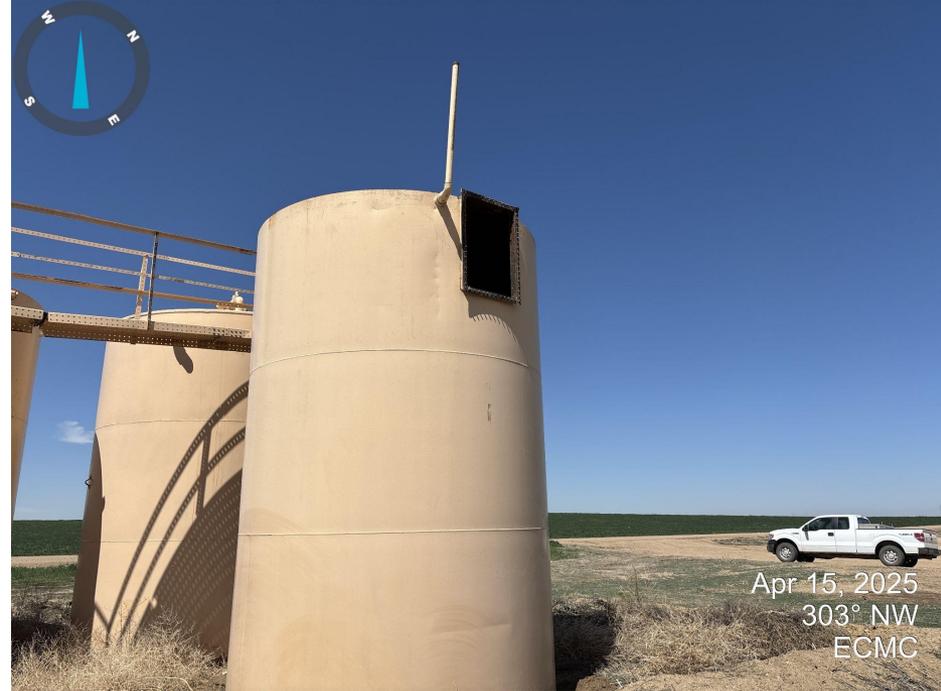
Photo 4. The eastern tank has an open inspection hatch. Birds were observed entering the hatch at the time of inspection.

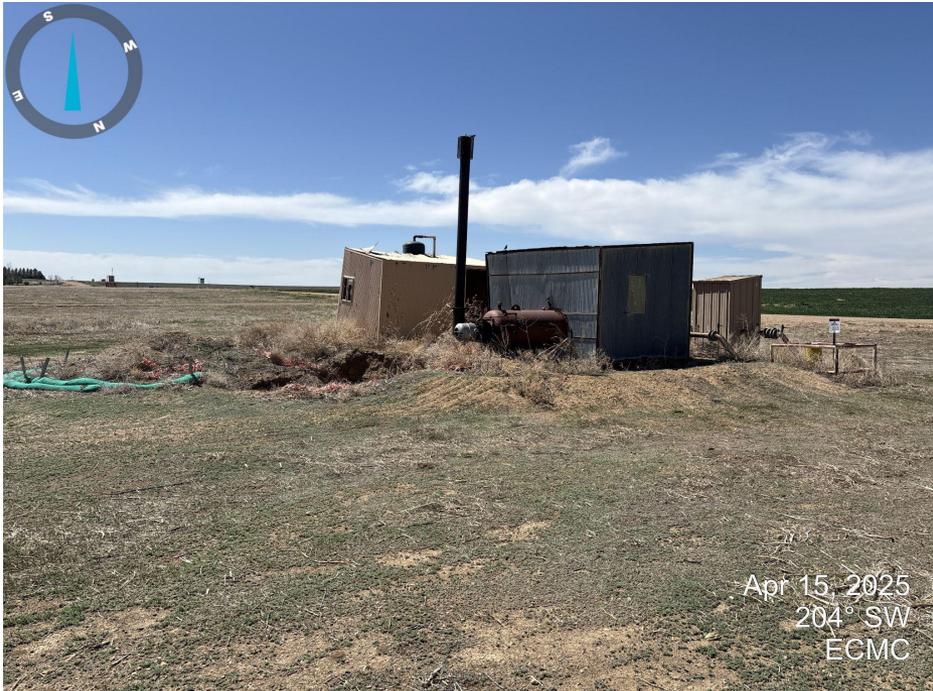
Photo 5. Looking south at the separator sheds on the southern side of location. Excavation and soil pile appear unchanged since last reclamation inspection (12/18/2024).

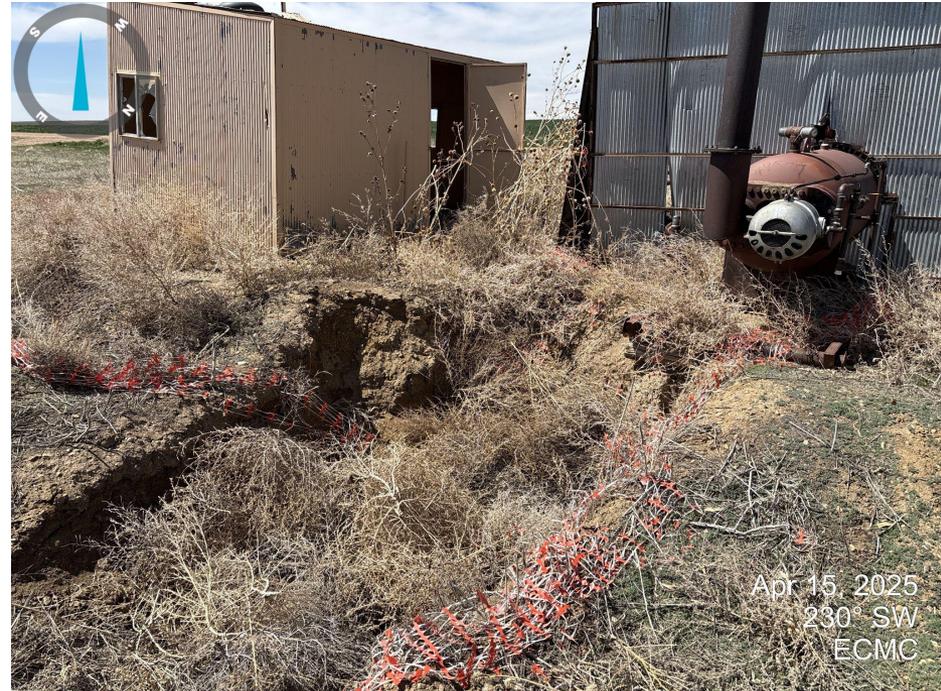
Photo 6. Open excavation remains. Fence is improperly installed. Undesirable weedy vegetation such as Kochia and Russian Thistle is present around the sheds.

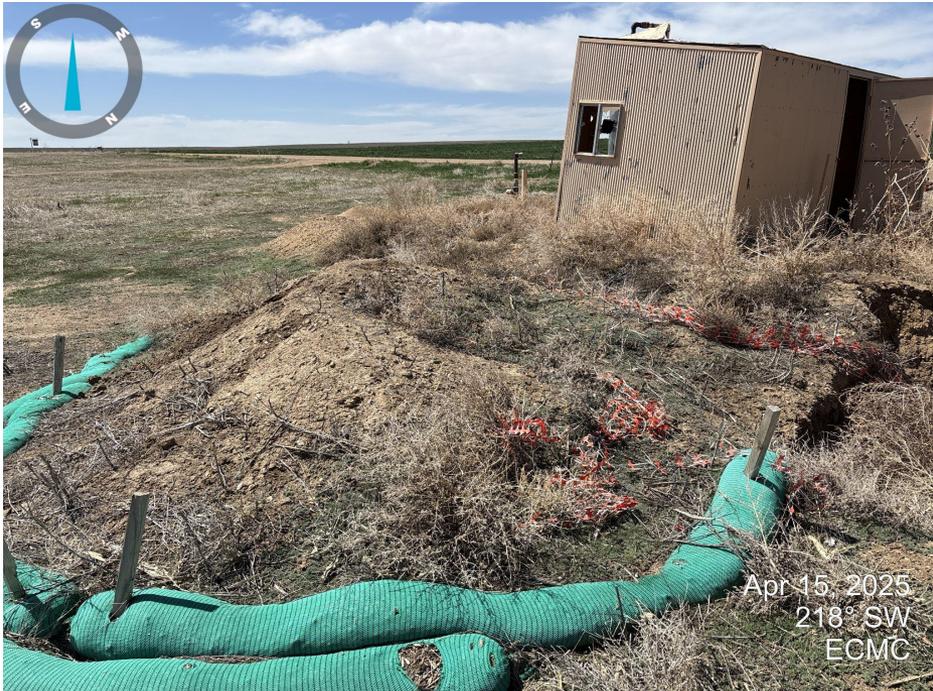
Photo 7. Soil pile and stormwater BMPs remain on location.

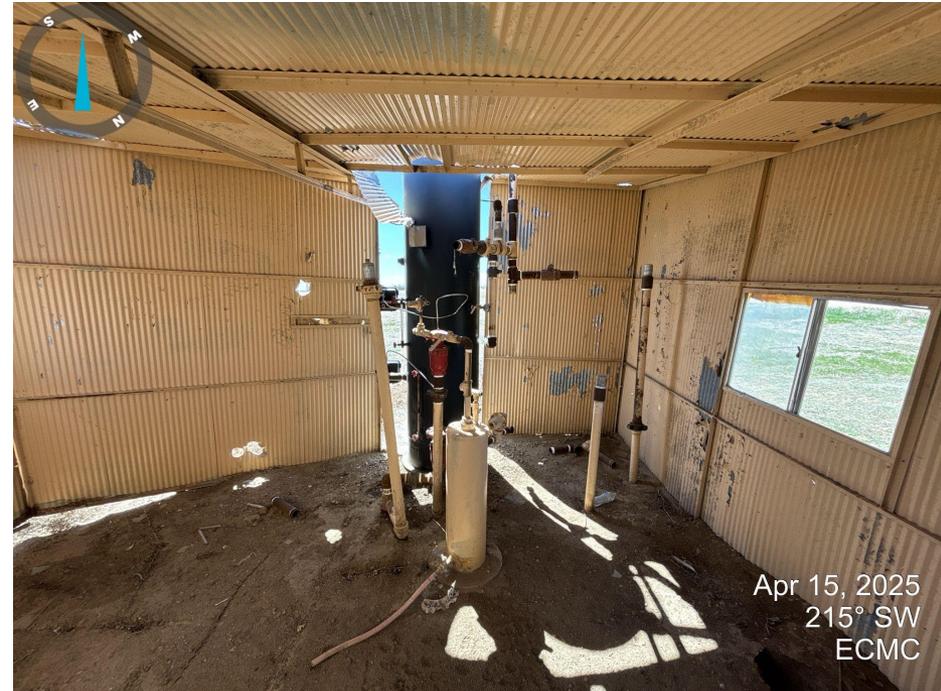
Photo 8. Inside of southern separator shed. Stained soil remains around separator.
