Interim Reclamation and Stormwater Inspection

Operator: KP KAUFFMAN COMPANY INC - 46290

Location Name: Bosky PC/Z22-14 Tank

Inspection Document #: 718600510

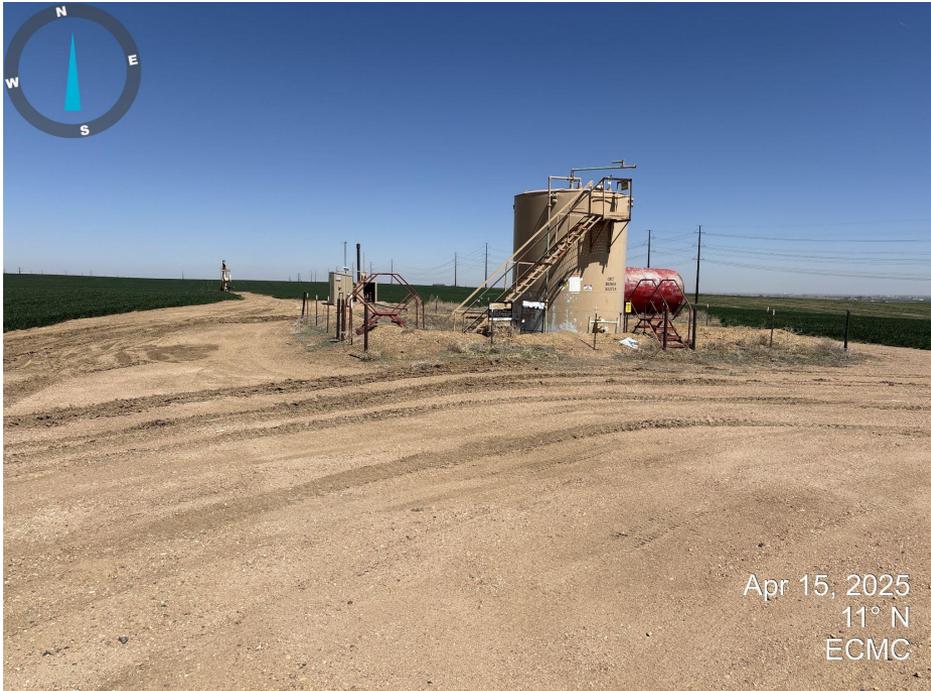
Photo 1. Looking north across the tank battery location. Weeds have been controlled around the tank battery and within secondary containment.

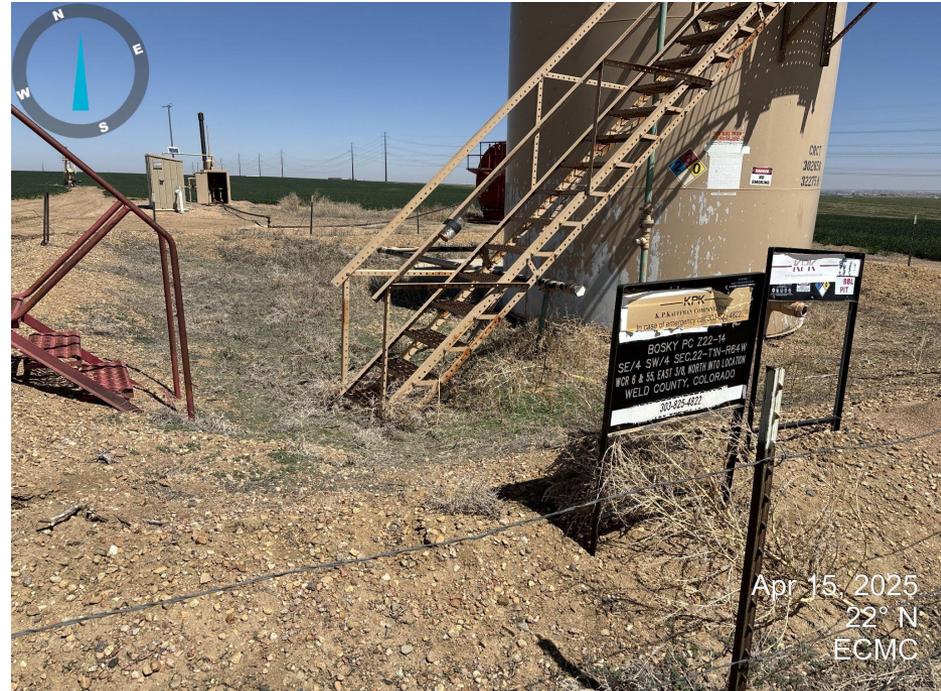
Photo 2. Tank battery sign. Weeds have been controlled.

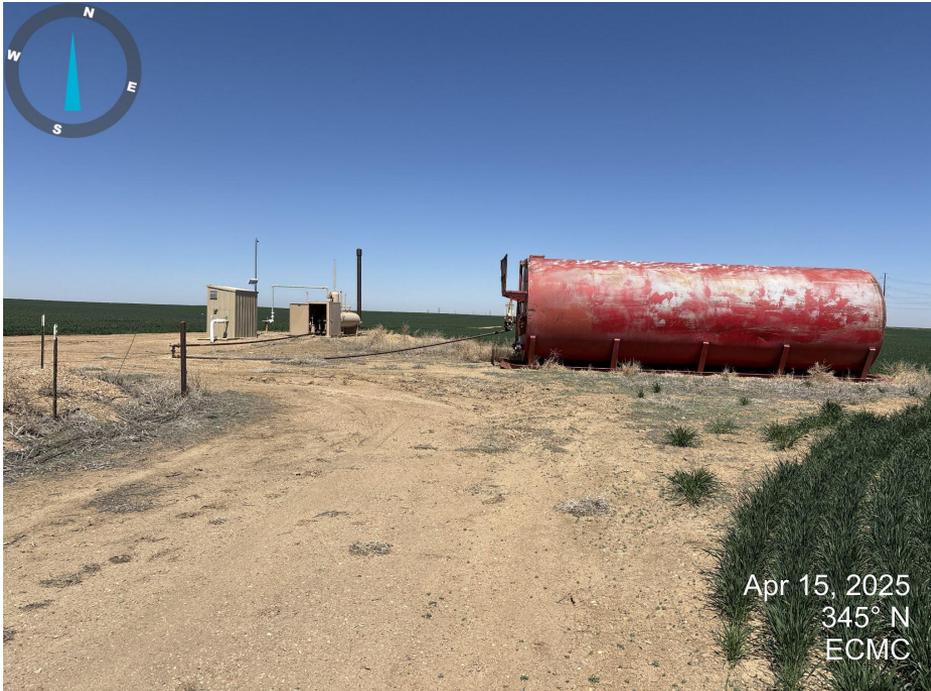
Photo 3. Looking north down the east side of the location. Bucket of oil has been removed. Produced water tank without secondary containment remains on location.

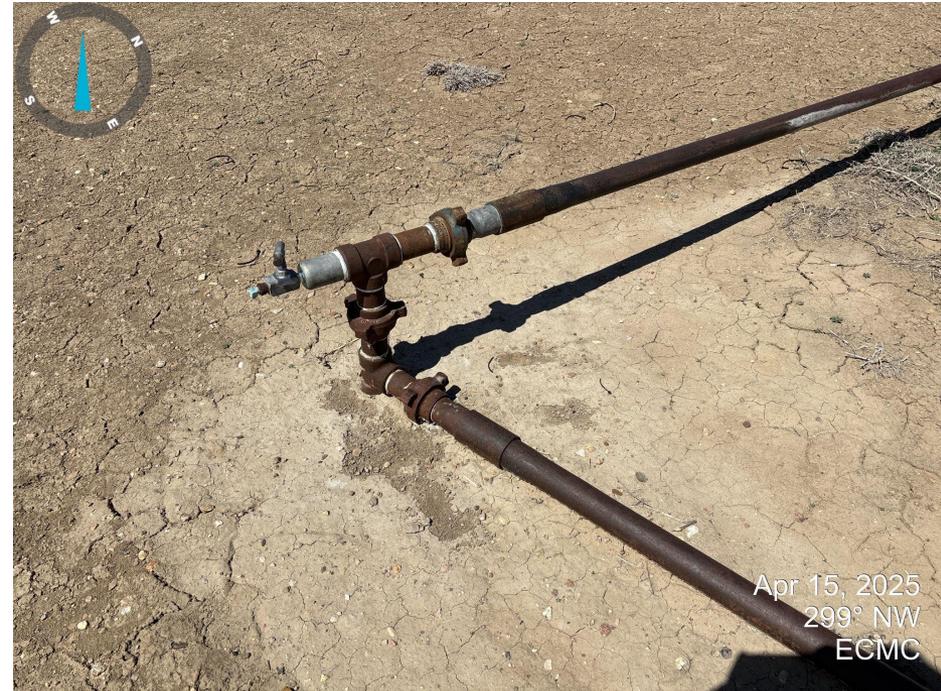
Photo 4. Looking at the joint between produced water tank and separator. Does not appear to be leaking. Some soil may have been removed around the joint.

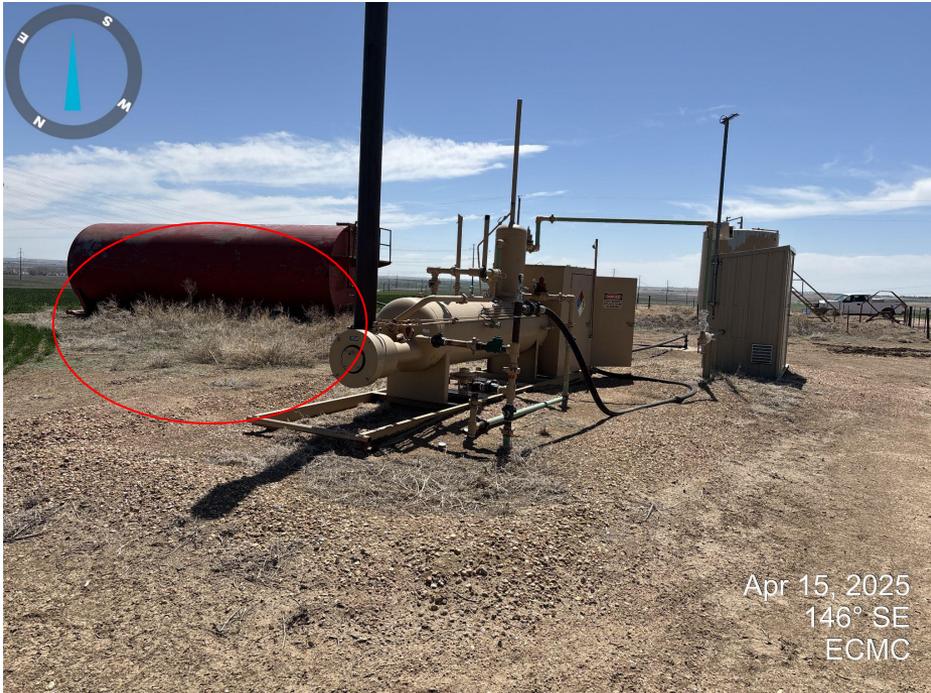
Photo 5. Looking south at the separator. Undesirable weeds such as Kochia and Russian Thistle are present behind the produced water tank (red circle).

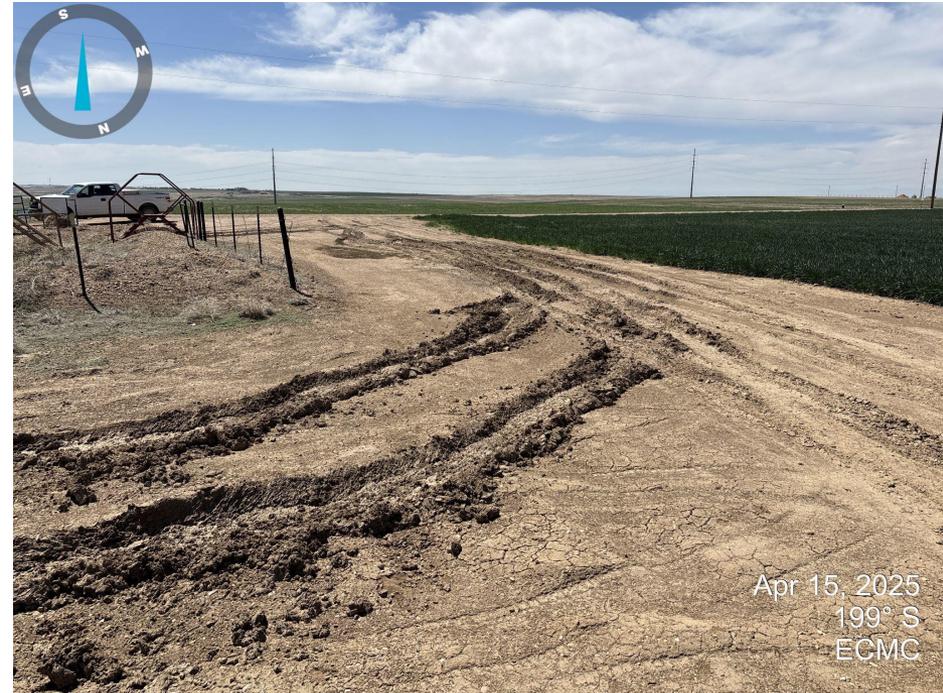
Photo 6. Deep ruts in the access road to the west of the tank battery.
