Inspection Photos

Operator: CAERUS PICEANCE LLC #10456

Location ID: 418660

Inspection Doc: 718100484

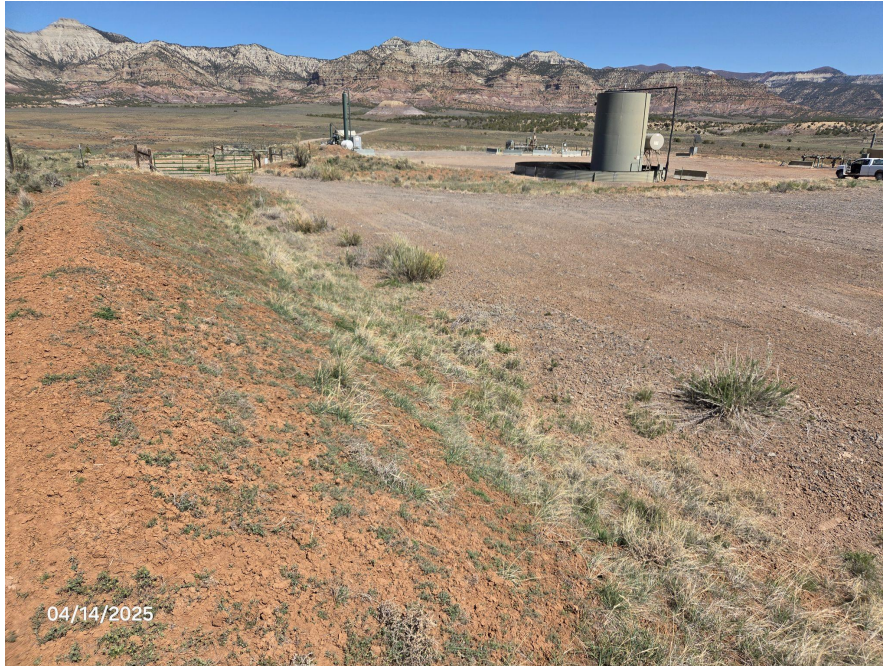
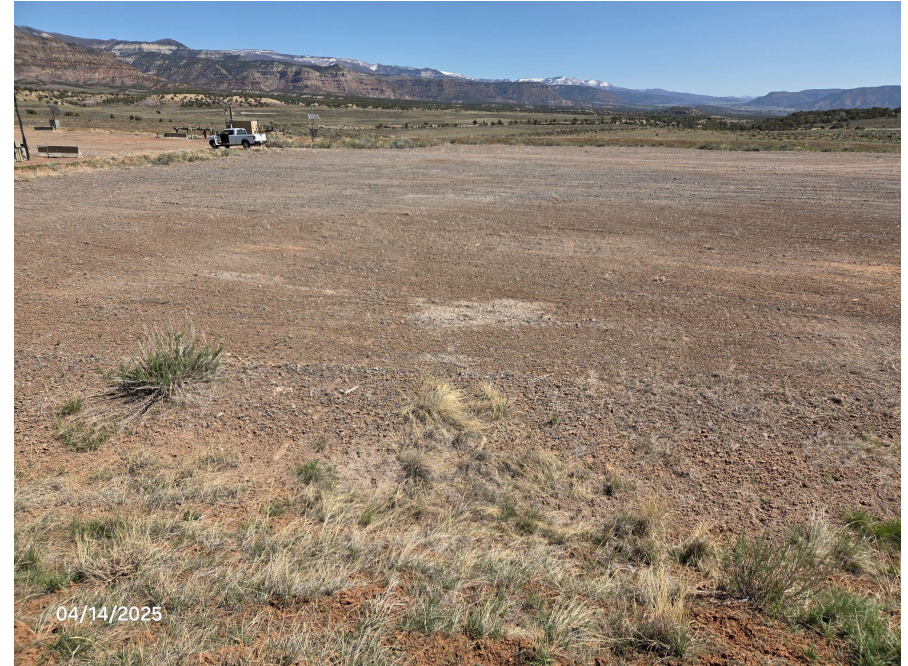
Photo 1: Photos 1-2 taken from the west end of the Location. Photos provide an overview of the Location from northwest, north, east to southeast. Photos show reclamation of areas not necessary for production have not been performed in accordance with 1003 requirements.

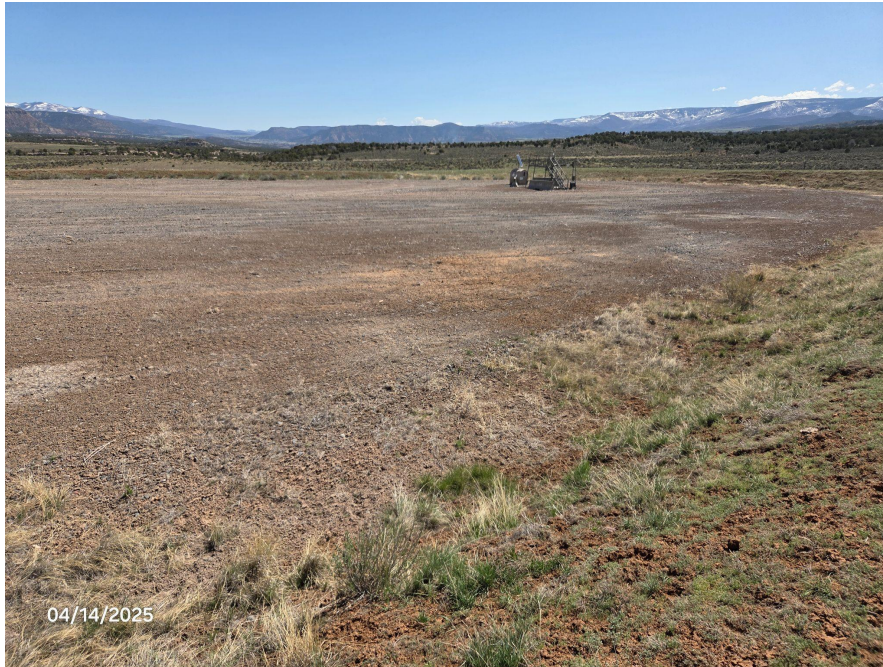
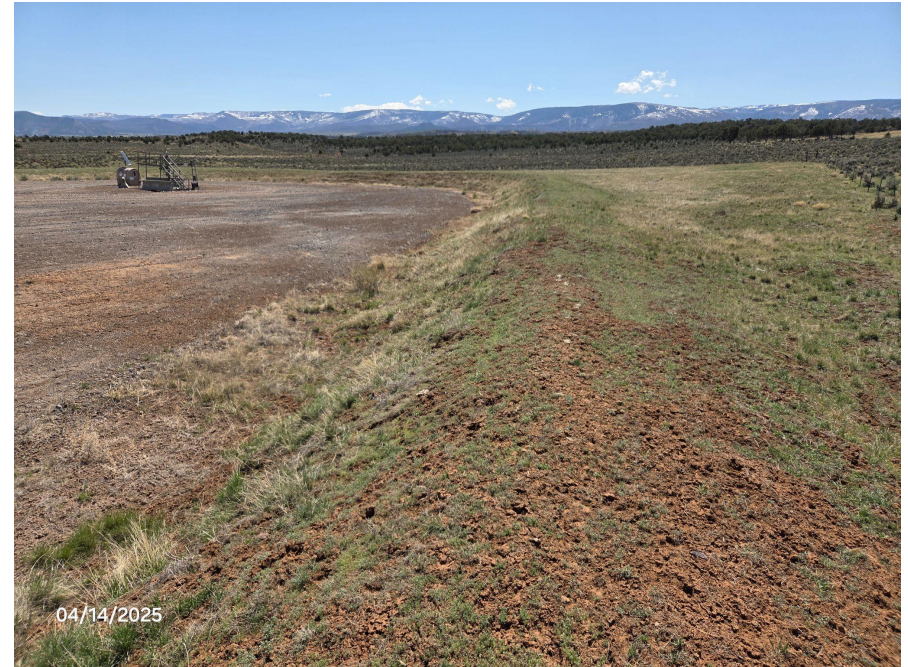
Photo 2: See comments under photo 1.

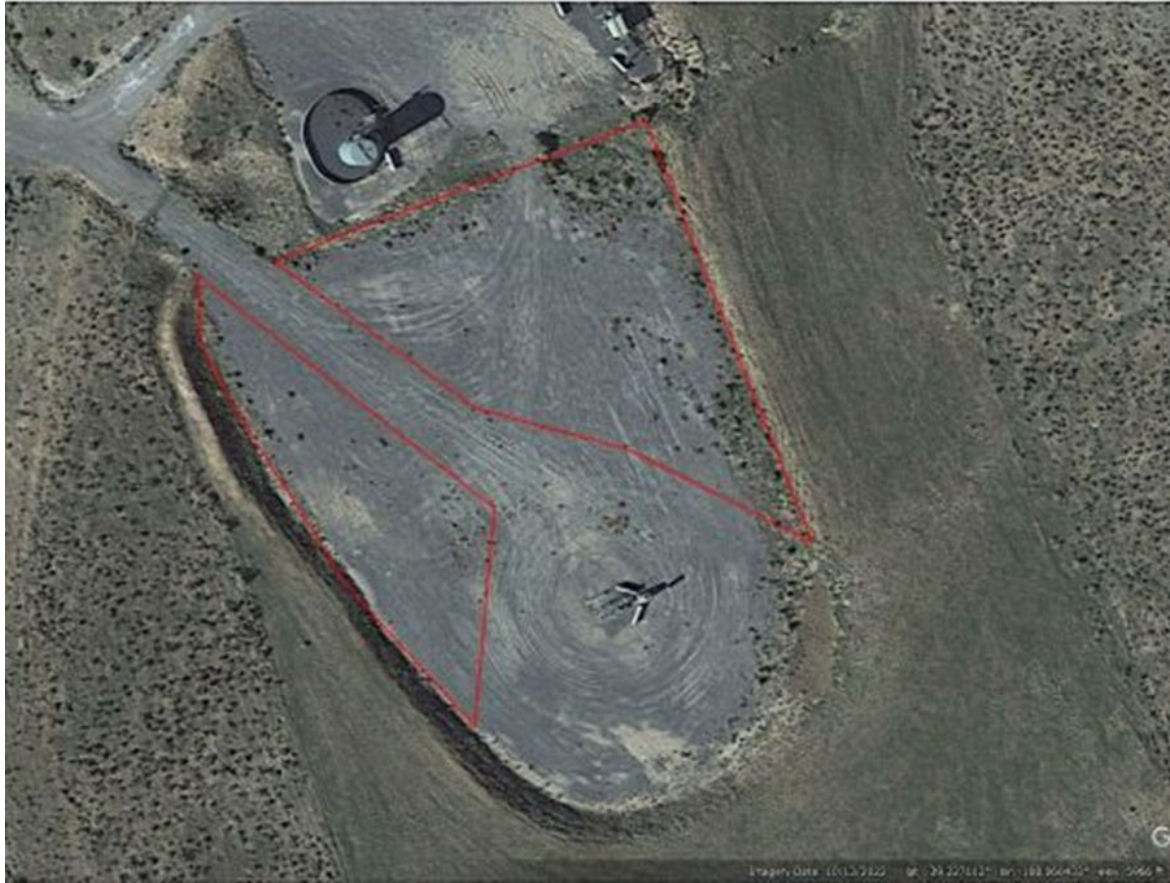
Photo 3: 2022 Google Earth aerial imagery. Photo provides an overview of the Stewart #36-13H Location (#418660). Red polygons represent approximate areas of the Location that are not necessary for production, and are subject to 1003.b reclamation requirements.
