Inspection Photos

Operator: QB ENERGY OPERATING LLC
#10844

Location ID: 414152

Inspection Doc: 718100500

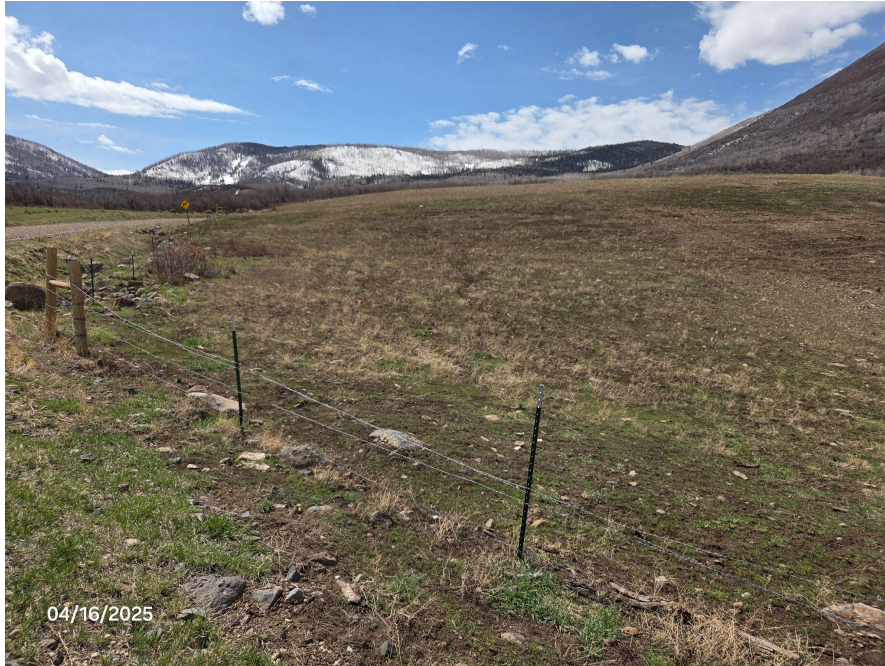
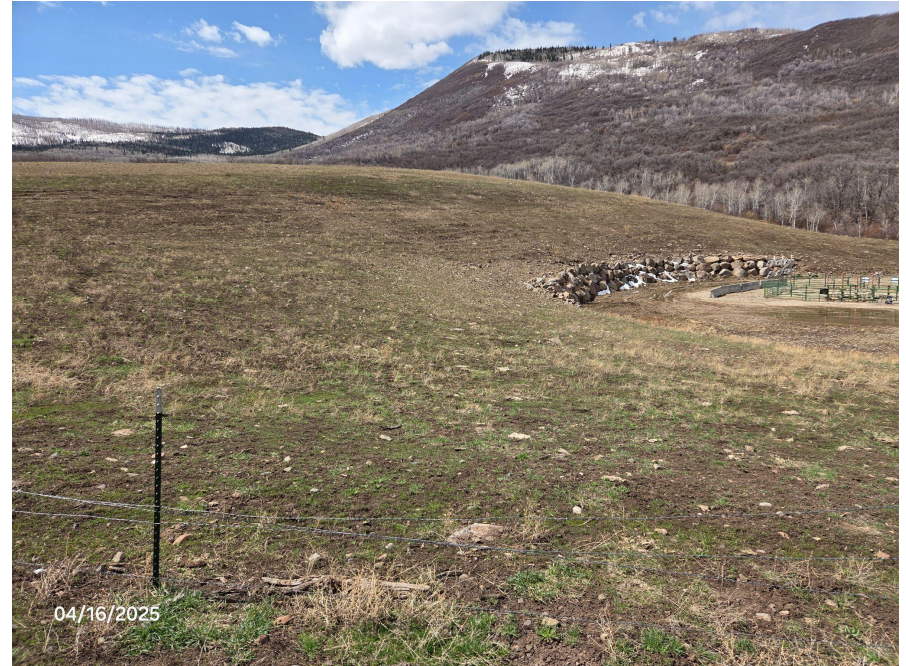
Photo 1: Photos 1-2 taken from the east end of the Location. Photos provide an overview of the Location south, southwest, northwest to northeast. Location has been reduced to areas reasonably needed for production; vegetation appears to be progressing towards 1003 Standards. Photos also show perimeter fence; maintenance advised.

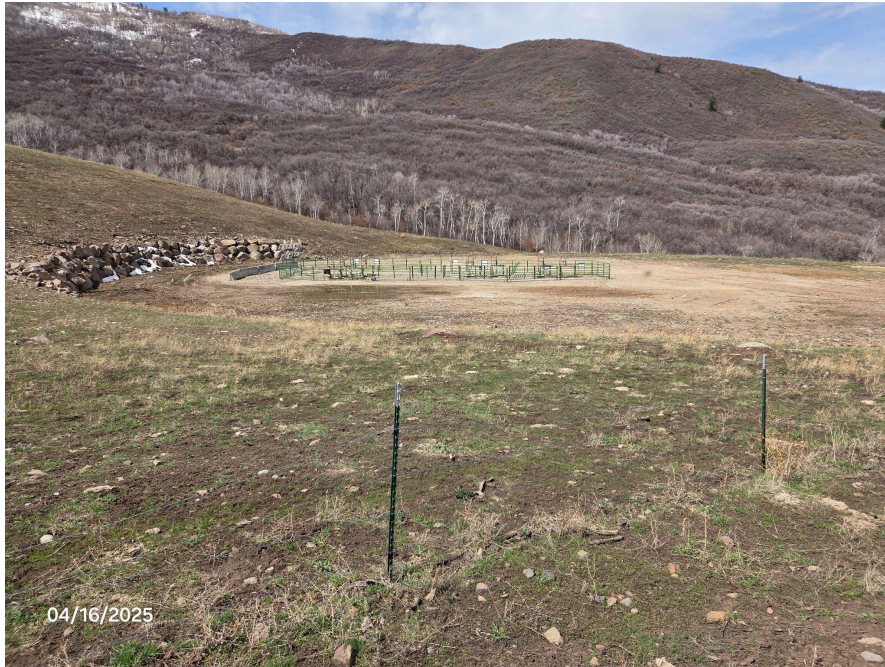
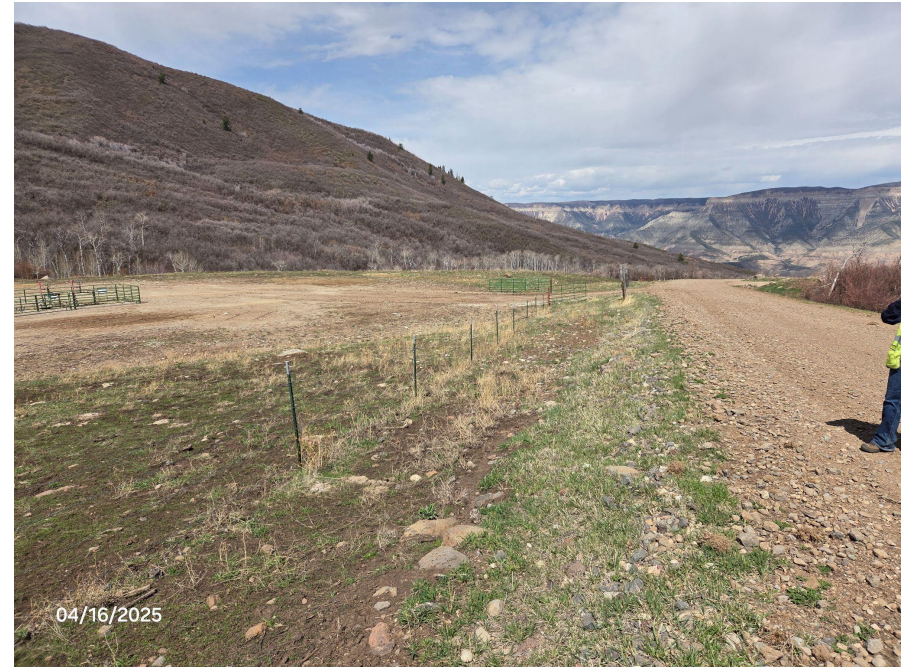
Photo 2: See comments under photo 2.

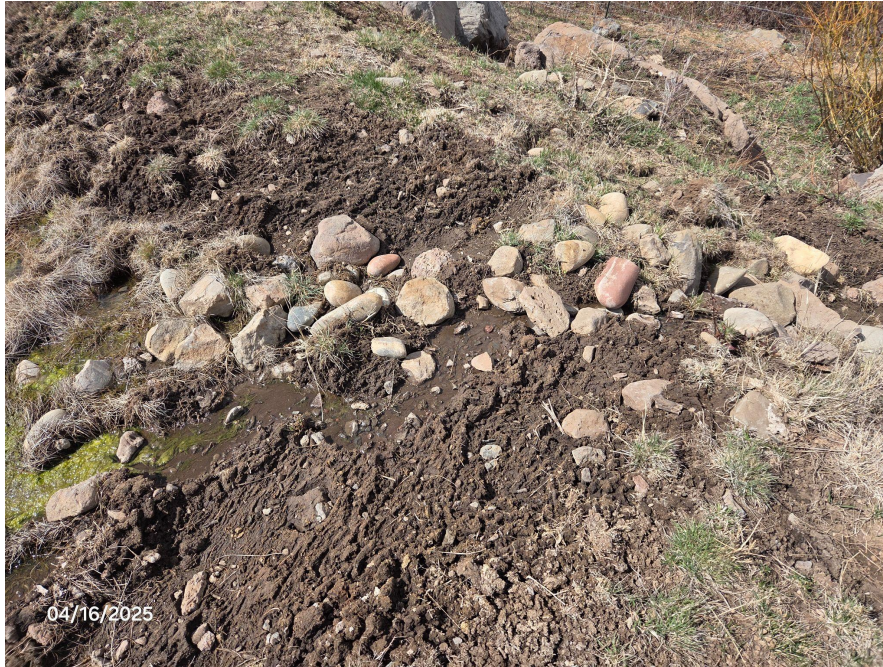
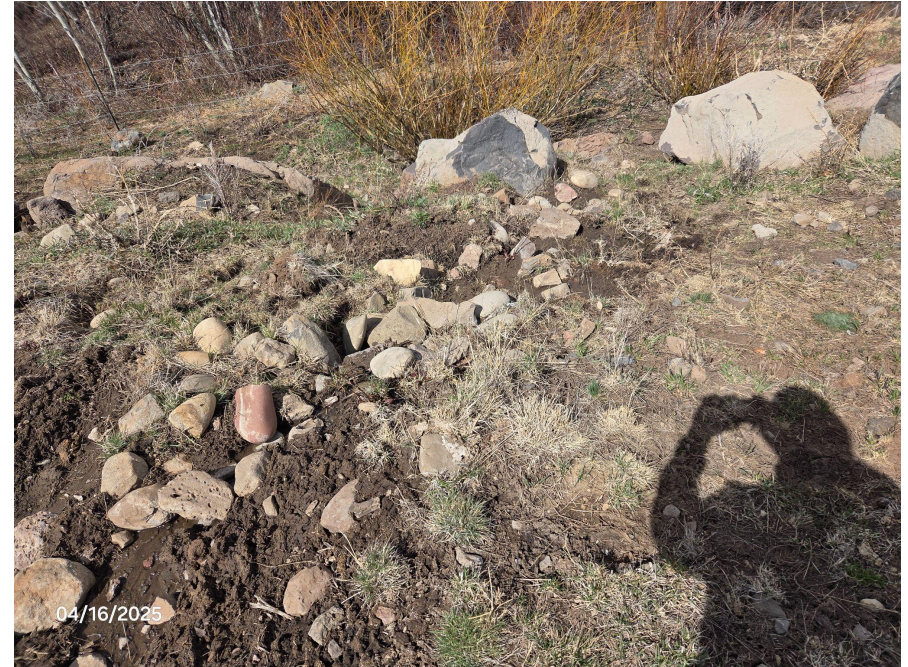
Photo 3: Photos taken from the west end of the Location. Photos examples showing outlet at the sediment trap has not been maintained in proper functioning condition; erosion degradation evident.

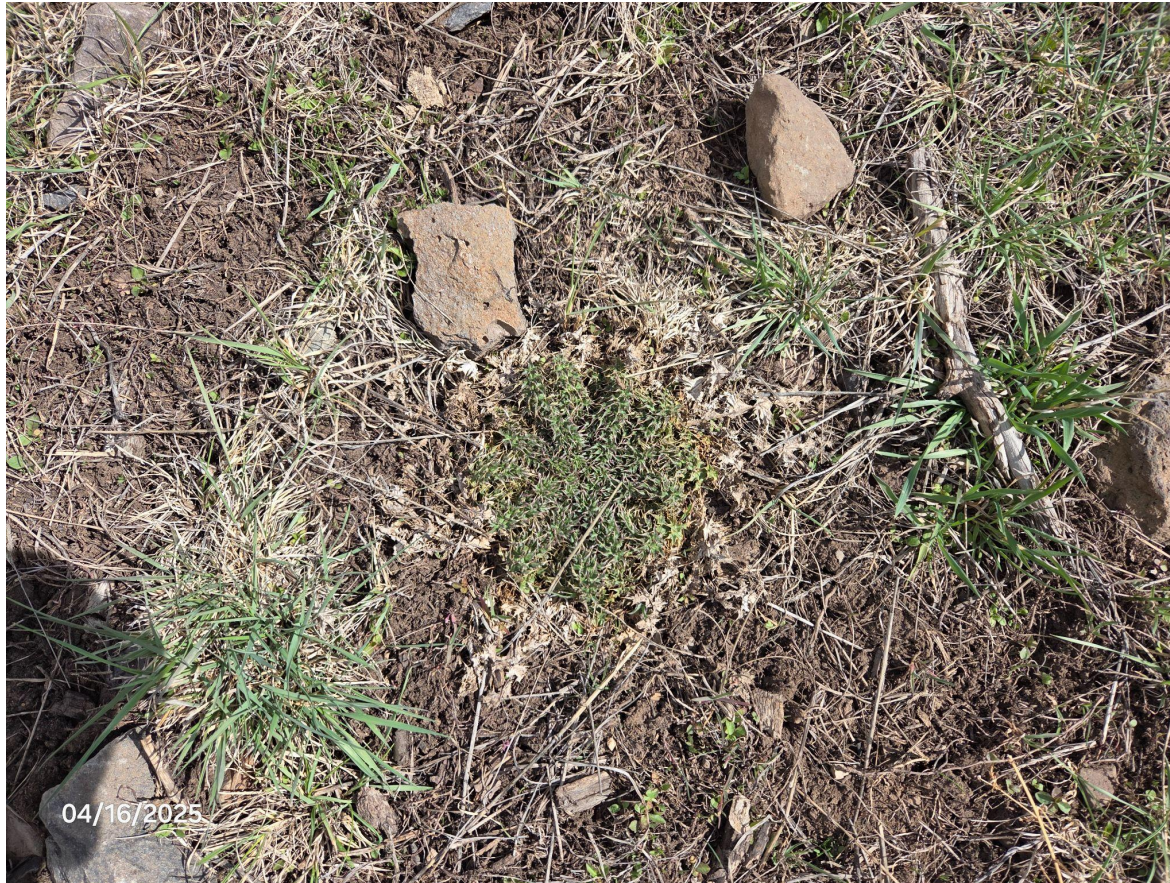
Photo 4: Photo taken from the interim areas of the Location. Photo example of Noxious Weed Rosettes observed within the interim.

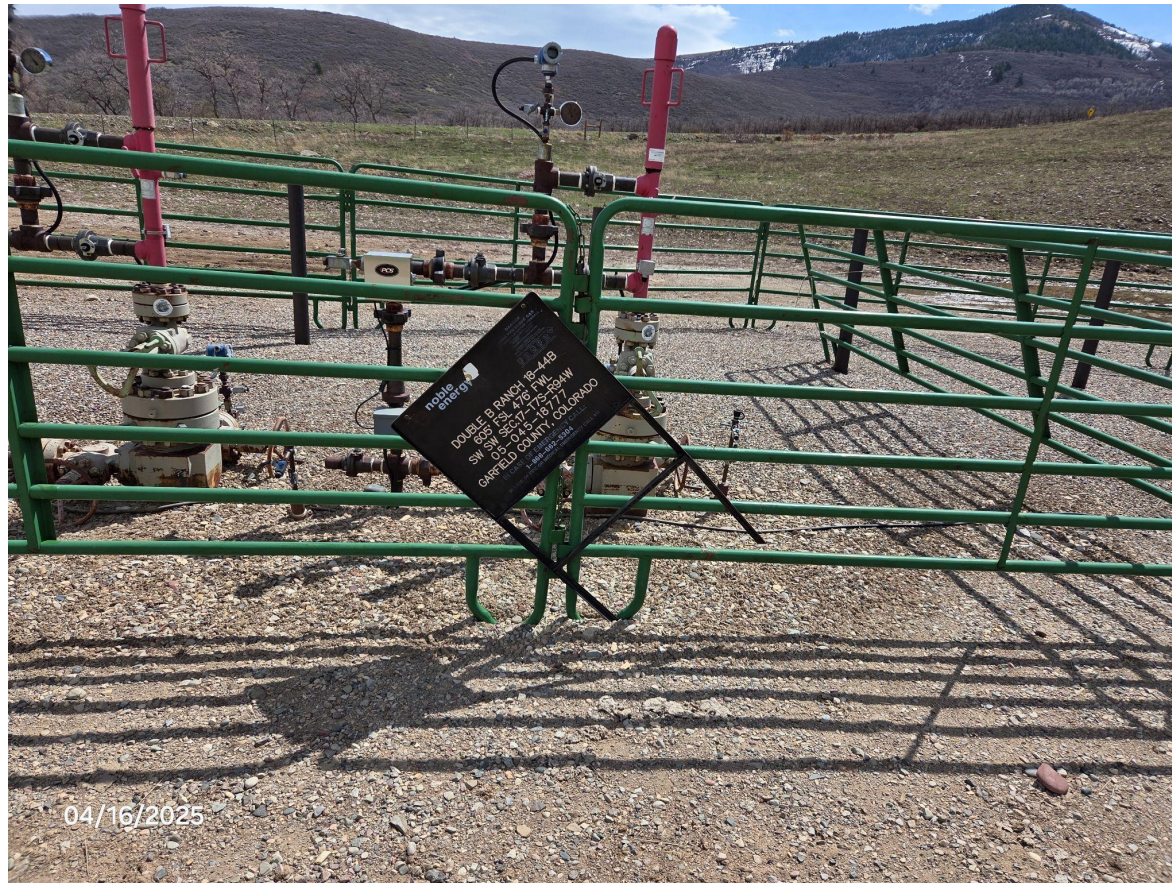
Photo 5: Operator information at signage incorrect.

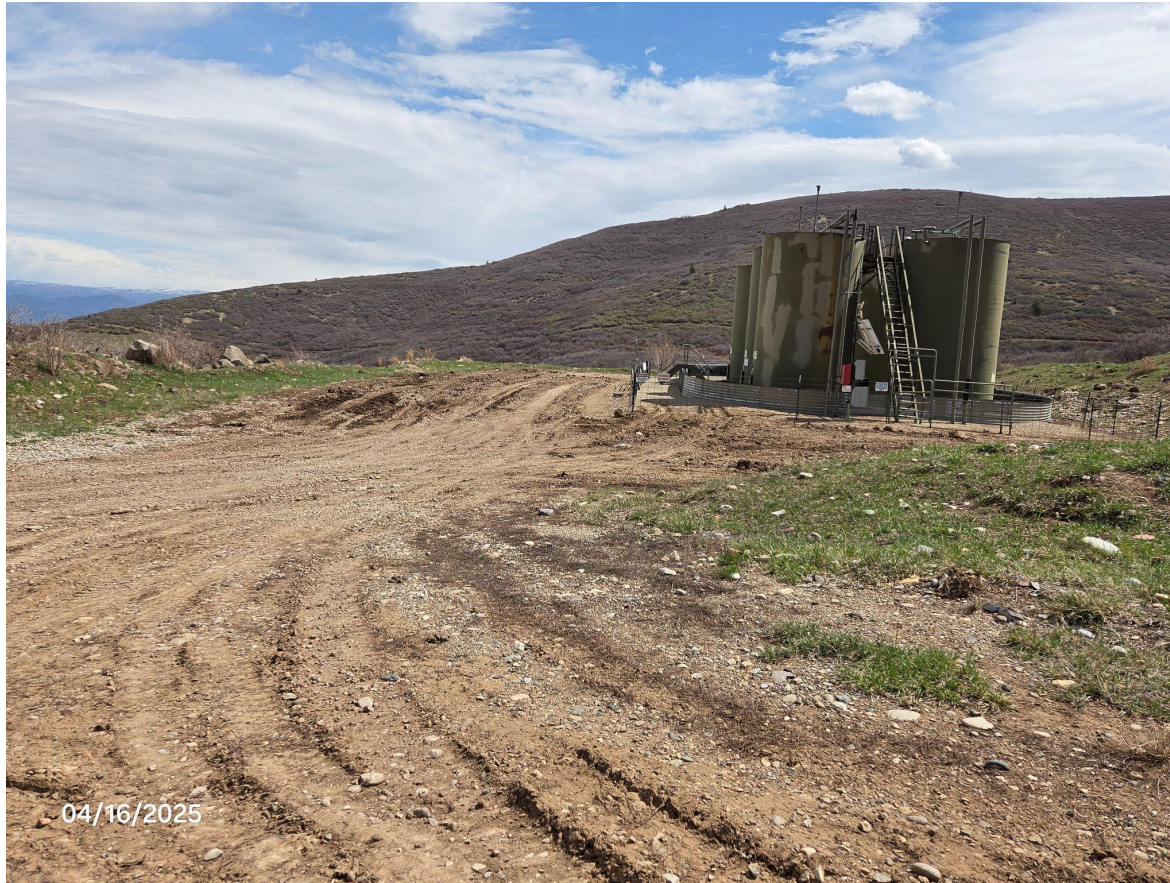
Photo 6: Photo taken from the west end of the tank battery Location, facing east. Photo shows stabilization and tracking controls show sign of disrepair; degradation/rutting observed.
