# Inspection Photos

API: 071-06343

Operator: OGRIS OPERATING LLC

Inspection Date: 4/29/2025

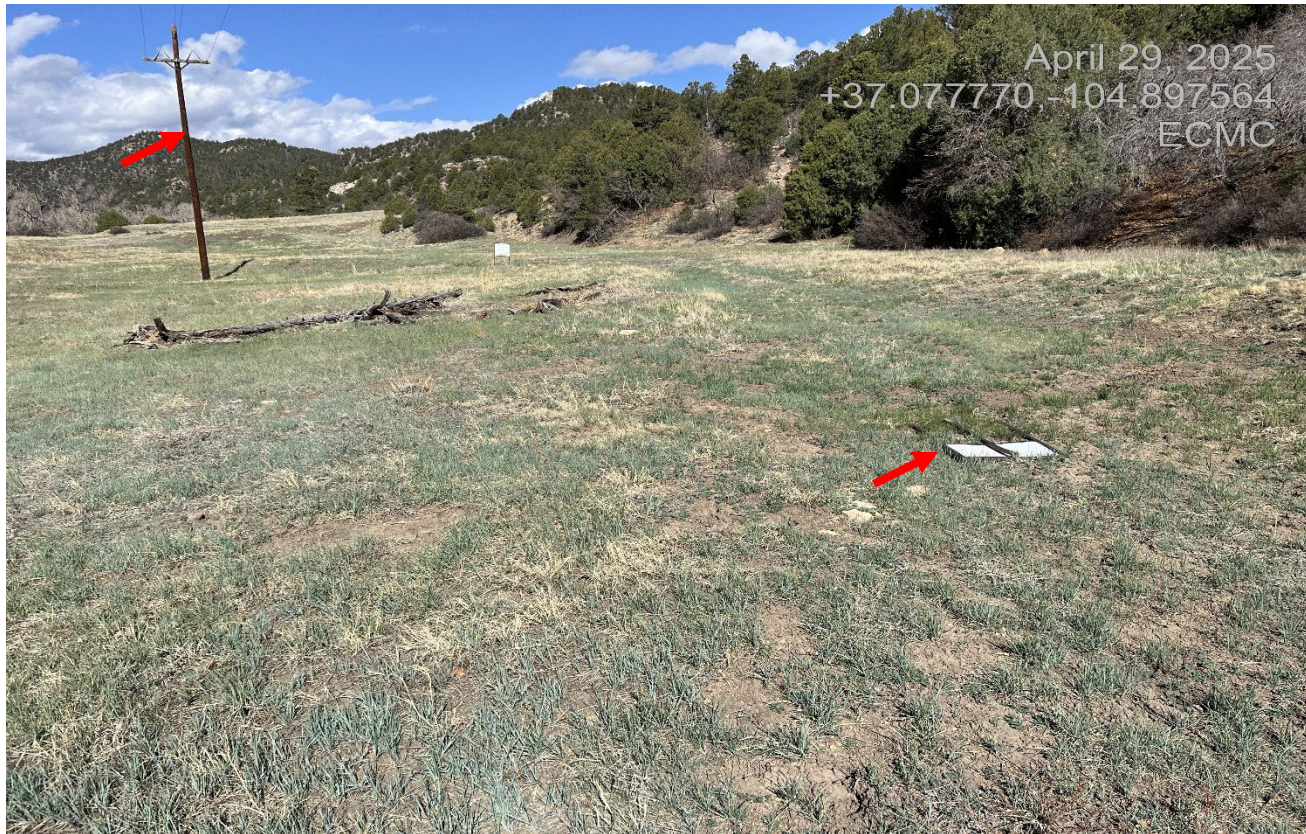
**Photo 1.** Facing west toward the wellsite. Sign has fallen over and the electric utility line has not been removed.

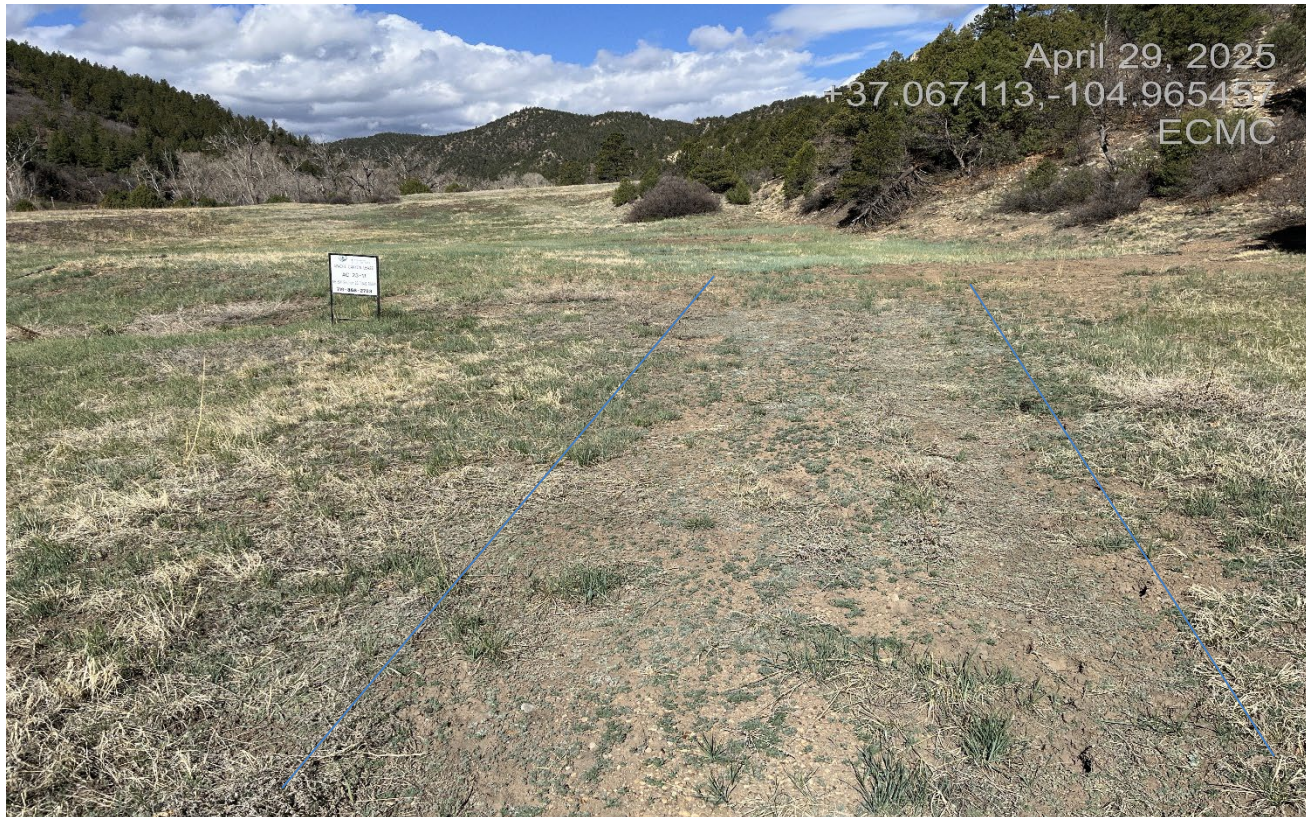
**Photo 2.** Facing west at the abandoned wellsite. This area of the former road needs to be reseeded. There is mostly weeds (Kochia) growing in the area between the two blue lines.

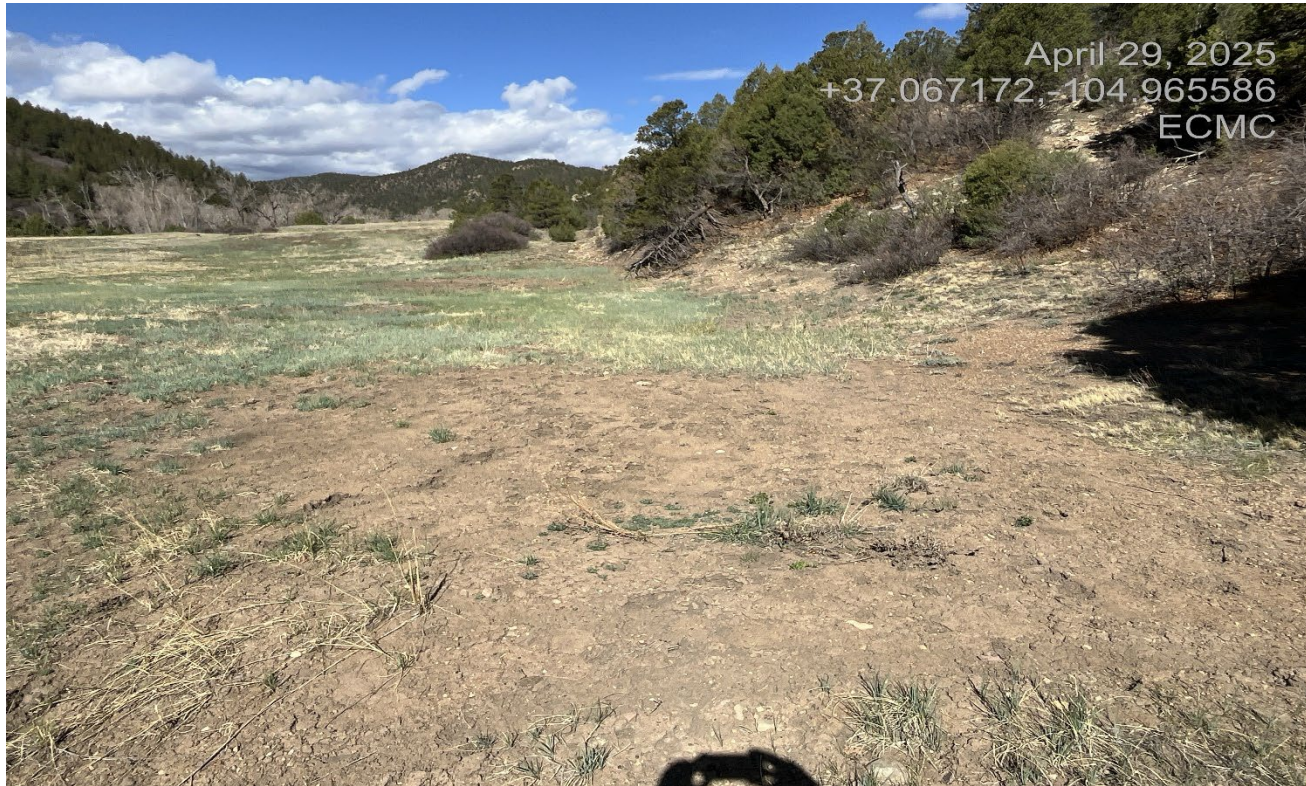
**Photo 3.** The area of the former well has not established perennial vegetation.

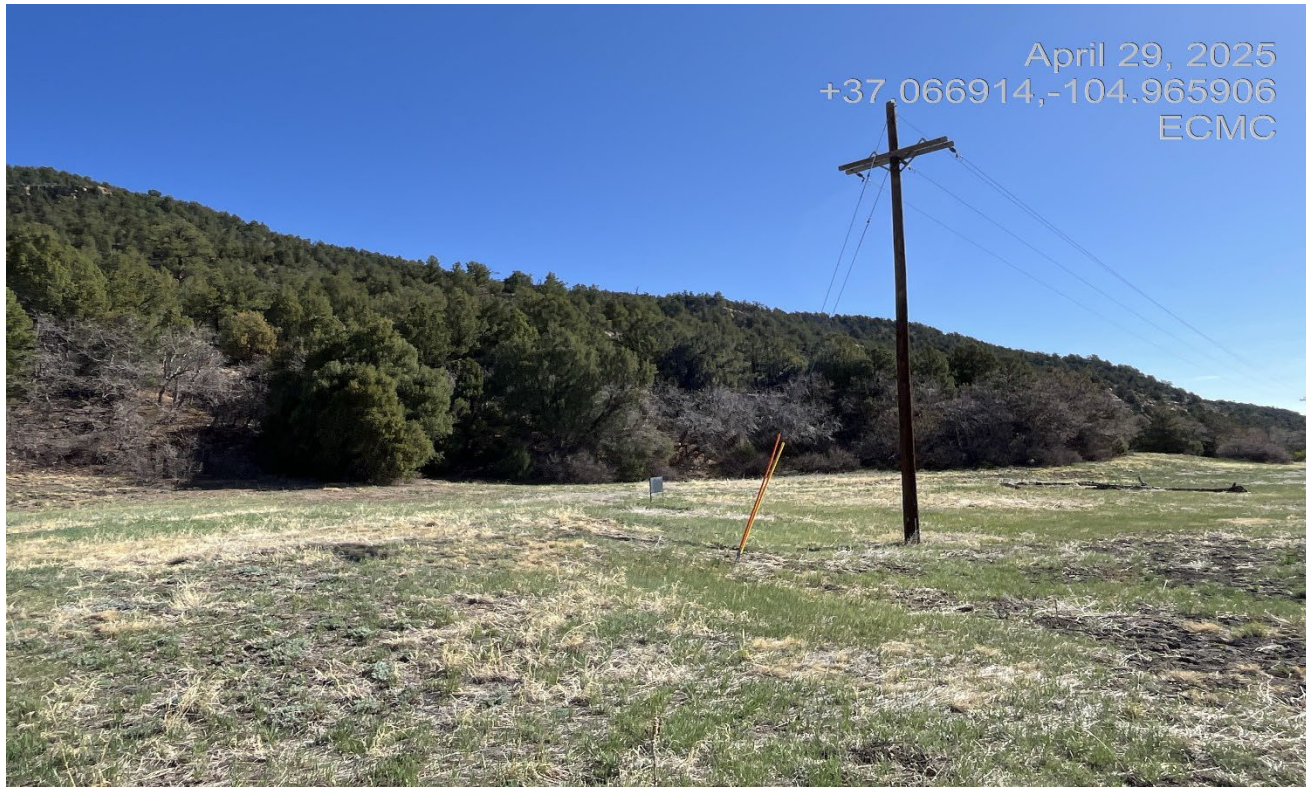
**Photo 4.** The electric line dead ends at this location and needs to be removed back to the next active wellsite that it serves.
