**Storm Water Management and Erosion control**  
**Location Name: TEP ROCKY MOUNTAIN LLC JOLLEY 31D-20-691 Pad**  
**Location ID: 335481**

**Location Overview: Location is within High  
Priority/Density/Black Bear Habitat areas.**

**Section/Township/Range: 20 6S91W**

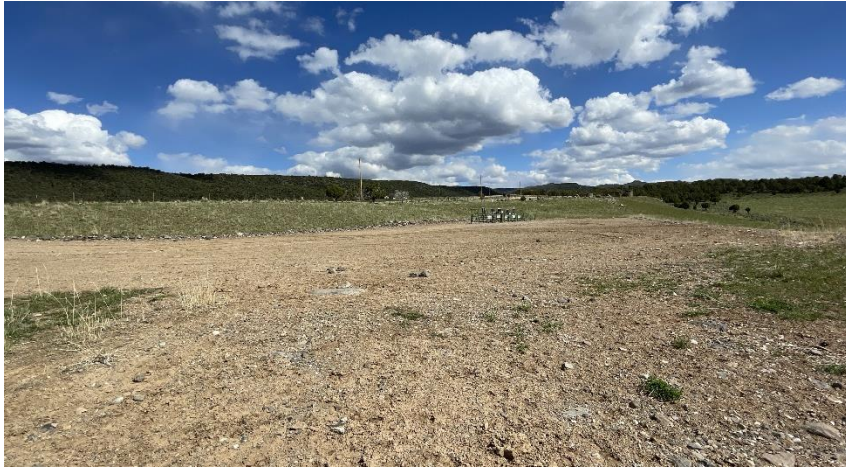
**North West corner of location.**

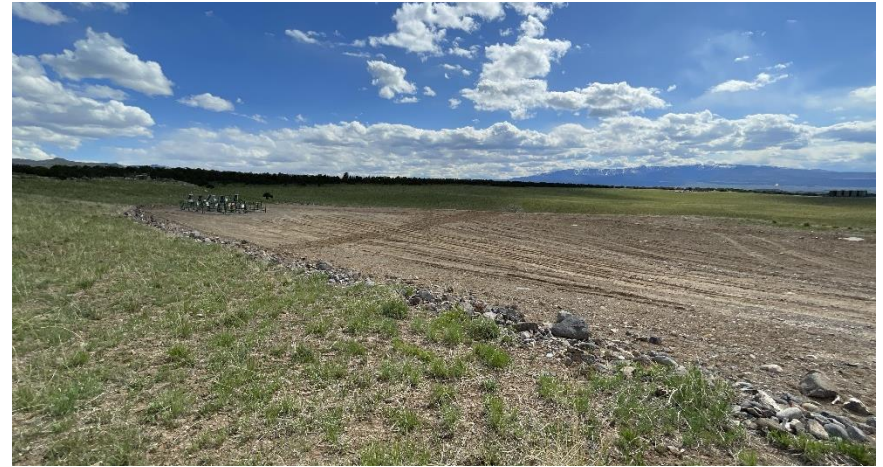
**North East corner of location.**

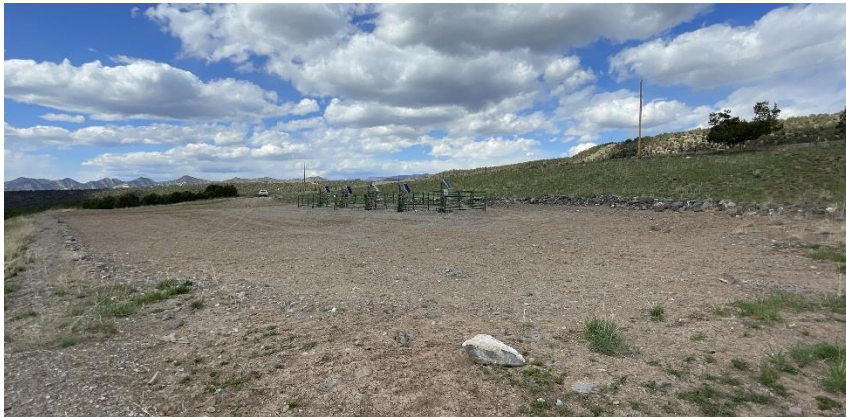
**South West corner of location.**

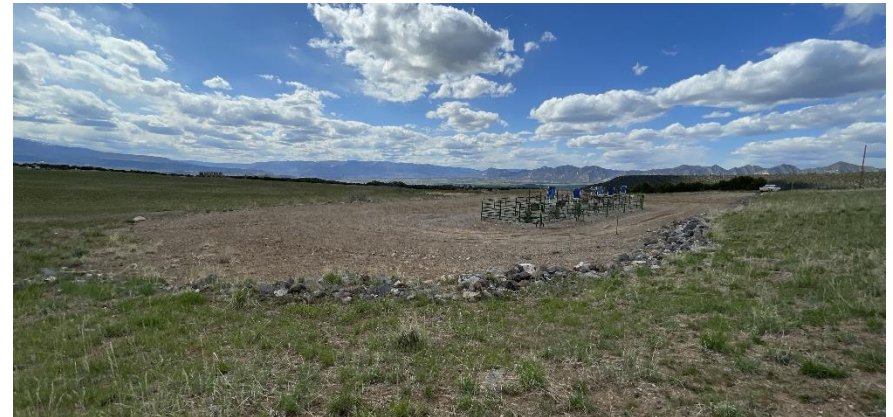
**South East corner of location.**

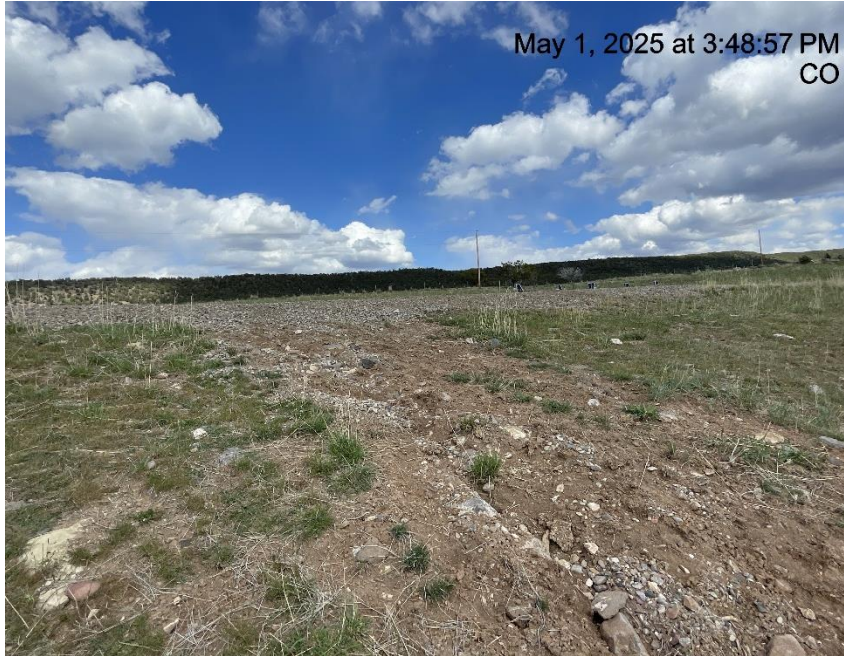
**Photo # 7958 Failure to minimize erosion & the transport of sediment off location/insufficient BMP's (W/NW edge of location)**

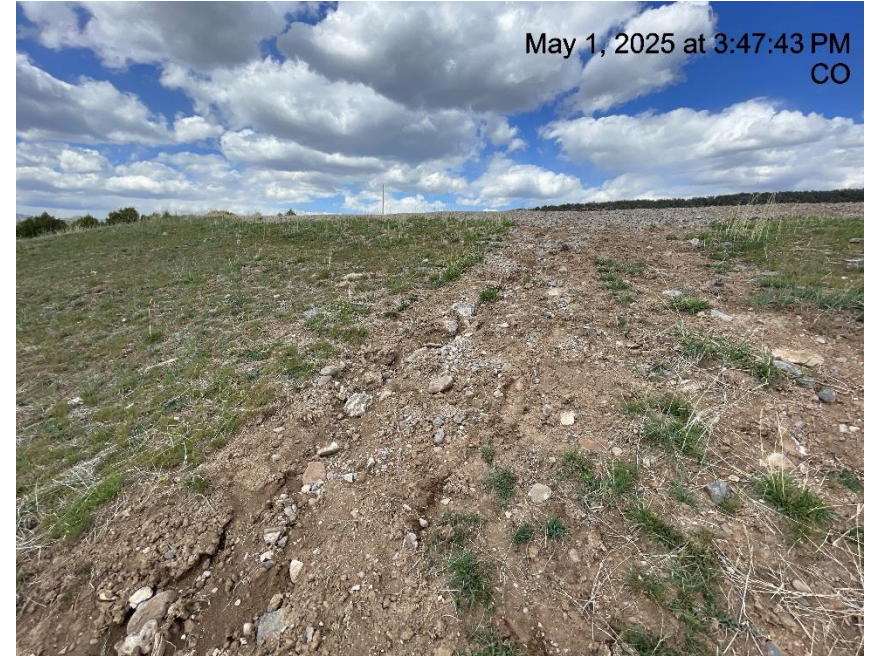
**Photo # 7959 Failure to minimize erosion & the transport of sediment off location/insufficient BMP's (W/NW edge of location)**

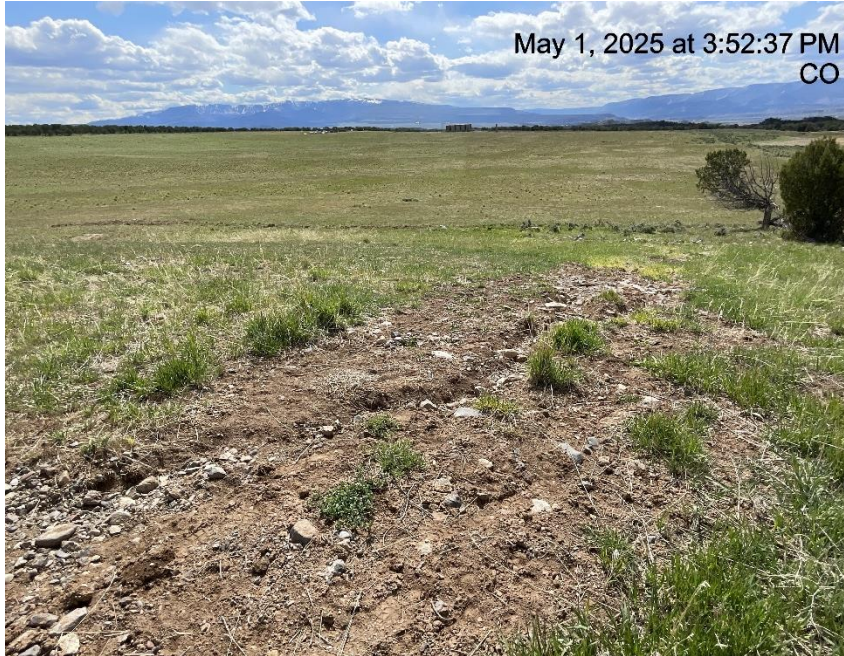
**Photo # 7960 Failure to minimize erosion & the transport of sediment off location/insufficient BMP's (W/NW edge of location)**

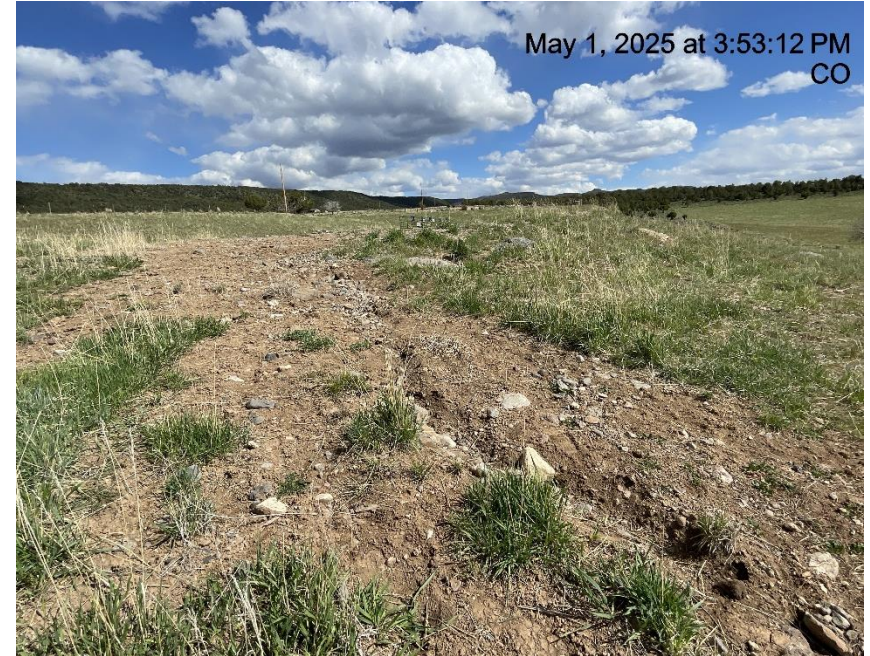
**Photo # 7961 Failure to minimize erosion & the transport of sediment off location/insufficient BMP's (W/NW edge of location)**

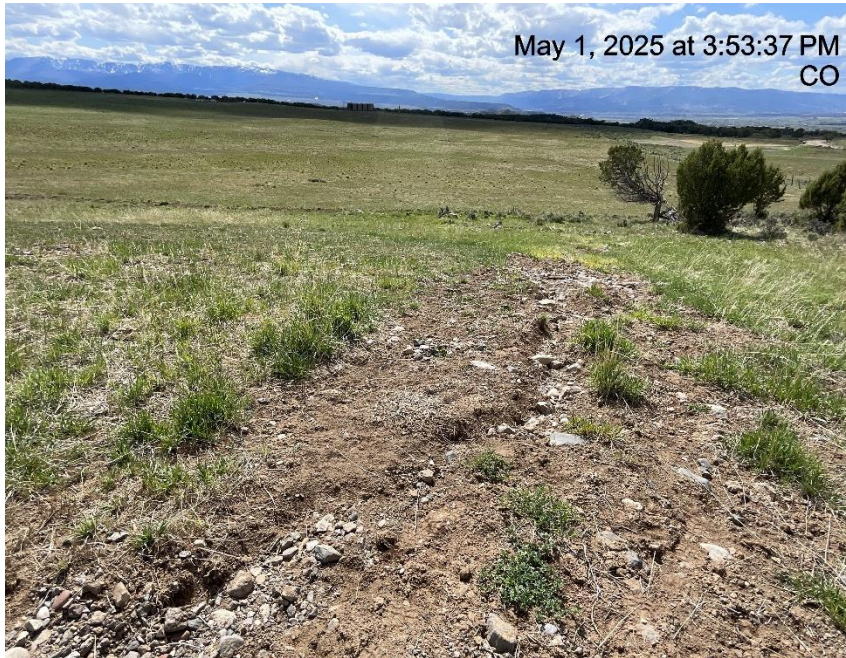
**Photo # 7962 Failure to minimize erosion & the transport of sediment off location/insufficient BMP's (W/NW edge of location)**
