Final Reclamation Inspection

Operator: KERR MCGEE OIL & GAS ONSHORE LP - 47120

Location ID: 329226

Inspection Photos
Location Name: GLOVER #30-7J
Location ID: 329226

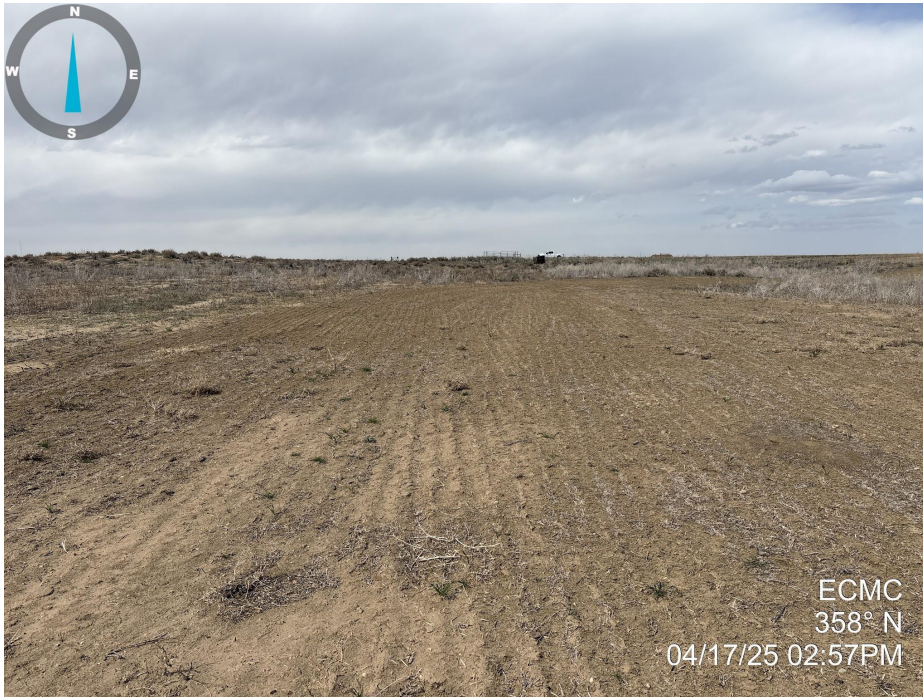
Photo 1. Photo taken from the well location, facing North. Photo illustrates that Operator has performed final reclamation activities with evidence of drill row seeding, however vegetation does not meet Rule 1004 final reclamation standards.

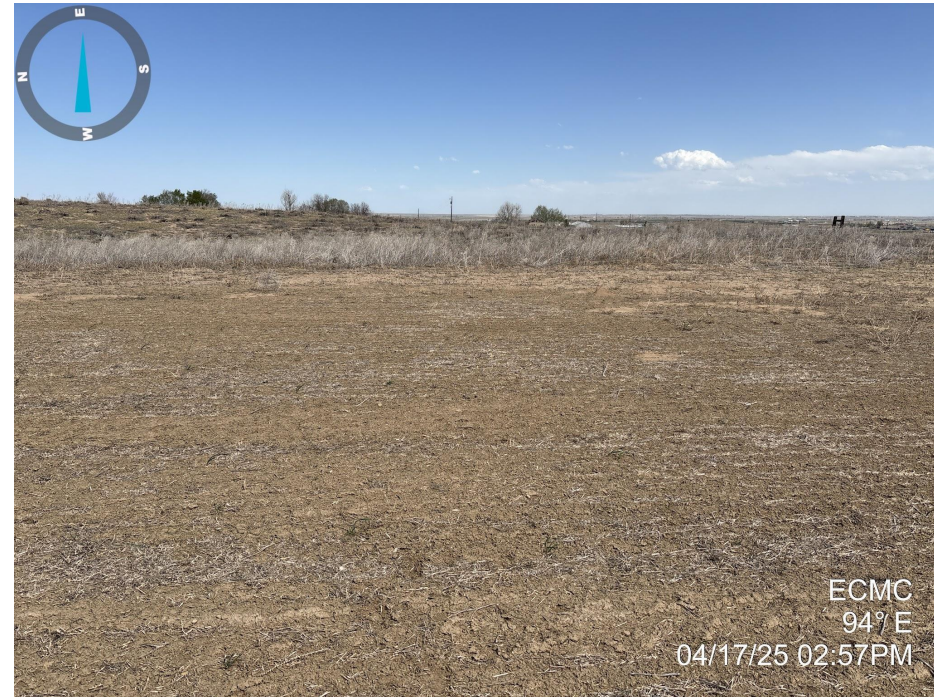
Photo 2. Photo taken from the well location, facing East. See comments under Photo 1.

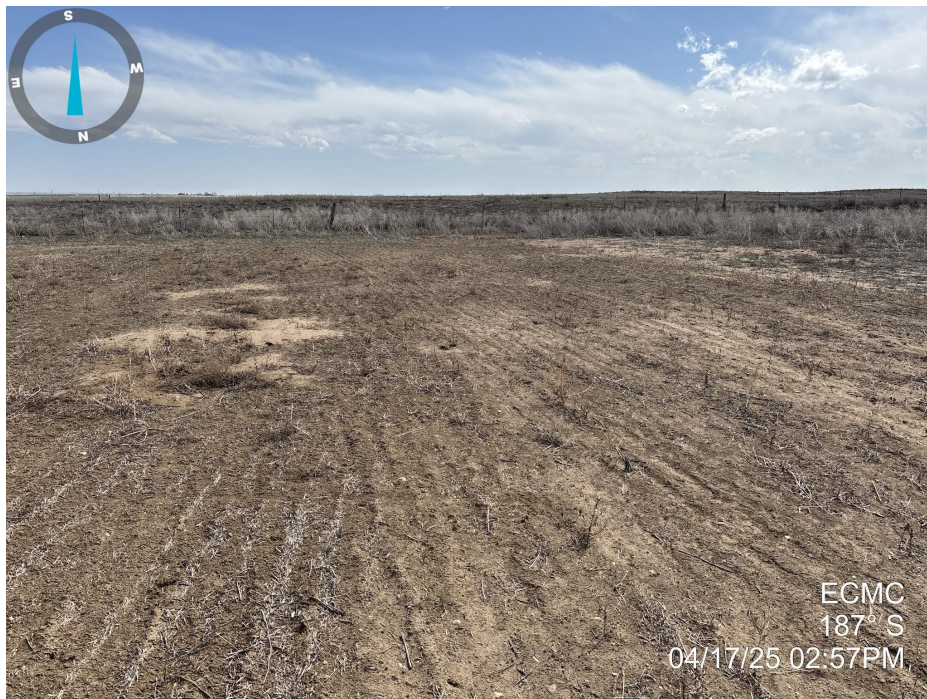
Photo 3. Photo taken from the well location, facing South. See comments under Photo 1.

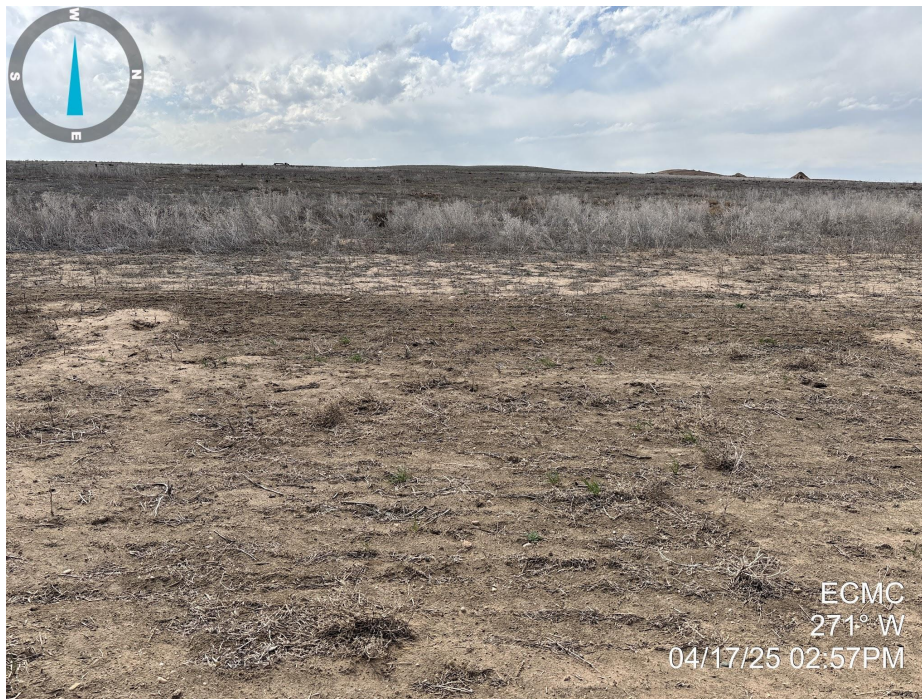
Photo 4. Photo taken from the well location, facing West. See comments under Photo 1.

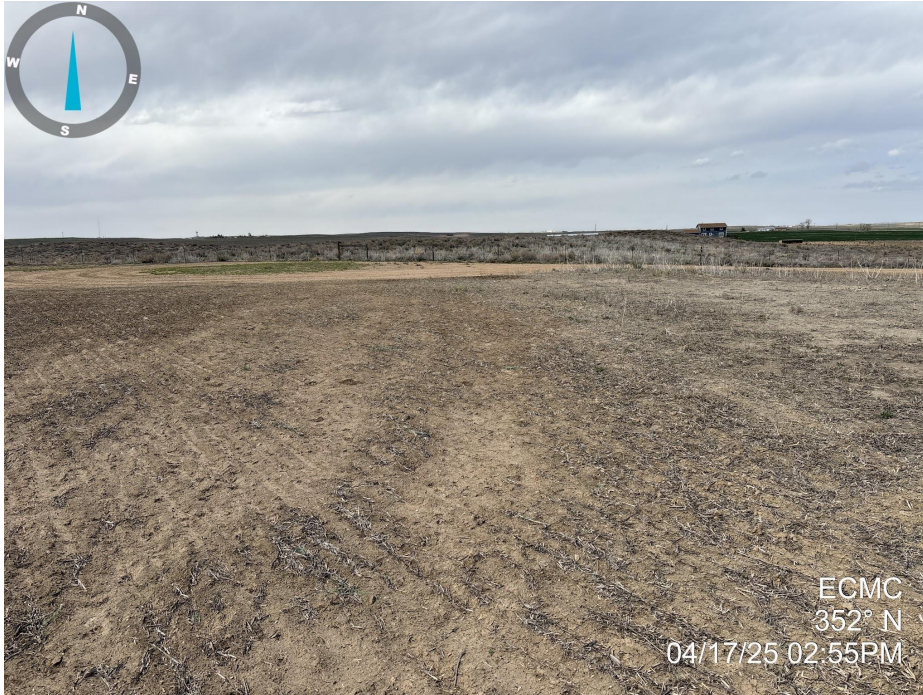
Photo 5. Photo taken from the access road, facing North. Photo illustrates that final reclamation activities have taken place, with evidence of drill rows, but vegetation establishment does not meet final reclamation standards.

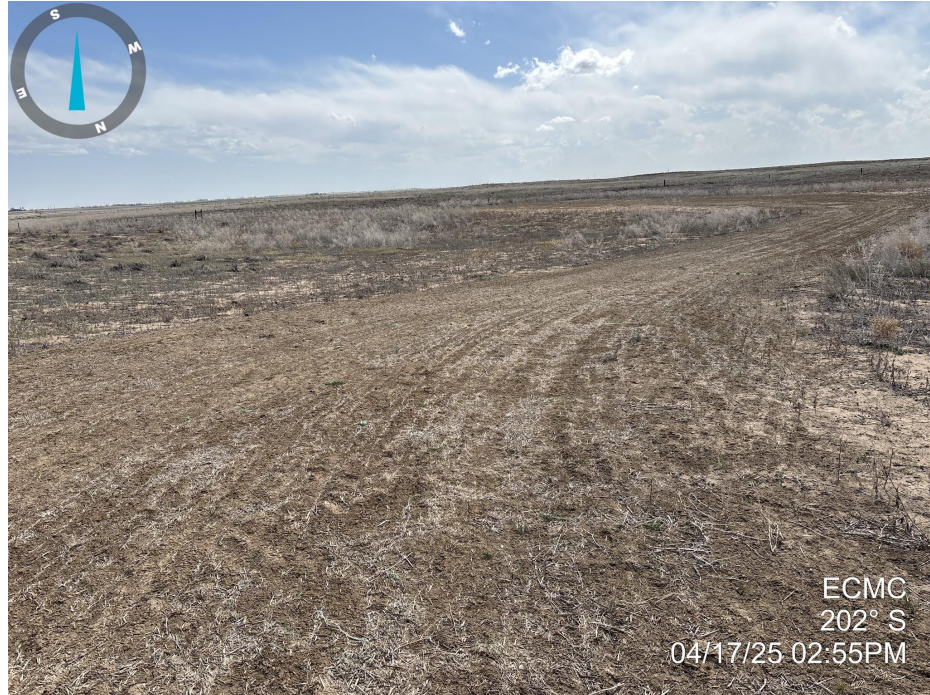
Photo 6. Photo taken from the access road, facing South, towards the location. See comments under Photo 5.

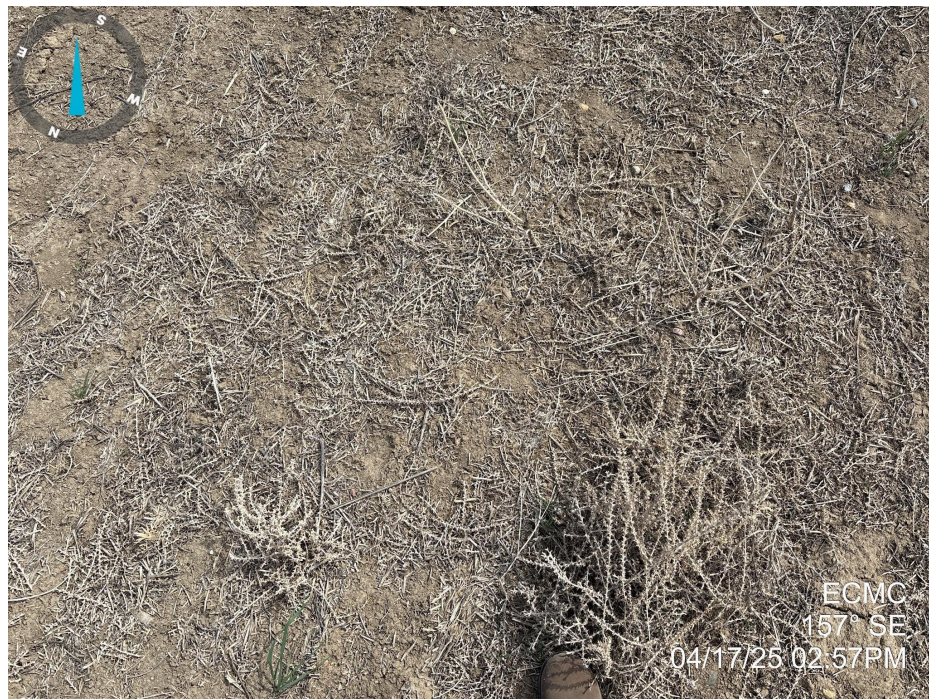
Photo 7. Photo taken of the well site. Photo illustrates weedy annual growth including kochia (*Kochia scoparia*) and Russian thistle (*Salsola tragus*).

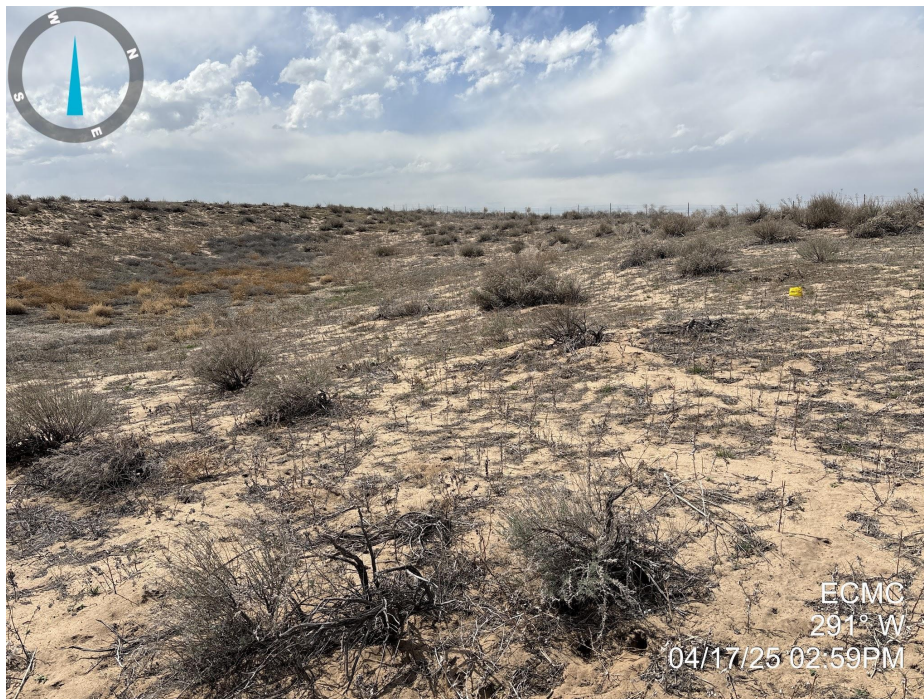
Photo 8. Photo taken from the reference area, north of the well location, facing West. Photo illustrates sandy soil with perennial grass and shrub vegetation.
