Final Reclamation Inspection

Operator: KERR MCGEE OIL & GAS ONSHORE LP - 47120

Location ID: 318115

Inspection Photos
Location Name: MEL ANDERSON GAS UNIT #1
Location ID: 318115

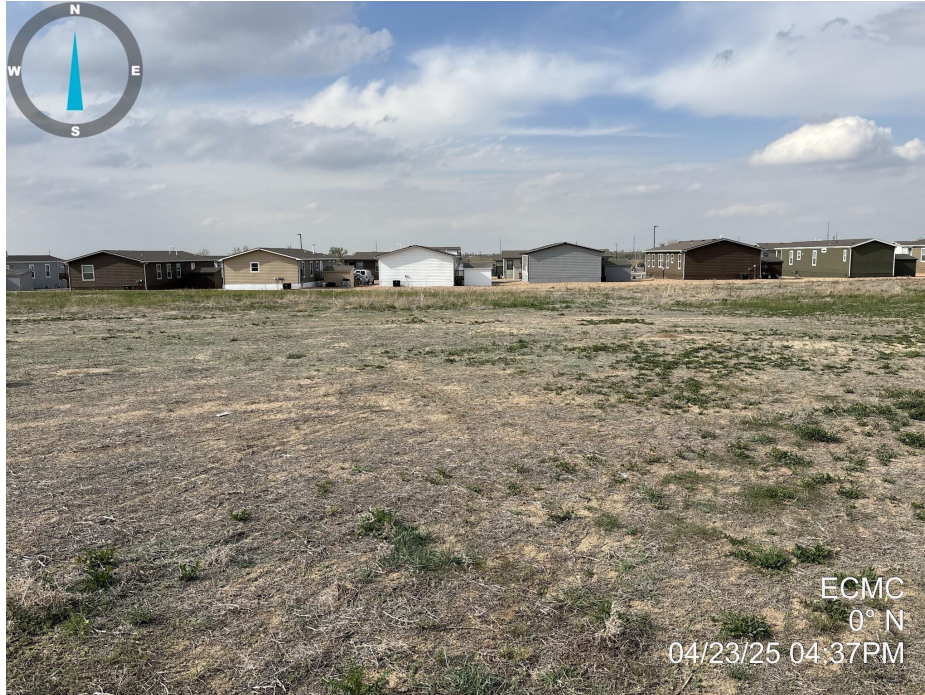
Photo 1. Photo taken from the well location, facing North. Photo illustrates that final reclamation activities have taken place, but vegetation has not established to final reclamation standards.

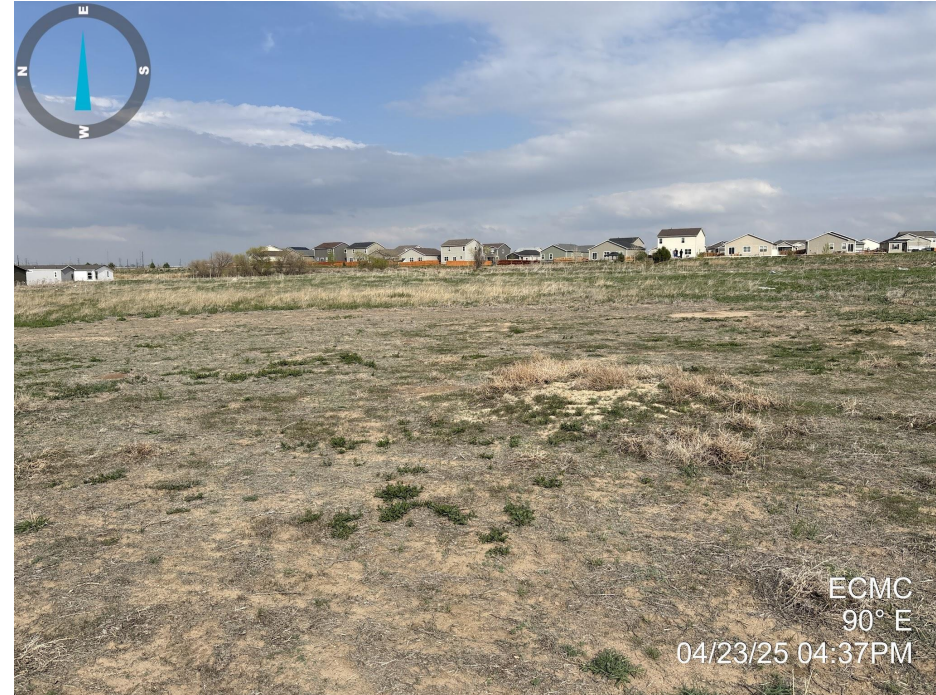
Photo 2. Photo taken from the well location, facing East. See comments under Photo 1.

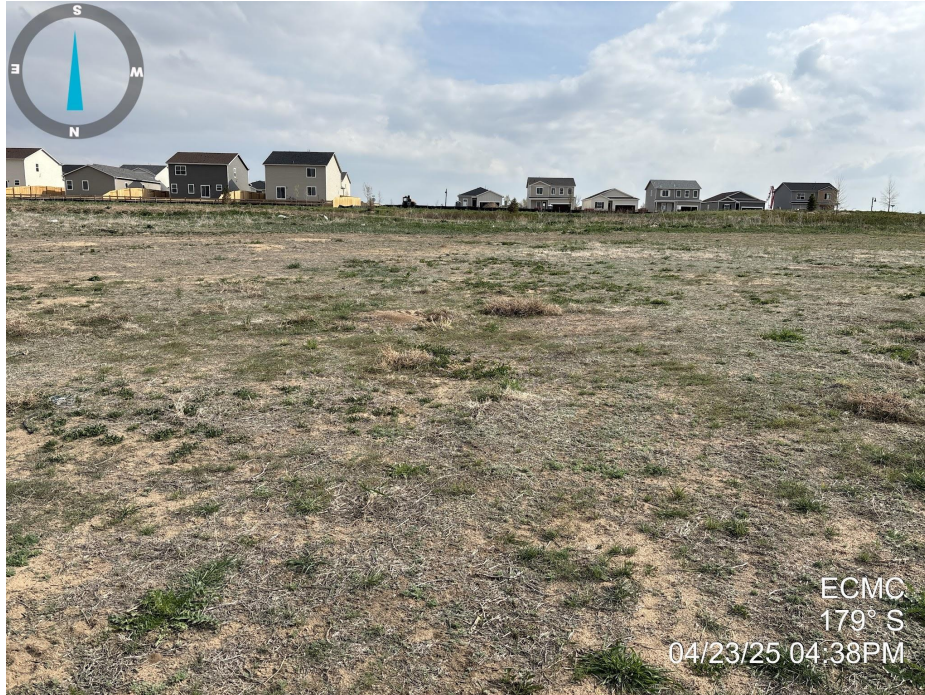
Photo 3. Photo taken from the well location, facing South. See comments under Photo 1.

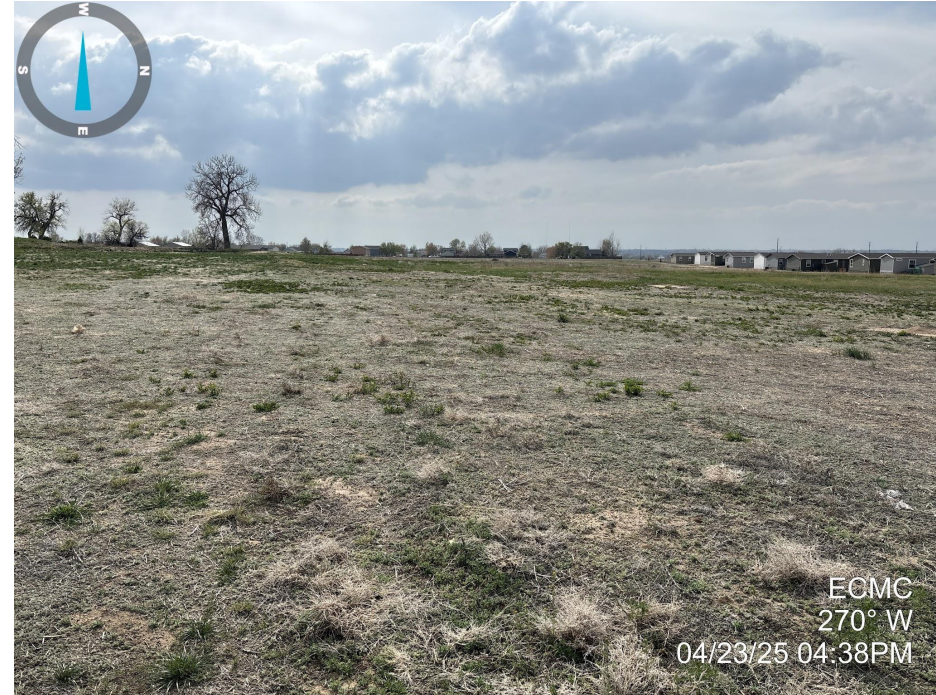
Photo 4. Photo taken from the well location, facing West. See comments under Photo 1.

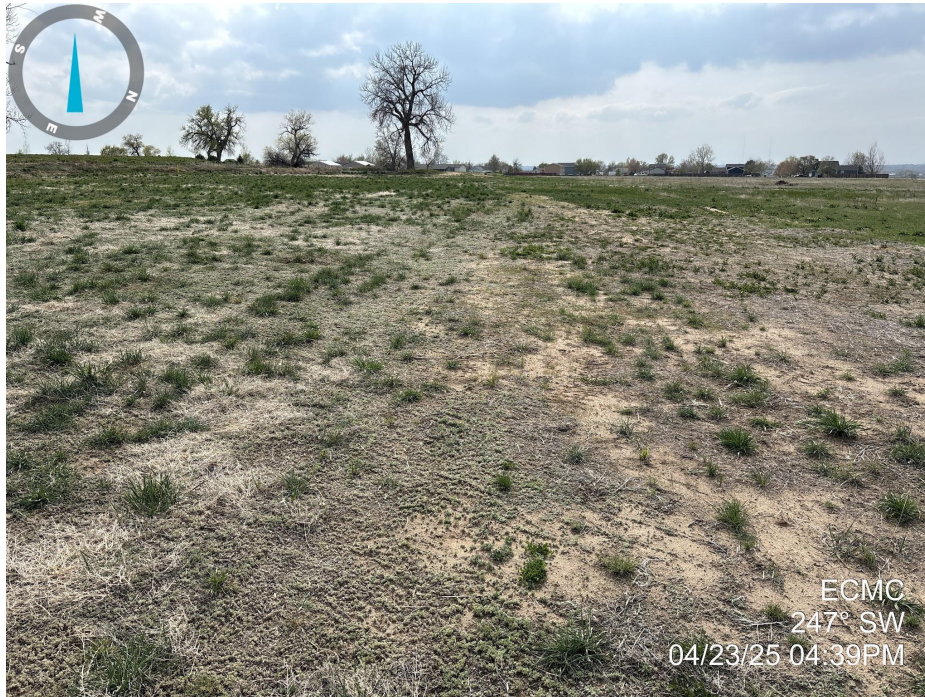
Photo 5. Photo taken of the access road, facing southwest away from the well location. Photo illustrates that final reclamation activities have taken place, with evidence of drill rows, but vegetation establishment does not meet final reclamation standards.

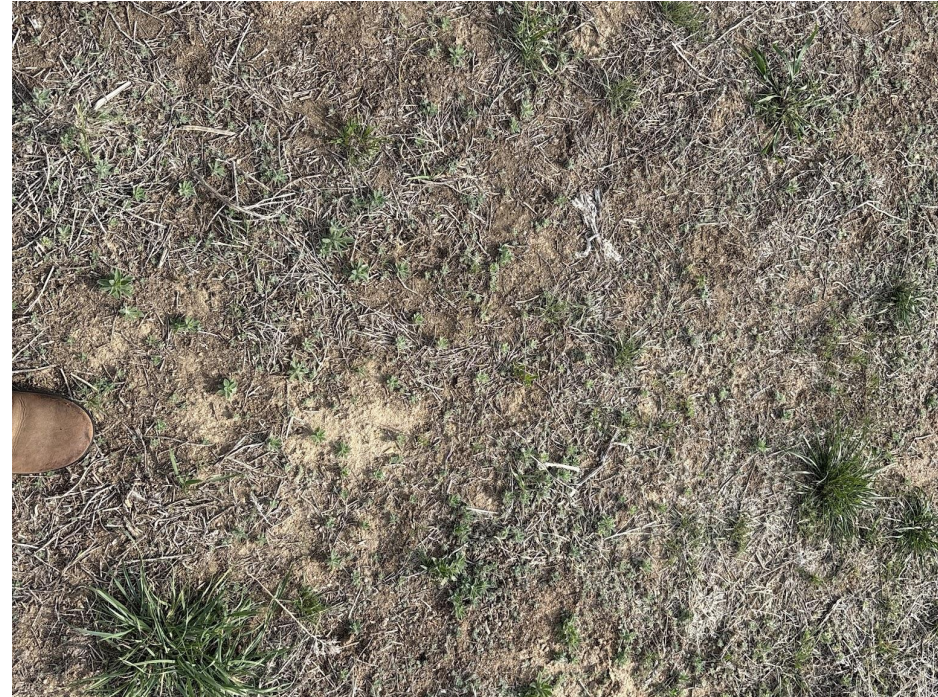
Photo 6. Photo taken of the well location. Photo illustrates that some perennial vegetation has established at the site, but establishment does not meet Rule 1004 standards.

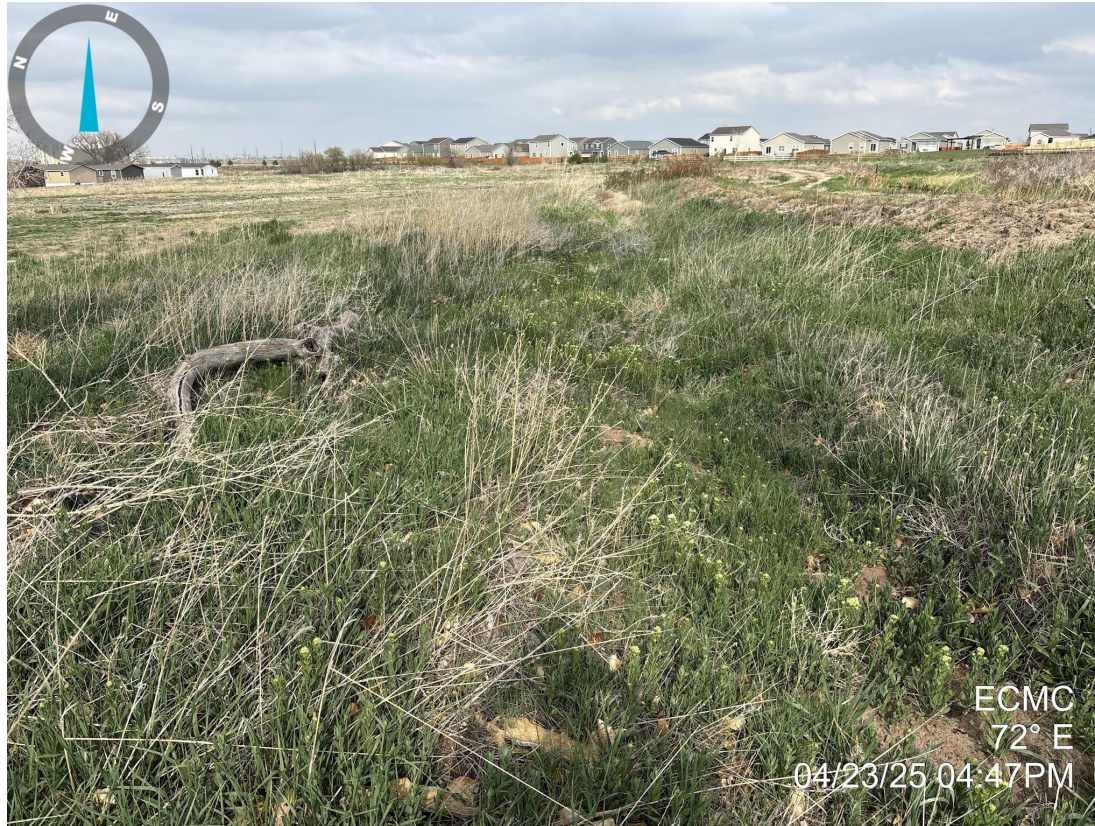
Photo 7. Photo taken of the reference area, south of the location, facing East. Photo illustrates area is dominated by perennial grass vegetation.
