# Final Reclamation Inspection

Operator: KERR MCGEE OIL & GAS ONSHORE LP - 47120

Location ID: 336169

Inspection Photos  
Location Name: HSR ALTER  
FEDERAL-61N66W/5NESE  
Location ID: 336169

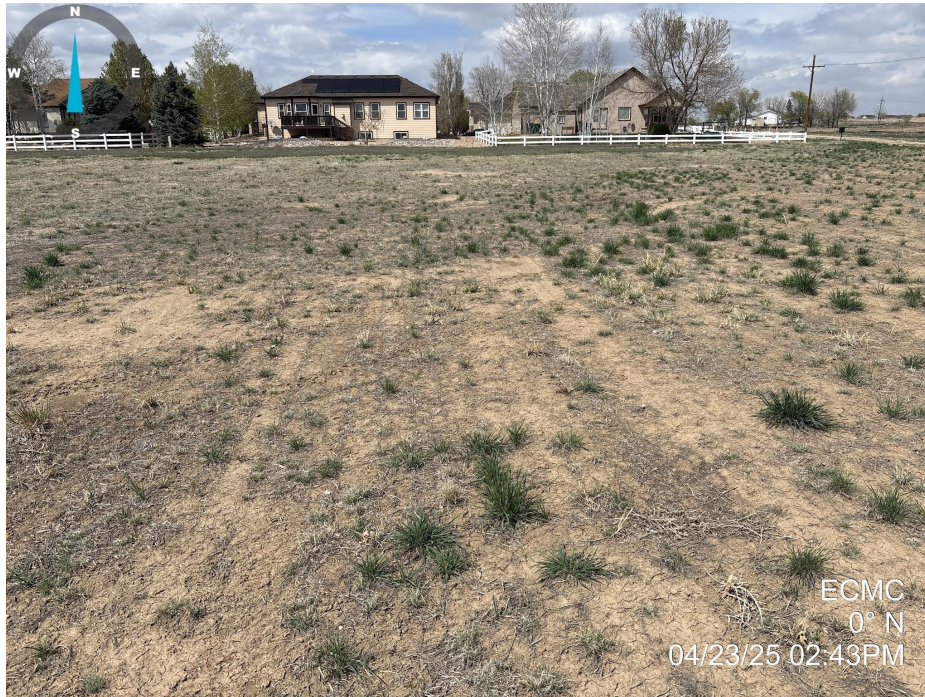
**Photo 1.** Photo taken from the multi-well location, facing North. Photo illustrates that final reclamation activities have taken place, with evidence of drill rows, but vegetation establishment does not meet final reclamation standards.

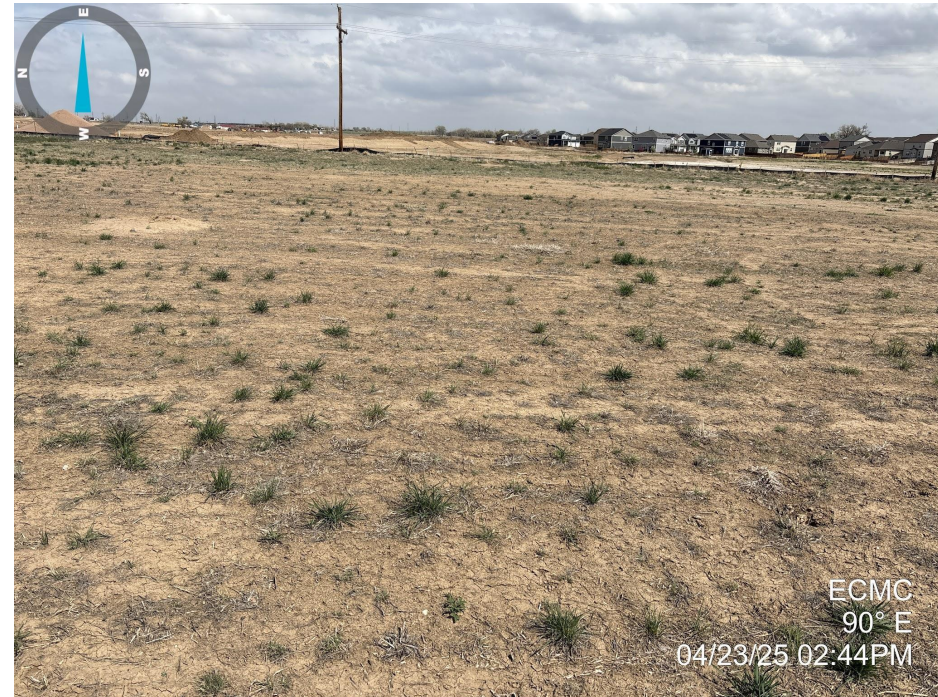
**Photo 2.** Photo taken from the multi-well location, facing East. See comments under Photo 1.

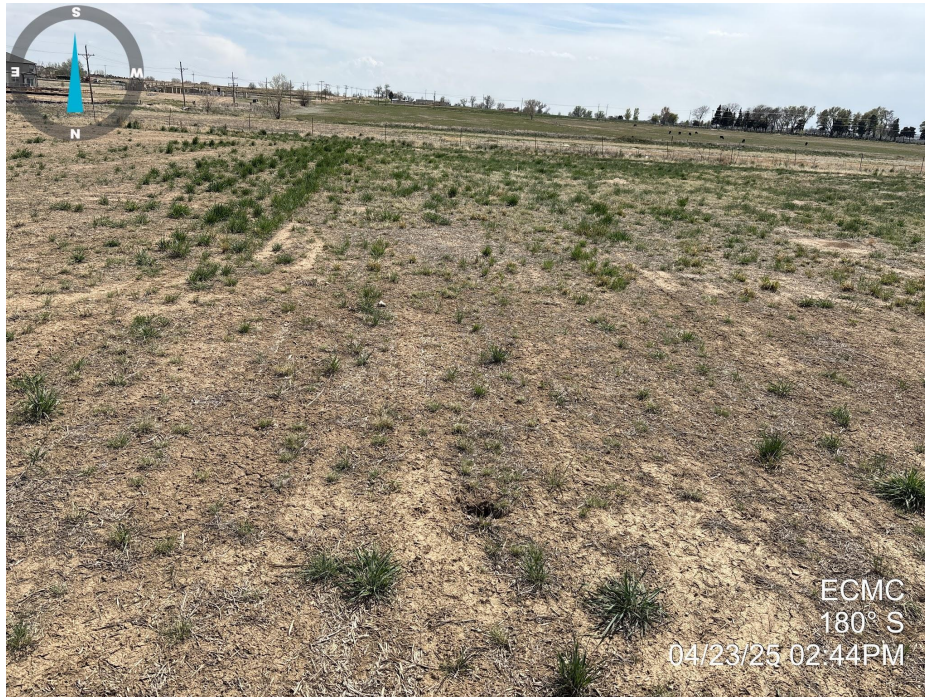
**Photo 3.** Photo taken from the multi-well location, facing South. See comments under Photo 1.

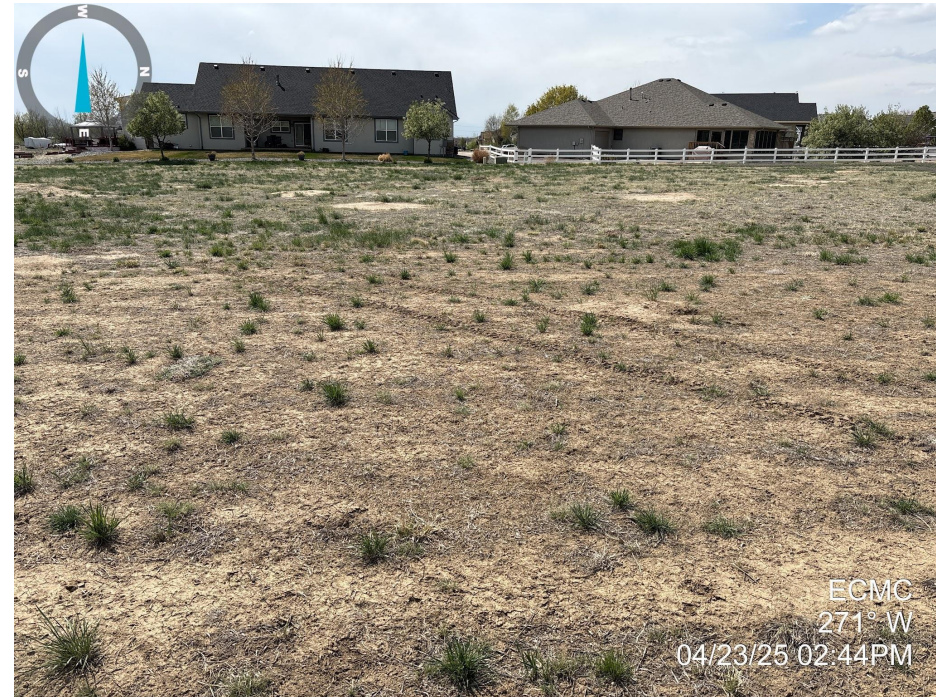
**Photo 4.** Photo taken from the multi-well location, facing West. See comments under Photo 1.

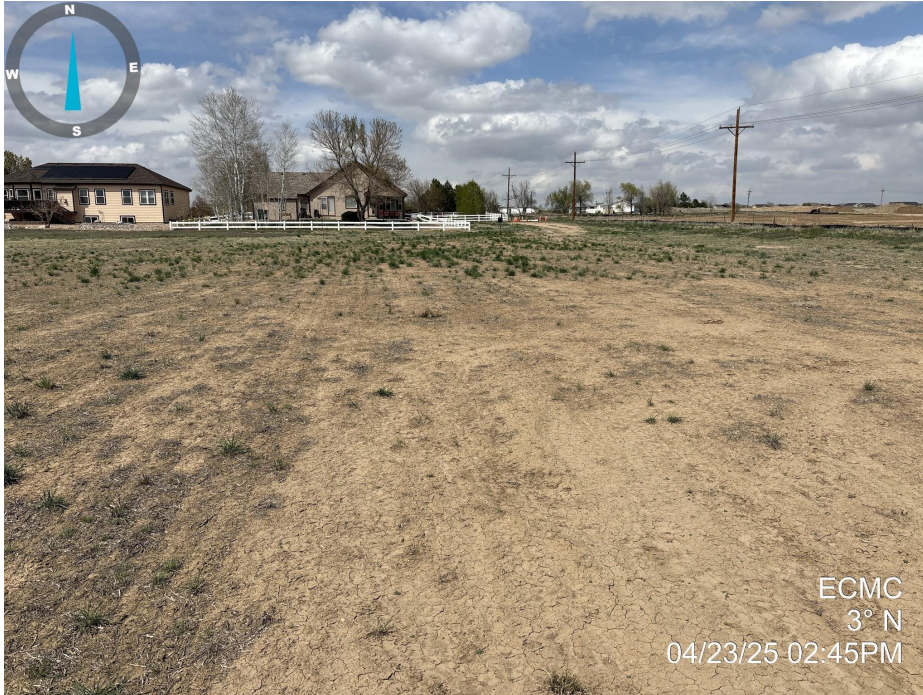
**Photo 5.** Photo taken of the tank battery location, facing North. Photo illustrates that there is evidence of drill rows from seeding activities, but vegetation has not established to Rule 1004 reclamation standards.

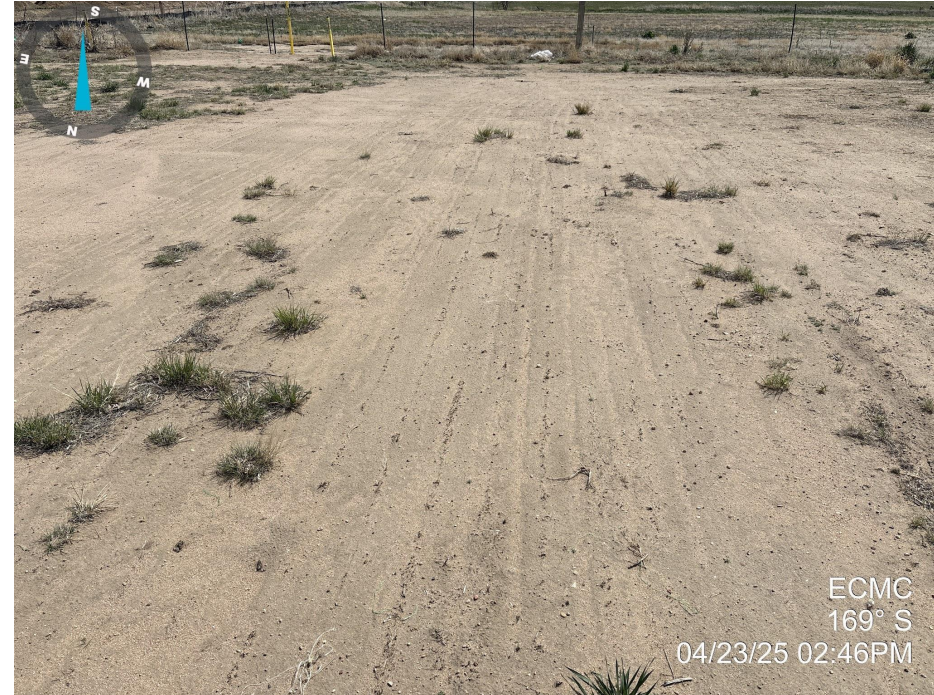
**Photo 6.** Photo taken of the tank battery location, facing South. See comments under Photo 5.

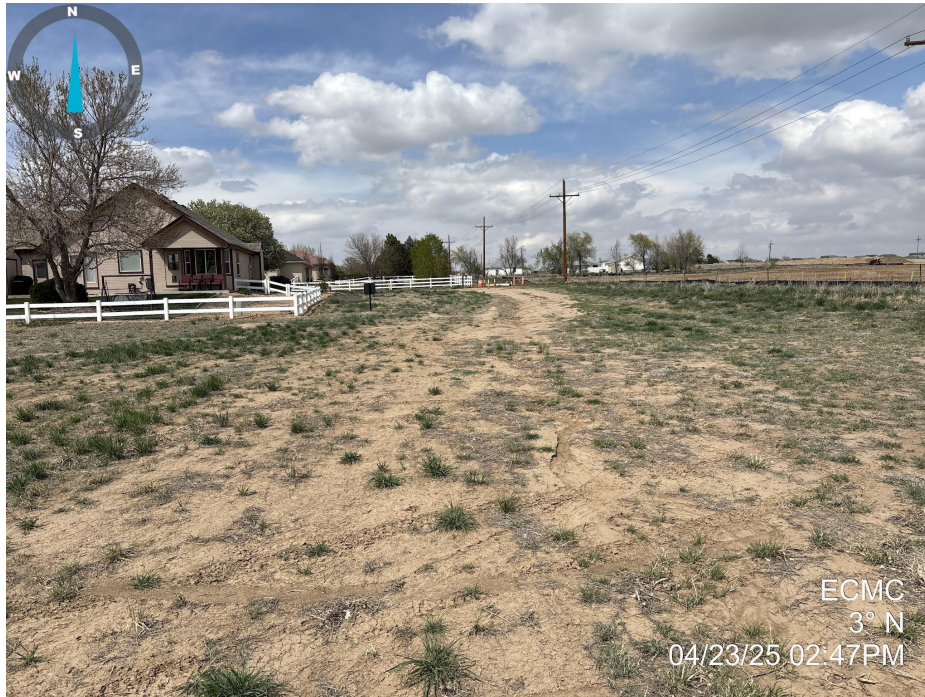
**Photo 7.** Photo taken of the access road, facing North. Photo illustrates that vegetation has reestablished partially on this portion of the access road, while the northern portion of the access road remains unreclaimed.

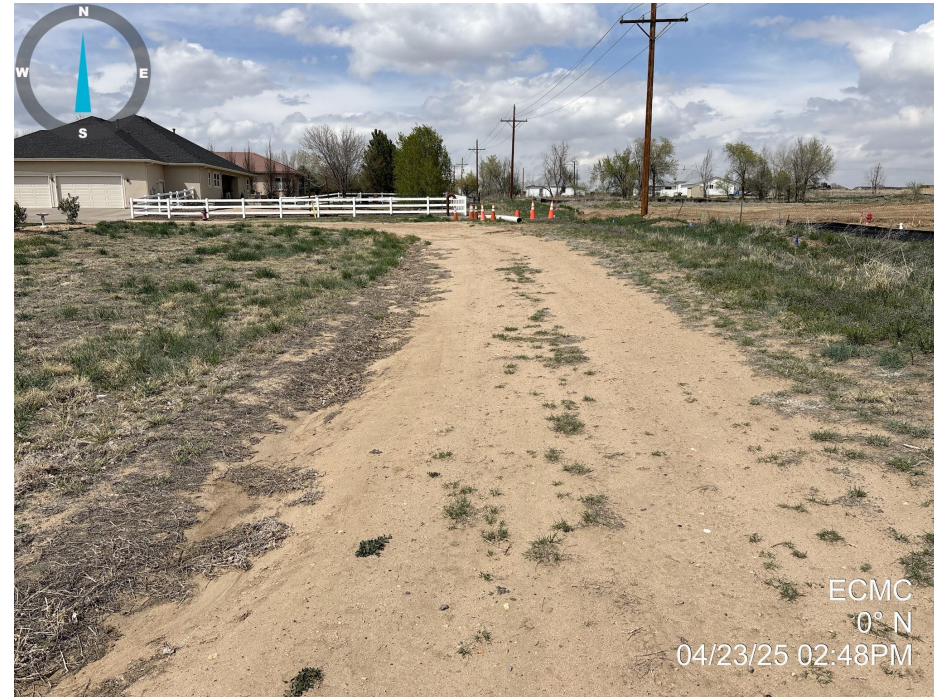
**Photo 8.** Photo taken of the access road, facing North. Photo illustrates that this portion of the access road has not been reclaimed.

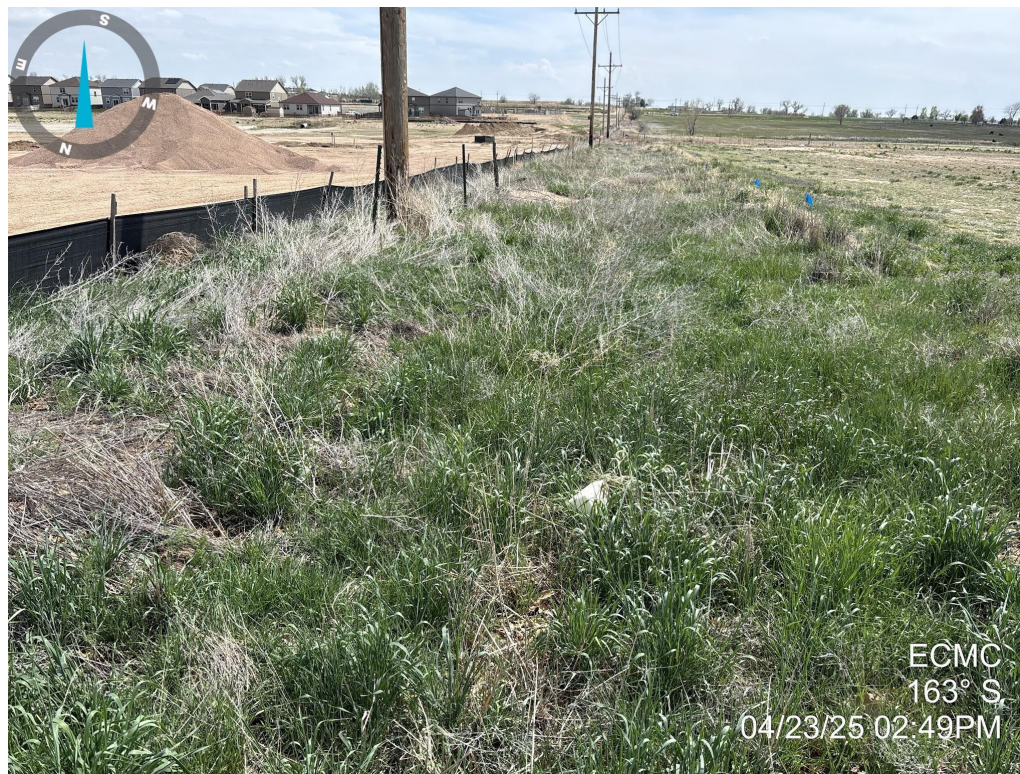
**Photo 9.** Photo taken of the reference area, east of the location, facing South. Photo illustrates perennial grass vegetation.
