# Flowline Closure Checklist

## COGCC Rule 911.a.(4) Environmental Site Closure Assessment Field Form

Site Name & COGCC Facility Number: UNI UPR C25-06	Date: 7/5/2023	Remediation Project #: 22716
---	----------------	------------------------------

**Noble Energy, Inc. – DJ Basin**  
**UNI UPR C25-6**  
 SENW, Section 25, Township 4 North, Range 64 West  
 Weld County, Colorado

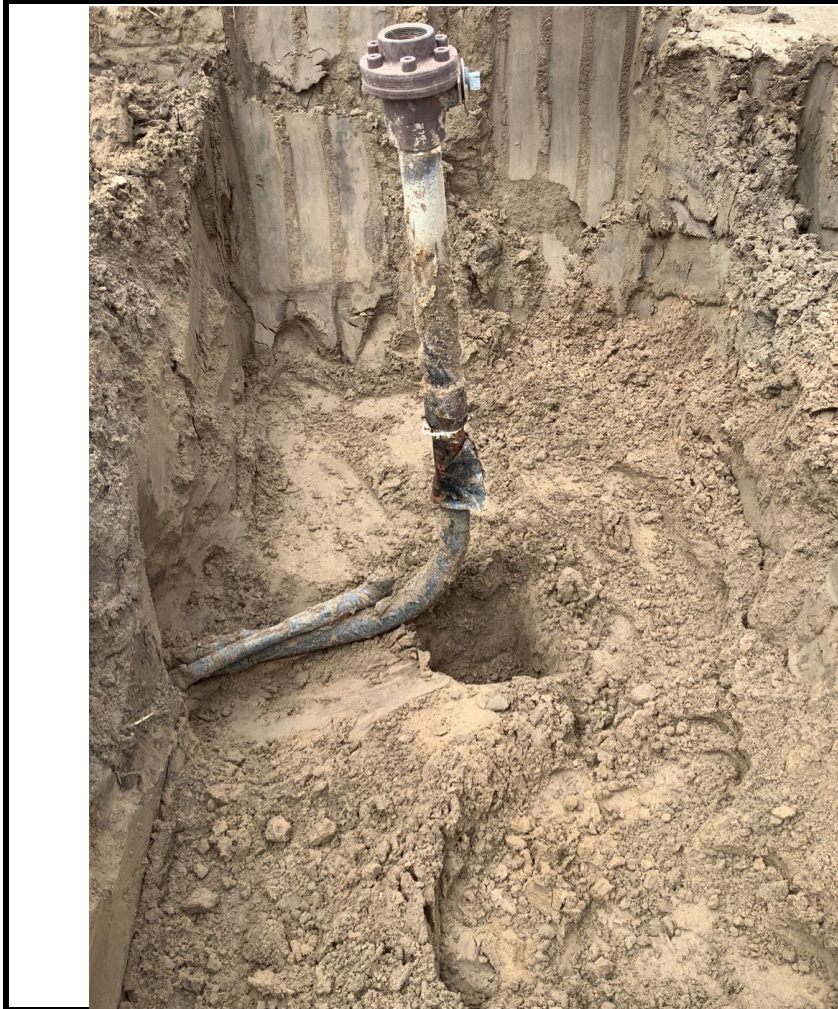
<b>Equipment ID:</b> FL01-A@4'	<b>Equipment Type:</b> Flowline	
<b>Material:</b> Steel	<b>Volume:</b>	<b>Contents:</b> Oil/Gas/Water
<b>Notes/Conditions:</b>

Other observations regarding on location flowlines:  
Samples were taken at the wellhead (FL01-A@4') and at the separator (FL01-B@3.5'). Both samples were submitted to the lab for analysis.  
Flowline was ABIP due to crops, and is scheduled to be pulled at a later date.

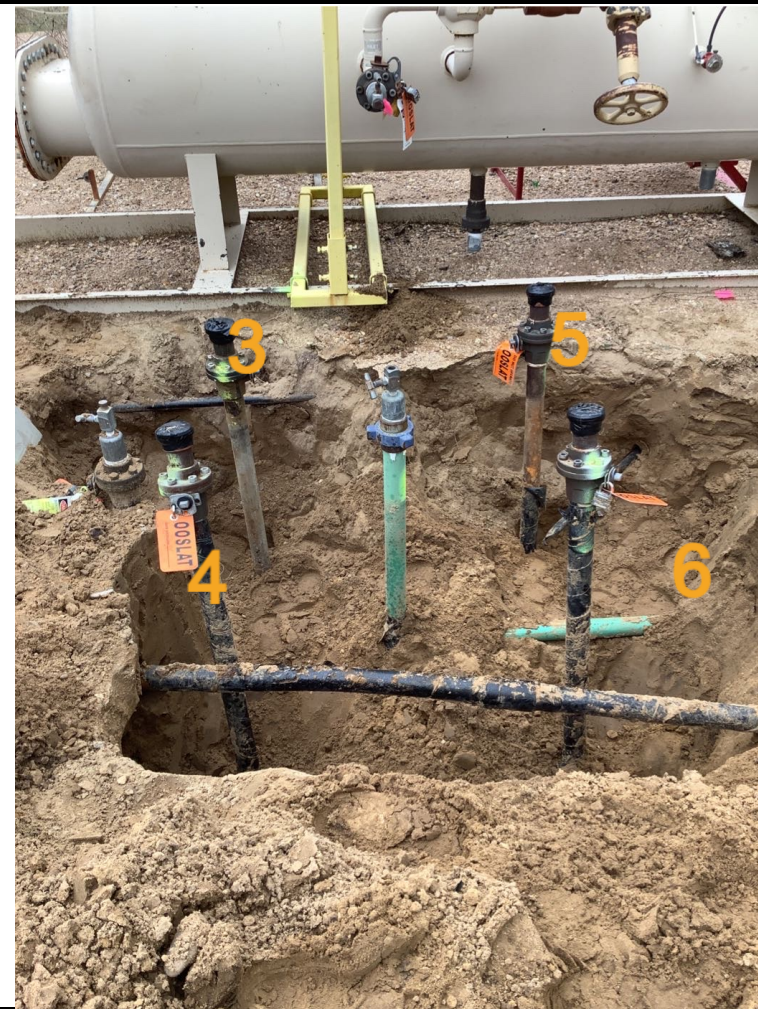
<b>Equipment ID:</b>	<b>Equipment Type:</b>	
<b>Material:</b>	<b>Volume:</b>	<b>Contents:</b>
<b>Notes/Conditions:</b> location of UNI UPR C25-03, UNI UPR C25-04, UNI UPR 25-05 and UNI UPR C25-06 flowlines at common separator labeled 3-6 respectively.

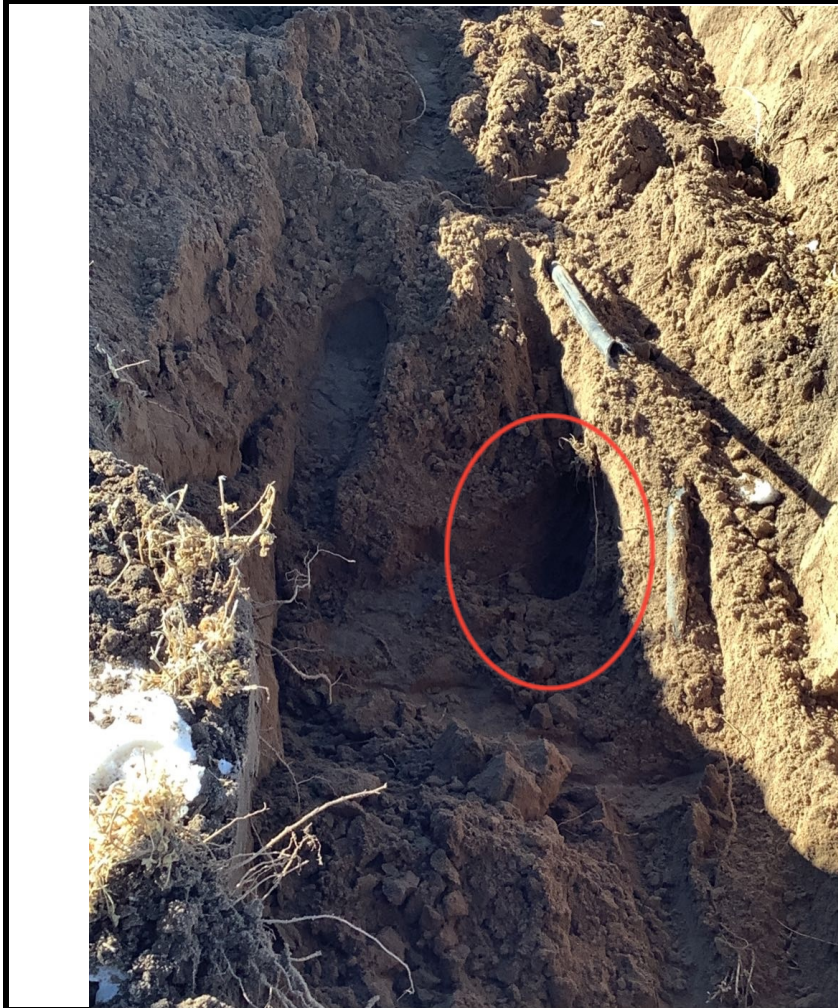
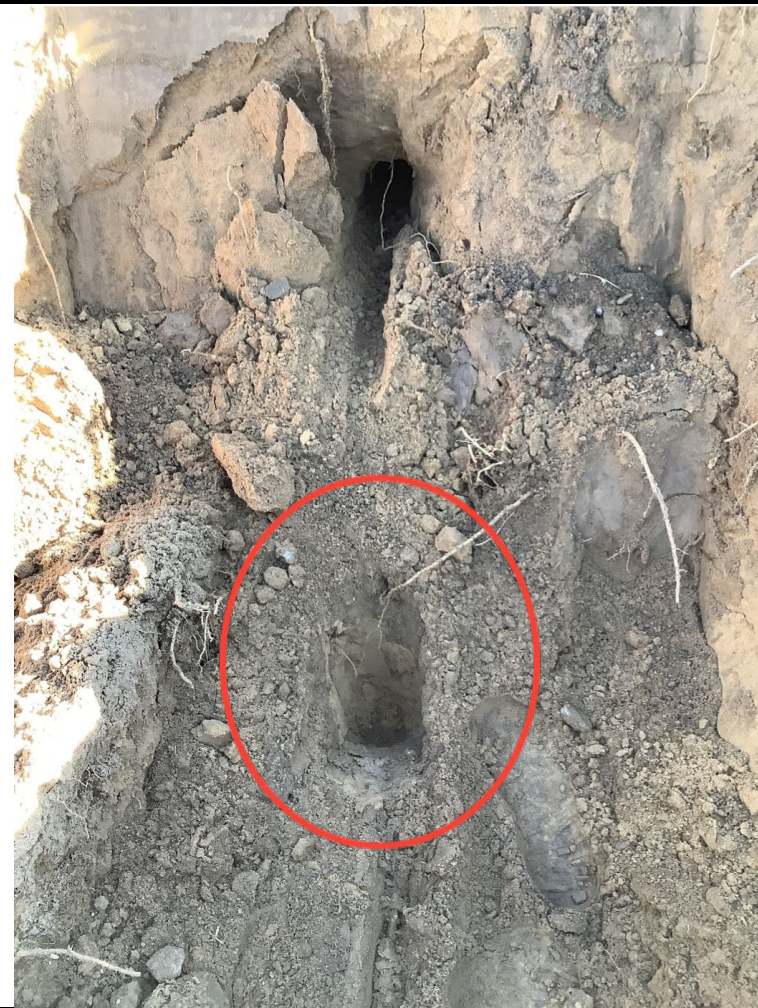
<b>Equipment ID:</b> FL01-C@3'		<b>Equipment Type:</b>		<b>Equipment ID:</b> FL01-D@3'		<b>Equipment Type:</b>	
<b>Material:</b>	<b>Volume:</b>	<b>Contents:</b>		<b>Material:</b>	<b>Volume:</b>	<b>Contents:</b>	
<b>Notes/Conditions:</b>				<b>Notes/Conditions:</b>

Samples were taken along the flowline path (FL01-C@3' - FL01-K@3').
