Inspection Photos

Operator: GUNNISON ENERGY LLC - 10515

Location ID: 324485

Inspection Doc: 718100509

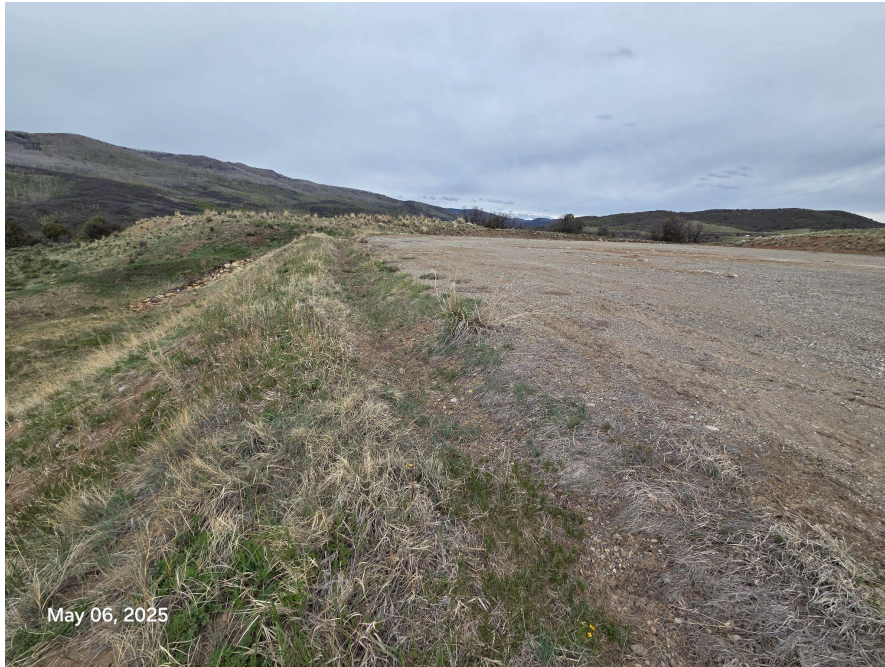
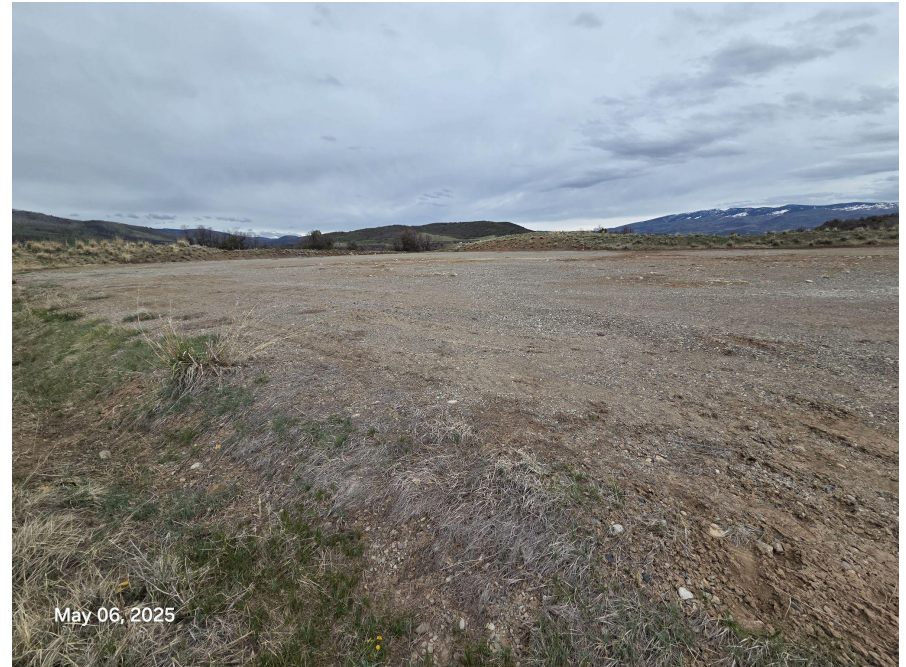
Photo 1: Photos 1-3 taken from the south end of the working pad surface. Photos provide an overview of the Location from west, northwest, northeast, southeast to southwest. Location and access road are subject to 1004 Final reclamation requirements including, but not limited to removal of gravel, compaction alleviation, recontouring/regrading, replacement of topsoil and revegetation activities by 7/9/2025.

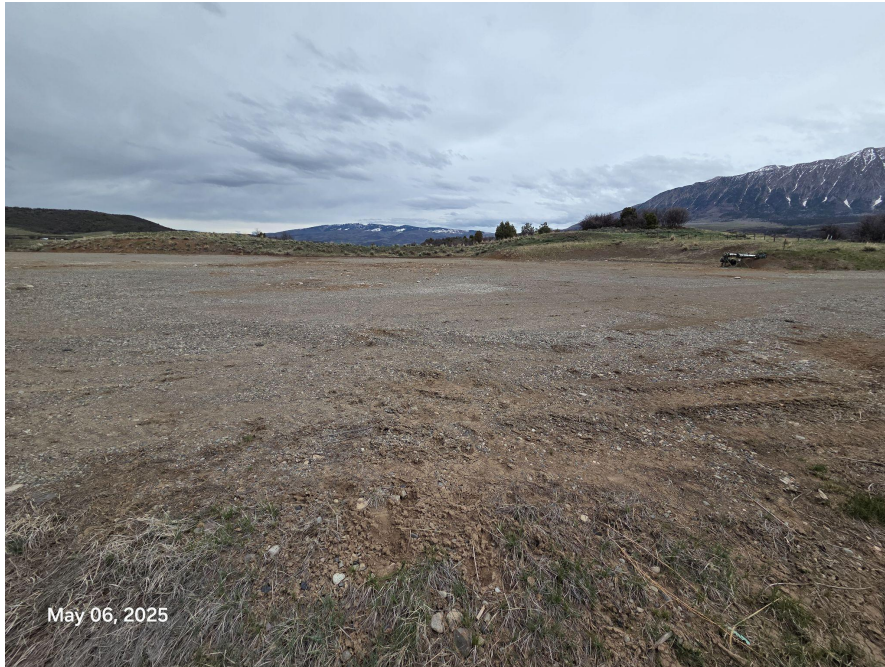
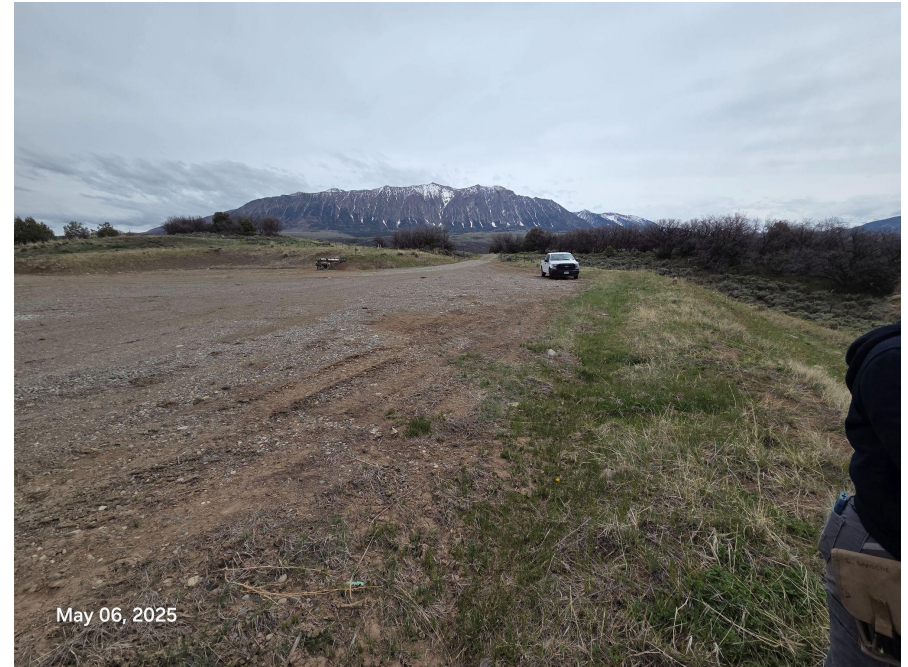
Photo 2: See comments under photo 1.

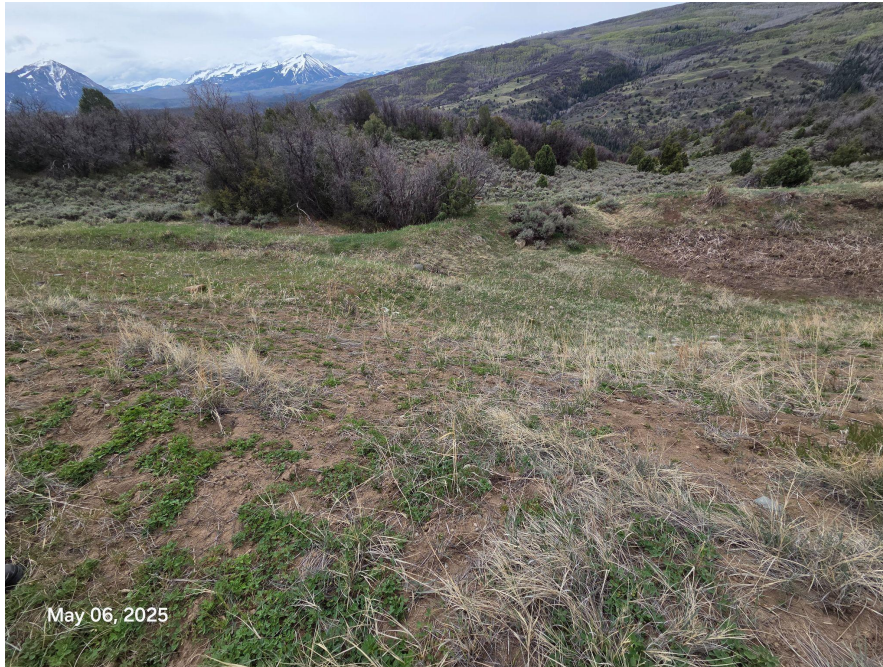
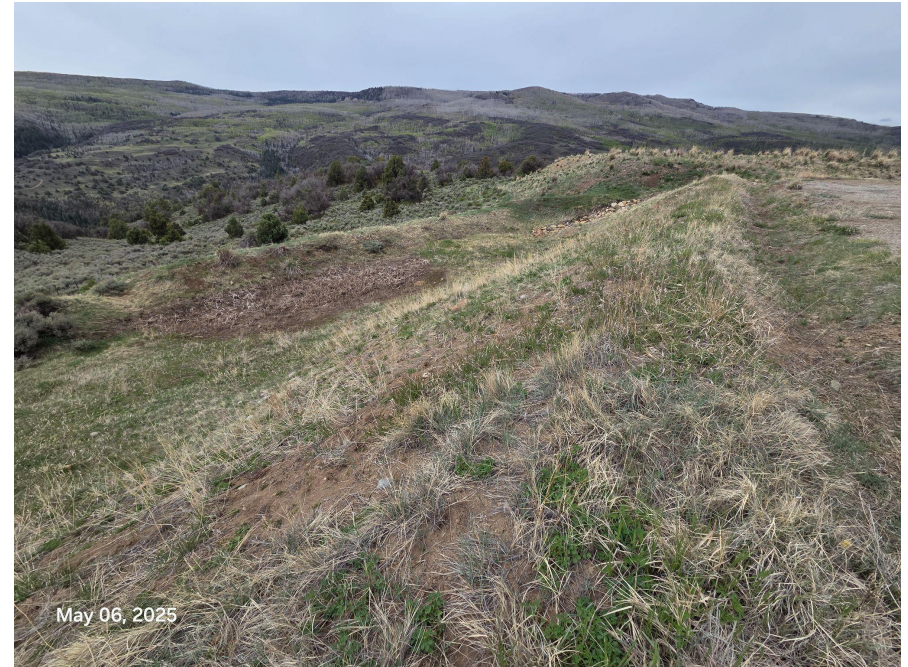
Photo 3: See comments under photo 1.

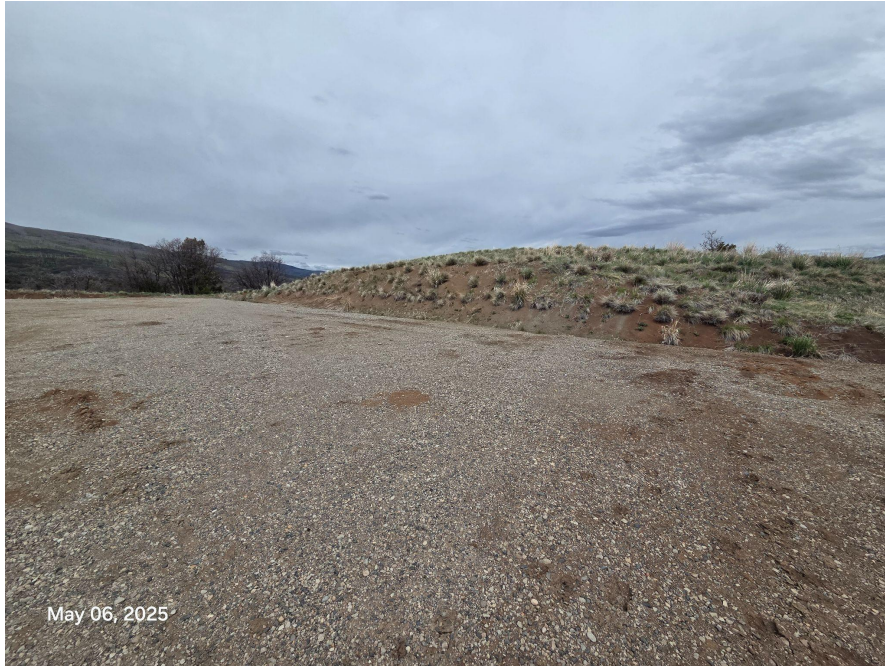
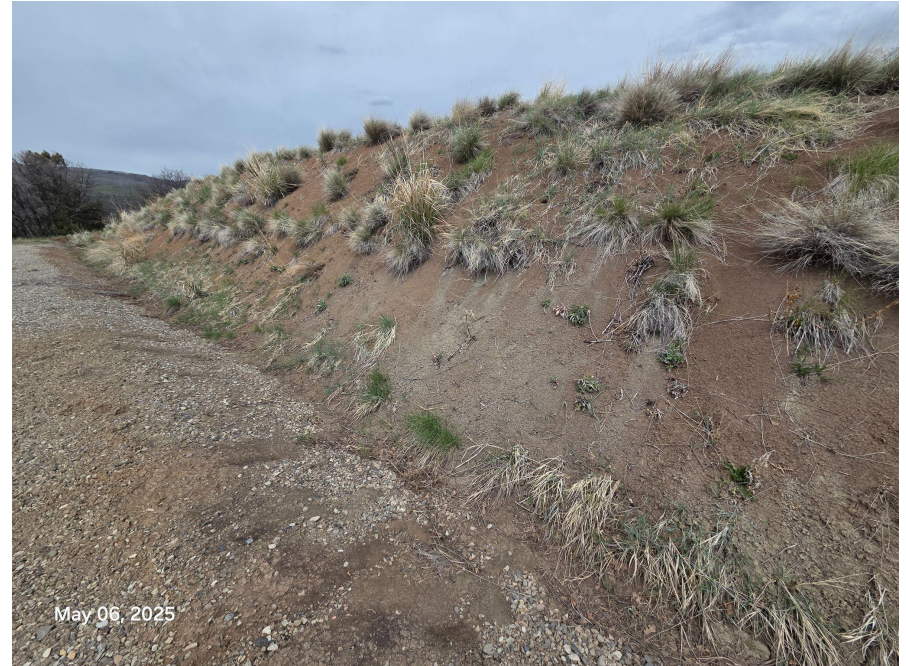
Photo 4: Photo taken from the Topsoil stockpile on the northwest end of the Location. BMPs to stabilize soils remain missing or insufficient; soils are bare and at risk to wind and water erosion.

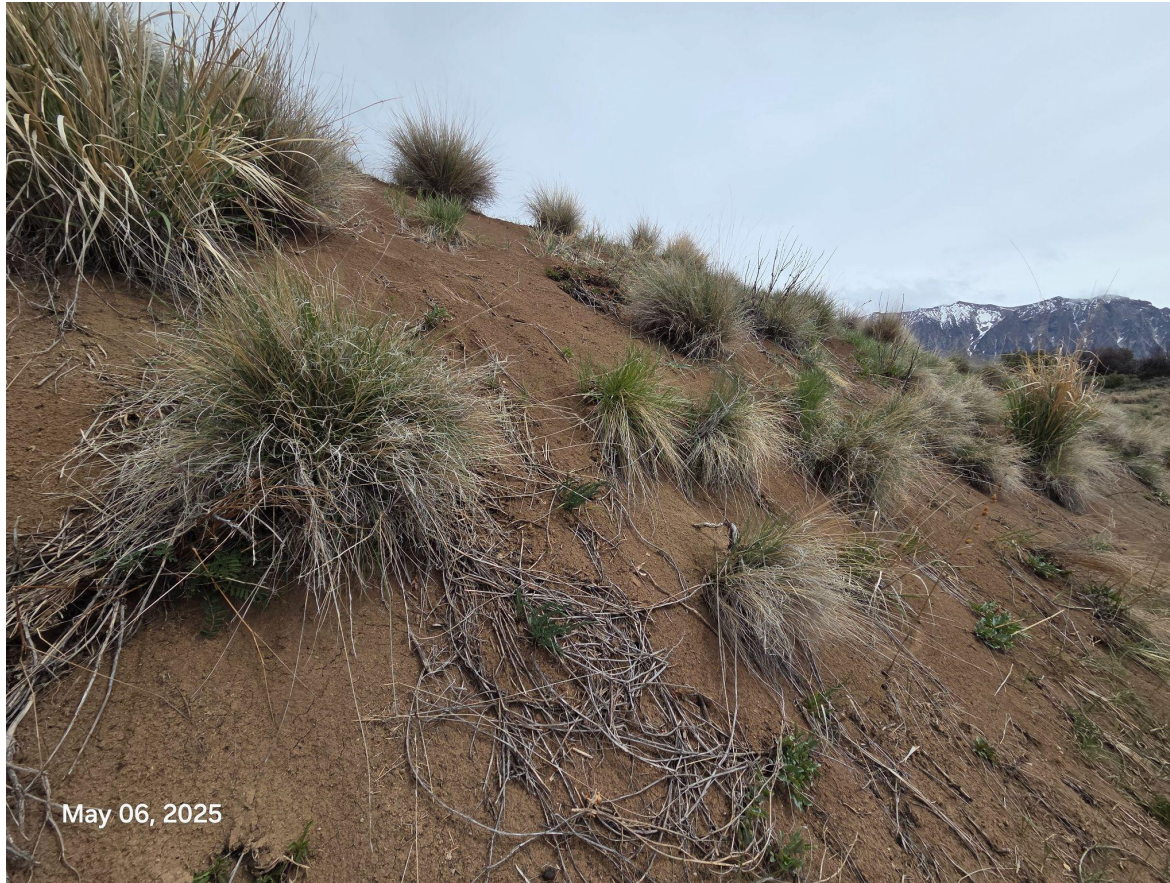
Photo 5: Continued from photo 5. Photo example showing unstabilized soils continue to erode, with sediment covering established vegetation at the stockpile

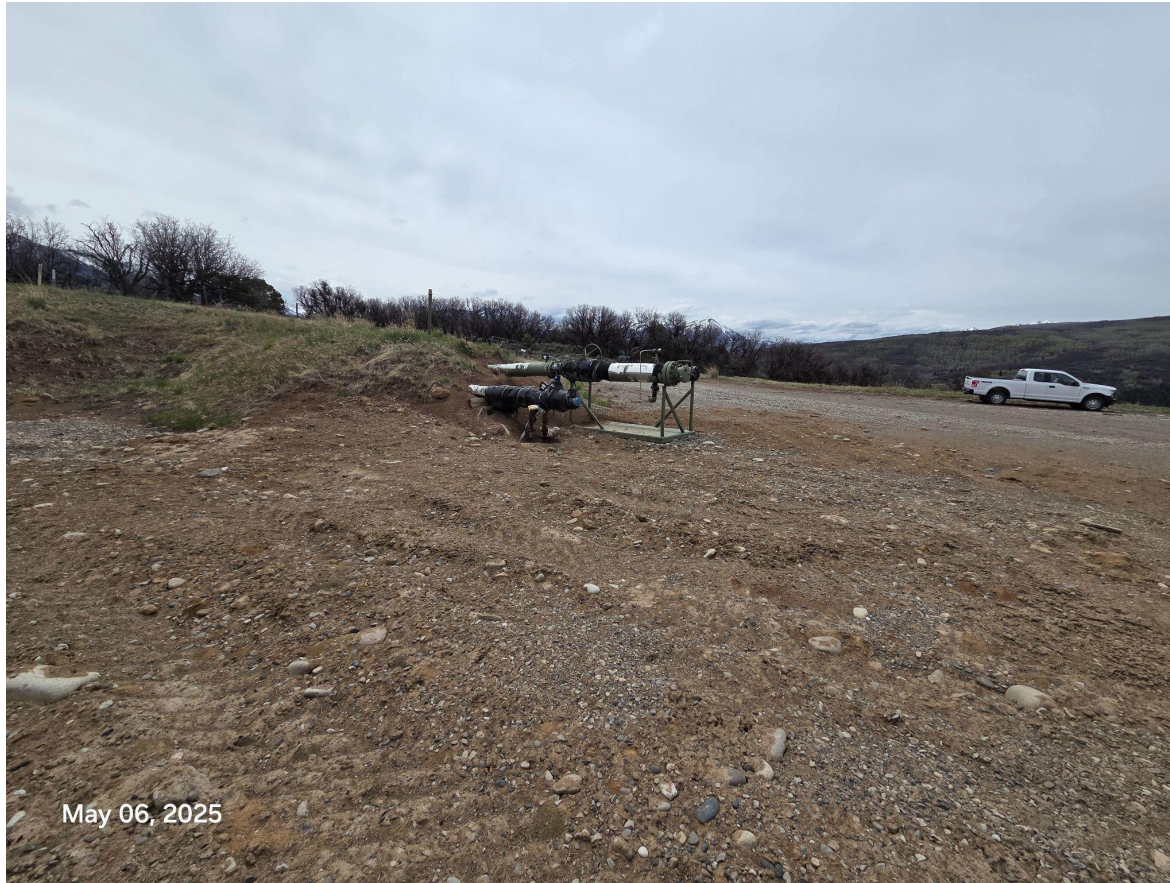
Photo 6: Photo taken from the west end of the Location, facing southwest. Photo shows surface equipment (pipe) has not been removed from the Location.
