Inspection Photos

Operator: GUNNISON ENERGY LLC - 10515

Location ID: 427218

Inspection Doc: 718100511

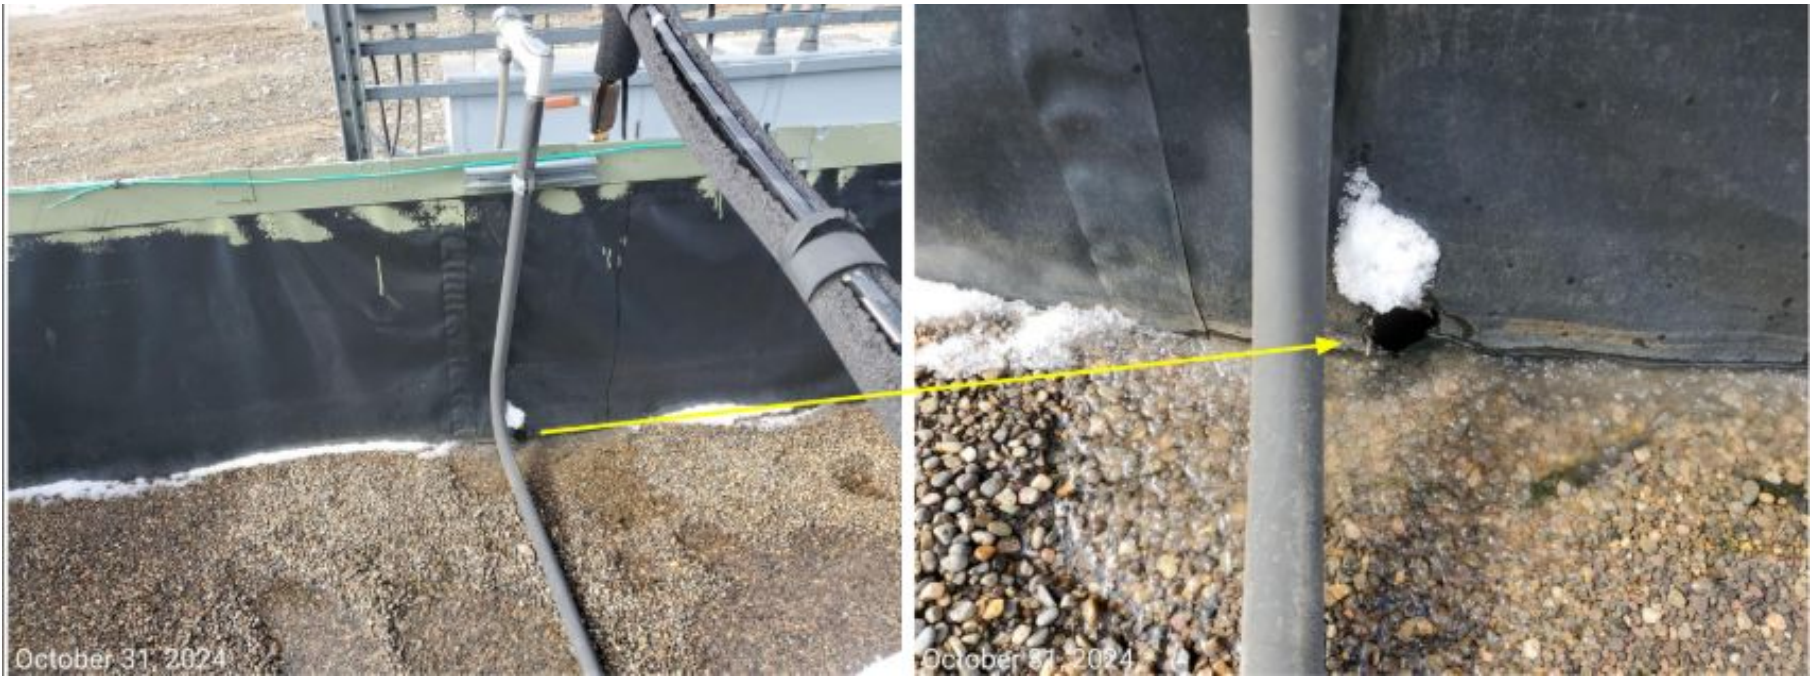
Photo 1: Photos taken from the 10/31/2024 inspection. Photos show hole within liner at the tank battery facility documented over multiple inspections.

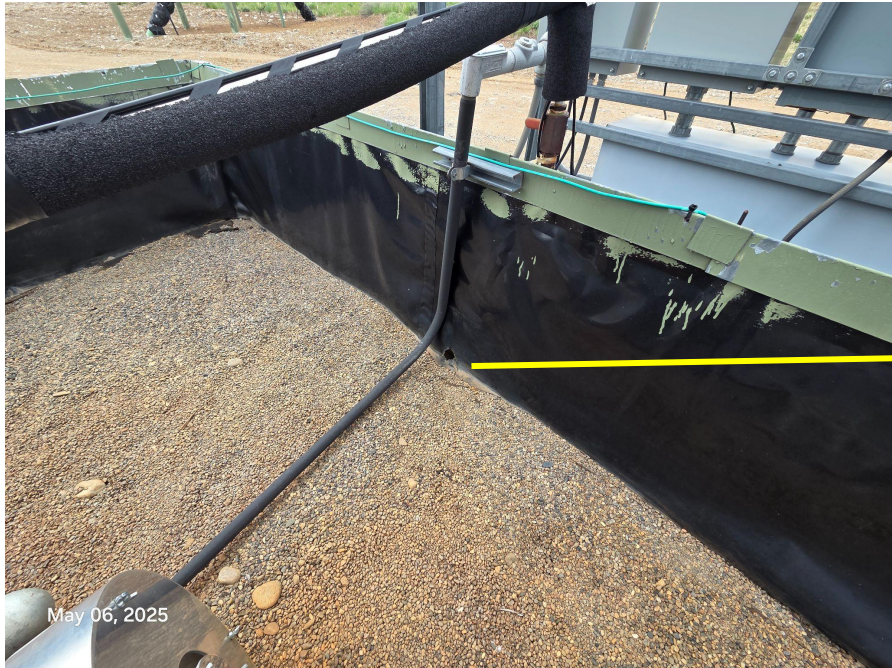
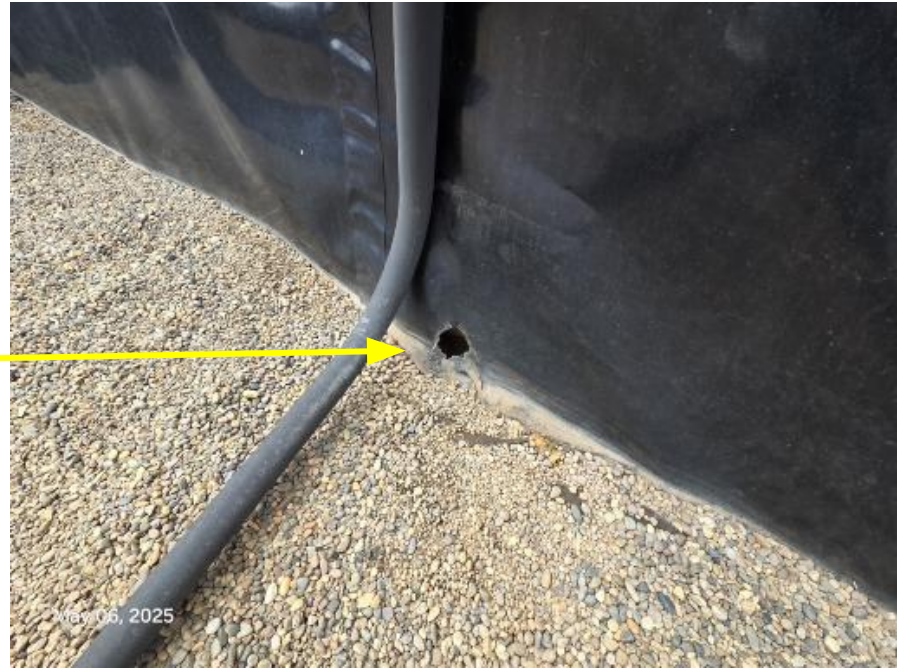
Photo 2: Continued from photo 1. Photos dated 5/6/2025. Photos show hole within liner at the tank battery facility has not been repaired; work to ensure that secondary containment remains impervious to contain a spill or release has not been performed, or has been insufficient.

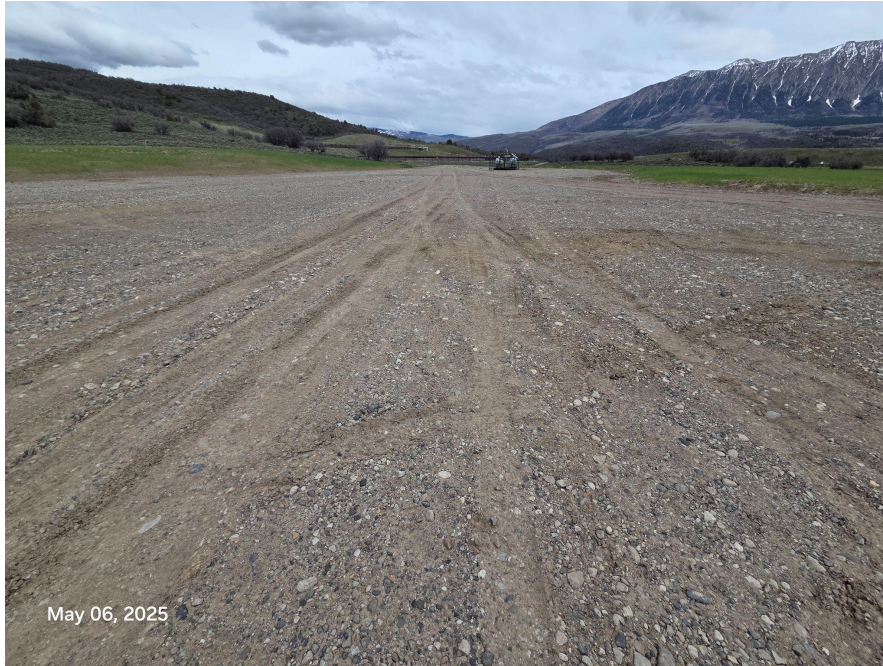
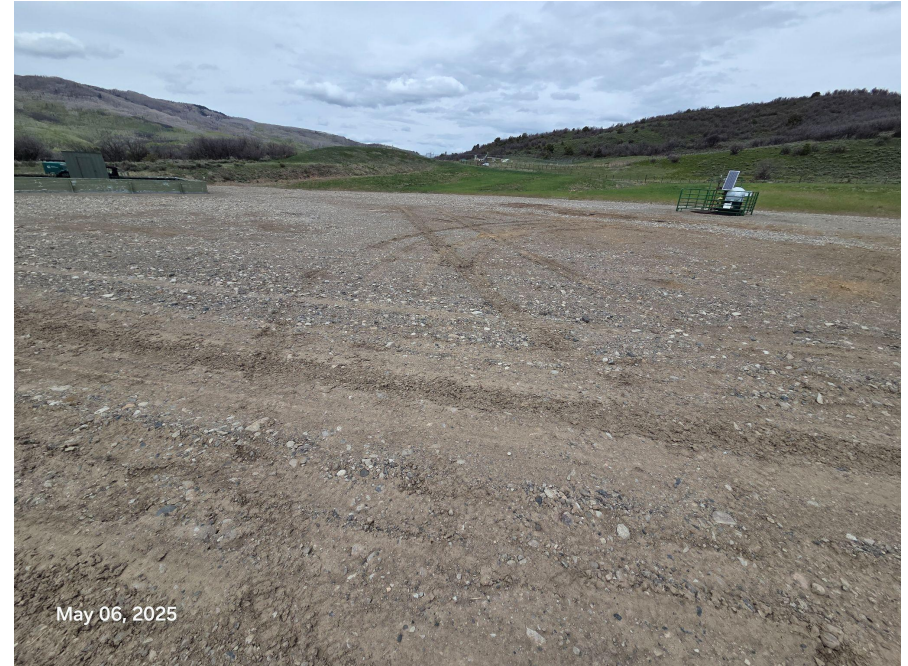
Photo 3: BMPs (Gravel/Compaction) to stabilize the working pad surface, and to minimize vehicle tracking/sediment transport is sparse and showing signs of disrepair; tracking/degradation becoming apparent. Maintenance advised.

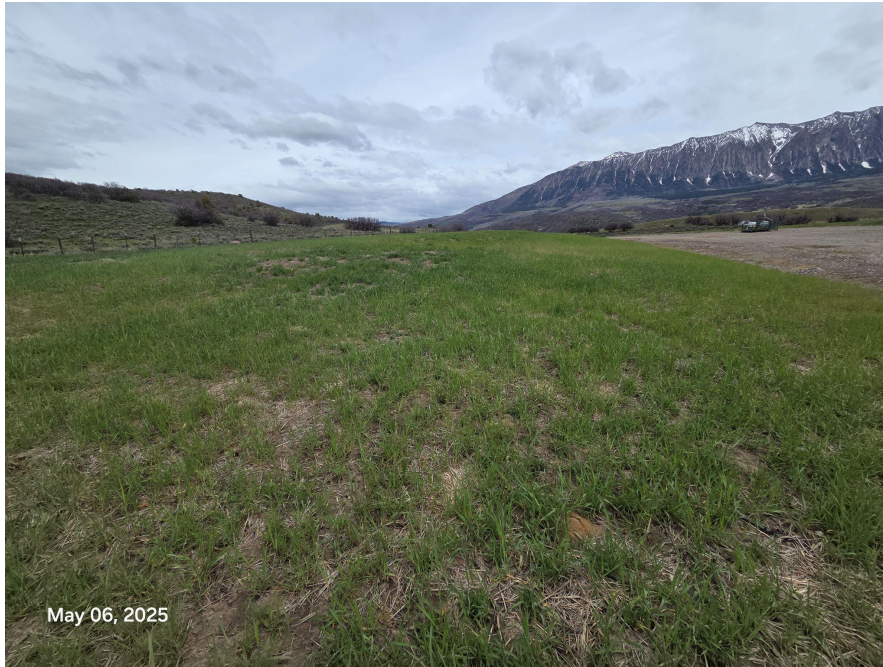
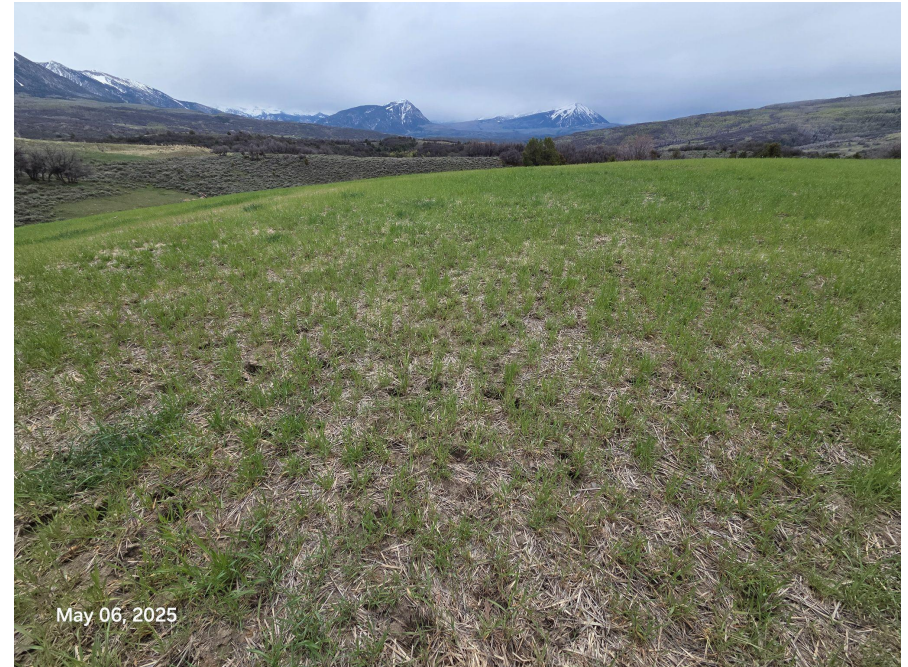
Photo 4: Photos taken from the interim areas. Perennial vegetation over the interim areas appears to be progressing towards a uniform standard. However, it is noted that the species establishing appears to be a Brome-grass monoculture (such as smooth brome), and is not reflective of the vegetation observed within the adjacent reference areas

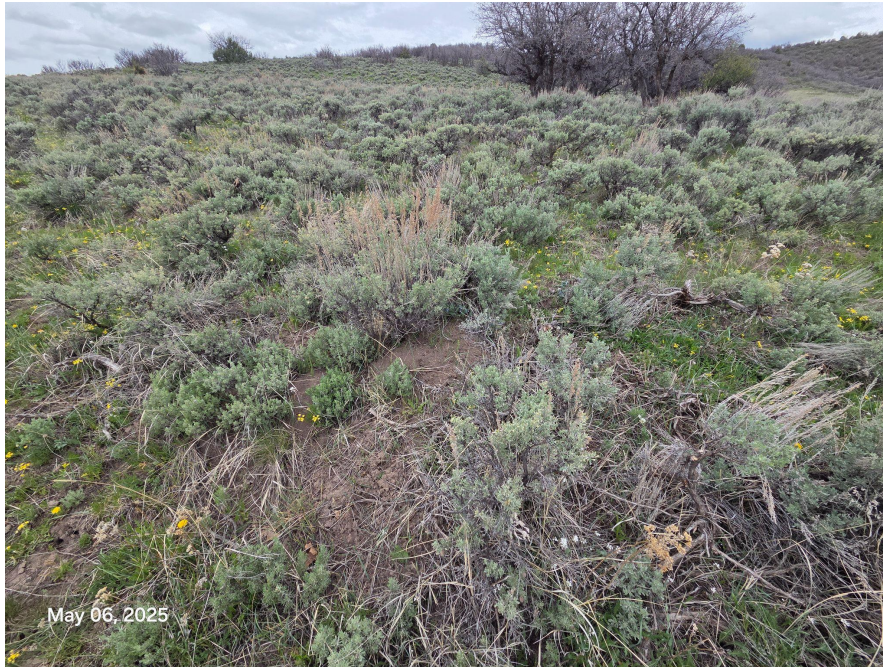
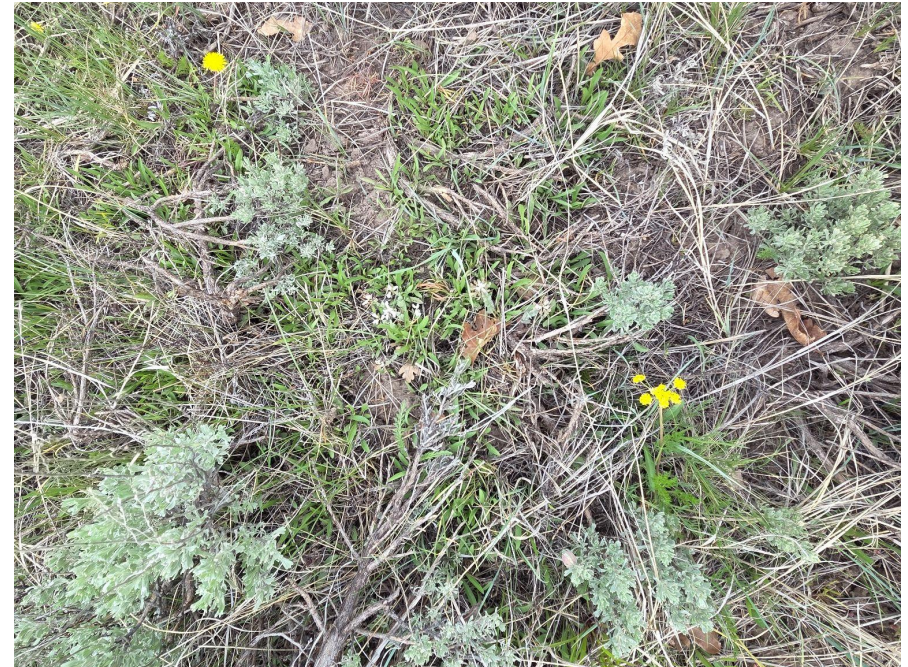
Photo 5: Photos taken from the adjacent reference areas for comparison; vegetation observed within the adjacent reference areas consist of species including *Artemisia tridentata*, *Pascopyrum smithii*, and various *Astragalus*, *Oxytropis* and *Brassicaceae* species.
