# Inspection Photos

API: 017-06678

Operator: **DECLAR OIL & GAS INC**

Inspection Date: 5/13/2025

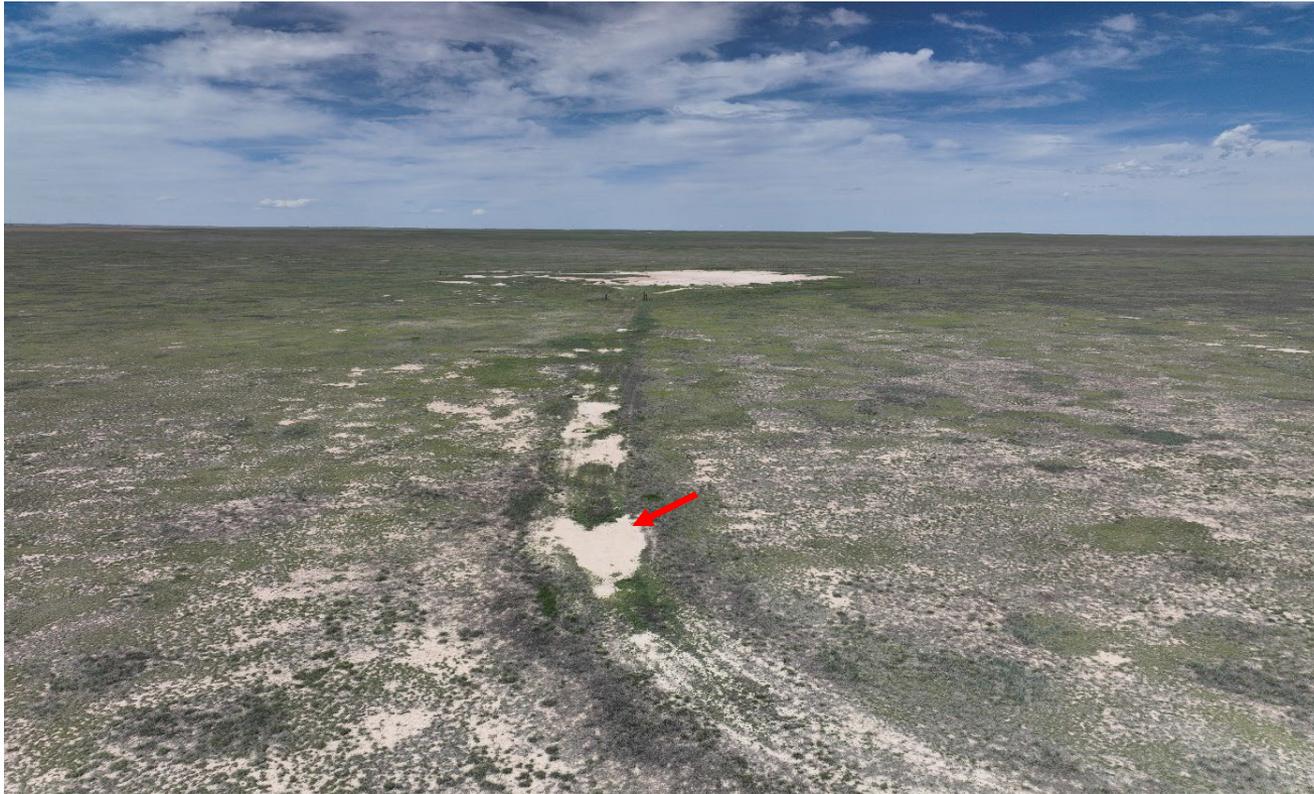
**Photo 1.** Drone aerial photo facing north along the access road and toward the location. There are areas of the access road that have not established vegetation shown at red arrow.

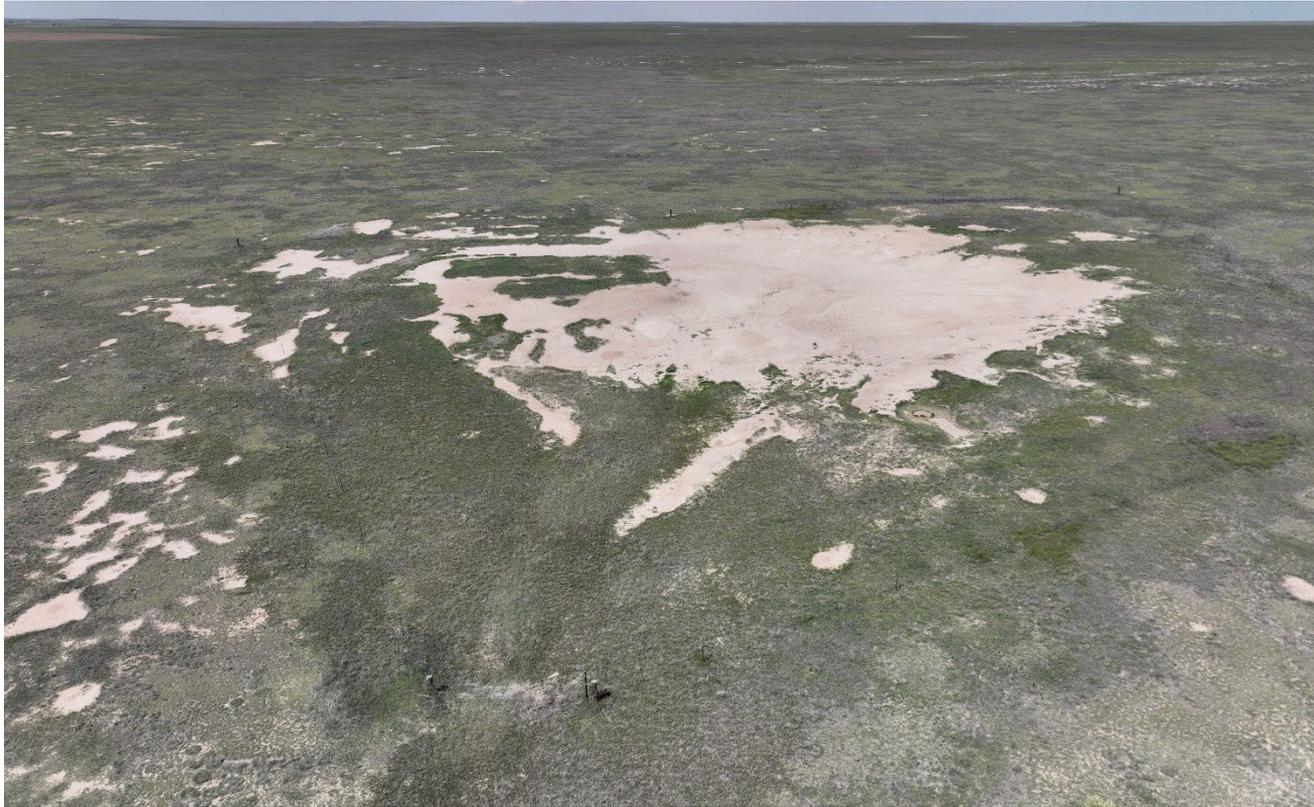
**Photo 2.** Drone aerial photo facing north downward toward the location. The location still remains fenced and most of the area is bare of vegetation inside the fenced area. .

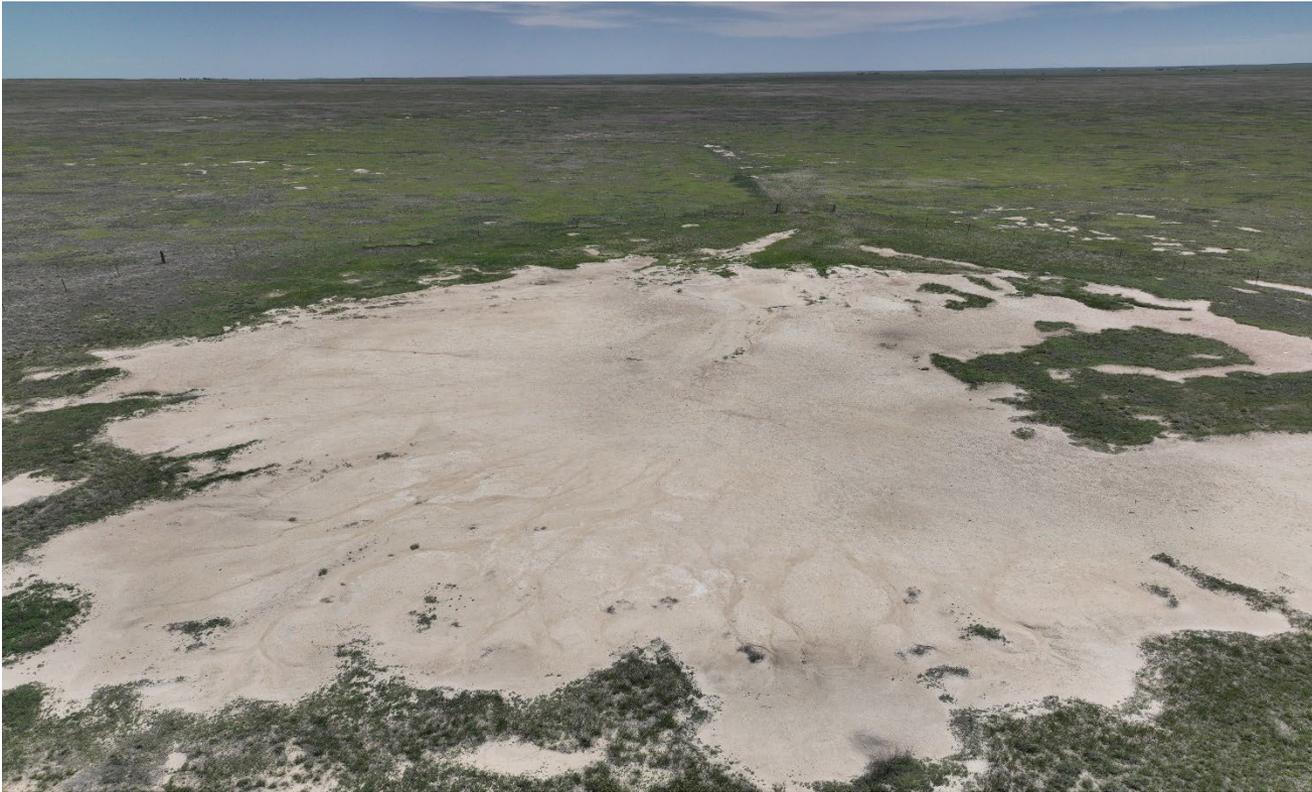
**Photo 3.** Drone aerial photo facing south. This bare soil area is approximately 250x250 feet. It appears soils are impacted preventing vegetation establishment.

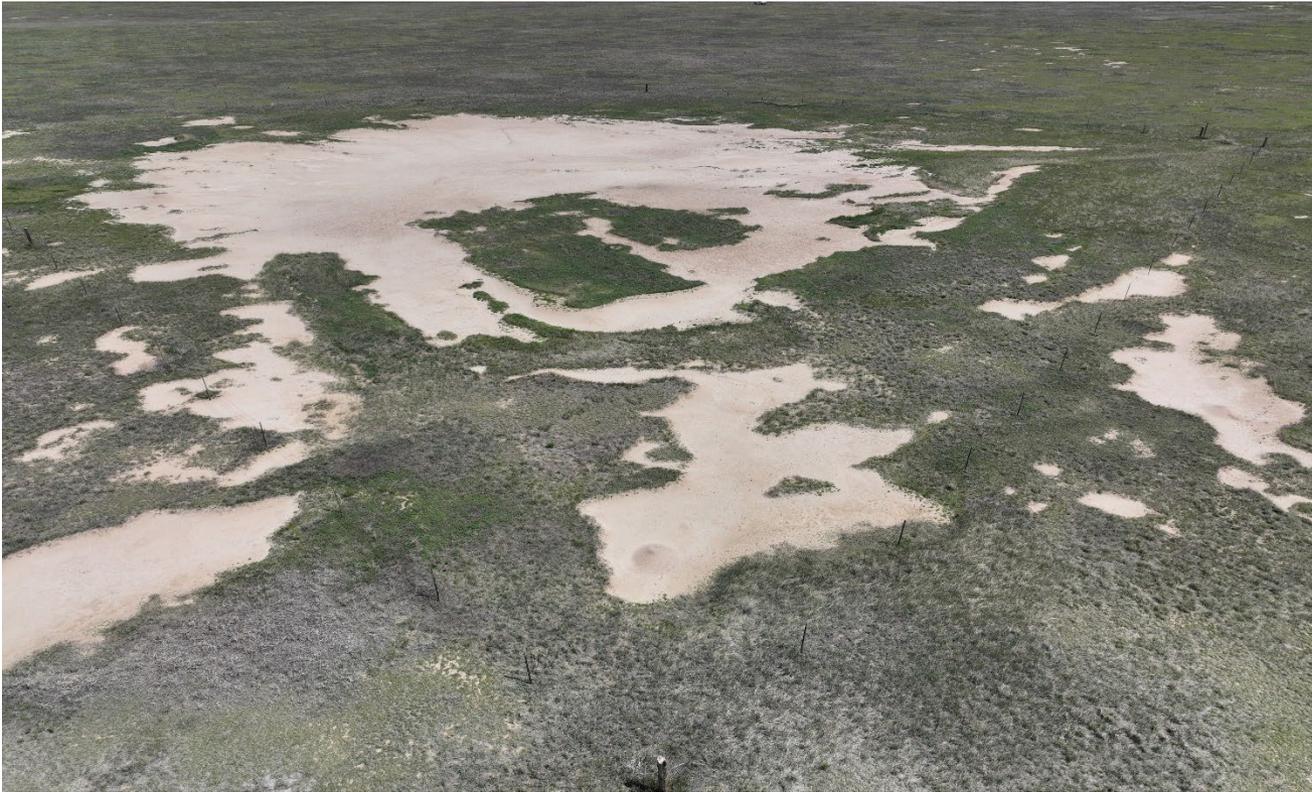
**Photo 4.** West side of the location facing east down toward the location. It appears soils are impacted preventing vegetation establishment.

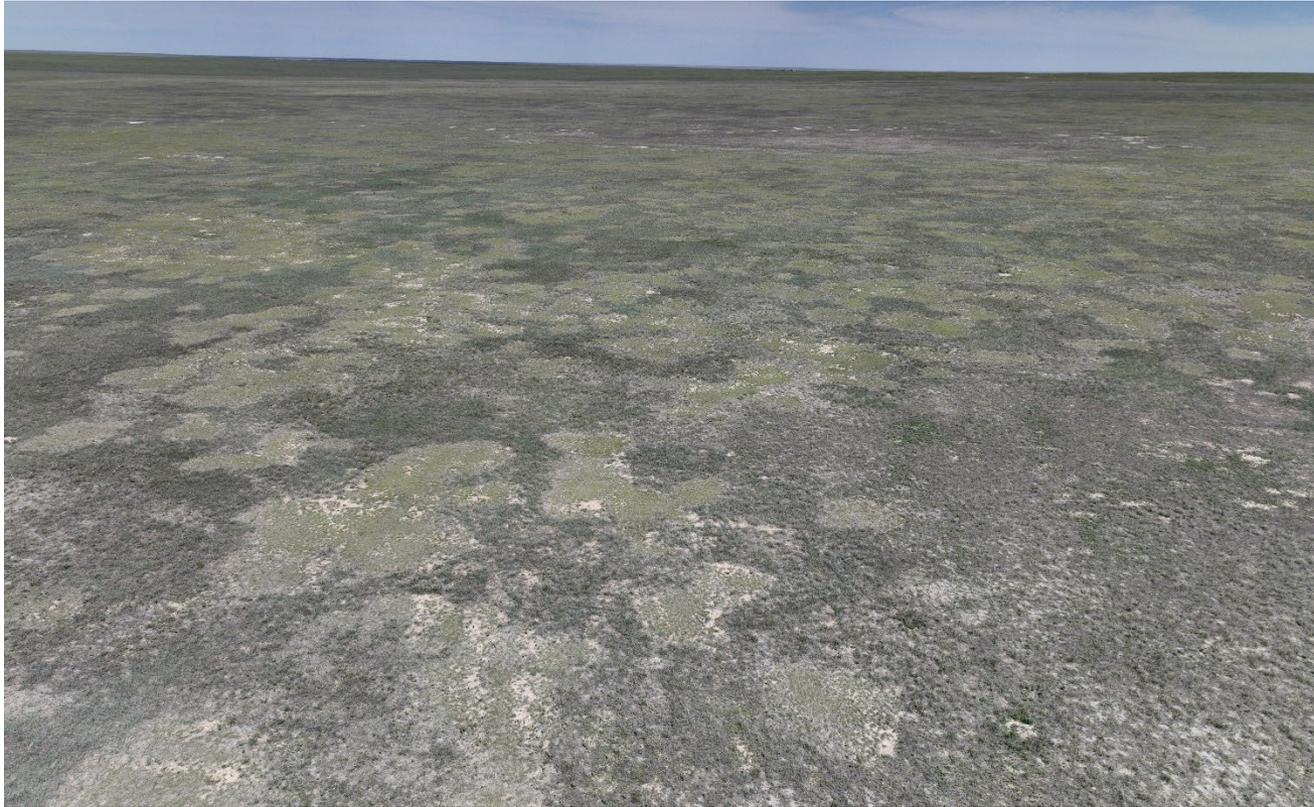
**Photo 5.** Facing northeast toward the surrounding reference area which consists of a uniform perennial vegetation cover.
