Final Reclamation Inspection

May 9, 2025

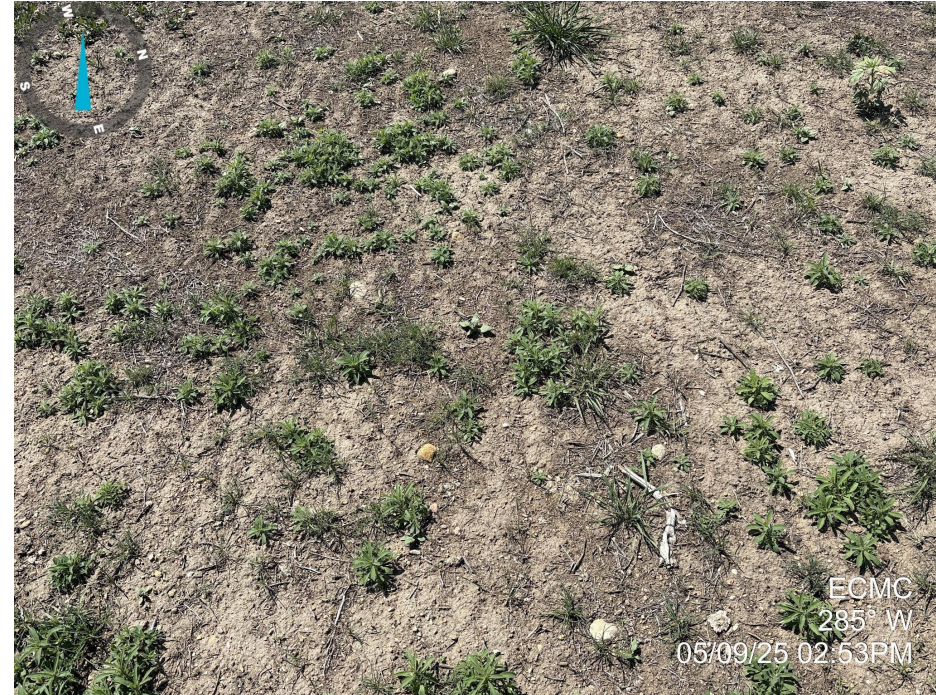
Photo 4. Photo taken of the tank battery location. Photo illustrates evidence of drill rows from seeding, but perennial vegetation has not established to reference area conditions per Rule 1004 standards.
