Final Reclamation Inspection

Operator: KERR MCGEE OIL & GAS ONSHORE LP - 47120

Location ID: 329974

Inspection Photos
Location Name: PSC #32-11
Location ID: 329974

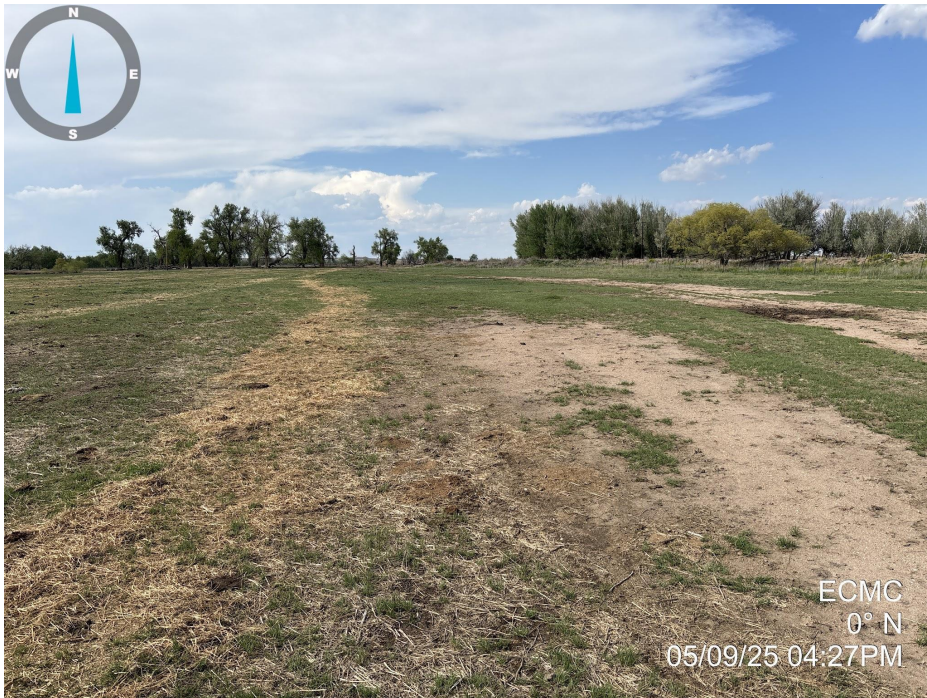
Photo 1. Photo taken from the well location, facing North. Photo illustrates that final reclamation activities have taken place, with evidence of seeding and straw mulch, but vegetation has not established to Rule 1004 standards.

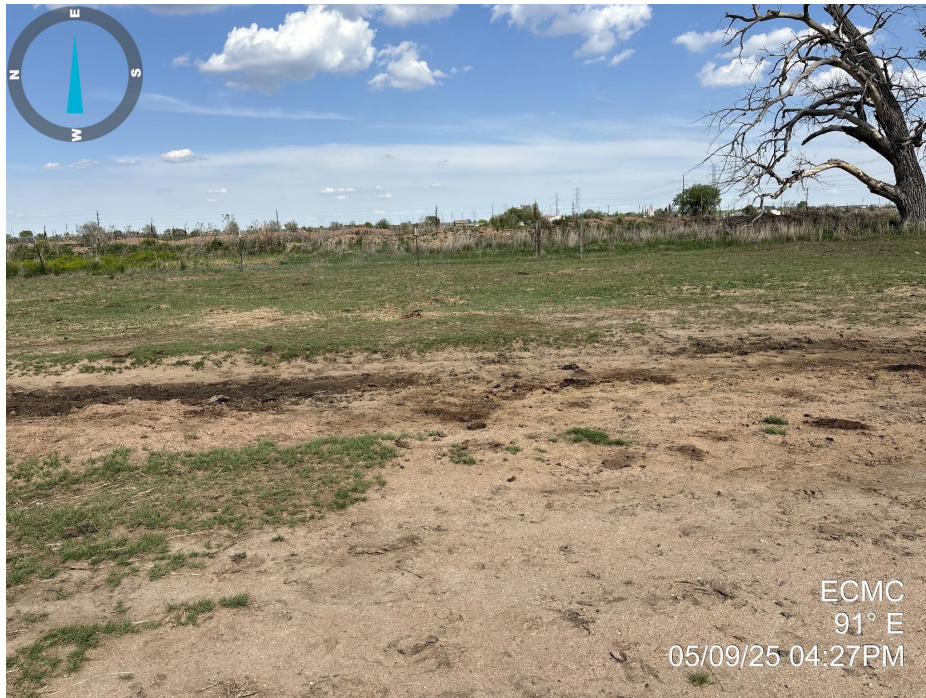
Photo 2. Photo taken from the well location, facing East. See comments under Photo 1. Photo illustrates that bare ground patches remain at the location.

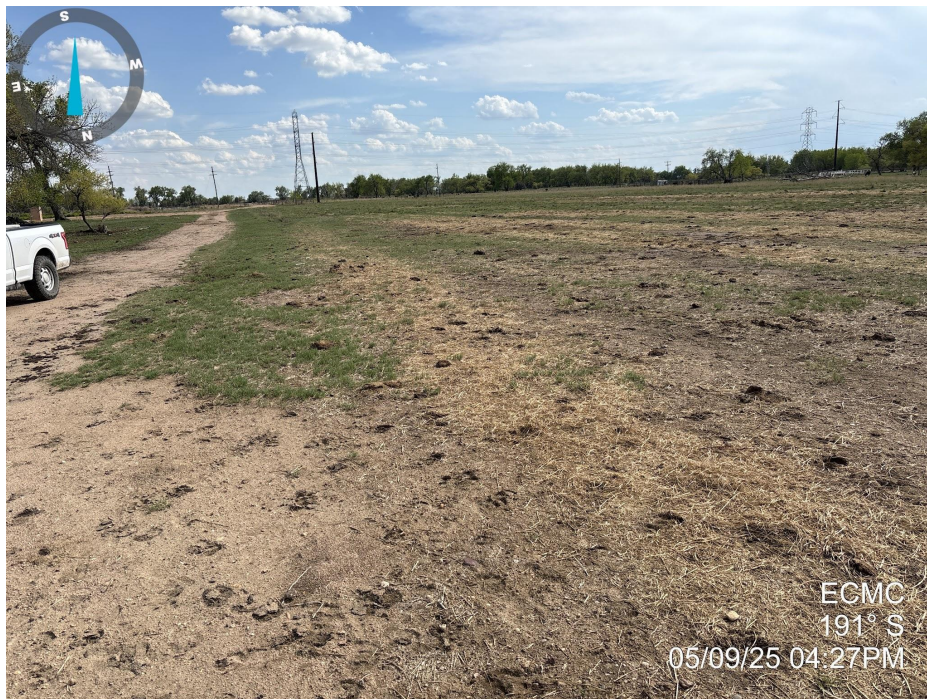
Photo 3. Photo taken from the well location, facing South. See comments under Photo 1.

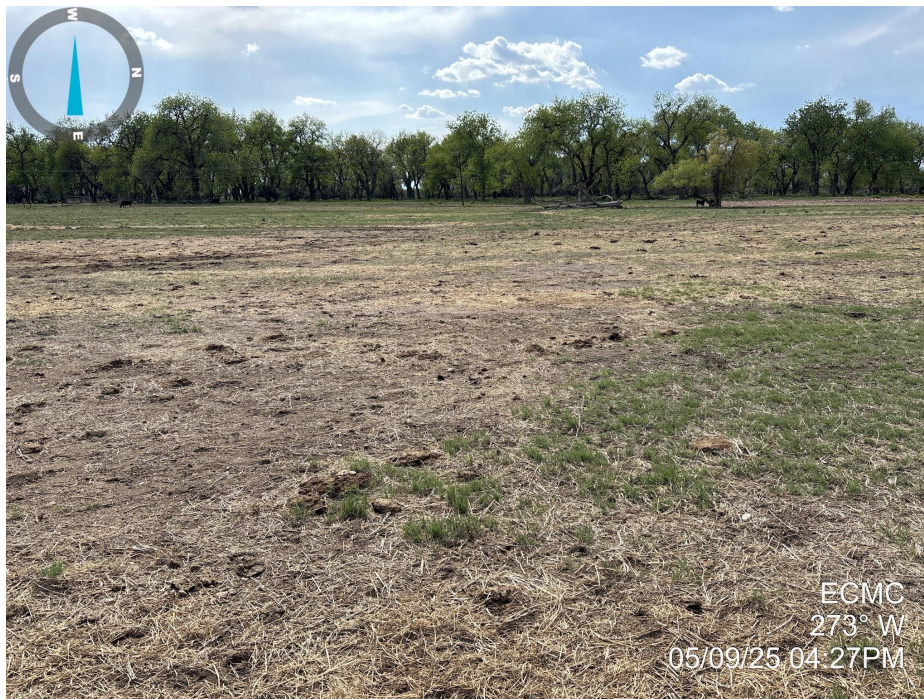
Photo 4. Photo taken from the well location, facing West. See comments under Photo 1.

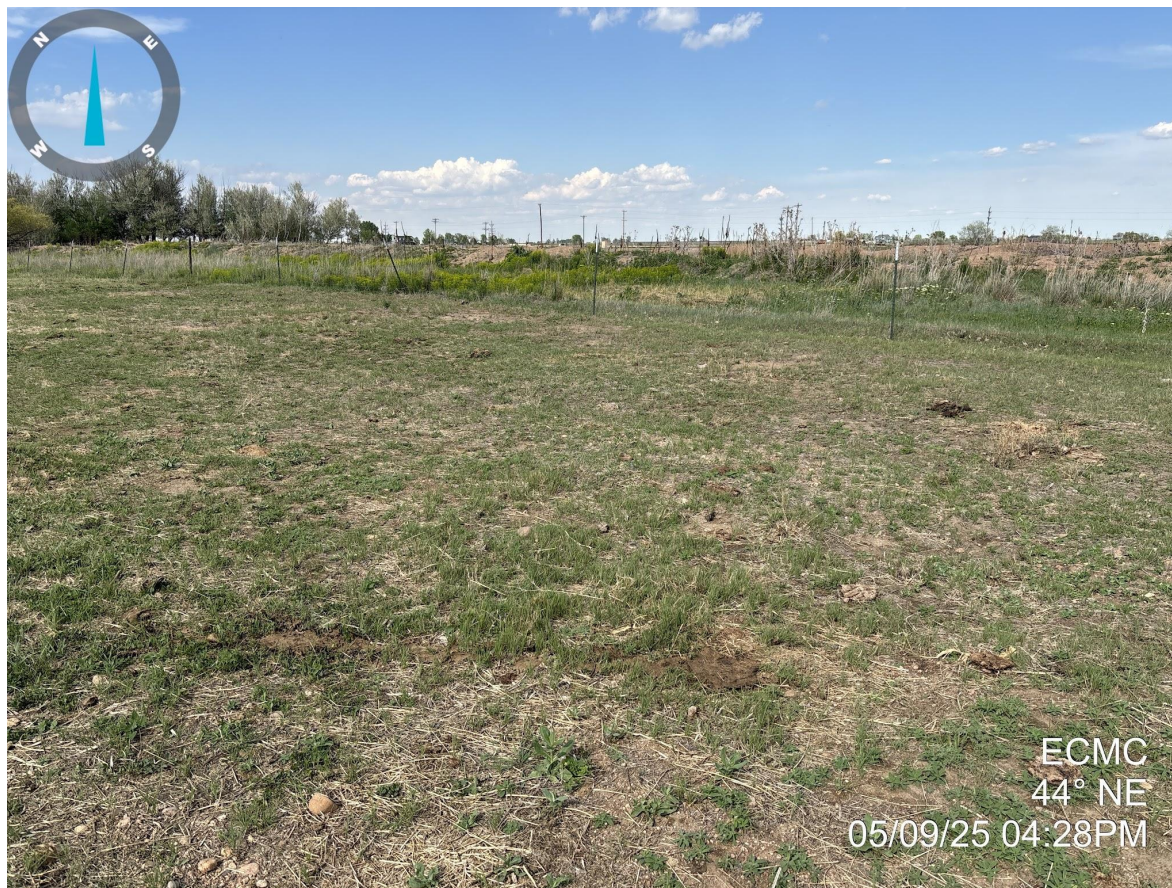
Photo 5. Photo taken of the reference area, east of the well site, facing Northeast. Photo illustrates perennial grass vegetation with evidence of disturbance from grazing.
