# Inspection Photos

Operator: BMG Drilling - 7650

Location ID: 325388

Location Name: La Posta Canyon 4

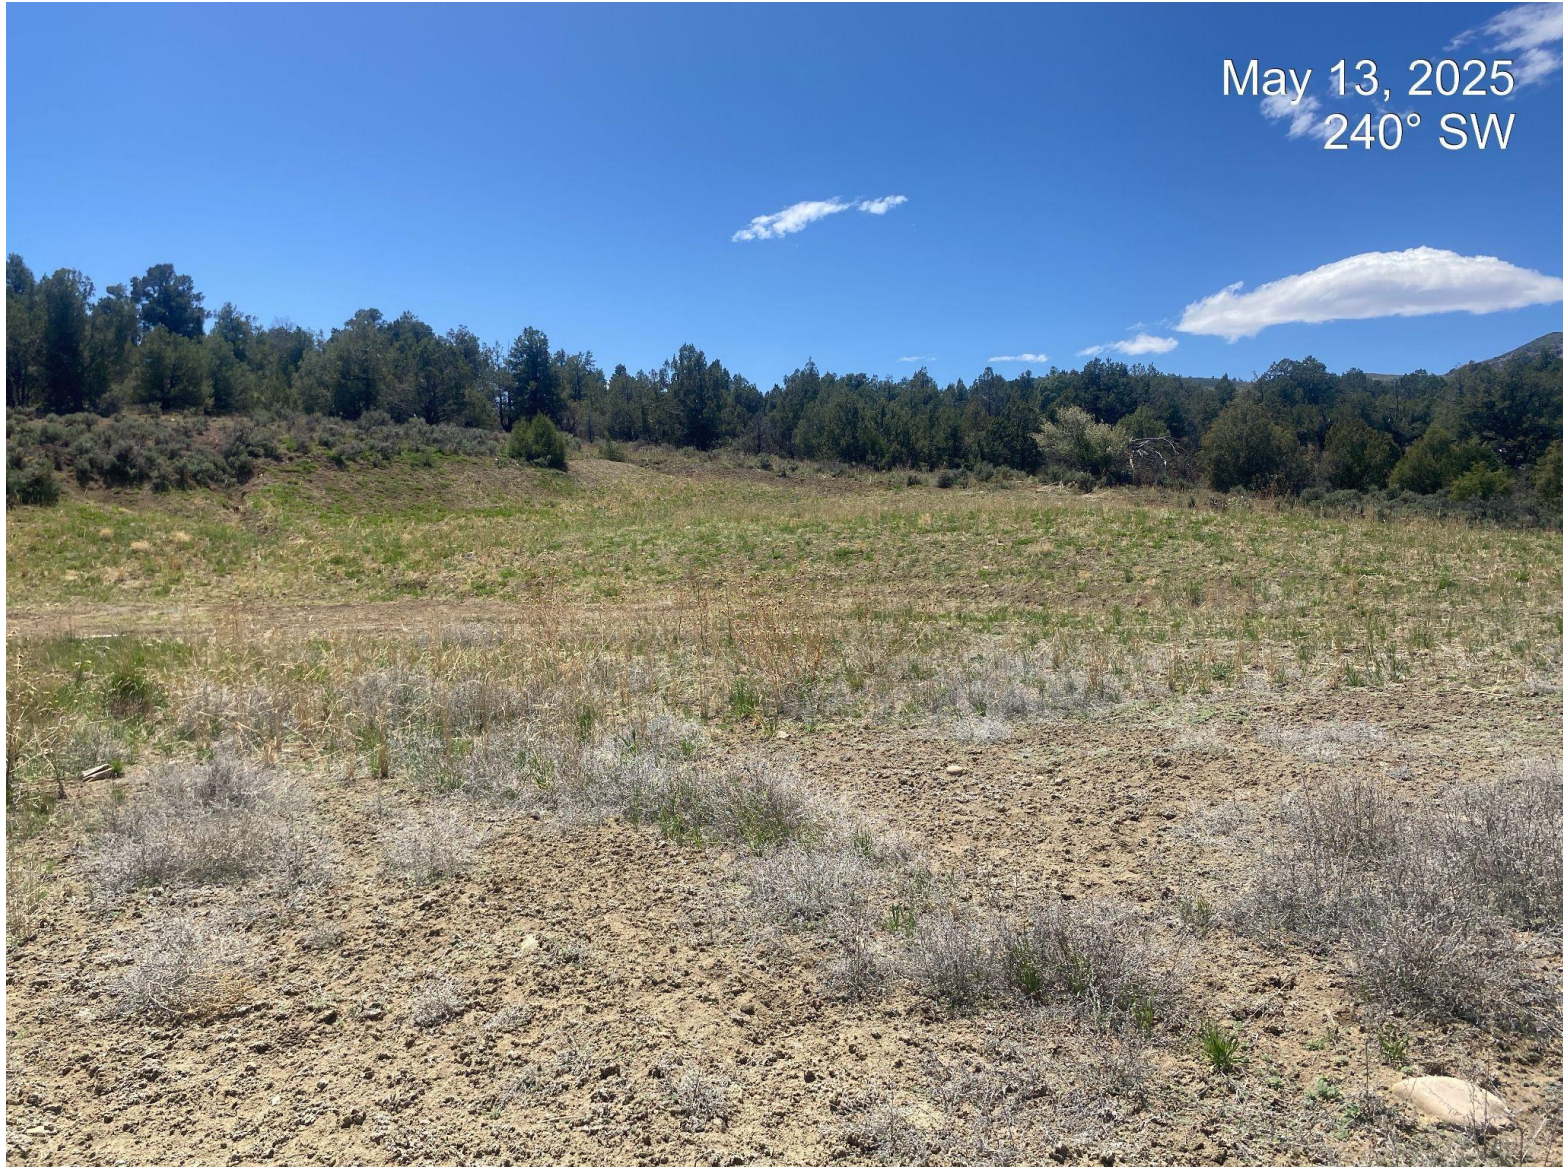
**Photo 1.** View of the project area taken from the northern edge facing center.

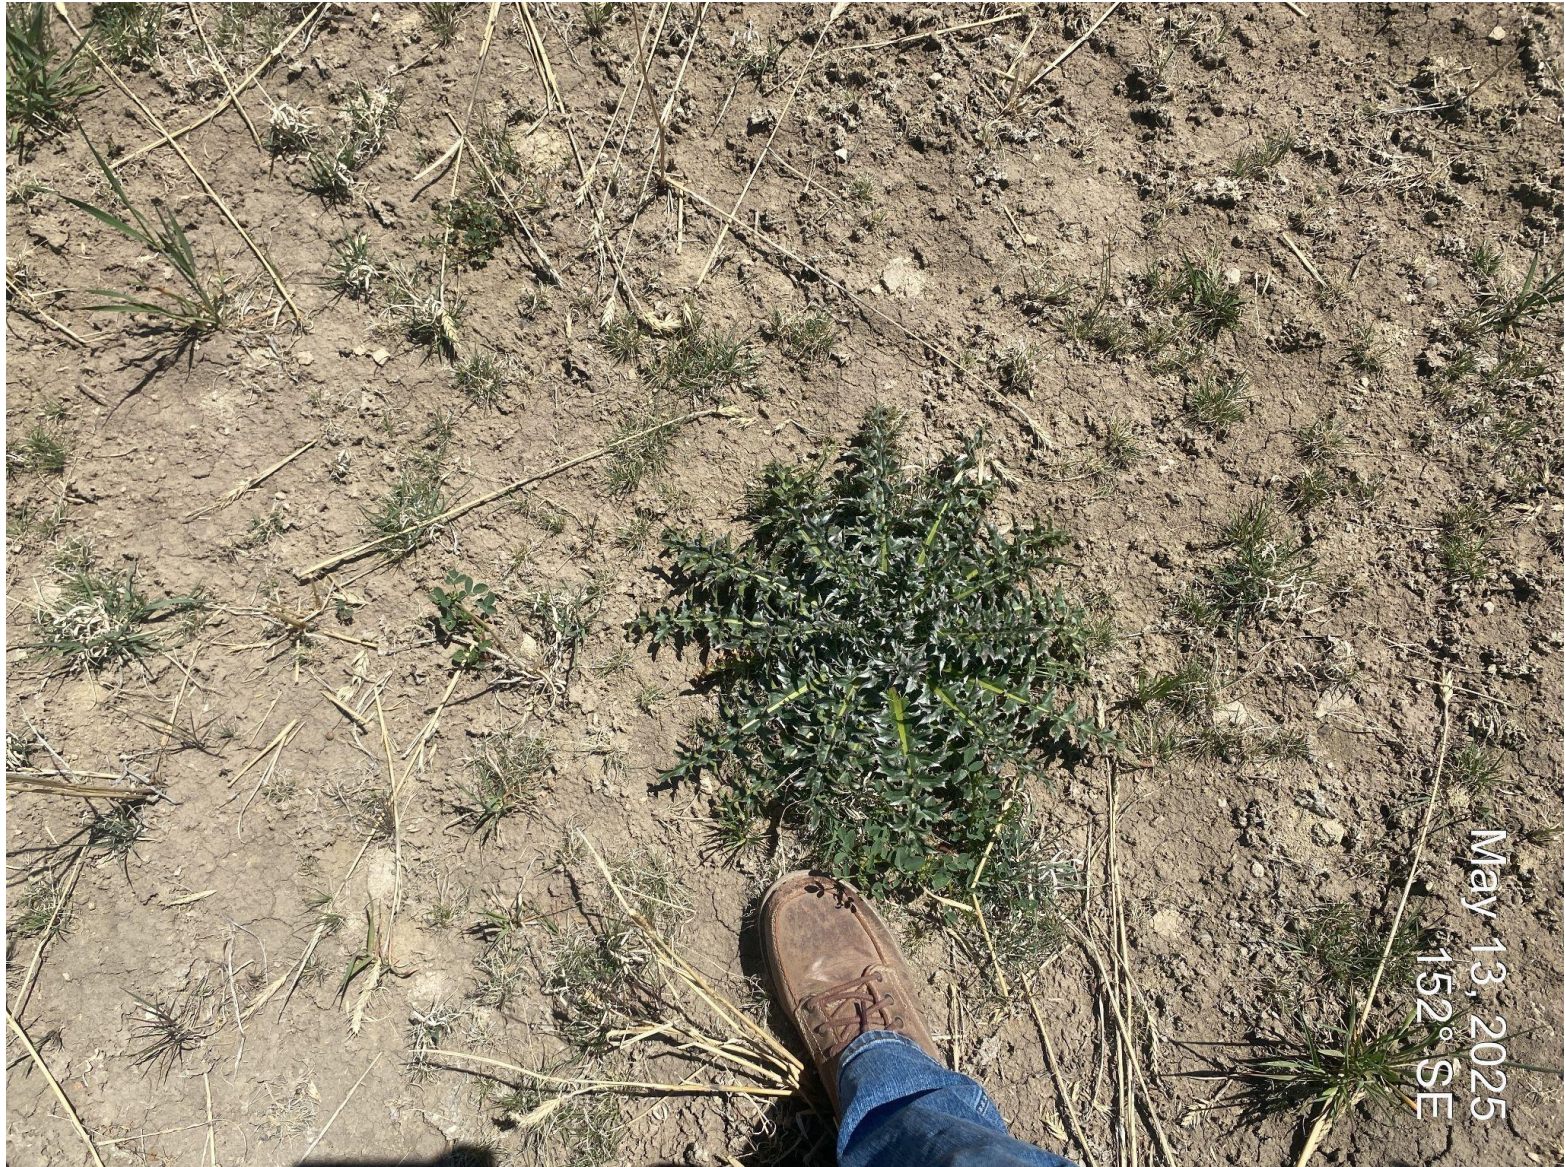
**Photo 2.** Musk thistle observed on location.

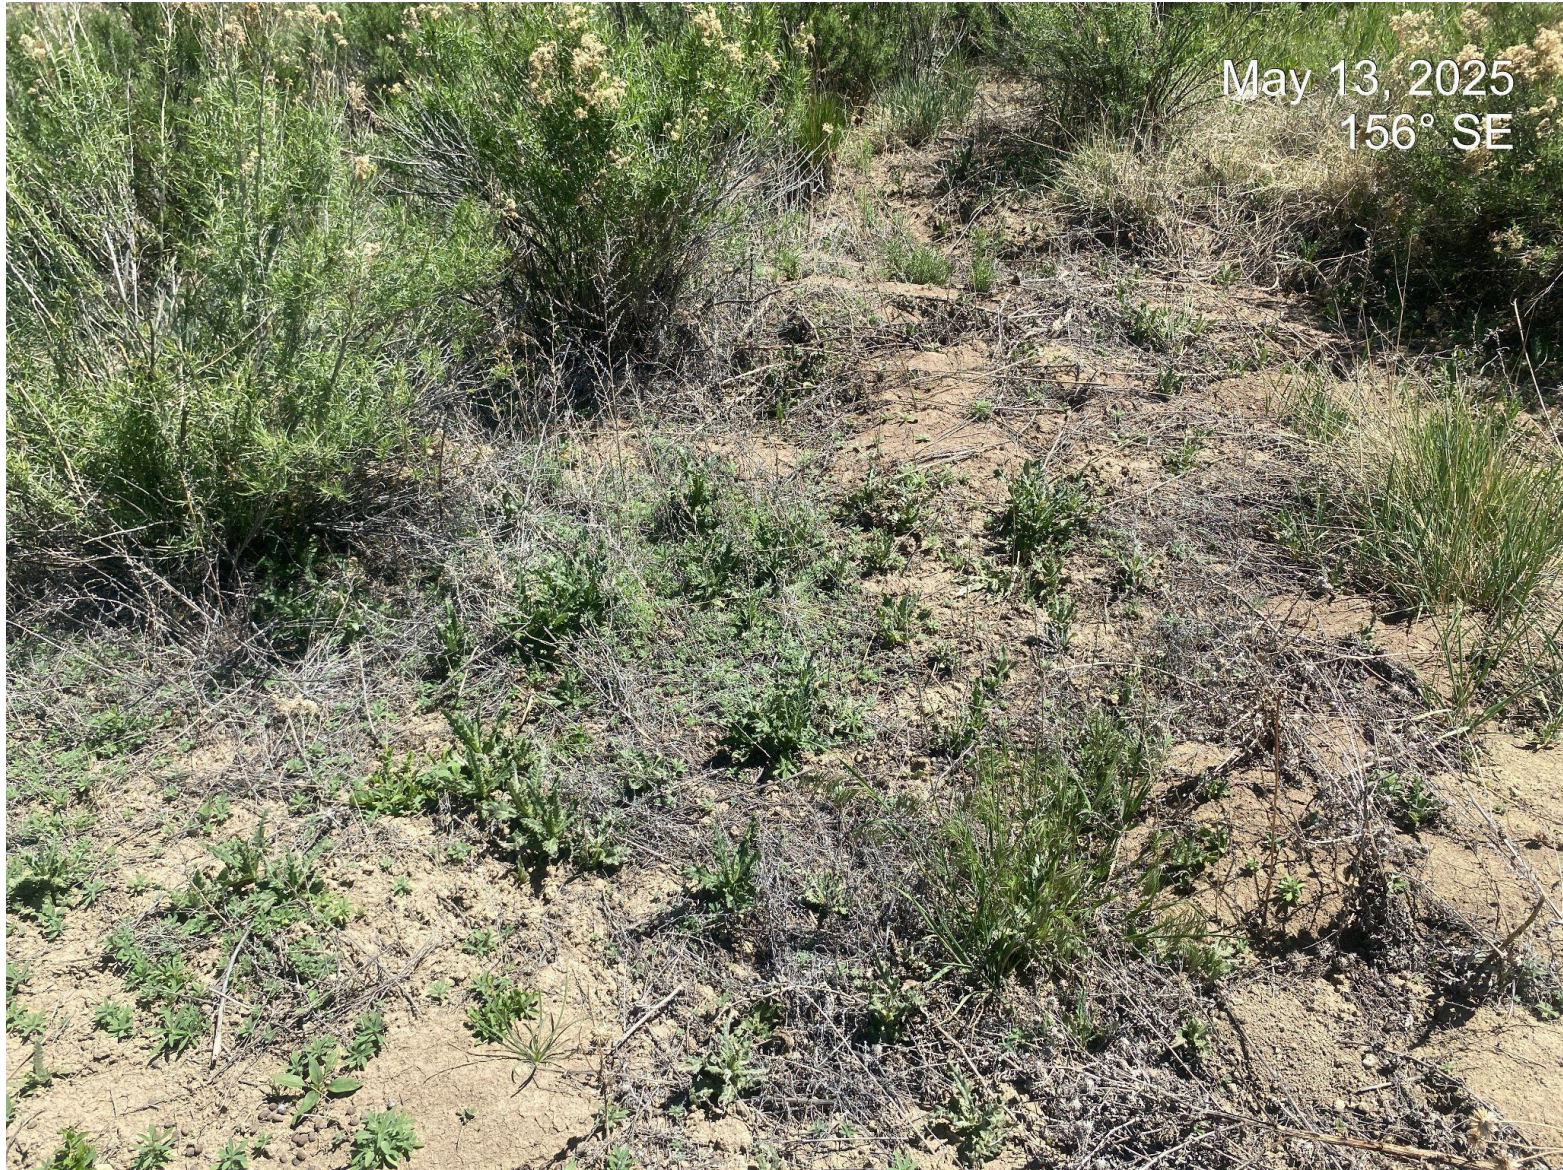
**Photo 3.** Patch of Canada Thistle observed on location.

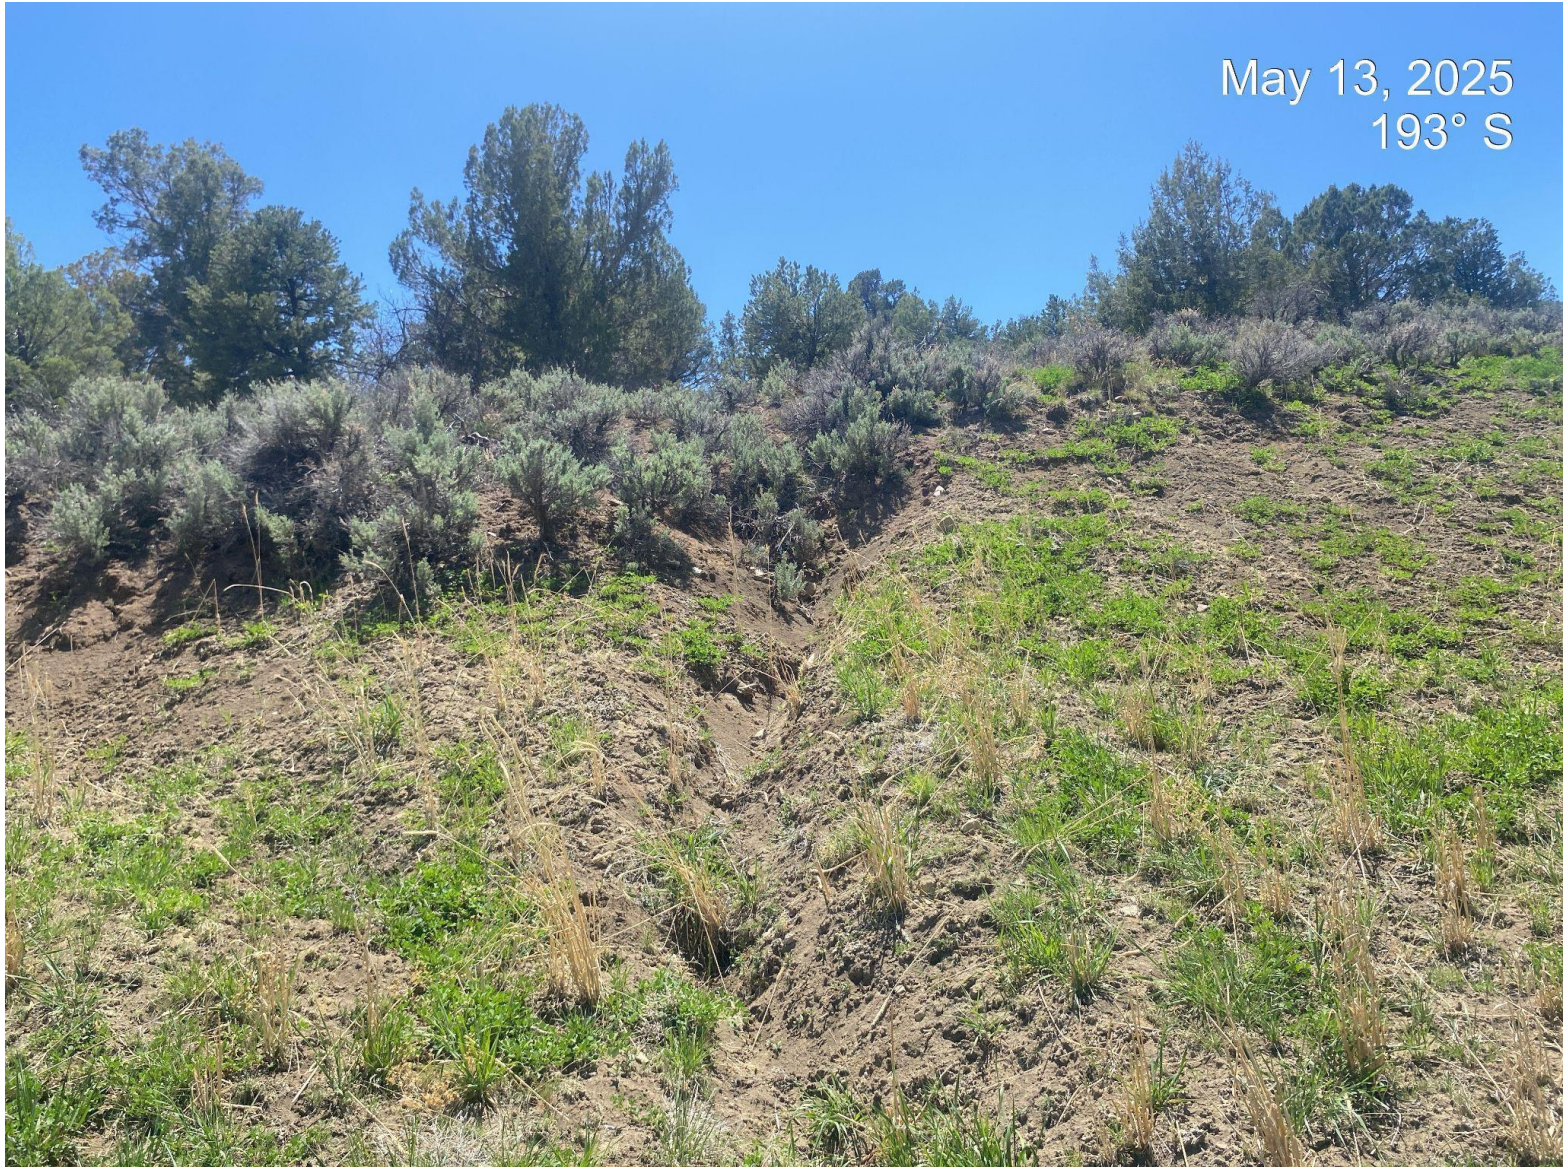
**Photo 4.** Gully erosion persists on the southern edge of the project area. Sediment transport and deposition occurring and impacting establishment of vegetation in the central portion of the project area (see photo 5).

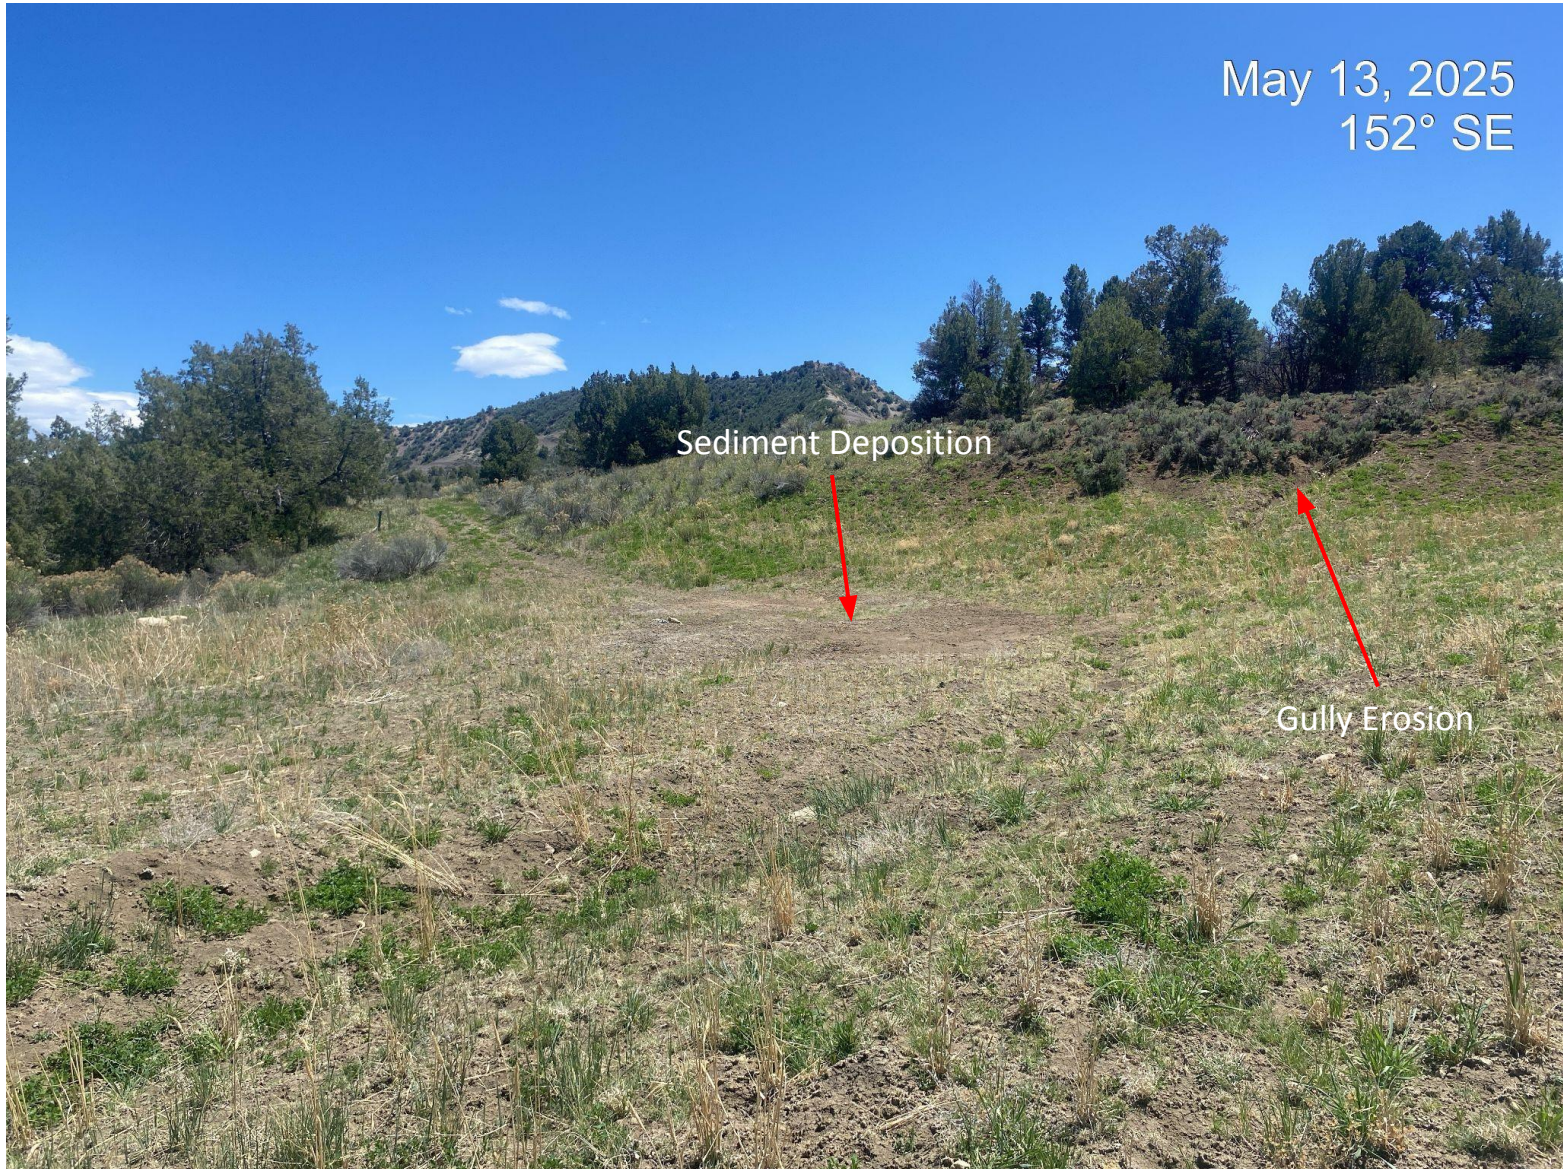
**Photo 5.** Sediment deposition occurring in the central portion of the project area. Stormwater BMPs are needed at gully erosion.

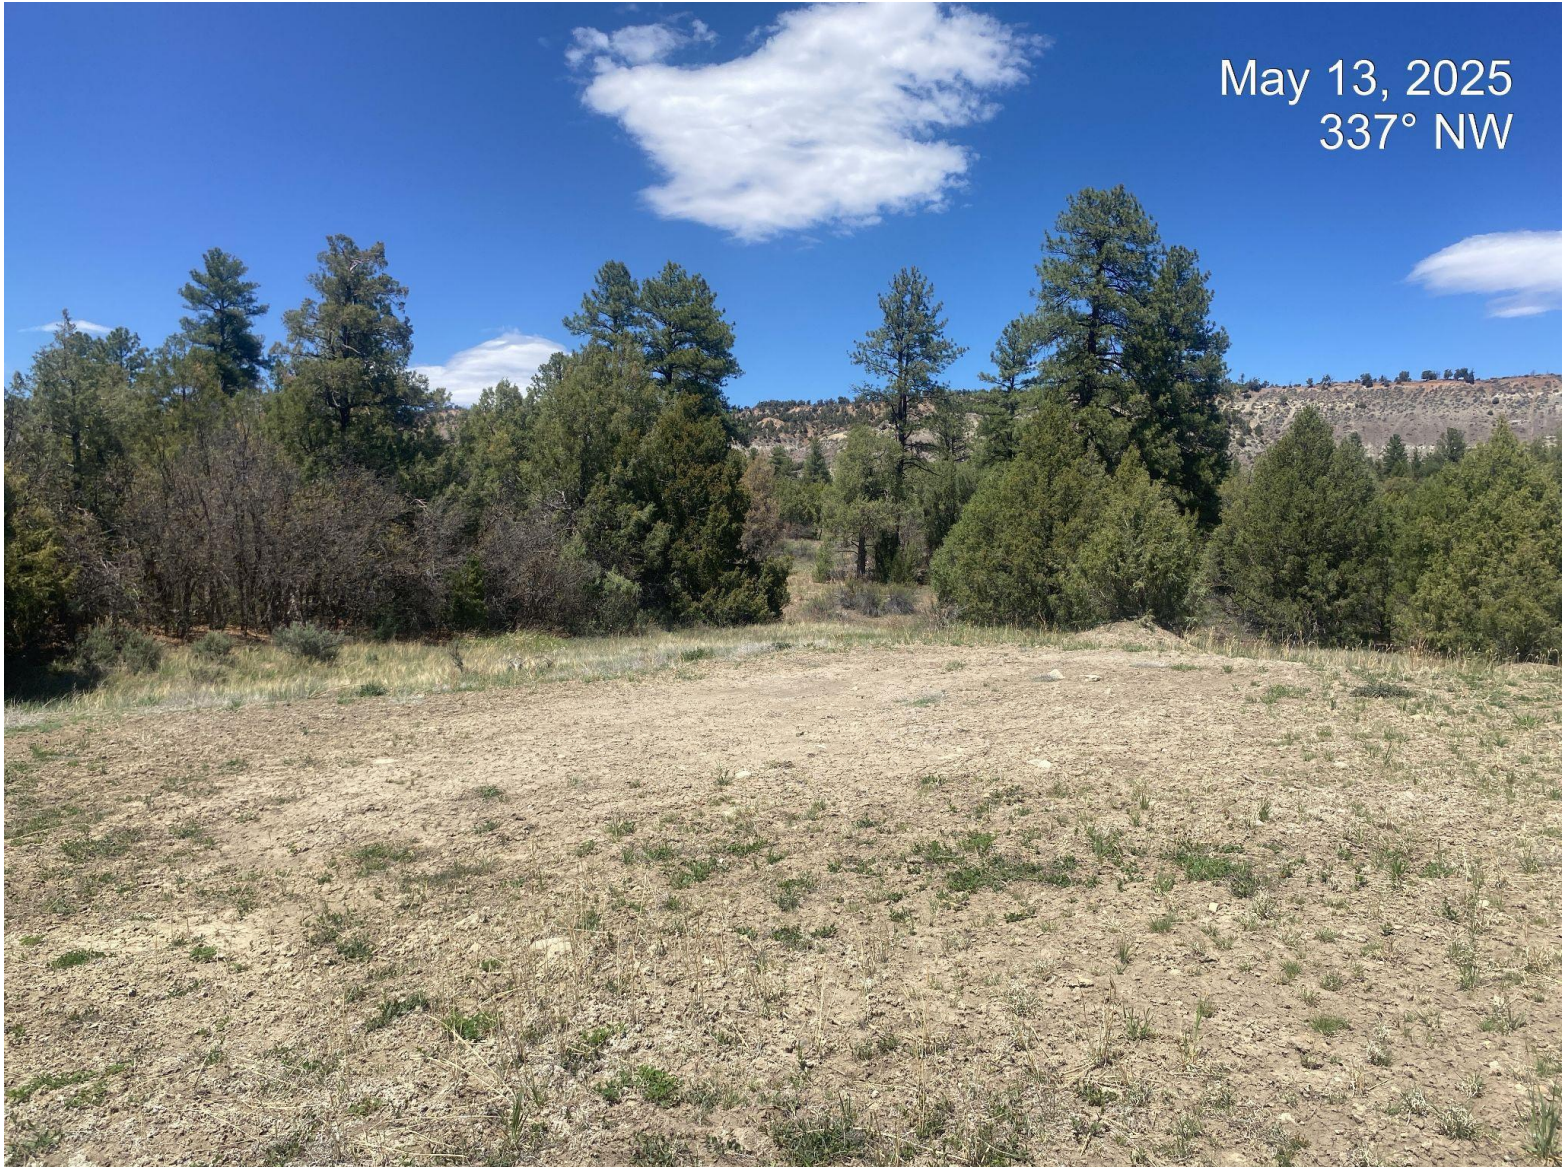
**Photo 6.** Northwest corner of the project area where vegetation is not progressing to 1004 standards. Additional seeding efforts are needed in this area.

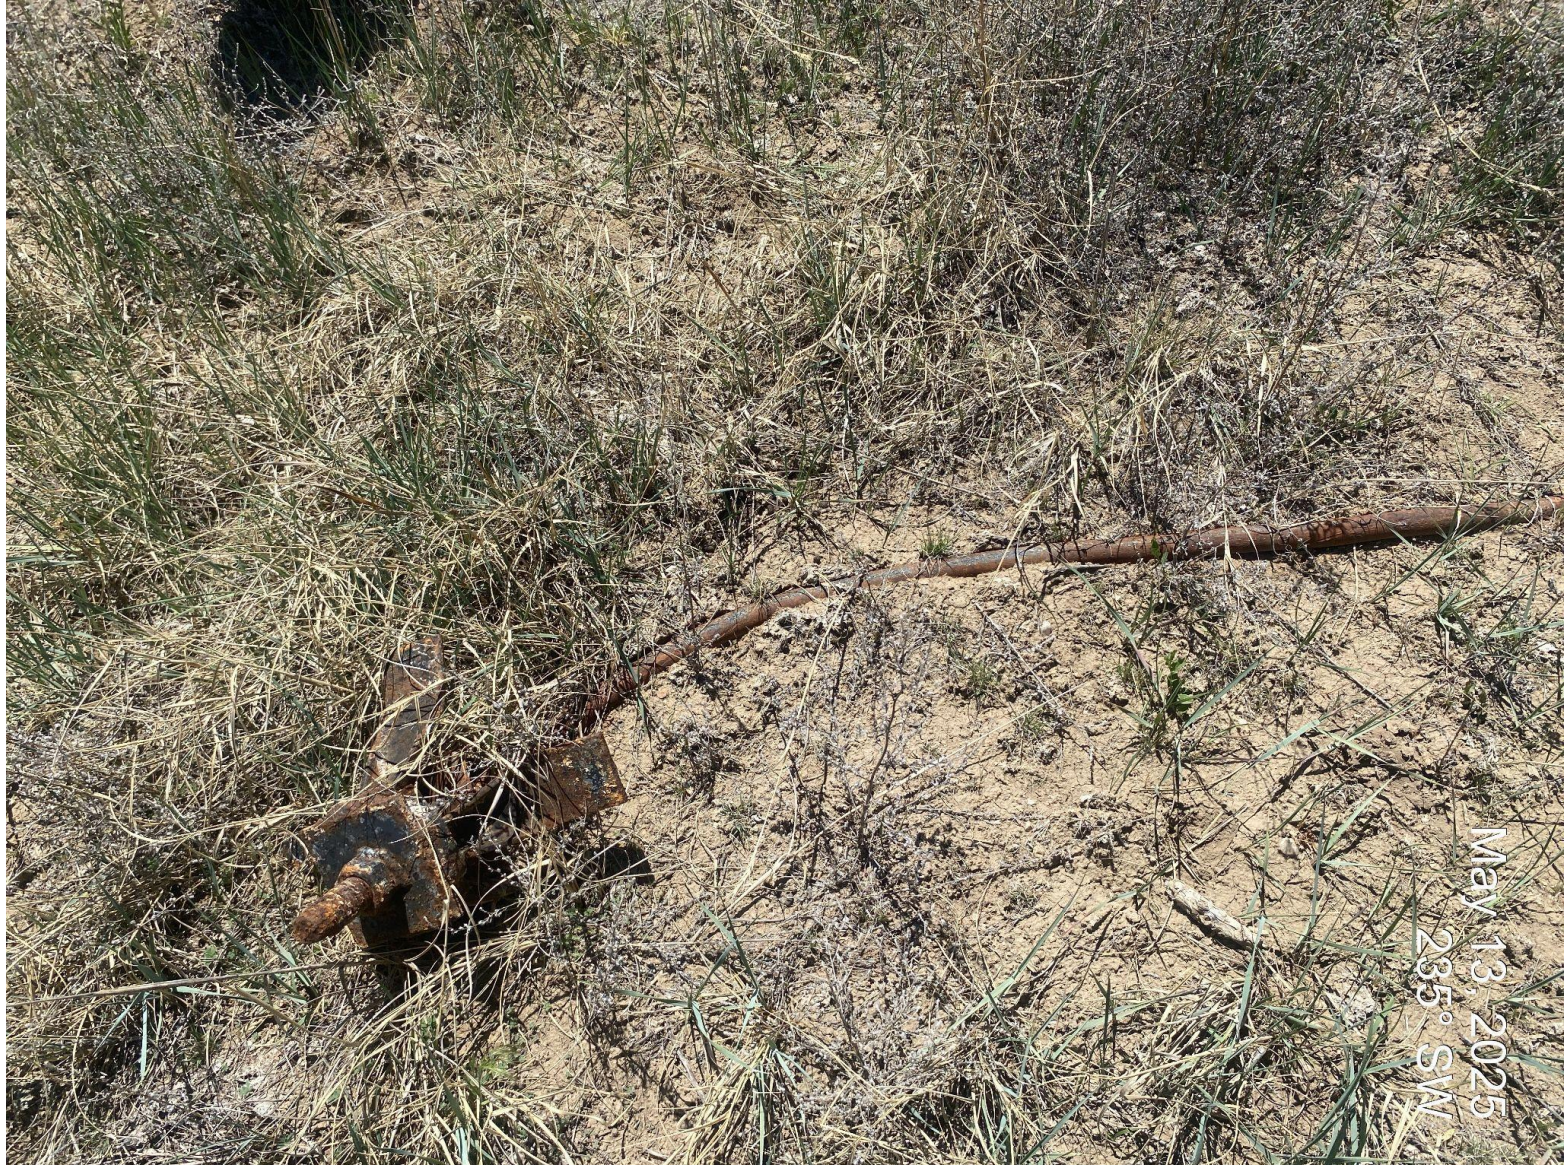
**Photo 7.** View of old anchor and cable that remains on location.

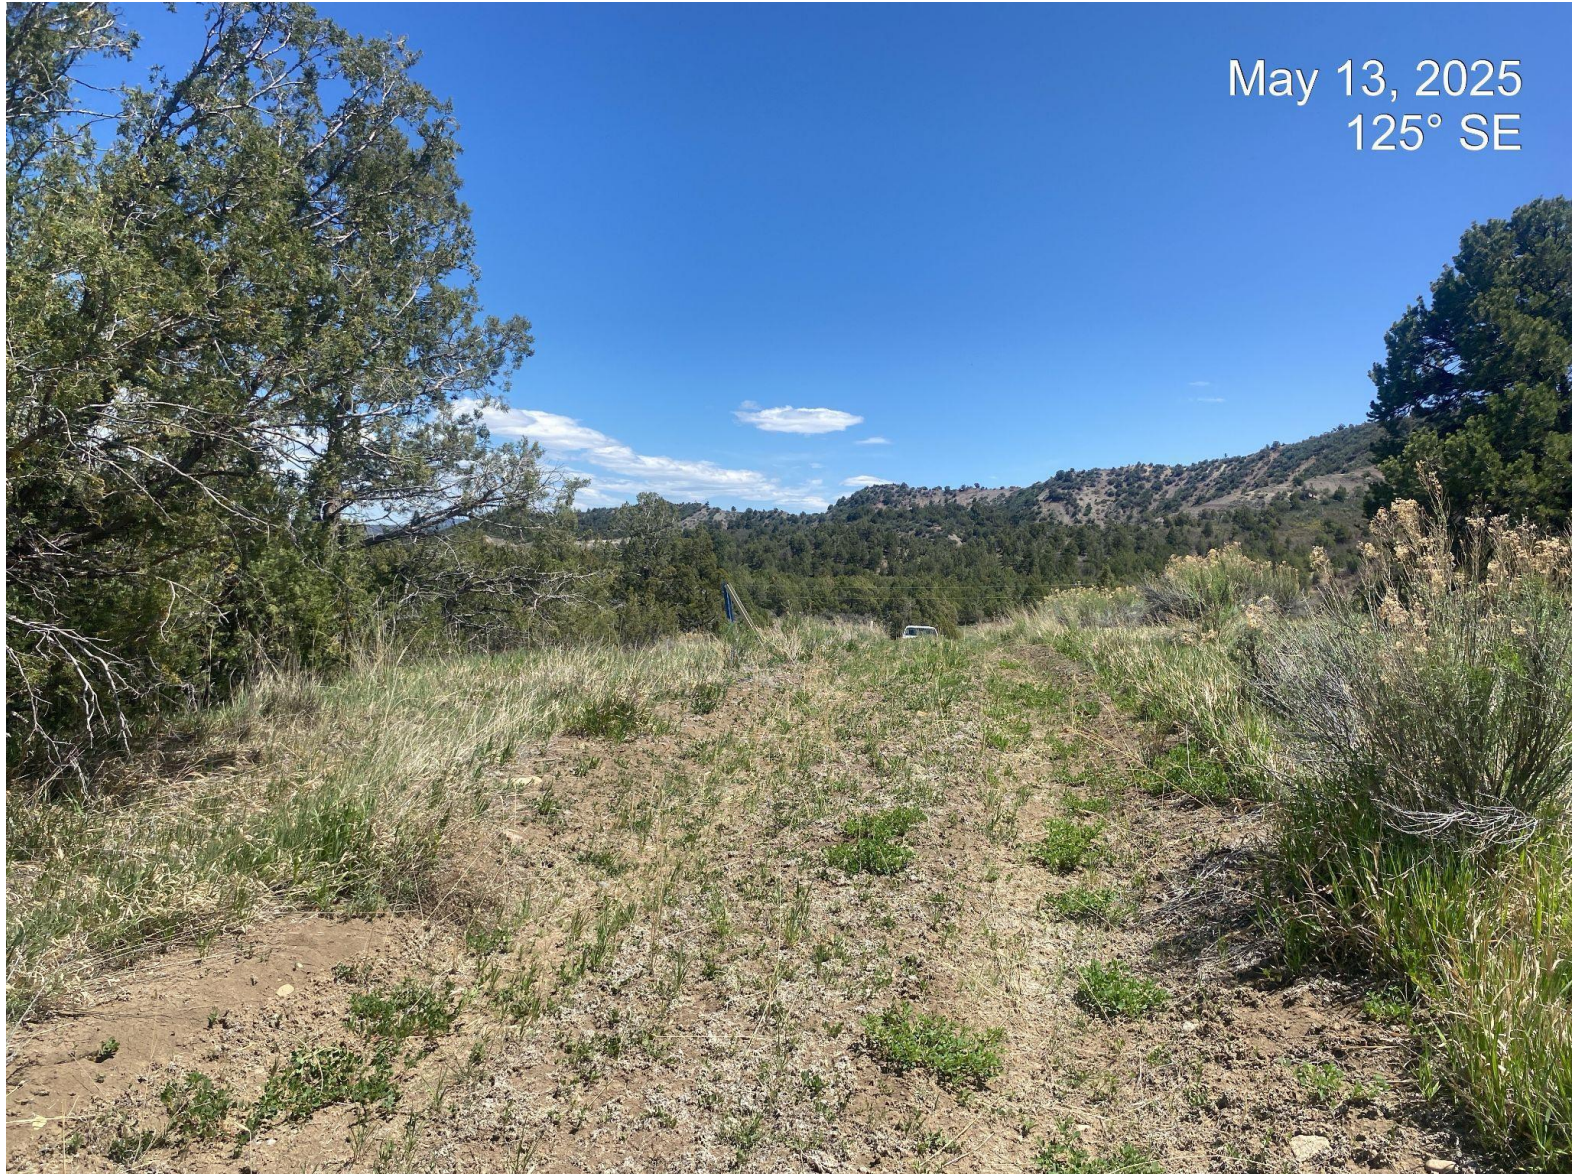
**Photo 8.** View of access road which has not been regraded/recontoured per rule 1004 however, vegetation is progressing on access road.
