# Final Reclamation and Stormwater Inspection

Operator: PDC ENERGY INC - 69175

Location Name: TALON VIEW/6-9

Inspection Document #: 718600578

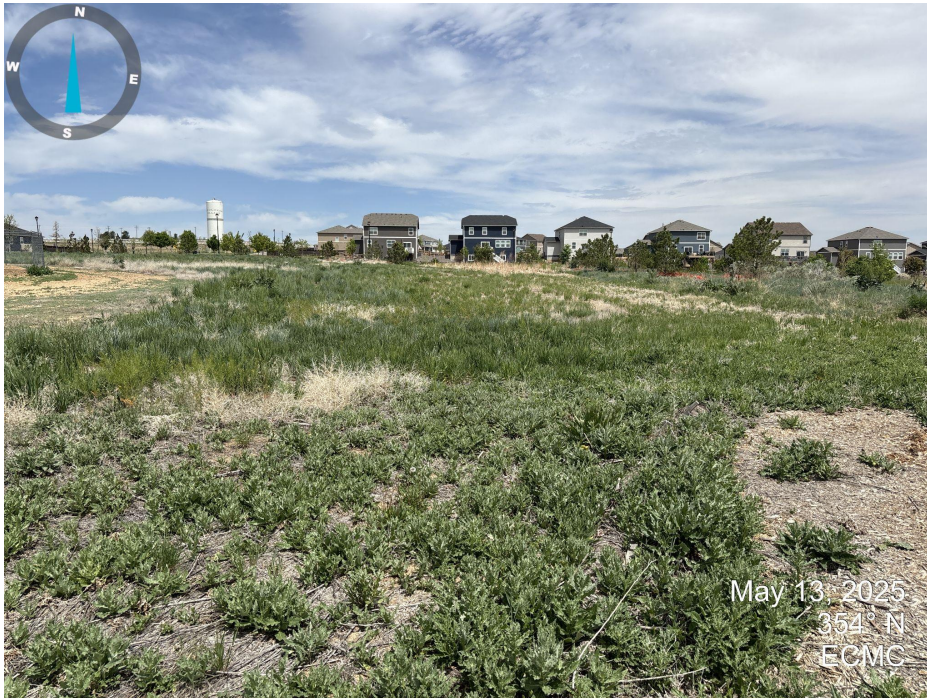
**Photo 1.** Looking north down the east side of the location. List B noxious weeds Canada thistle is present on the edge of the location.

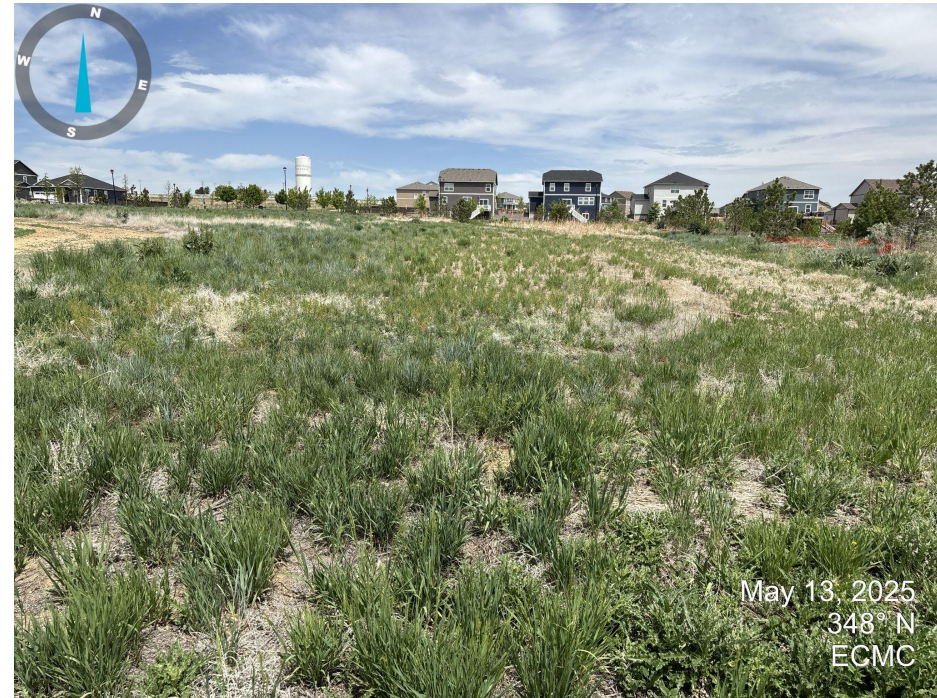
**Photo 2.** Looking north across the wellbores. Some desirable vegetation has established and appears to be progressing towards 80% of the reference area.

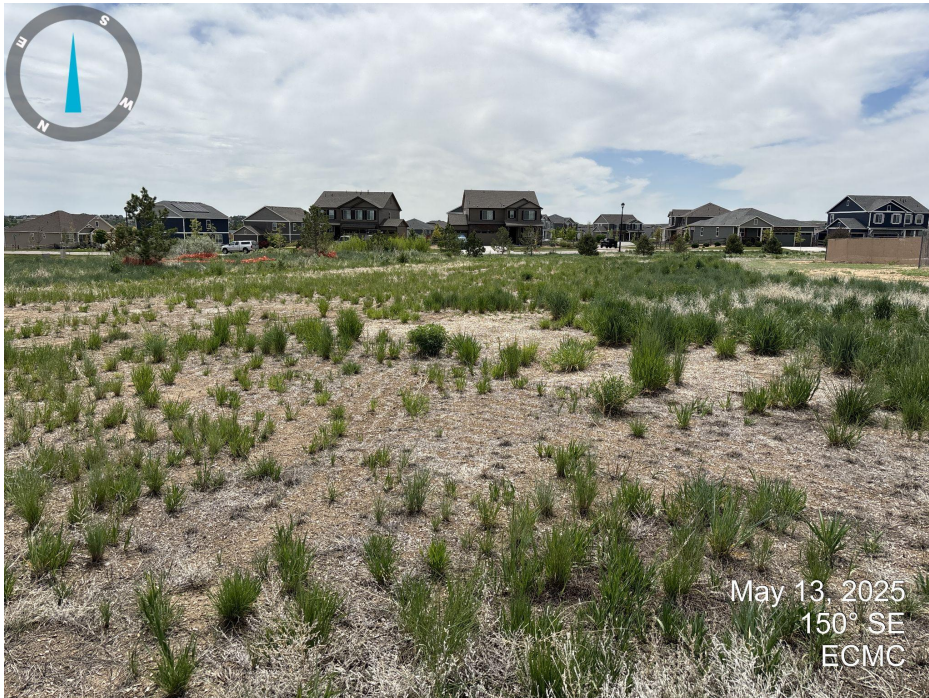
**Photo 3.** Picture taken at the northeast corner of the location looking south across the wellbores. This area has lower vegetation establishment than surrounding areas and a patch of bare earth is present.

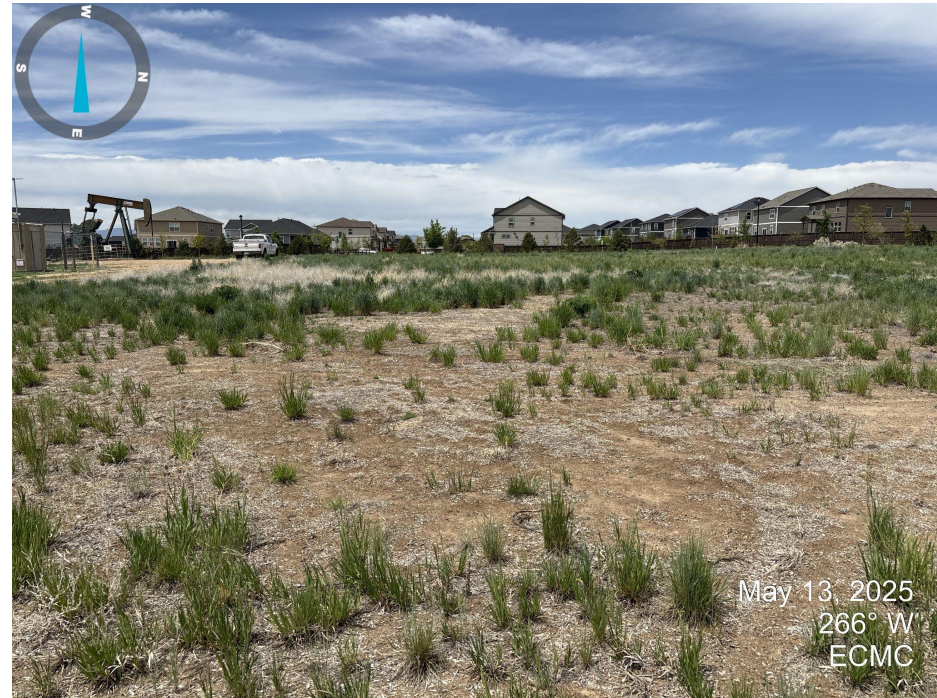
**Photo 4.** Looking west from the northeast corner of the location across the former tank battery. See photo 3 comments.

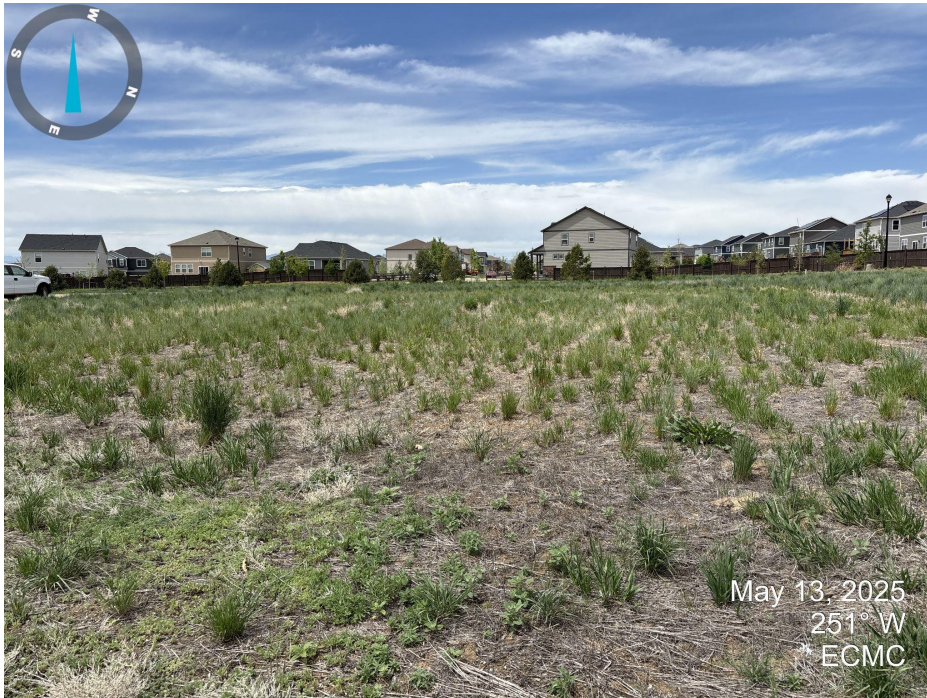
**Photo 5.** Looking west across the tank battery from the north side of the location. Some desirable vegetation has established in this area but may need additional reclamation work the reach 80% of the reference area.

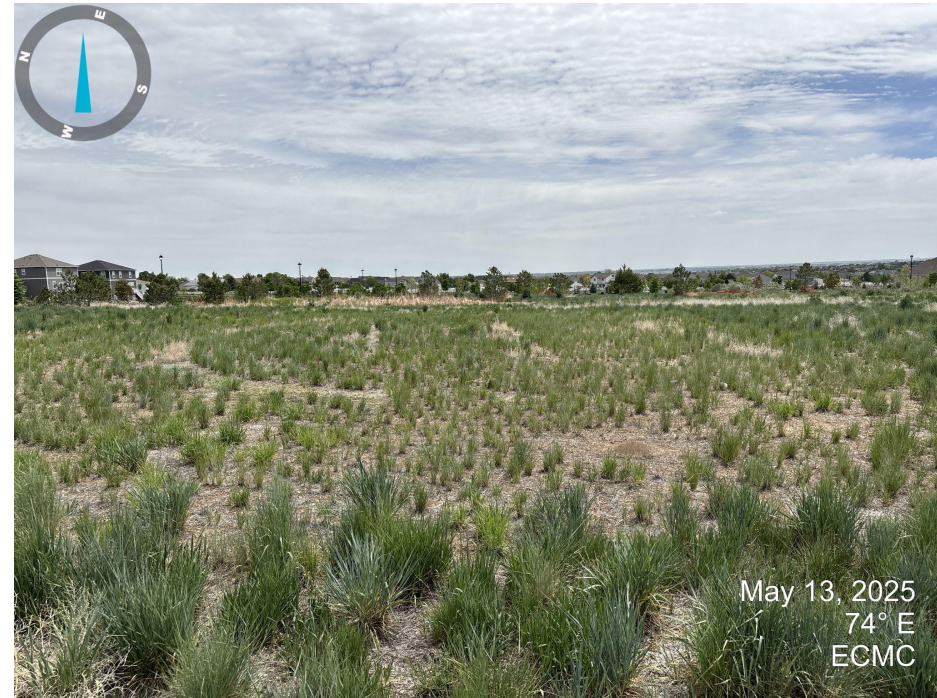
**Photo 6.** Looking east across the tank battery. See photo 5 comments.

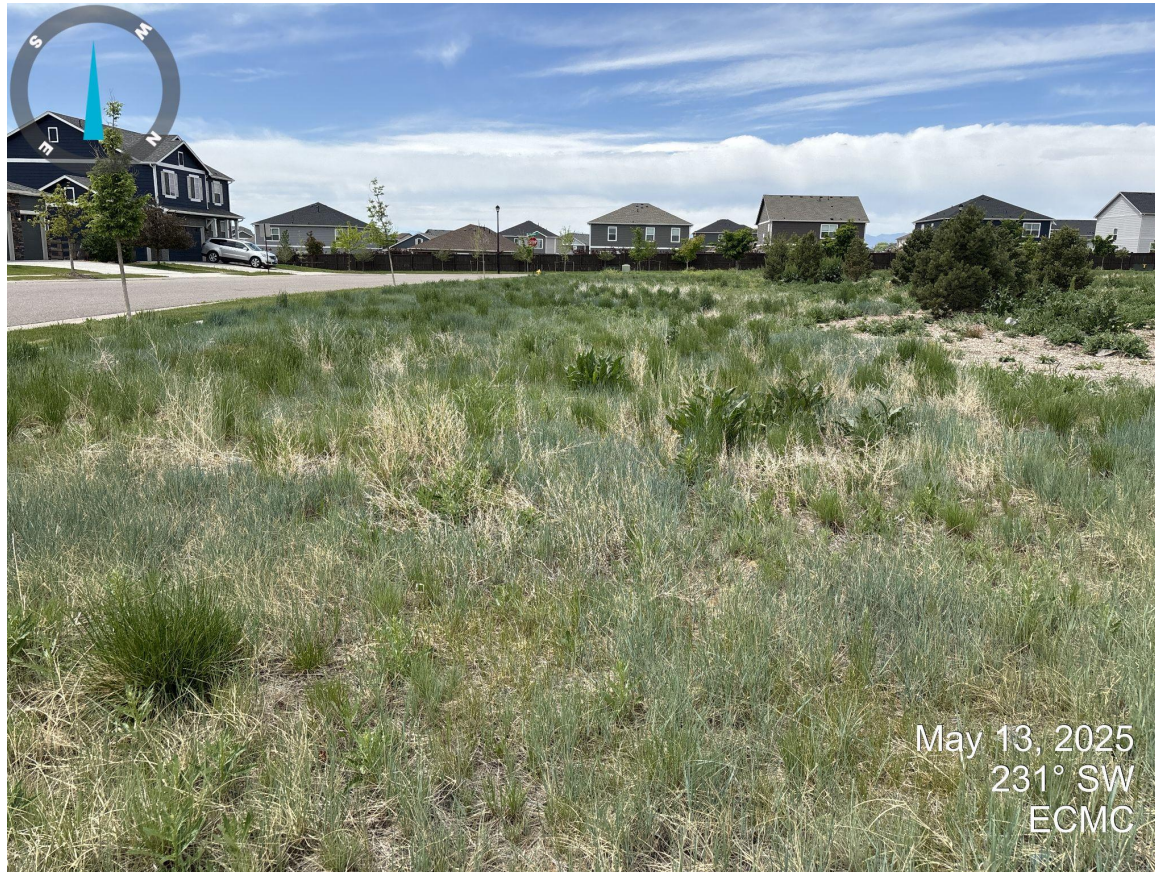
**Photo 7.** Reference vegetation to the south of the location.
