Inspection Photos

Operator: CAERUS PICEANCE LLC - 10456

Location ID: 312661

Inspection Doc: 718100526

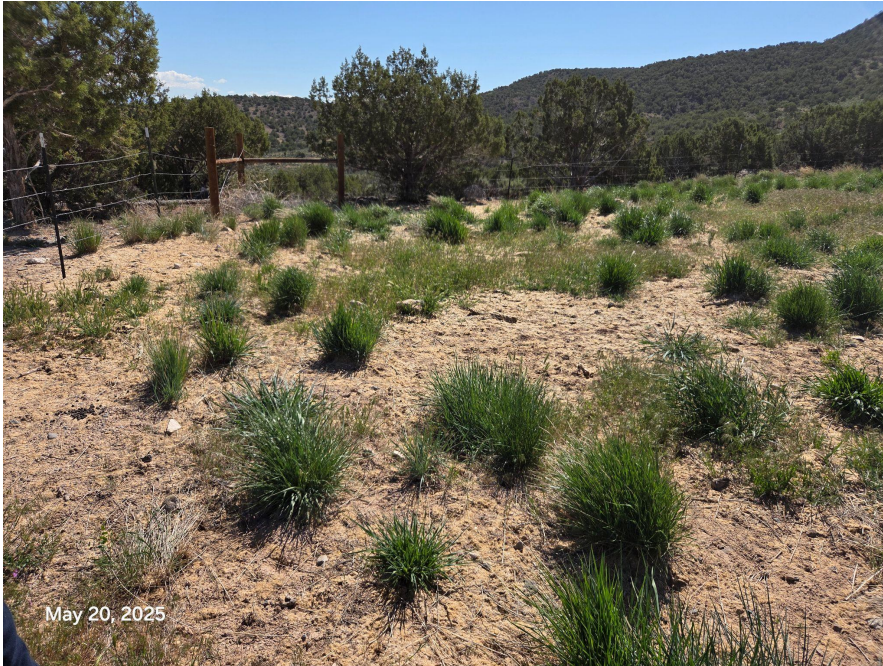
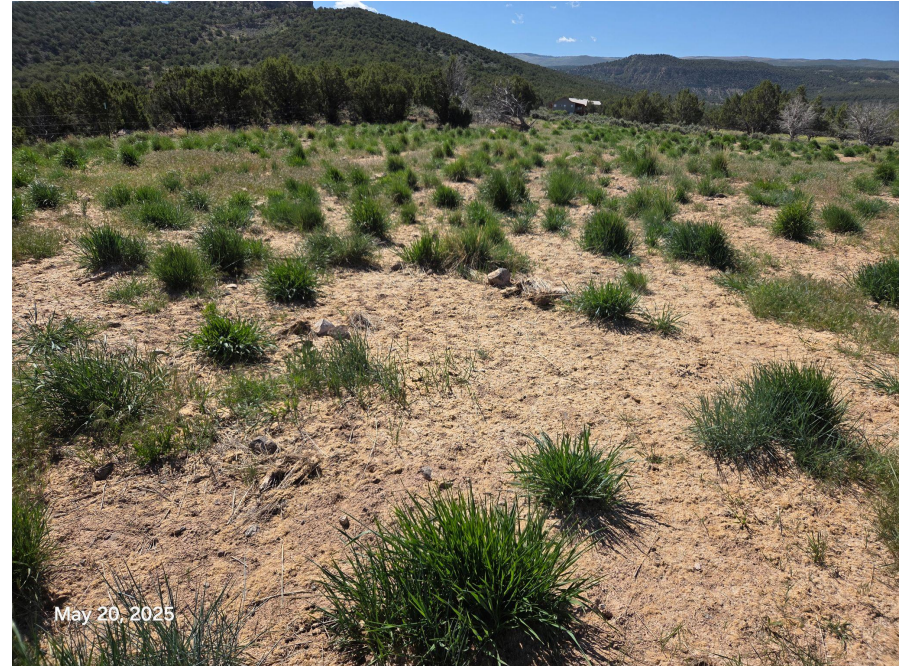
Photo 1: Photos 1-2 taken from north end of the Location. Photos provide an overview from east, southeast, southwest to west. Photos also show additional reclamation efforts on the Location are apparent. Site appears to be progressing towards ECMC 1004 revegetation requirements.

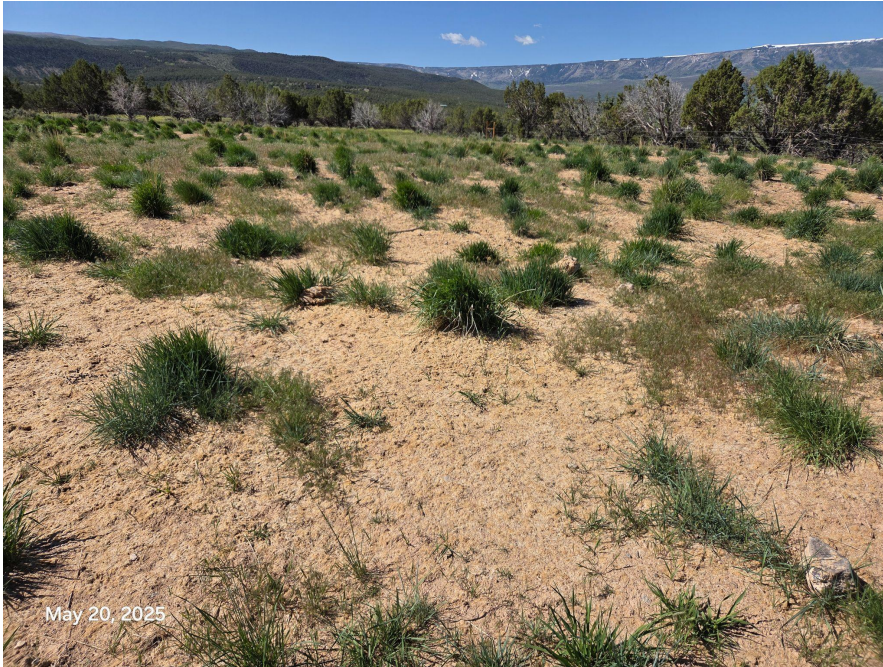
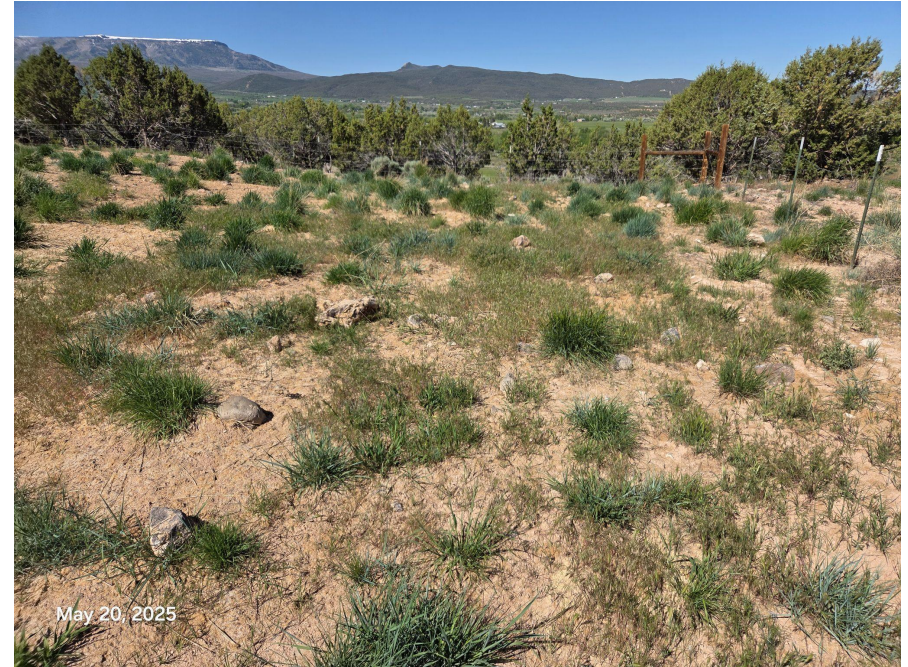
Photo 2: See comments under photo 1.

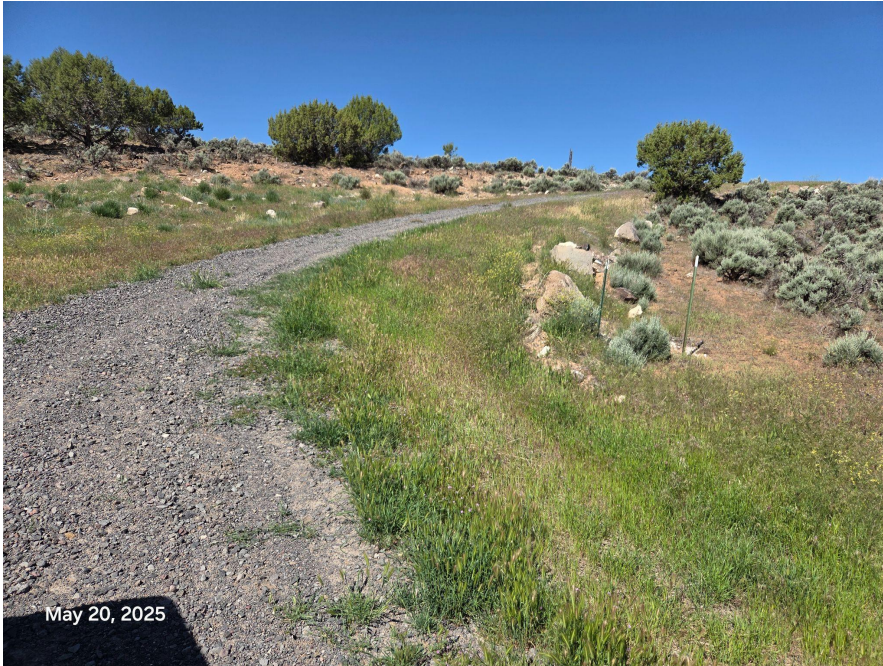
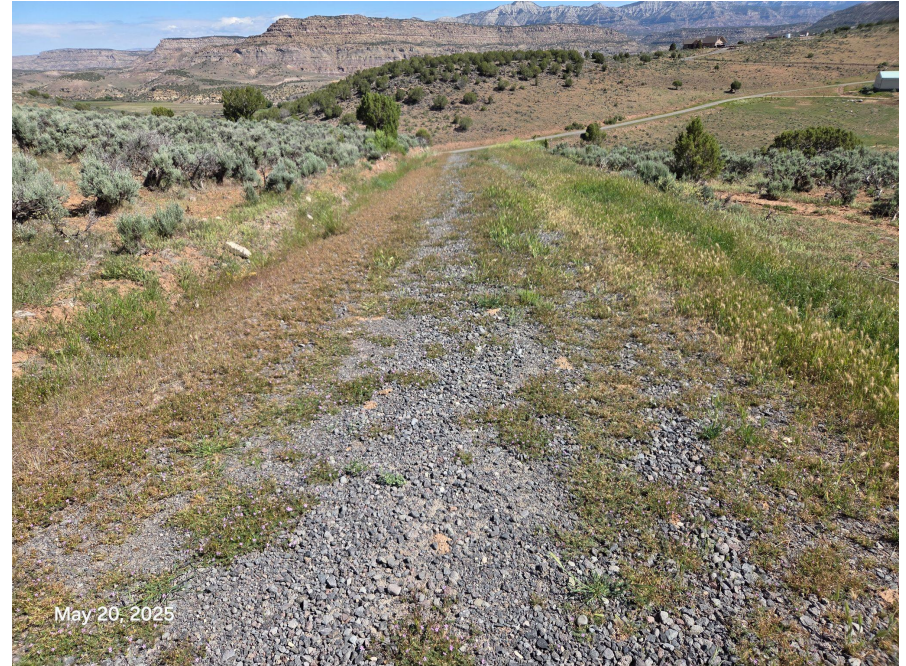
Photo 3: Photos examples showing access road leading to the Location. Road has not been reclaimed in accordance with 1004 requirements. Operator filed a hearings application (docket #230900303) with a 502.b surface owner variance request from ECMC Rules 1004.a and 1004.d to leave the O&G Access road.

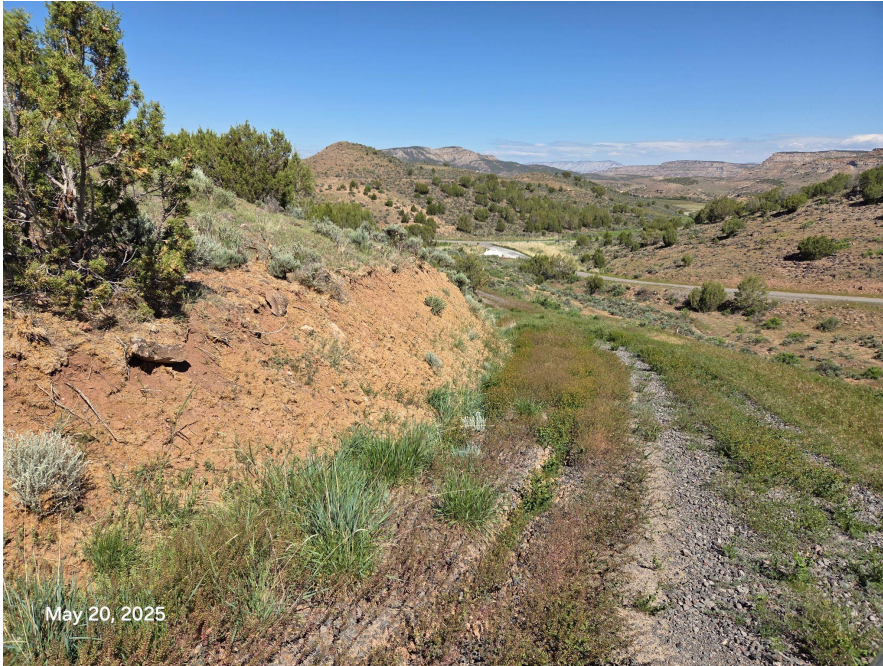
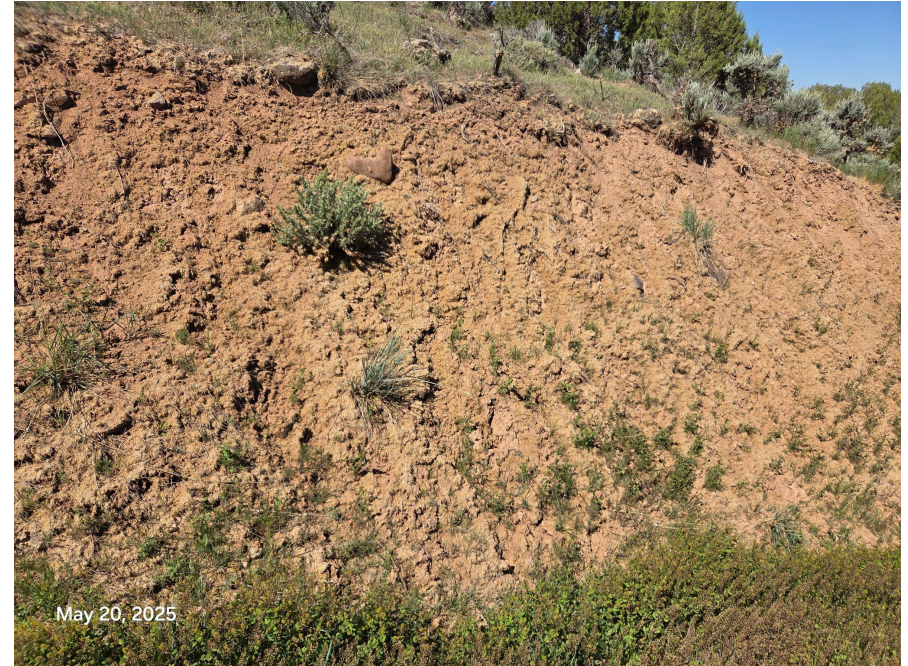
Photo 4: Continued from photo 3. Photo shows additional reclamation and stabilization efforts are evident on the the cut slopes of the access road.
