Inspection Photos

Operator: BLACK HILLS PLATEAU

Location ID: 312477

Inspection Doc: 718100528

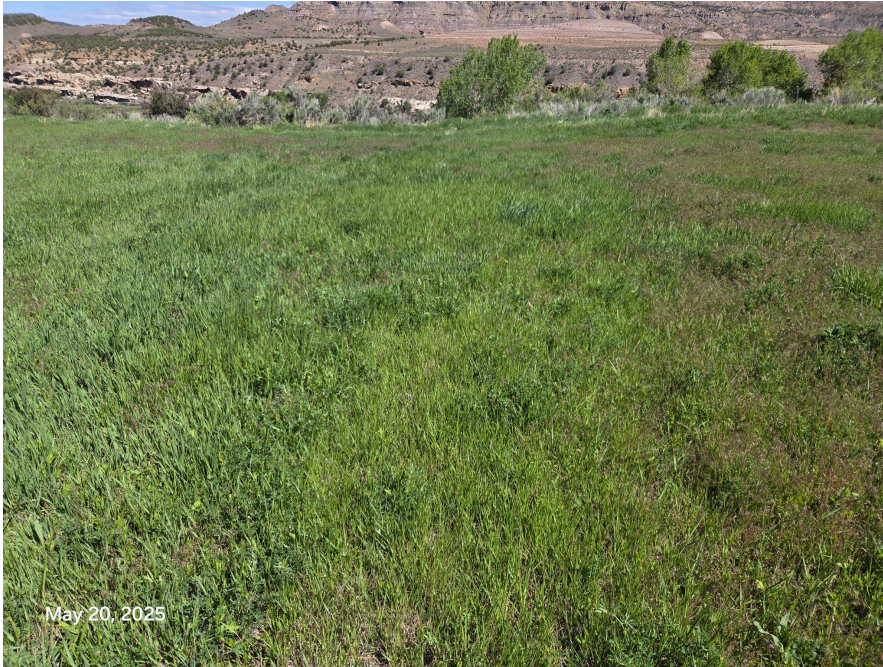
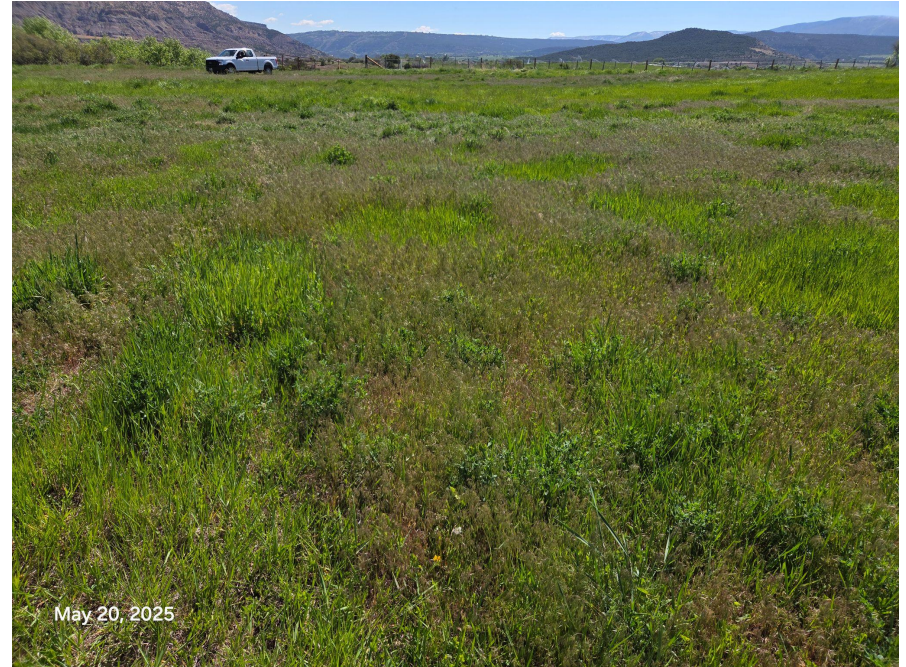
Photo 1: Photos 1-2 taken from the central areas of the Location. Photos provide an overview from north, east, south to west. Photos also show Location has met ECMC 1004 revegetation requirements.

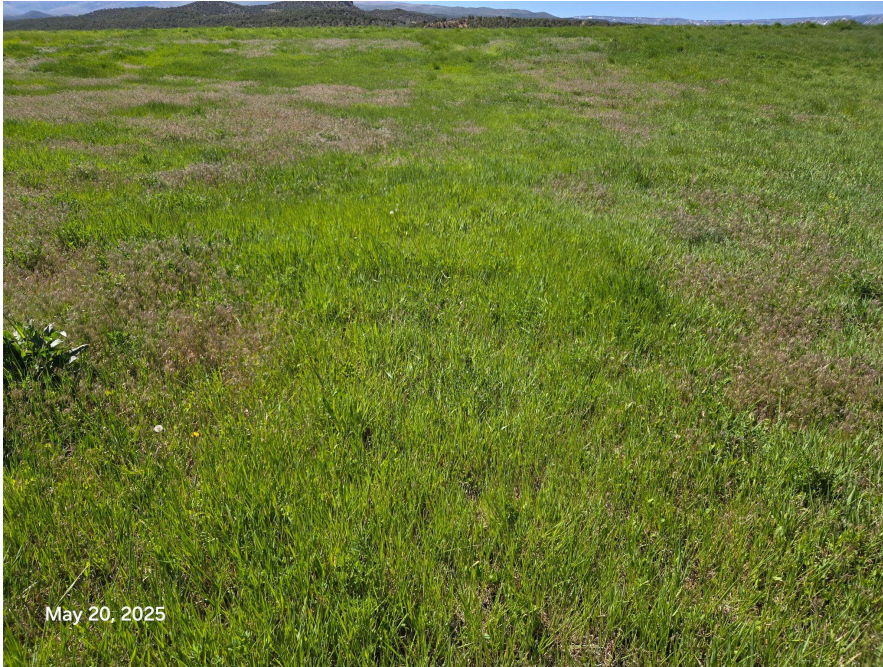
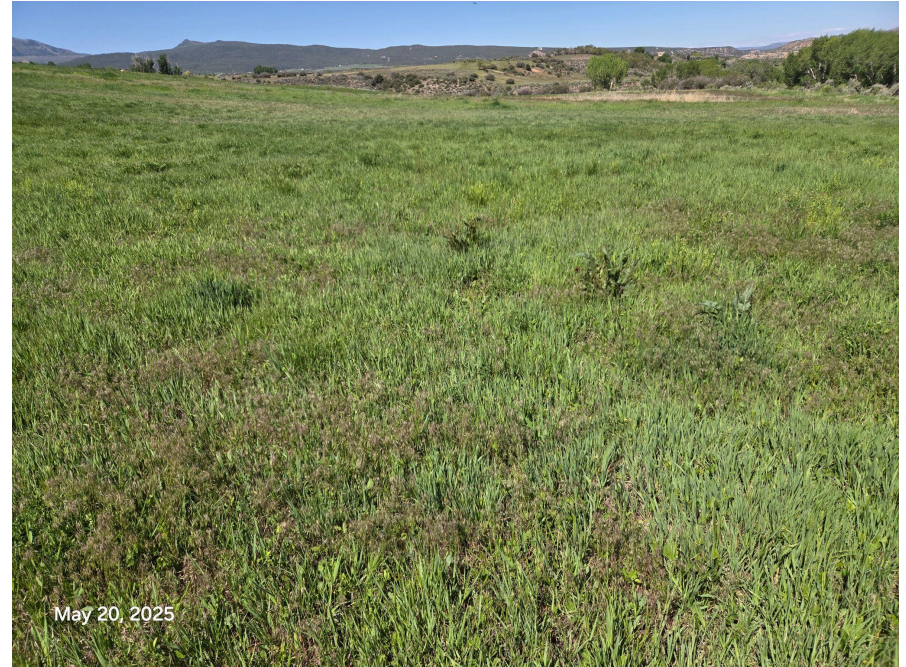
Photo 2: See comments under photo 1.

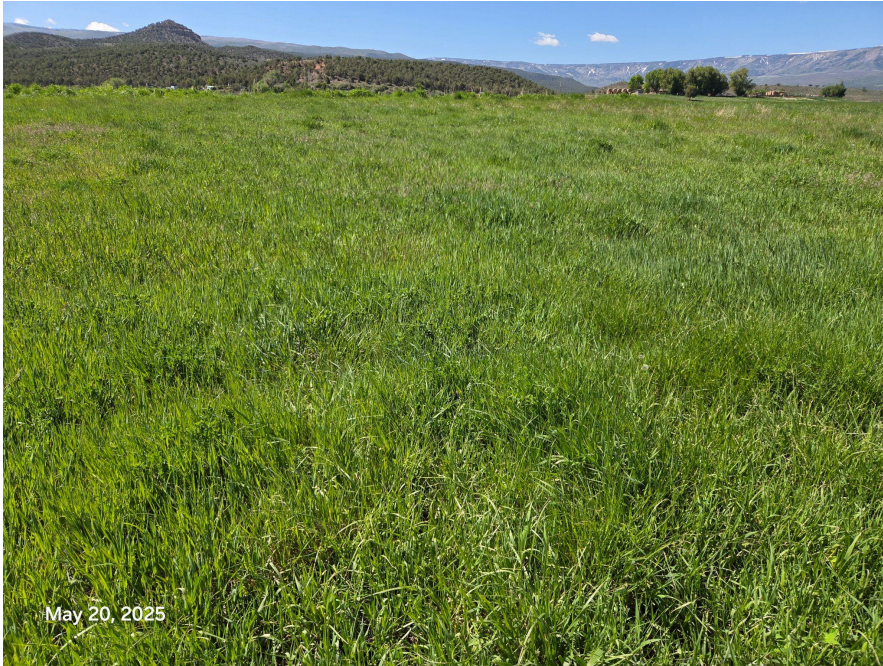
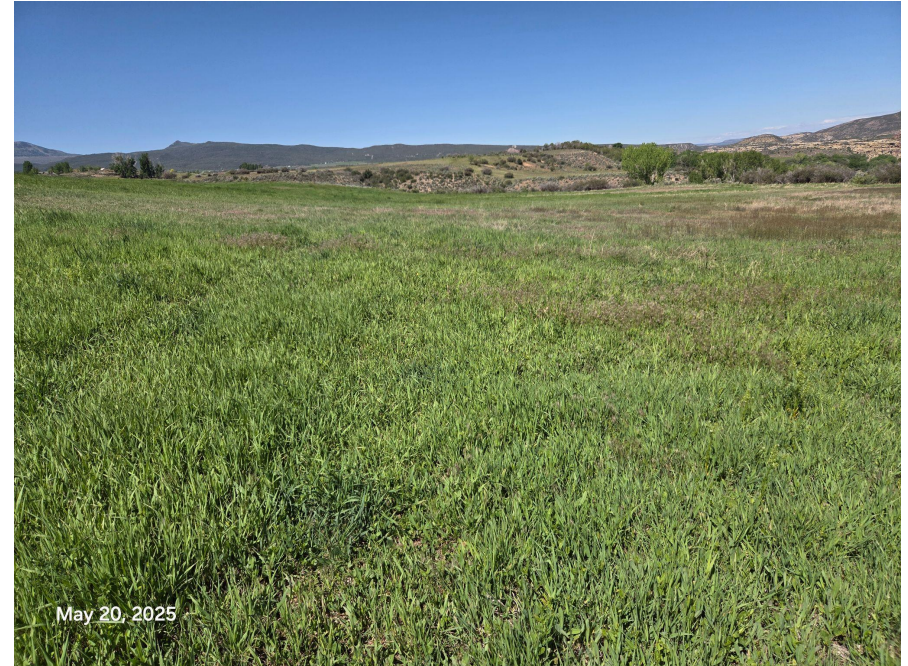
Photo 3: Photos taken from the adjacent reference areas south and west of the Location. Photos provide comparison of vegetation on the reference to that on the Locations.

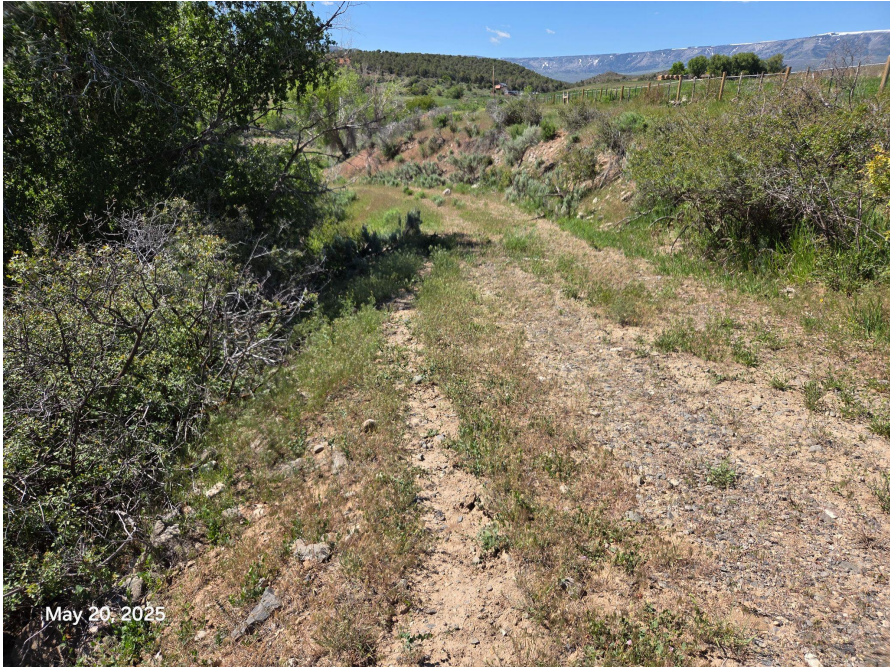
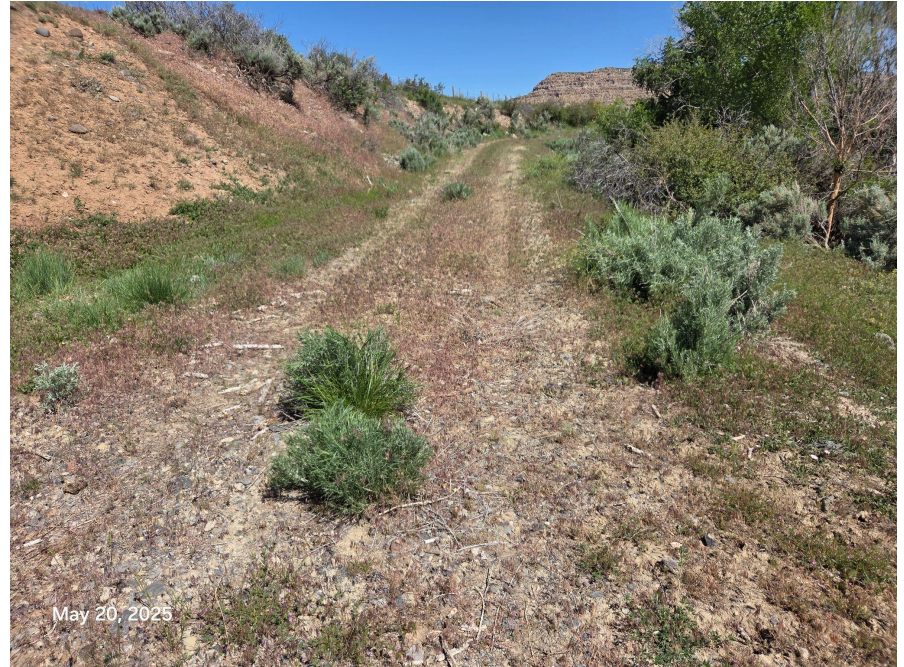
Photo 4: Photos taken from along the access road. Photos show access road has not been reclaimed in accordance with 1004 Requirements.
