Final Reclamation Inspection

Operator: KERR MCGEE OIL & GAS ONSHORE LP - 47120

Location ID: 329895

Inspection Photos
Location Name: PSC #23-11
Location ID: 329895

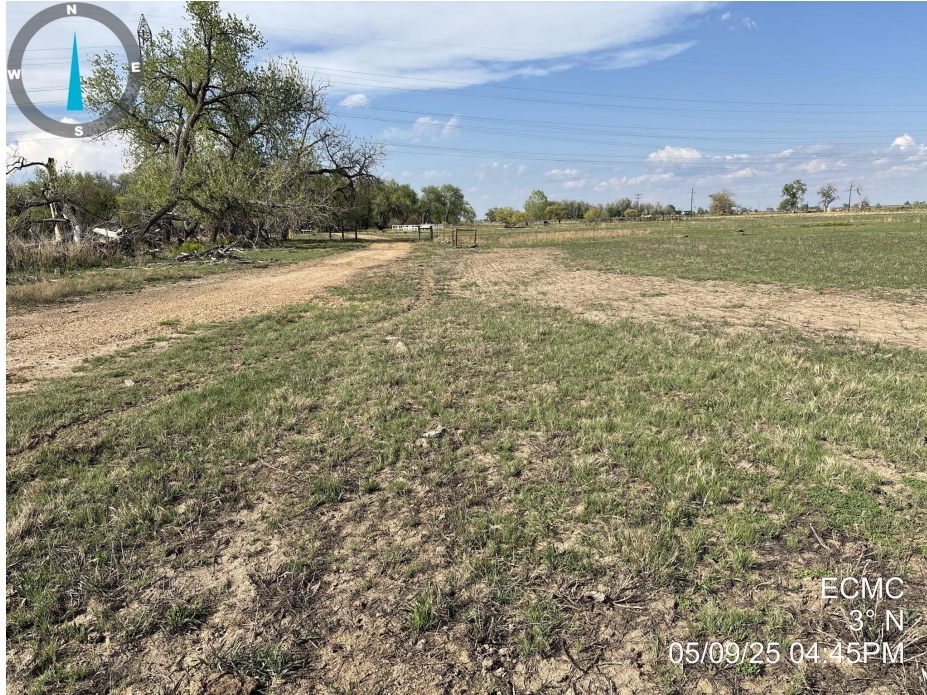
Photo 1. Photo taken from the well location, facing North. Photo illustrates that final reclamation activities have taken place, but vegetation has not established to Rule 1004 standards.

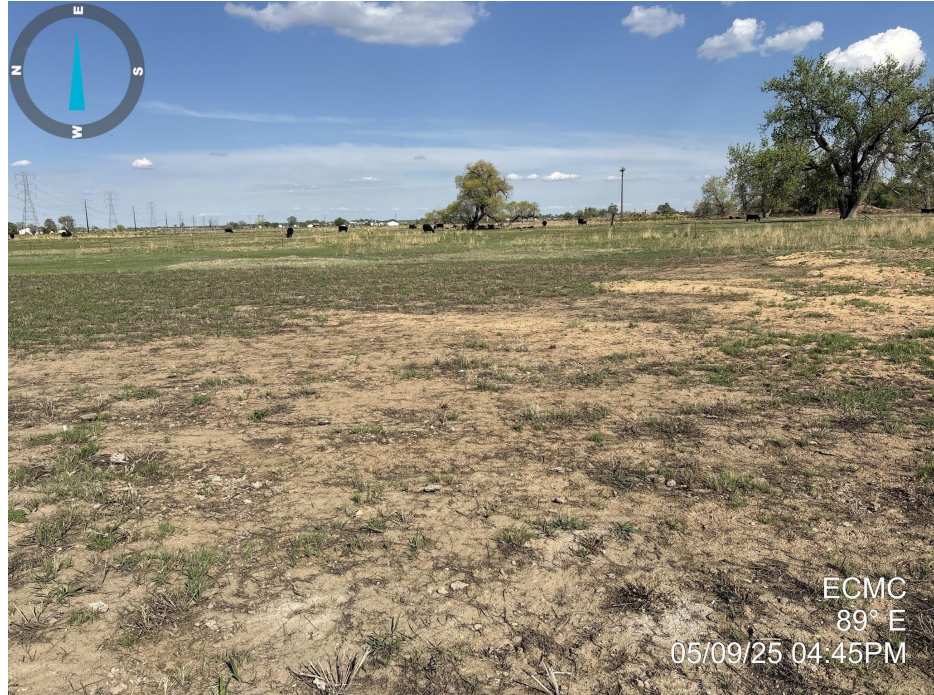
Photo 2. Photo taken from the well location, facing East. Photo illustrates that bare ground patches remain at the location. However, based on Google Earth Aerial Imagery, disturbances appear to be caused by development adjacent to the well location (See Photo 3).

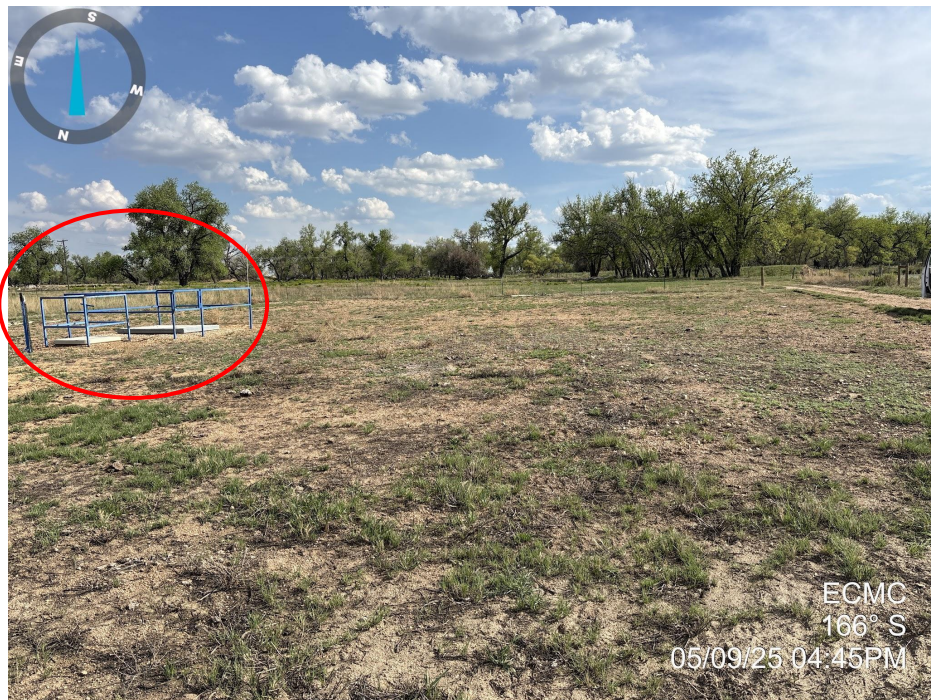
Photo 3. Photo taken from the well location, facing South. Disturbances at the location appear to be related to development adjacent to the well site (circled in red).

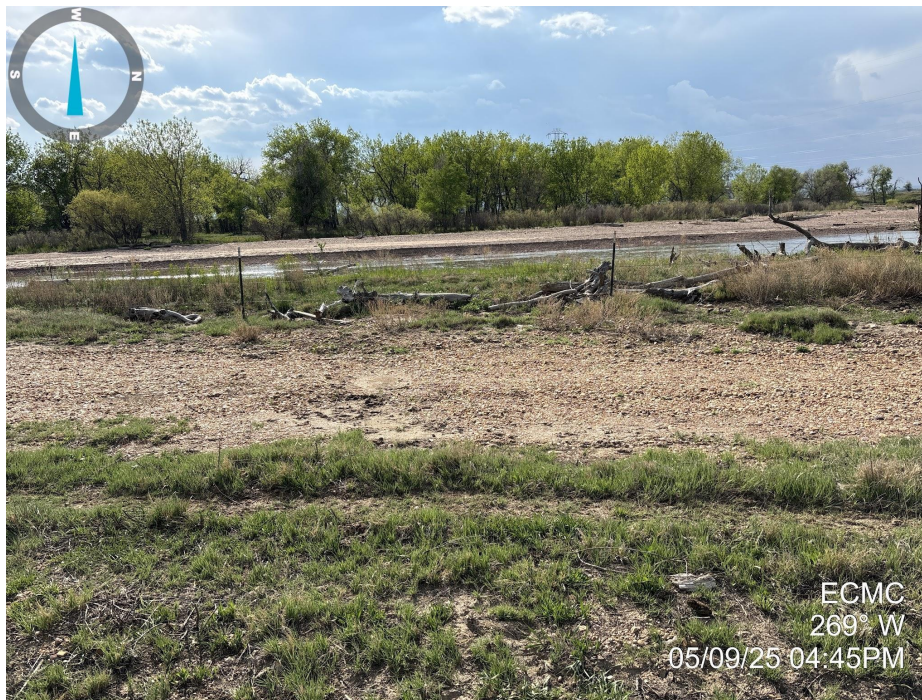
Photo 4. Photo taken from the well location, facing West. See comments under Photo 1.

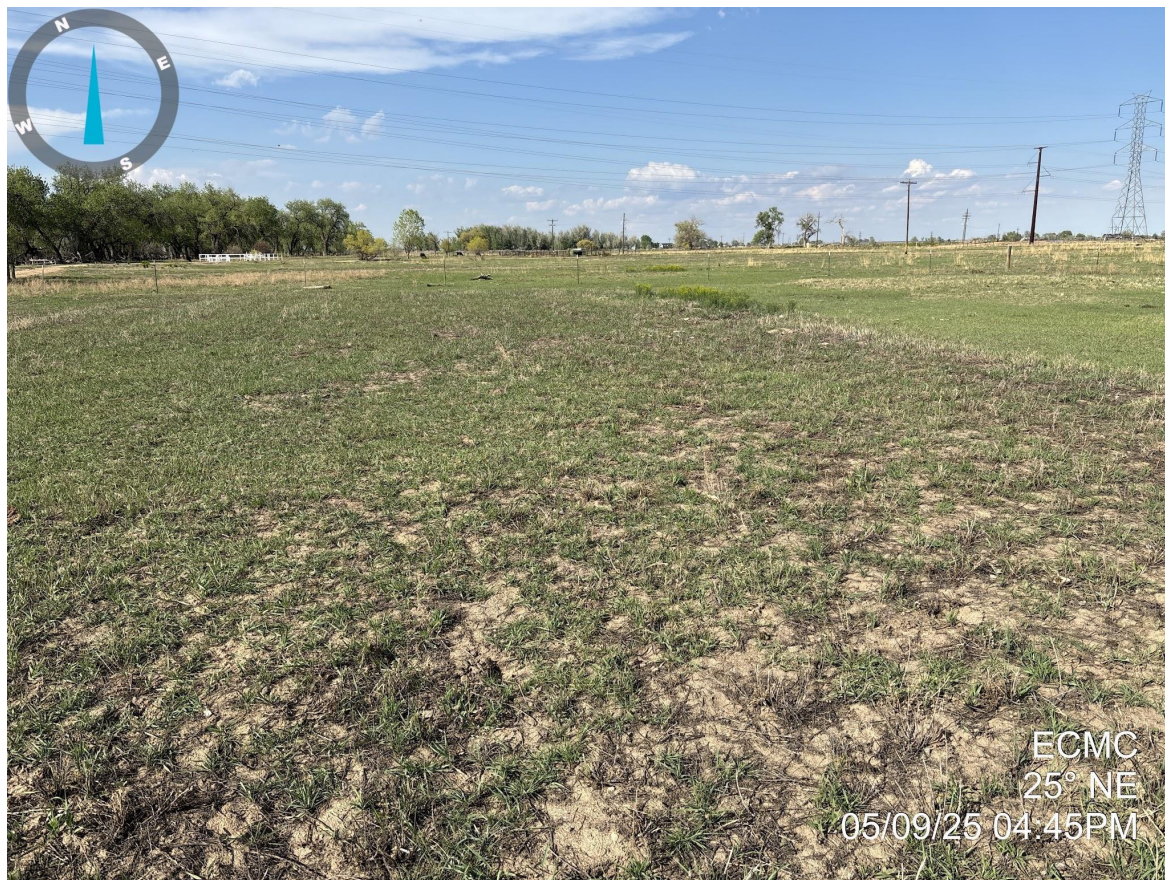
Photo 5. Photo taken of the reference area, east of the well site, facing Northeast. Photo illustrates perennial grass vegetation.
