Final Reclamation Inspection

Operator: NOBLE ENERGY INC - 100322

Location ID: 323717

Inspection Photos
Location Name: BOHLENDER #D20-3
Location ID: 323717

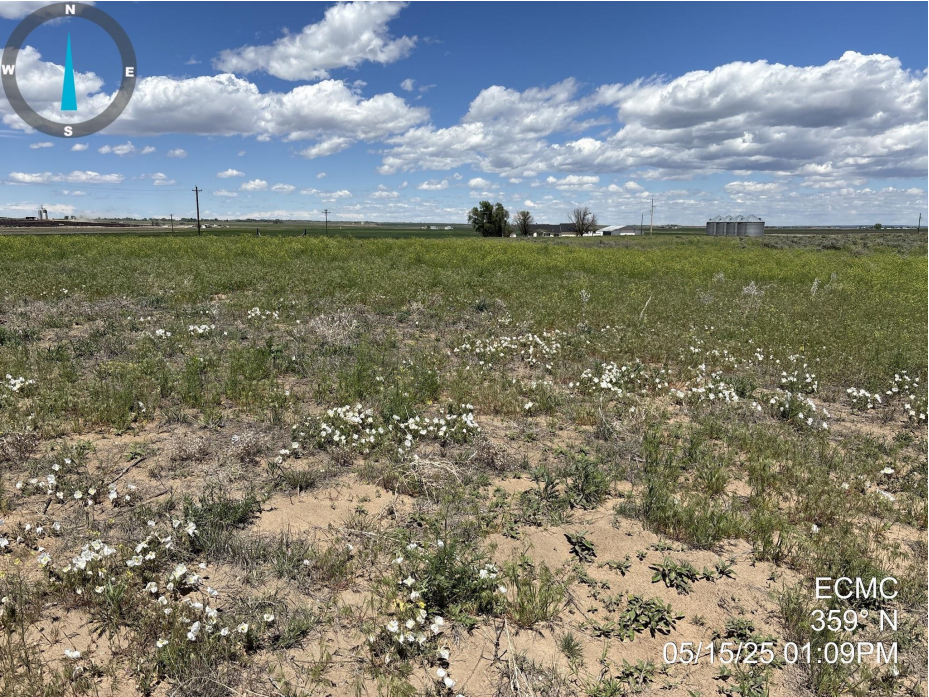
Photo 1. Photo taken from the well location, facing North. Photo illustrates that final reclamation activities have taken place, but vegetation has not established to Rule 1004 standards.

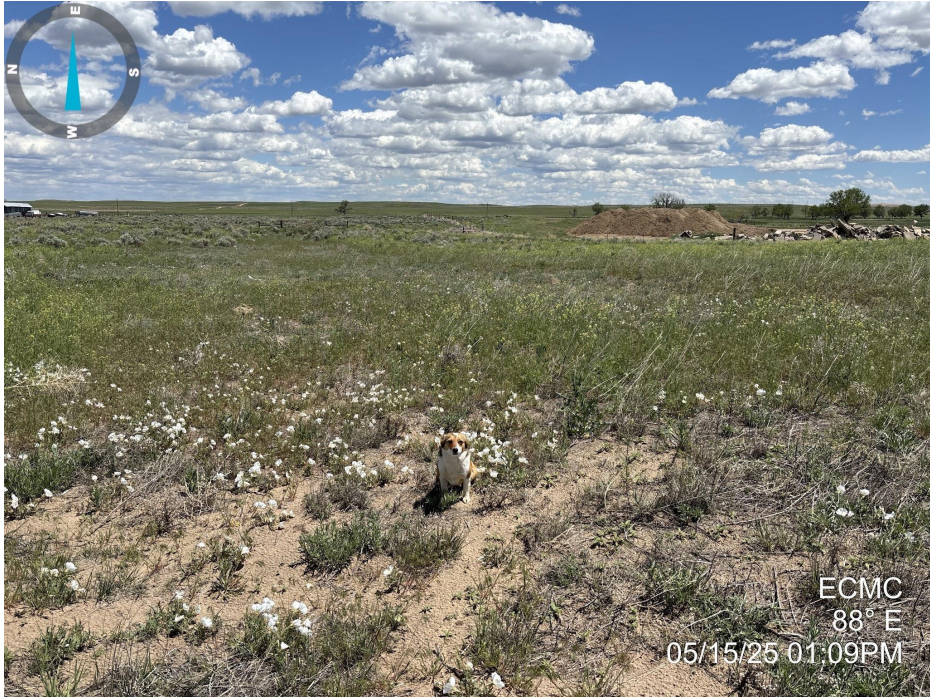
Photo 2. Photo taken from the well location, facing East. See comments under Photo 1.

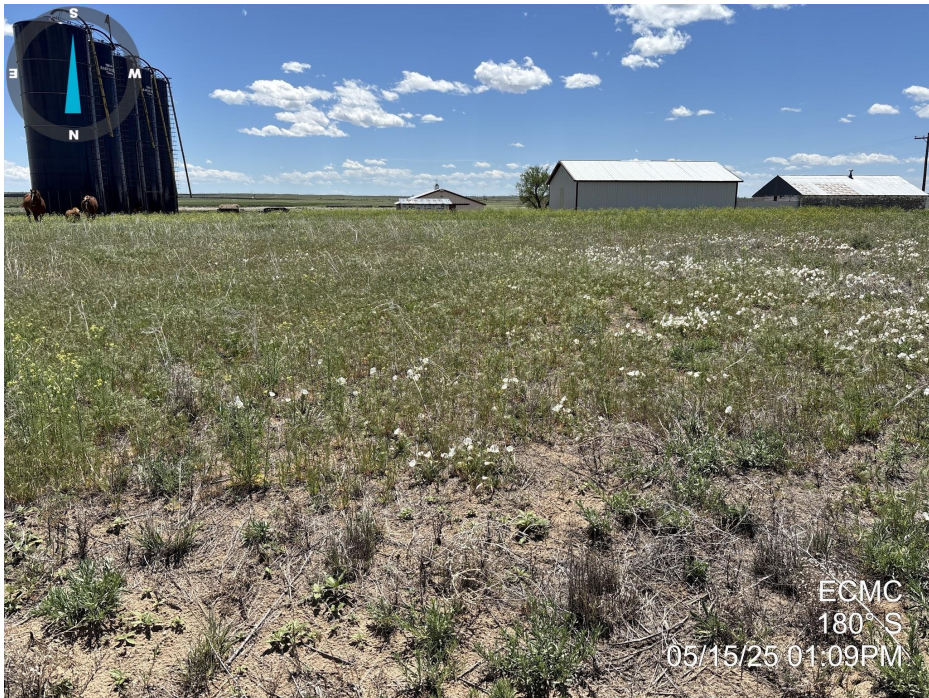
Photo 3. Photo taken from the well location, facing South. See comments under Photo 1.

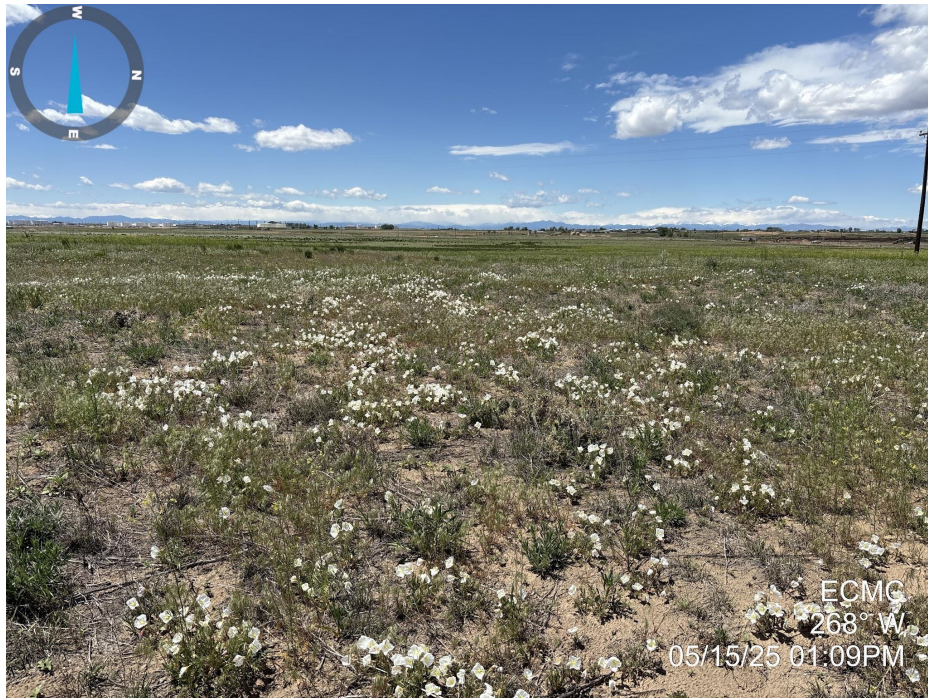
Photo 4. Photo taken from the well location, facing West. See comments under Photo 1.

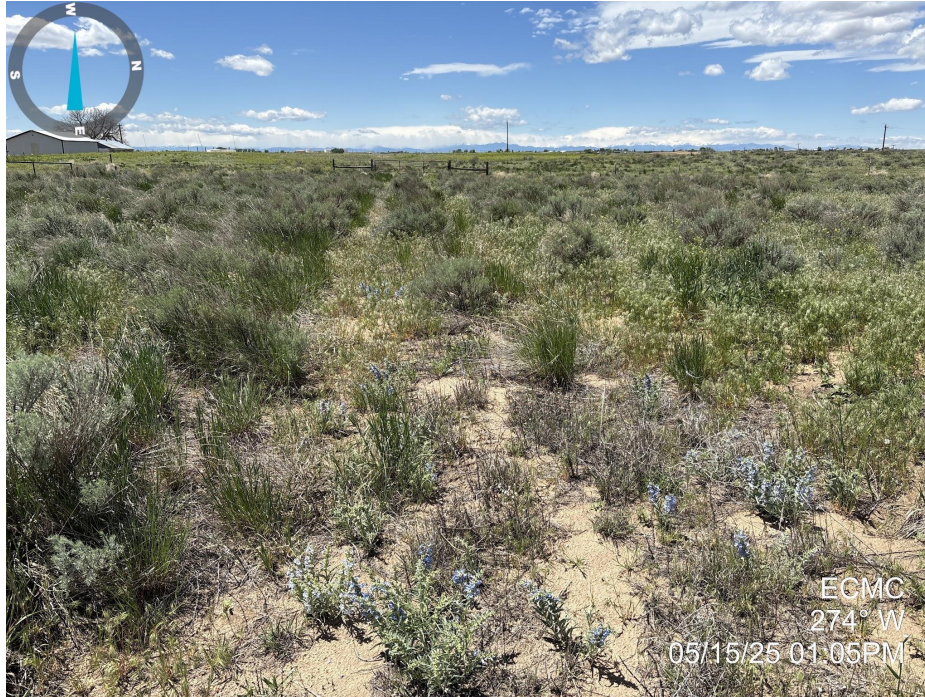
Photo 5. Photo taken from the access road, facing West towards the well location. Photo illustrates that weedy annual vegetation and bare ground remain along the access road.

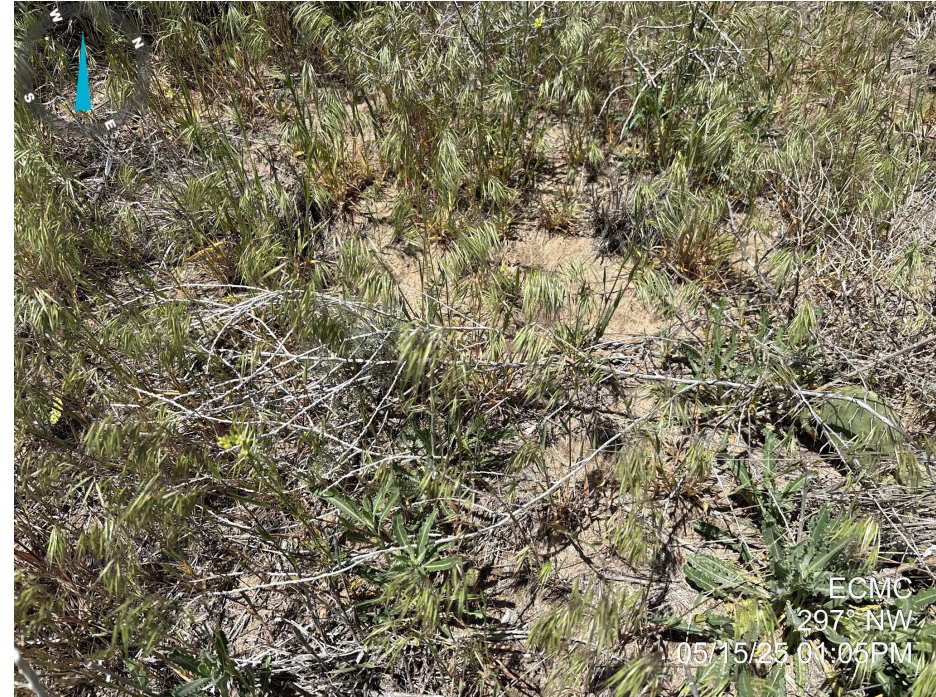
Photo 6. Photo taken of vegetation along the access road. Photo illustrates that cheatgrass (*Bromus tectorum*) is present across the location and is a List C noxious weed species.

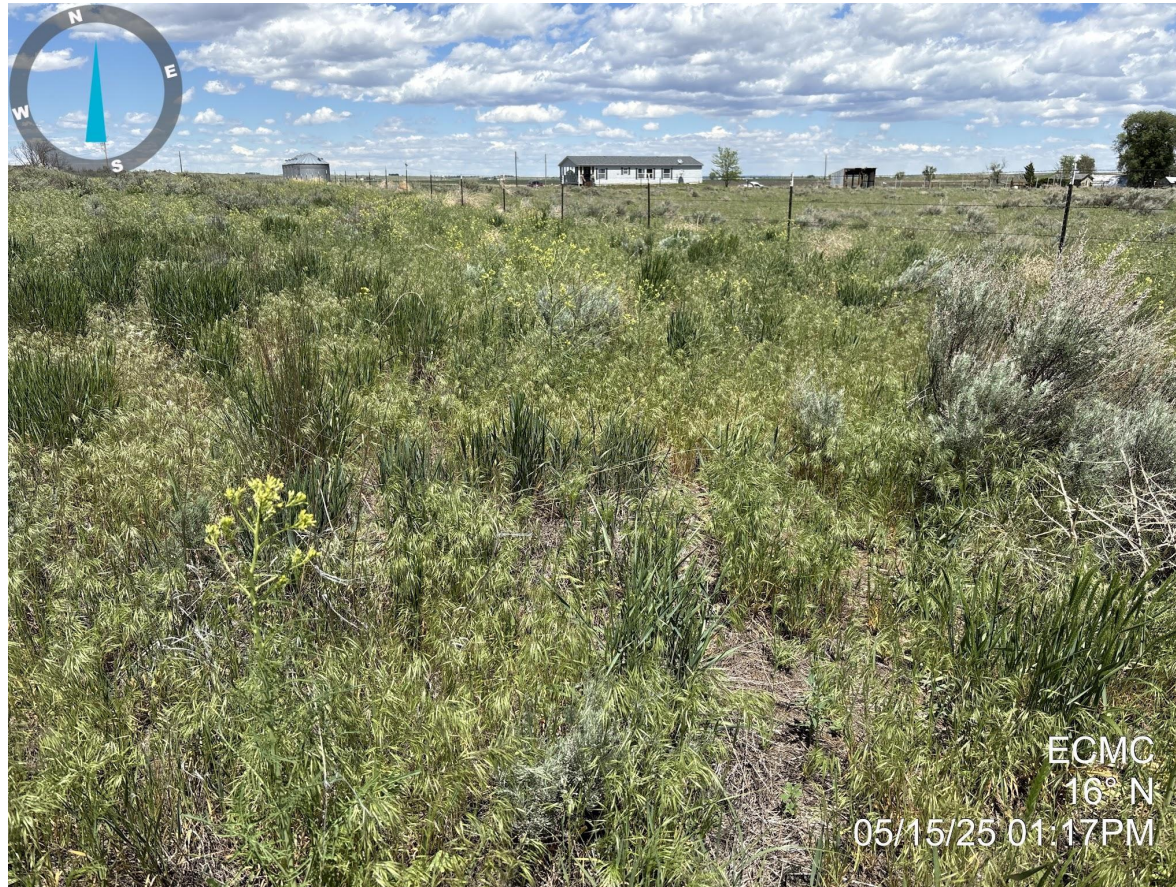
Photo 7. Photo taken of the reference area, east of the location, facing North. Photo illustrates some perennial vegetation and weedy annual growth including cheatgrass (*Bromus tectorum*).
