Final Reclamation and Stormwater Inspection

Location ID: 452648

Location Name: Colorado State A/CTB

Inspection Document #: 718600599

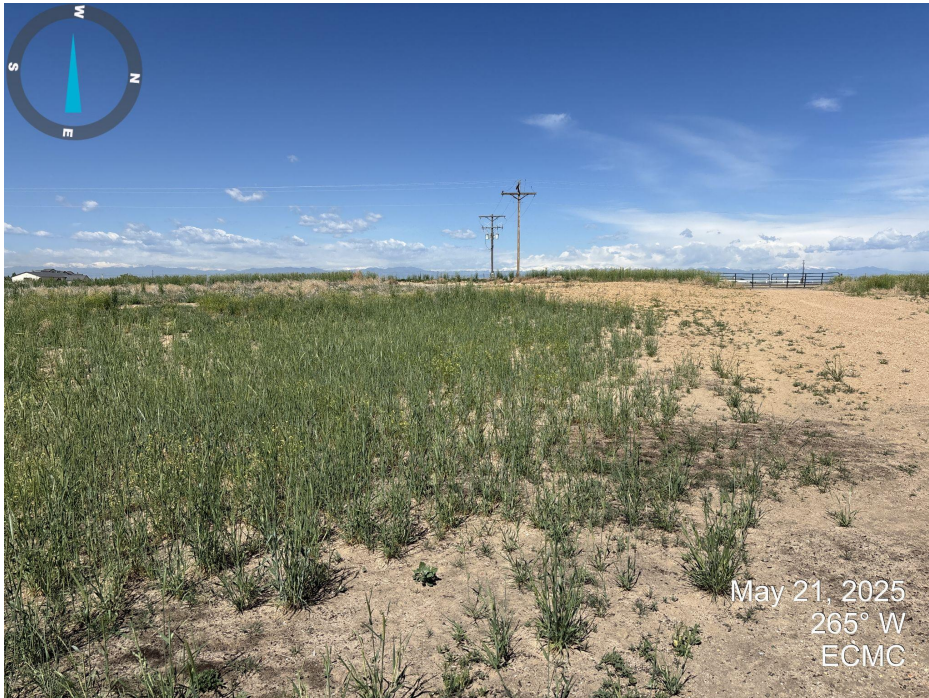
Photo 1. Looking west from the center of location. Desirable vegetation appears to be primarily Canada wild rye and appears to be progressing on the south side of the location.

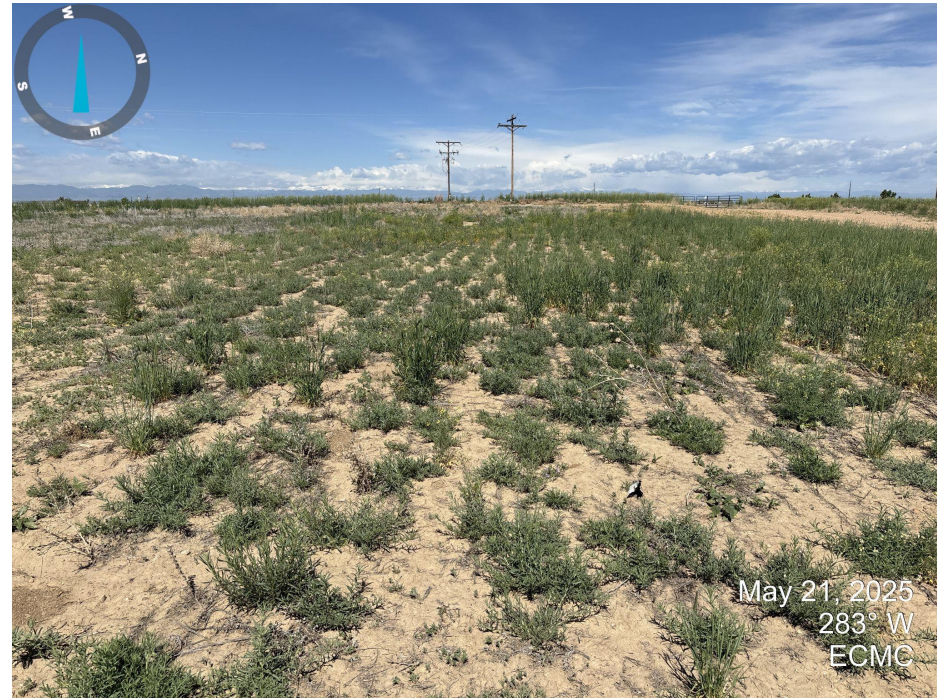
Photo 2. Looking west across the south side of the location. Desirable vegetation is present. Undesirable weeds such as Russian thistle are present on location.

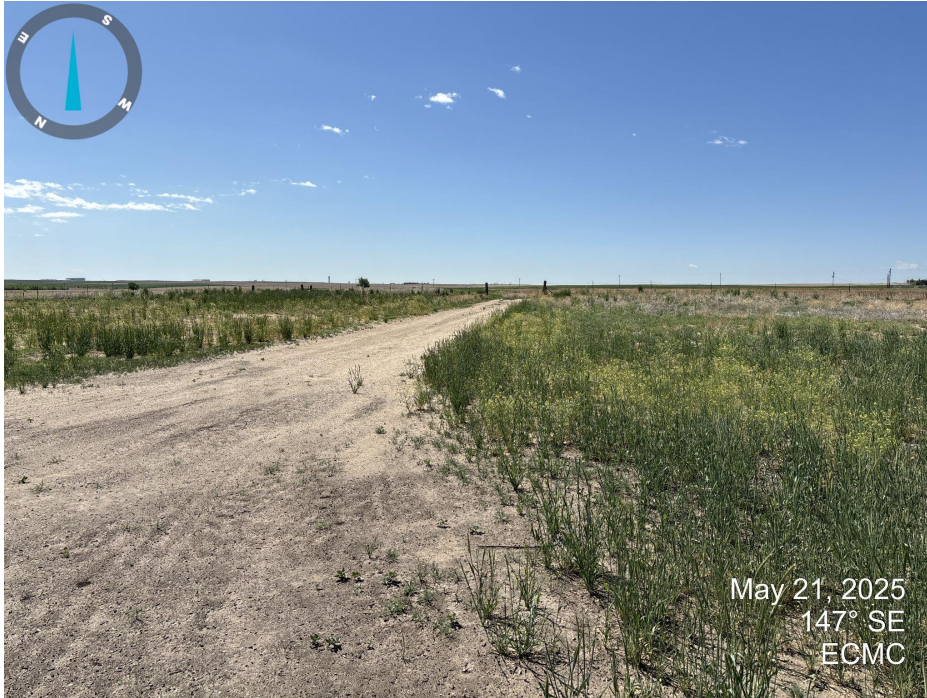
Photo 3. Looking south down the south access road. All access roads remain.

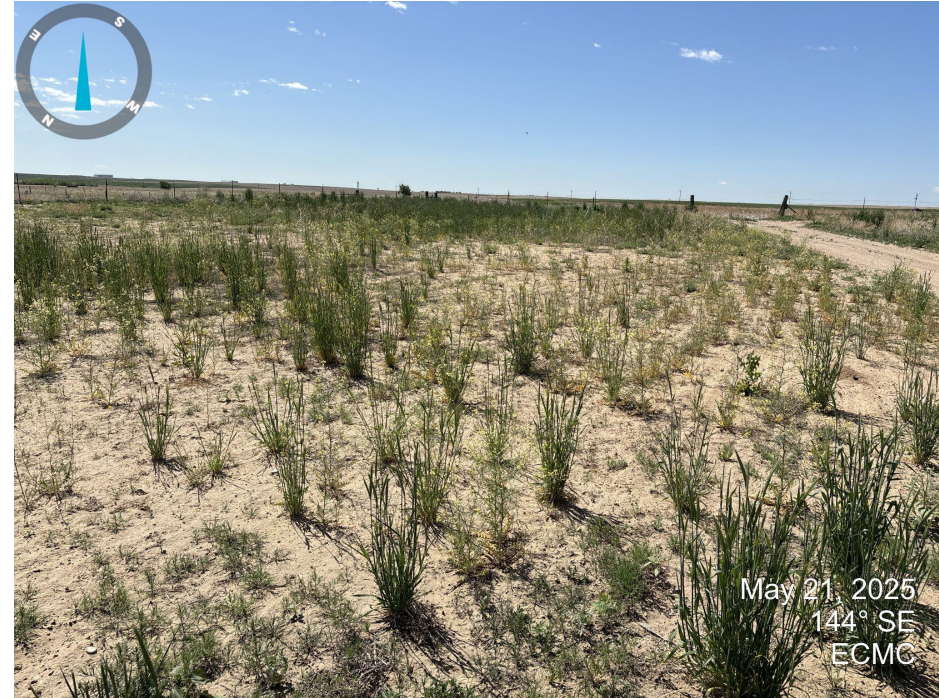
Photo 4. Looking south across the east side of the location. Desirable vegetation is present but has lower coverage in this area.

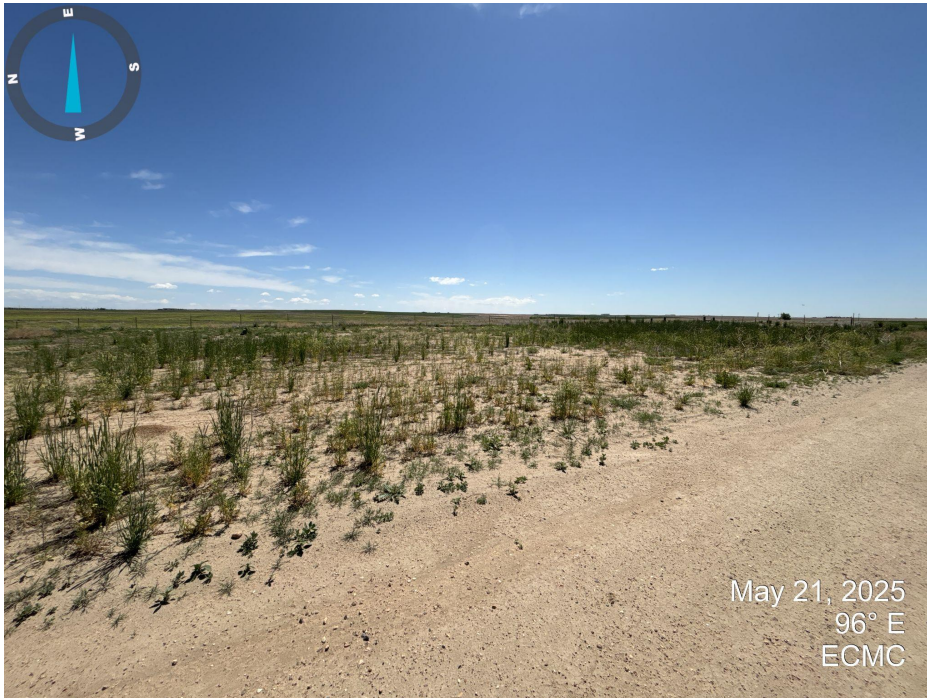
Photo 5. Looking at the east side of location. See photo 4 comments.

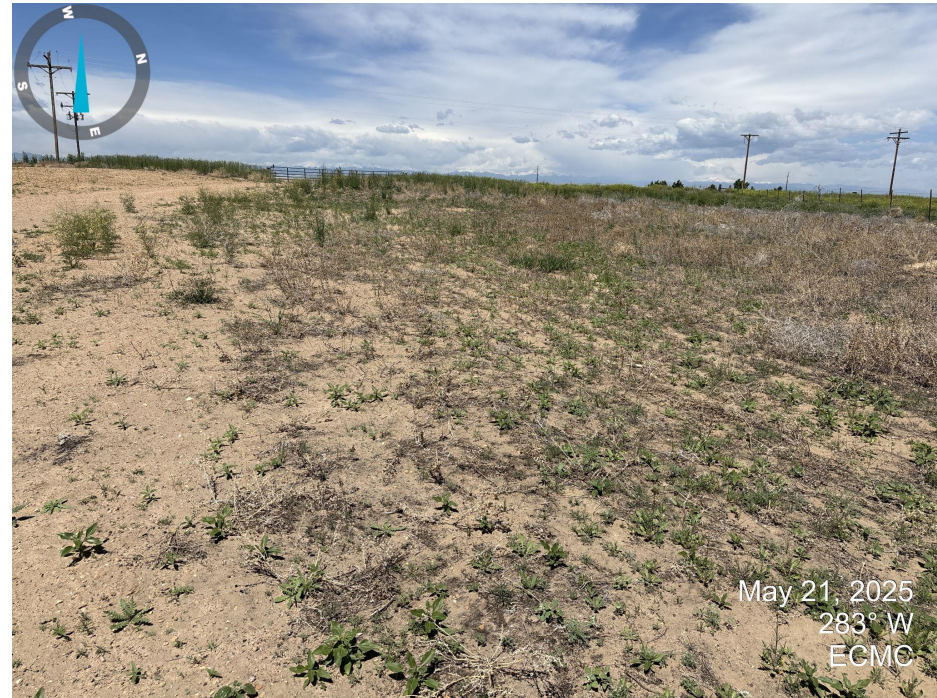
Photo 6. Looking west across the north side of the location. There is little perennial vegetation establishment in this area.

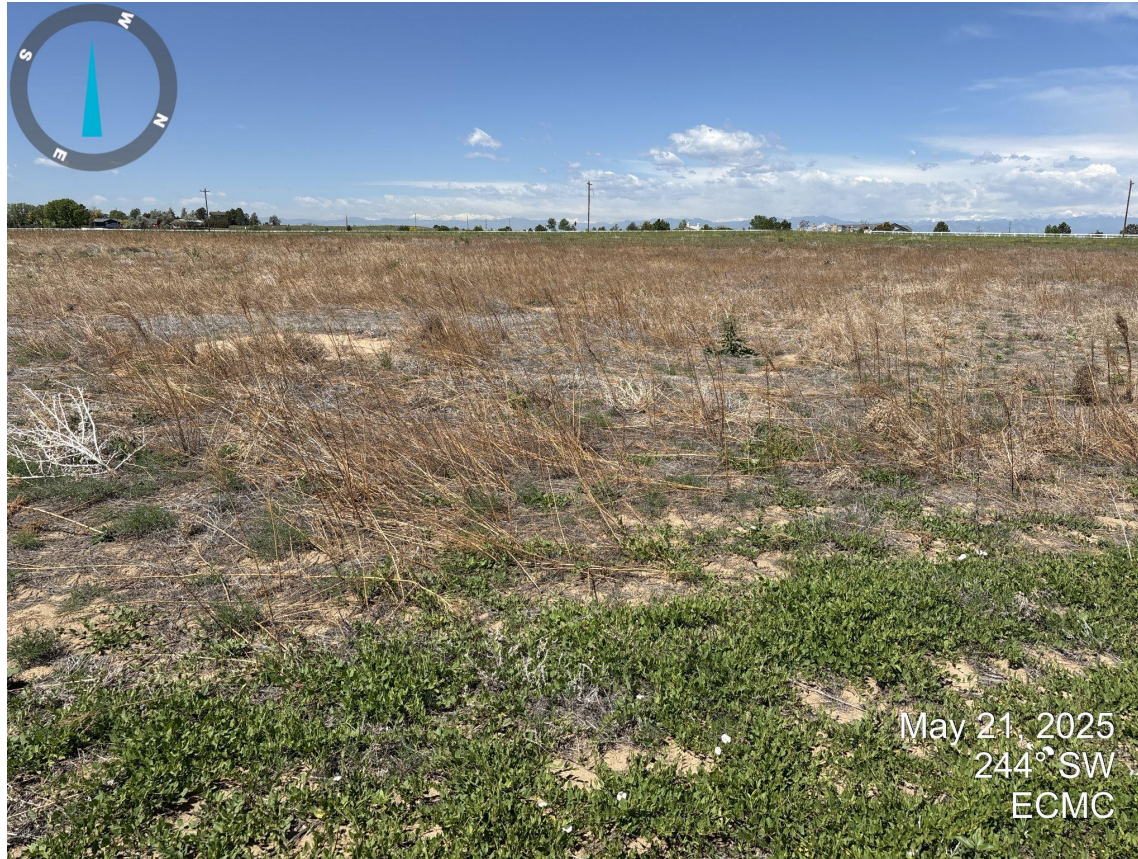
Photo 7. Reference vegetation to the south of the tank battery.
