WELL NAME: ITTY BITTY 12-31, API #: 071-08232, INSP. # 716301054

COLORADO
Energy & Carbon Management
Commission
Department of Natural Resources

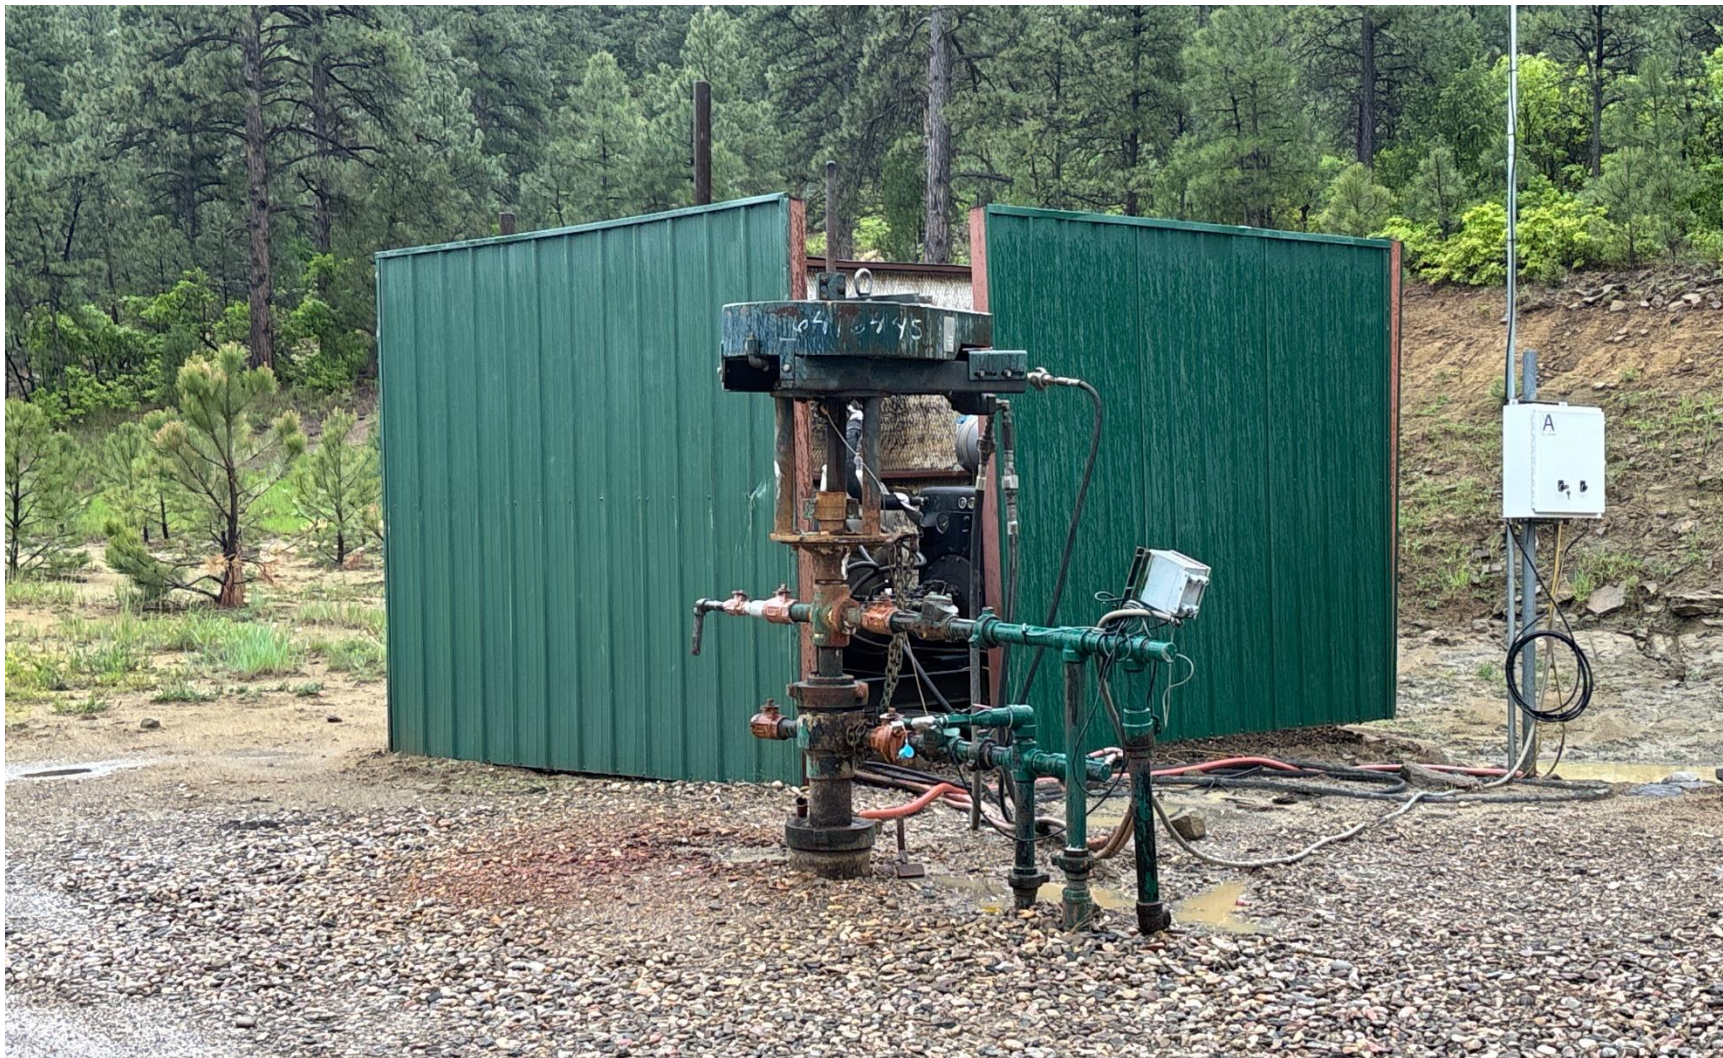
PHOTO 3: WELLHEAD AND EQUIPMENT.

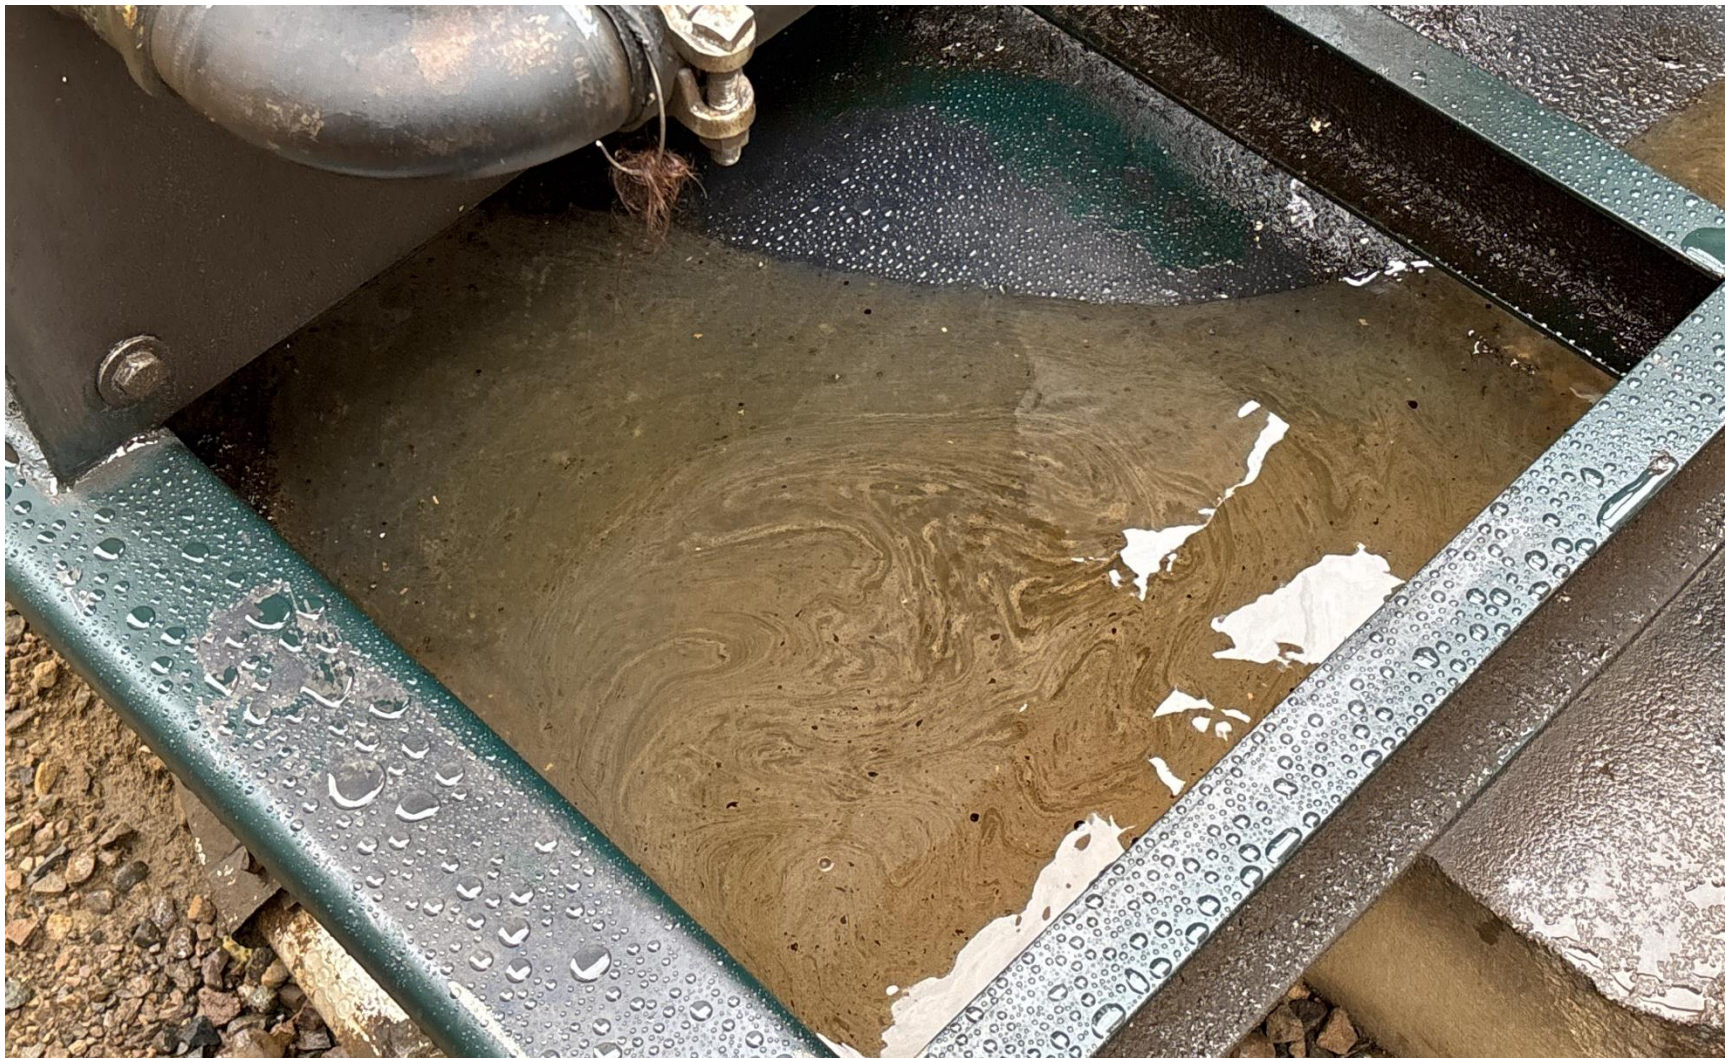
PHOTO 5: OILY WASTE IS PRIME MOVER ENGINE SKID (ALTHOUGH IT APPEARS THAT THE SKID HAS BEEN CLEANED SINCE LAST INSPECTION THE EQUIPMENT MAINTANANCE HAS EITHER NOT BEEN PERFORMED OR REPAIRS ARE INADEQUATE). DRAIN OILY WASTE REPAIR ALL LEAKS AND REMOVE IMPACTED SOIL PER RULE 1002..(2).D & 1002.f.(2)B, Comply with general provisions of the oil and gas act for wildlife protection AND SB-181. (THIS IS THE 3RD INSPECTION OF THIS EQUIPMENT WITH THE SAME COMPLIANCE CONDITIONS LEAKING EQUIPMENT MUST BE REPAIRED OR REPLACED. CA DATE 6/3/2025.
