Inspection Photos

Operator: FULCRUM ENERGY OPERATING- #10805

Location ID: 324754

Inspection Photos
Location Name: Spicer Pad
Location ID: 324754

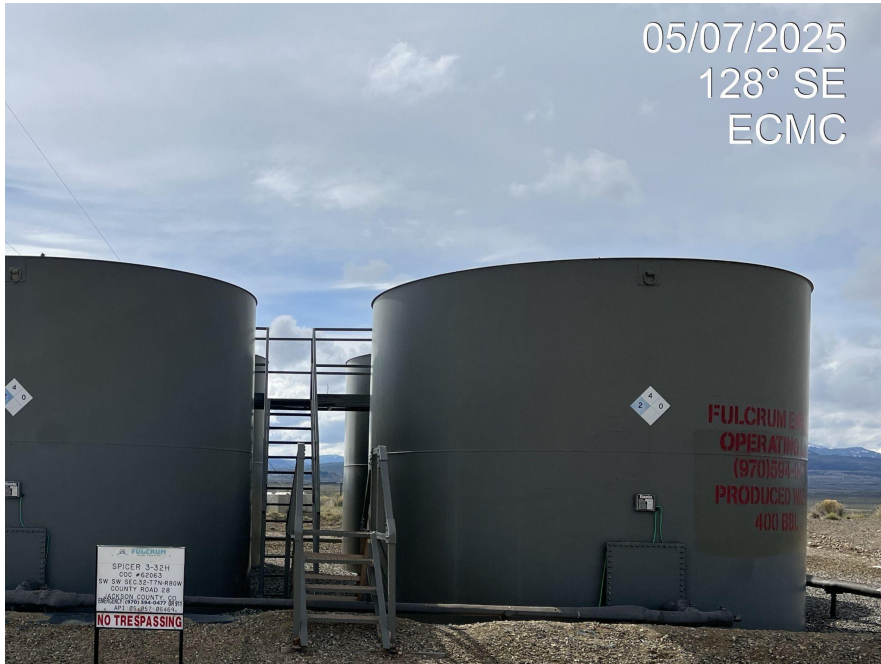
Photo 3. Photo taken at the tank battery. Well API # has been added to signage.

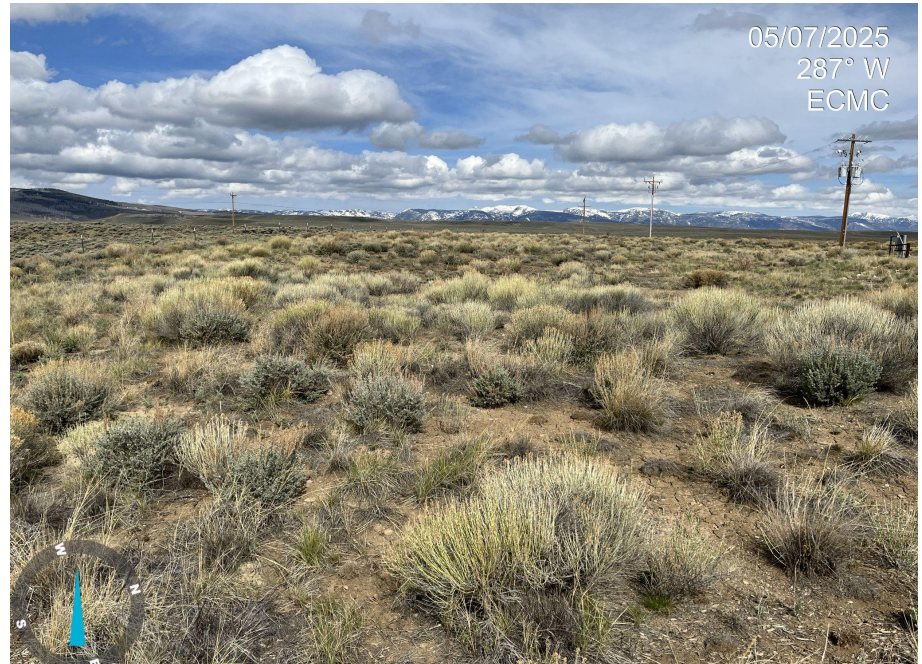
Photo 4. Photo taken from the entrance of the pad, facing west. Photo taken from the southeastern portion of the pad, facing west. Photo shows interim reclamation appears to be progressing towards 1003 standards.

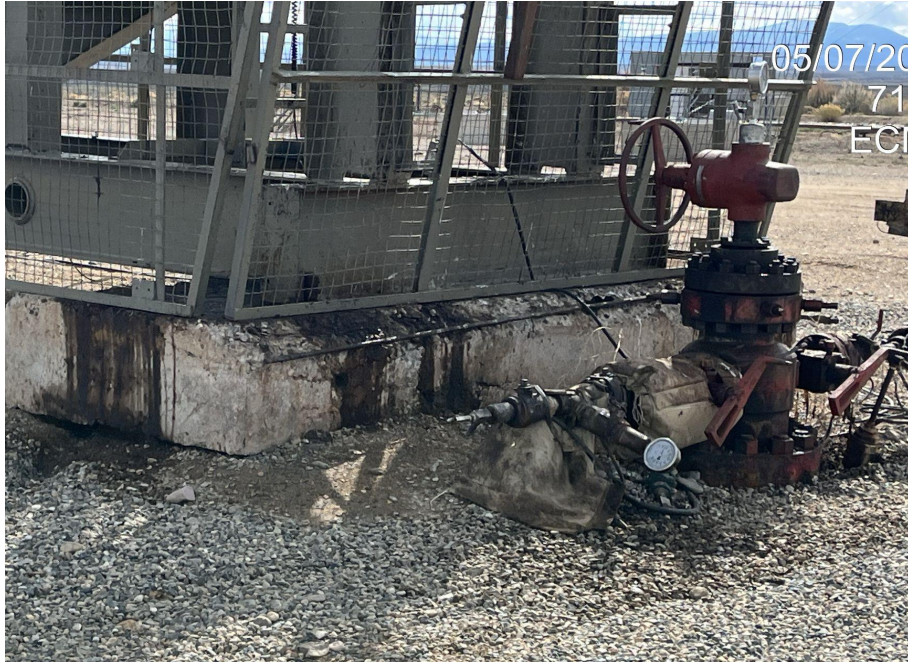
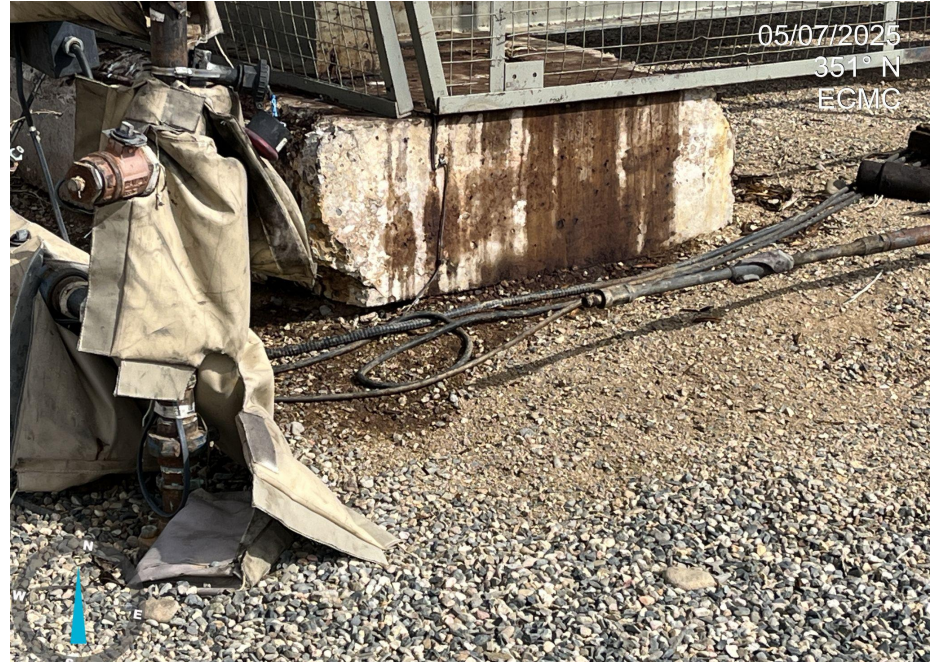
Photo 6. See comments under photo 5.

Photo 5. Photos 5-6 taken at the southwestern and eastern sides of the wellhead. Photos illustrates stained soils. Clean up soils pursuant to Rule 912 and maintain equipment per 608.e.

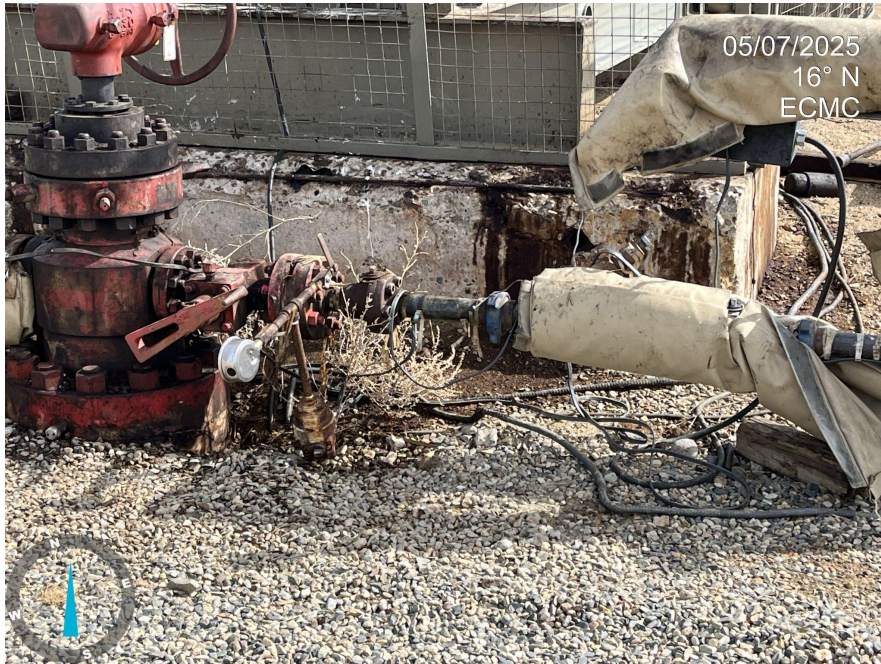
Photo 7. Photo taken at the wellhead. Photo illustrates weedy debris around well. Comply with Rule 606.

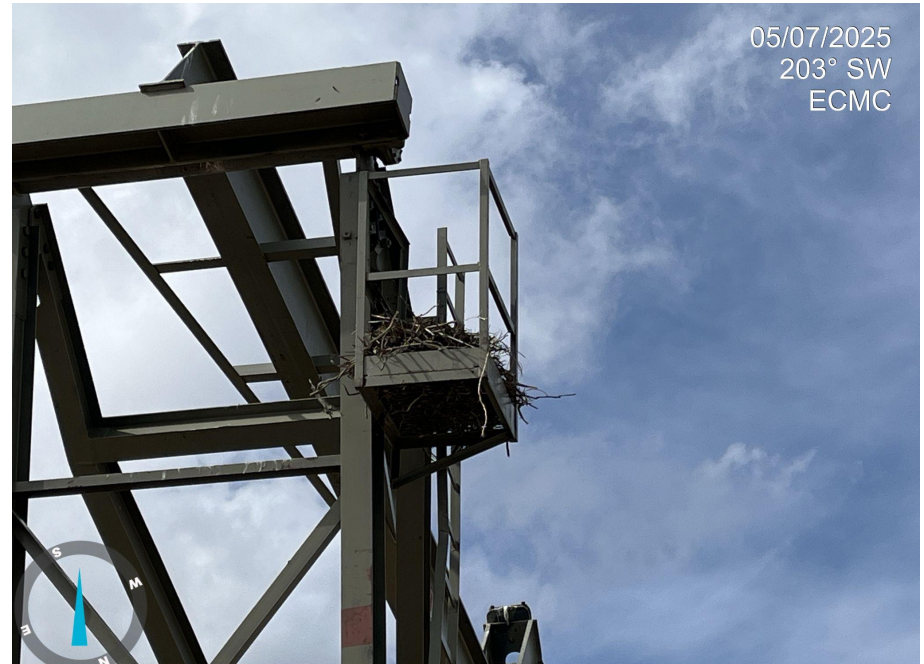
Photo 8. Photo taken at the northern side of the wellhead, illustrating an active bird nest on the pumpjack. Operator shall implement a work zone buffer and wait until fledglings are no longer present to continue operations pursuant to Rule 902.b.
