## Report of Work Completed – Flowline Release Investigation

<b>ECMC Location Name (ID)</b>	N. Parachute/EF P27 595 (335806)
<b>Operator Location Name</b>	P27 595 16C-27
<b>ECMC Spill/Release Point ID</b>	489807
<b>Legal Description</b>	SESE Sec. 27 T5S-R95W
<b>Coordinates (Lat/Long)</b>	39.579433 / -108.033247
<b>County</b>	Garfield County, Colorado

## Site Diagram - Site Investigation (P27 595 16C-27)

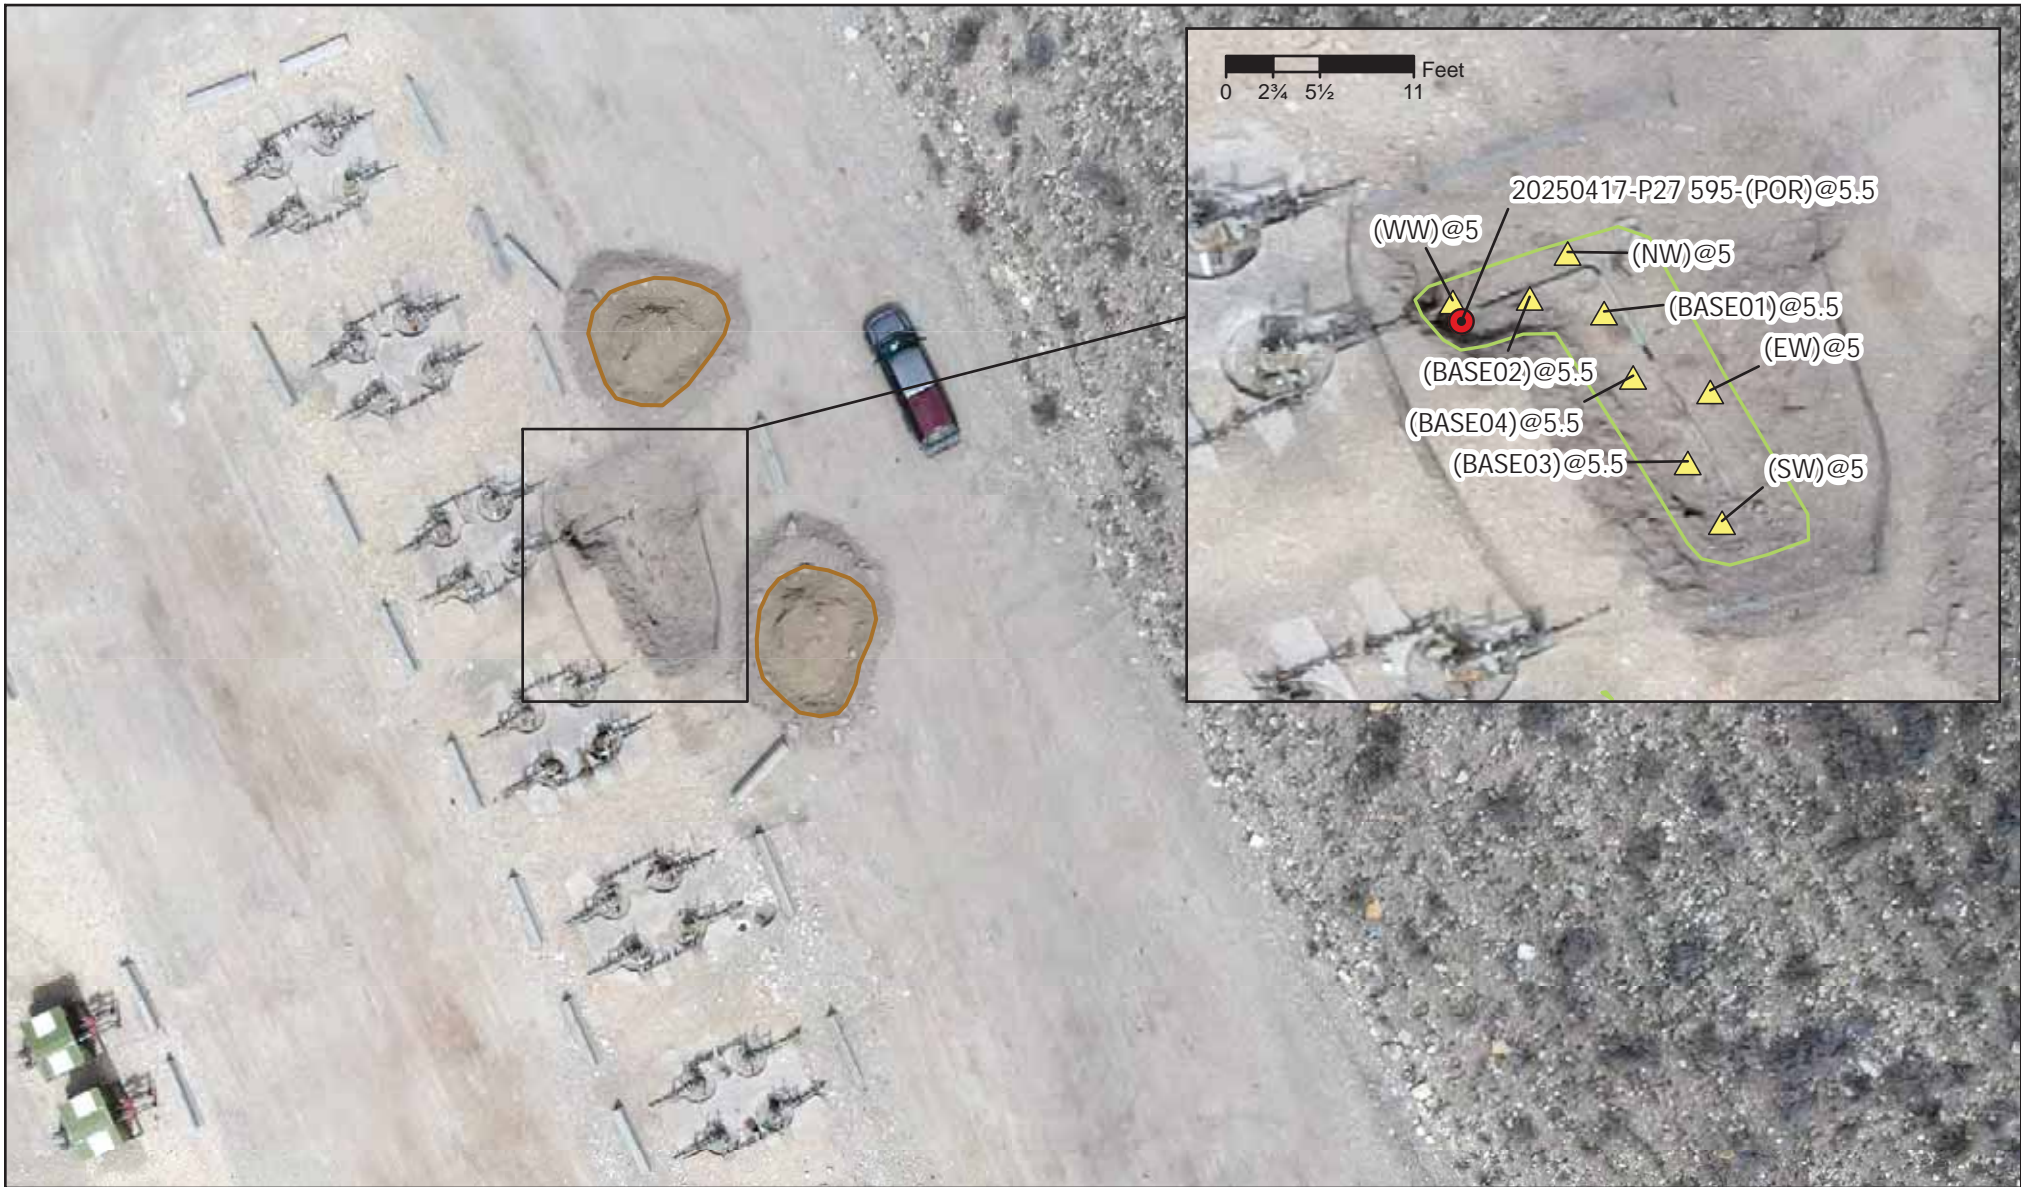
On April 17, 2025, Confluence completed initial site investigation activities to characterize potential soil impacts associated with the release. Prior to investigation activities, the POR was exposed using a hydrovacuum truck and the associated flowline was trenched to allow access for repairs. The trench base and sidewalls were field screened for evidence of impacts using visual and olfactory indicators, as well as a photoionization detector (PID). One discrete soil sample was collected from the most impacted area of the excavation as indicated by field screening, located directly beneath the POR at a depth of approximately 5.5 feet bgs. Additionally, one composite soil sample was collected from the approximate 70 cubic yards of excavated soil stockpiled on site.

-   Point of Release
-   Soil Samples: Field Screened Only
-   Excavation Extent: 04/17/2025
-   Excavation Stockpile: Composite Sample 20250417-P27 595-(STOCK)

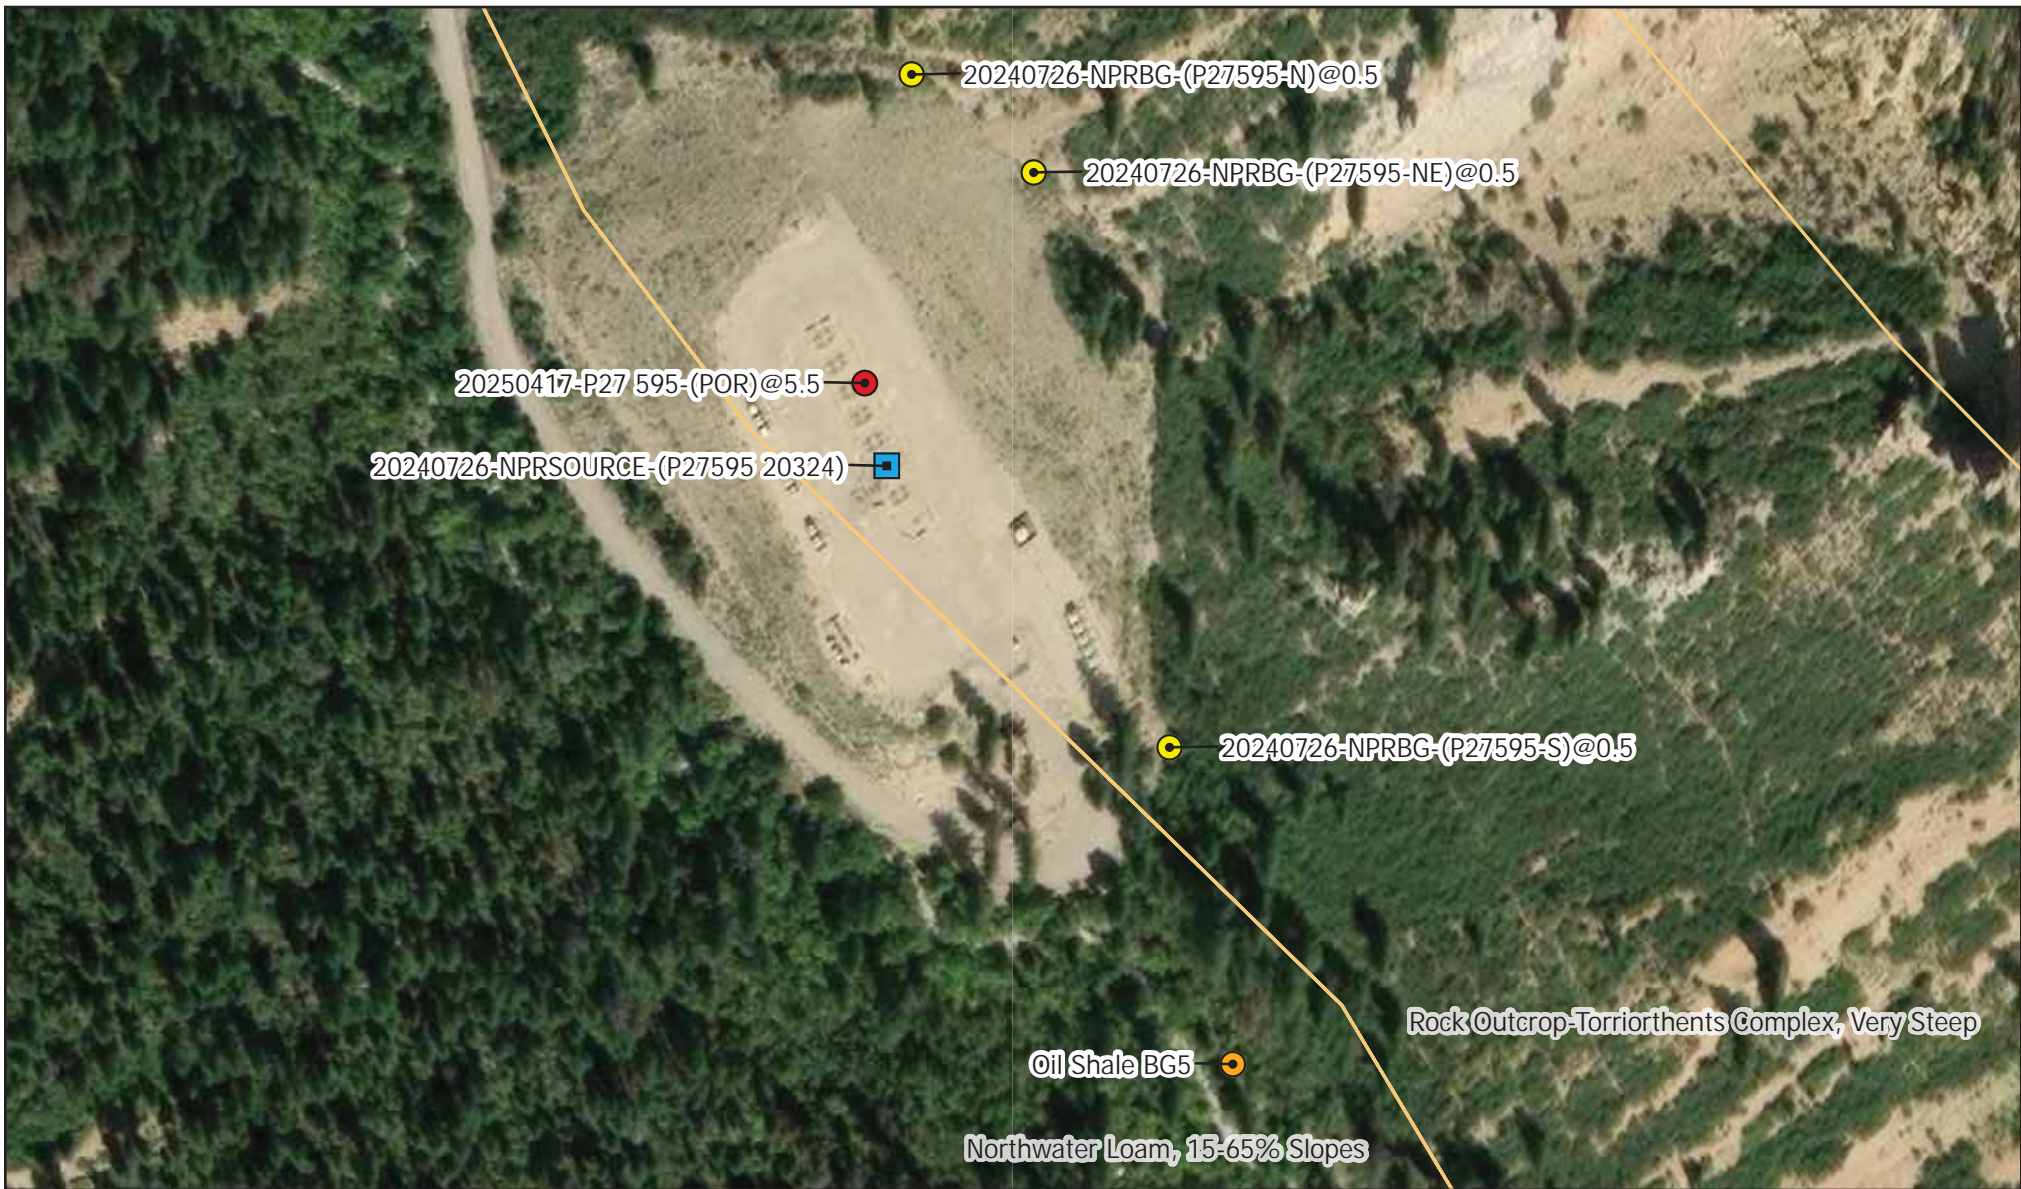
## Site Diagram - Supporting Samples (P27 595 16C-27)

Levels of arsenic exceeding RSSL remain within the investigation area. However, site specific background data indicates these results are within native levels at the Location. Background samples were collected less than 400 feet to the northeast and southeast of the Location, and the elevation difference of collected background samples compared to site investigation samples range from the same relative elevation as the Location to approximately 88 feet above the release area, indicating consistently elevated arsenic levels throughout the area. Background soil samples and the investigation area also share an identical soil type: Rock outcrop-Torriorthents complex with very stony colluvium and alluvium derived from calcareous shale parent material. For these reasons, it is reasonable to conclude that elevated levels of arsenic at the Location are consistent with native conditions. Confluence recommends that QB request an alternative allowable limit for arsenic of 36.23 mg/kg, in accordance with Table 915-1 Footnote 11.

- Point of Release
- Produced Water Sample
- Background Soil Sample
- Historic Soil Boring
- NRSC Soil Survey: Map Unit Boundary

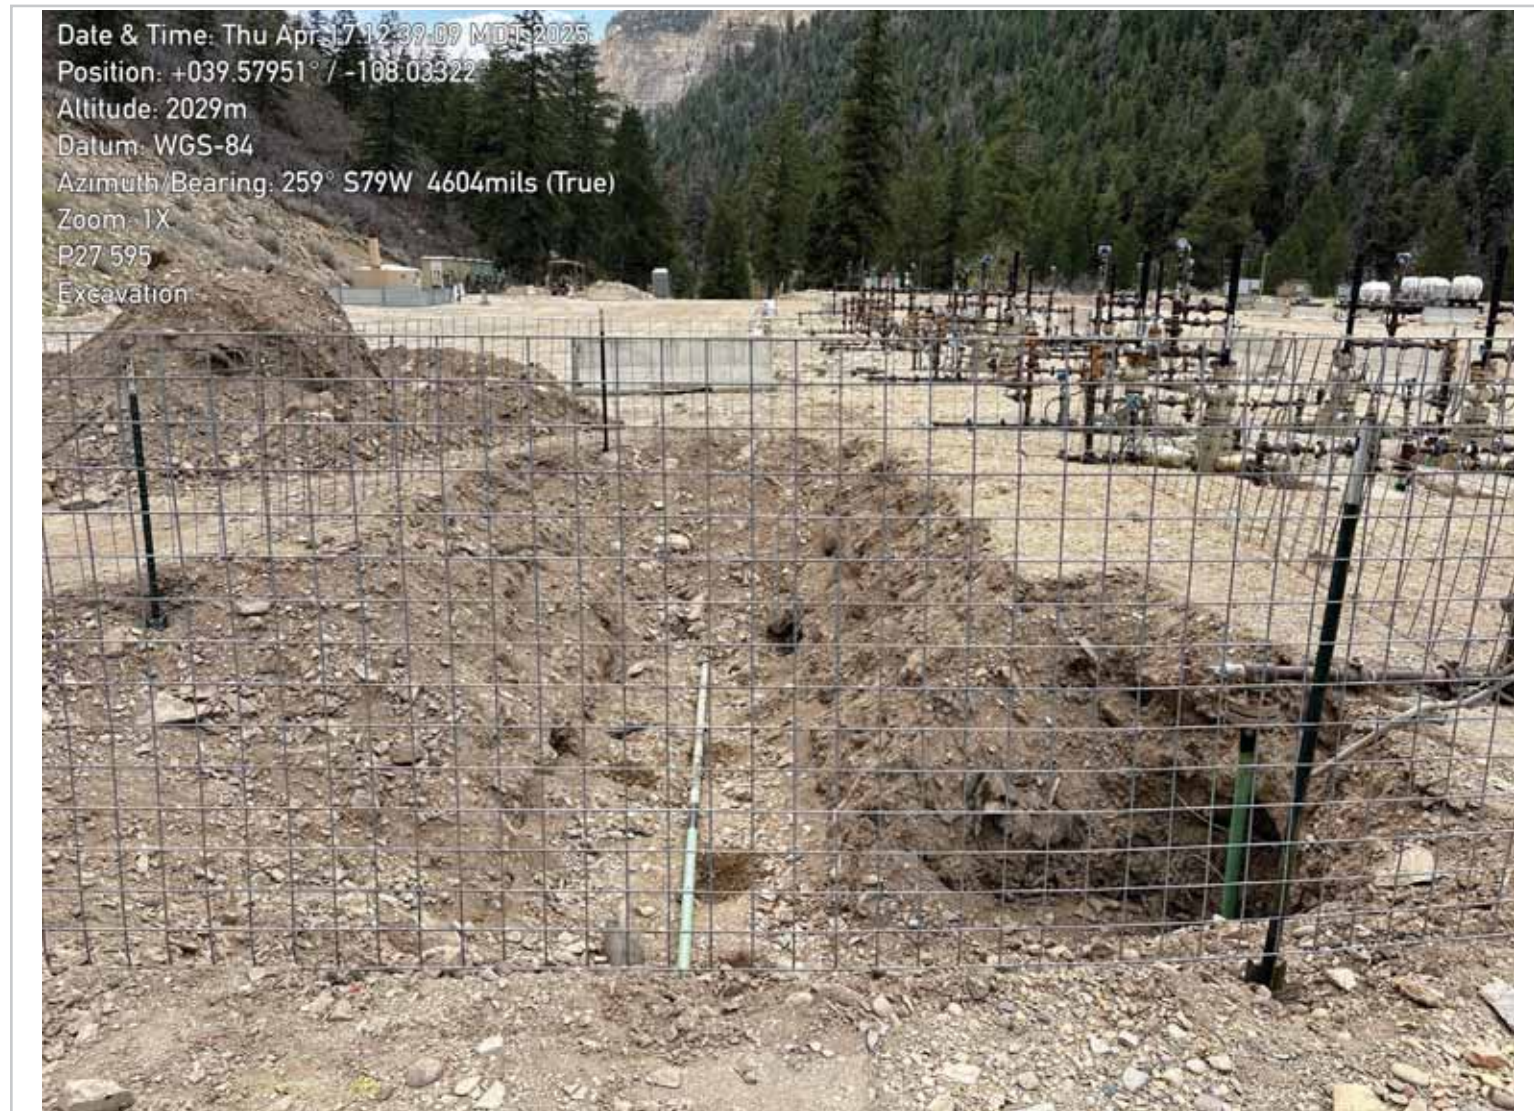
P27 595 16C-27 Excavation: View Southwest

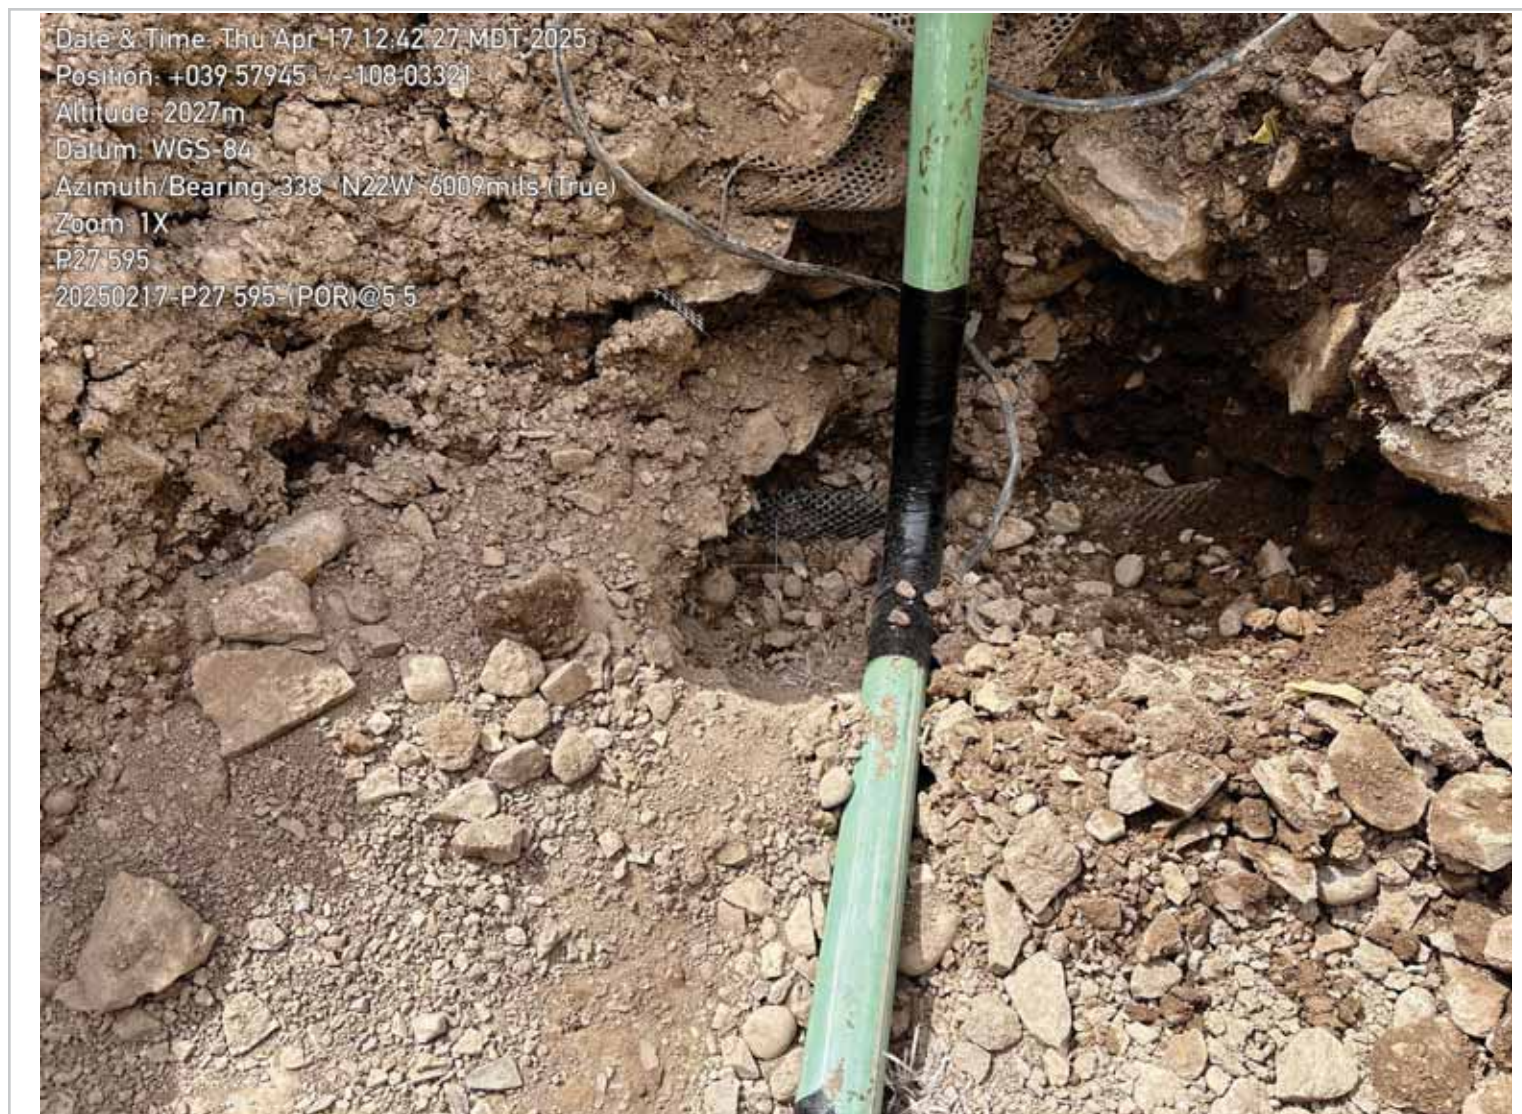
Field screening PID measurements range from 6.3 to 88.8 parts per million (ppm). Laboratory analysis of the soil sample collected beneath the POR indicates that concentrations of organic constituents are compliant with Table 915-1 Protection of Groundwater Soil Screening Levels (PGSSL), with the exception of the following compounds: benzene (0.15 milligrams per kilogram [mg/kg]), 1,2,4-trimethylbenzene (0.15 mg/kg), 1,3,5-trimethylbenzene (0.36 mg/kg), 1-methylnaphthalene (0.161 mg/kg), 2-methylnaphthalene (0.514 mg/kg), and naphthalene (0.290 mg/kg). Exceedances of metals above PGSSL include arsenic (22.35 mg/kg), barium (2,062.97 mg/kg), cadmium (0.56 mg/kg), lead (15.32 mg/kg), and selenium (5.41 mg/kg).

(POR)@5.5 Sample Location

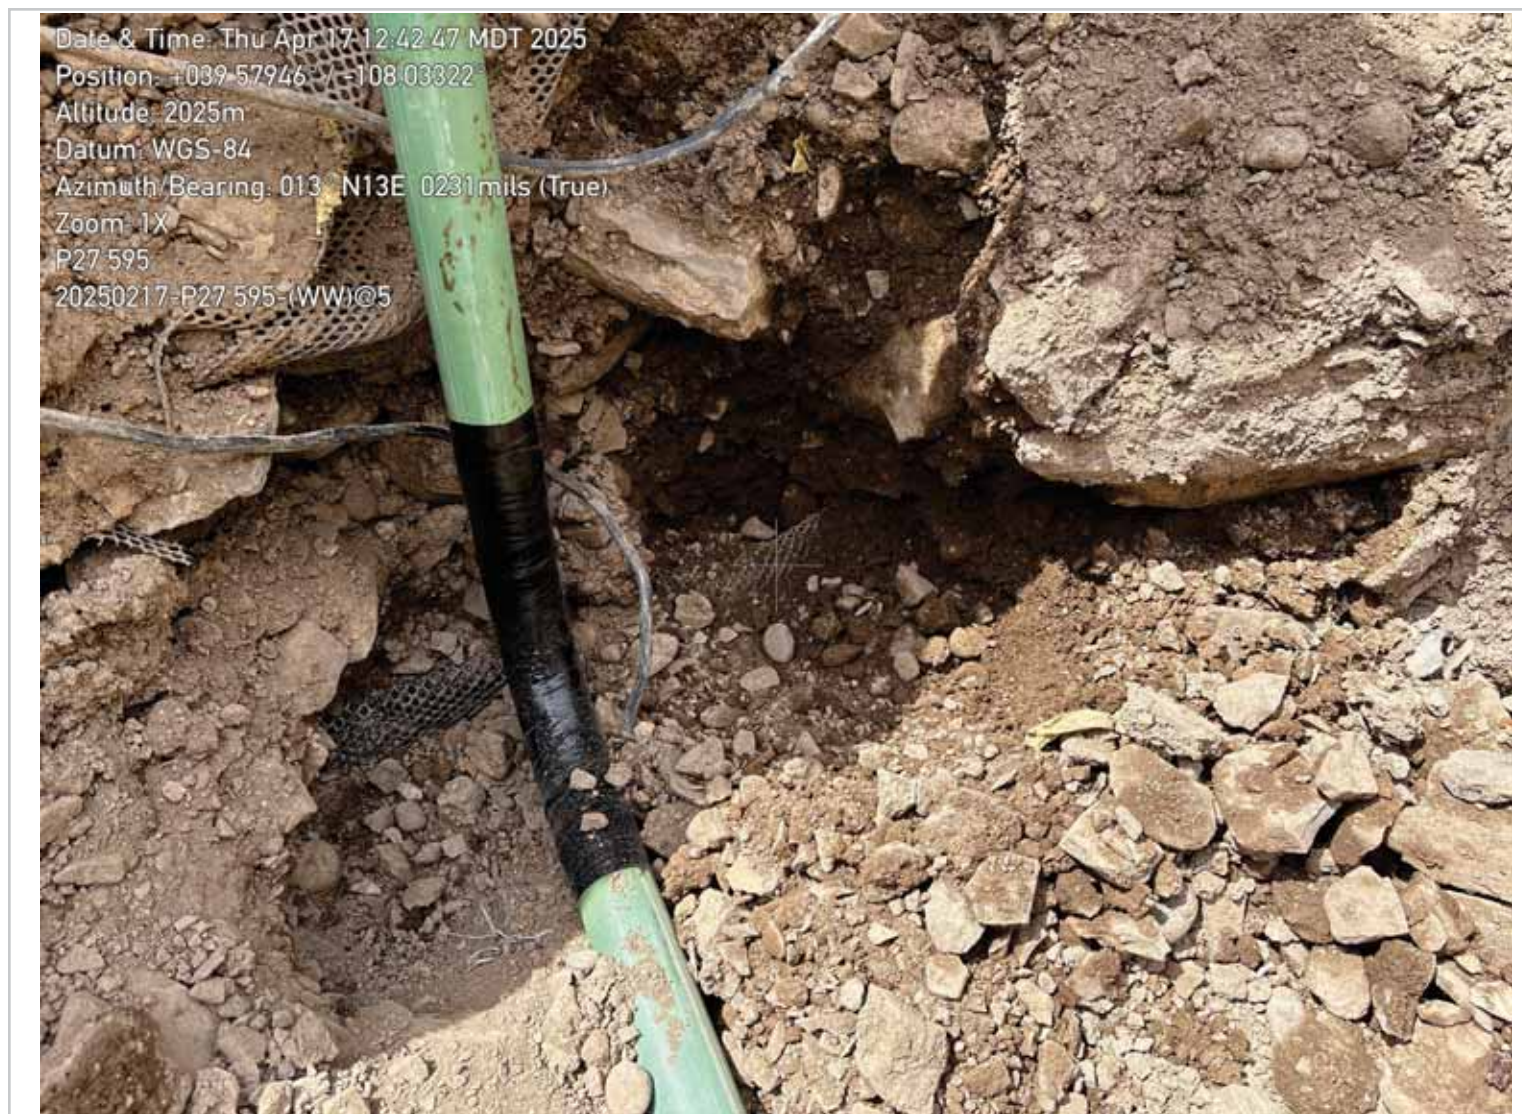
(WW)@5 Sample Location

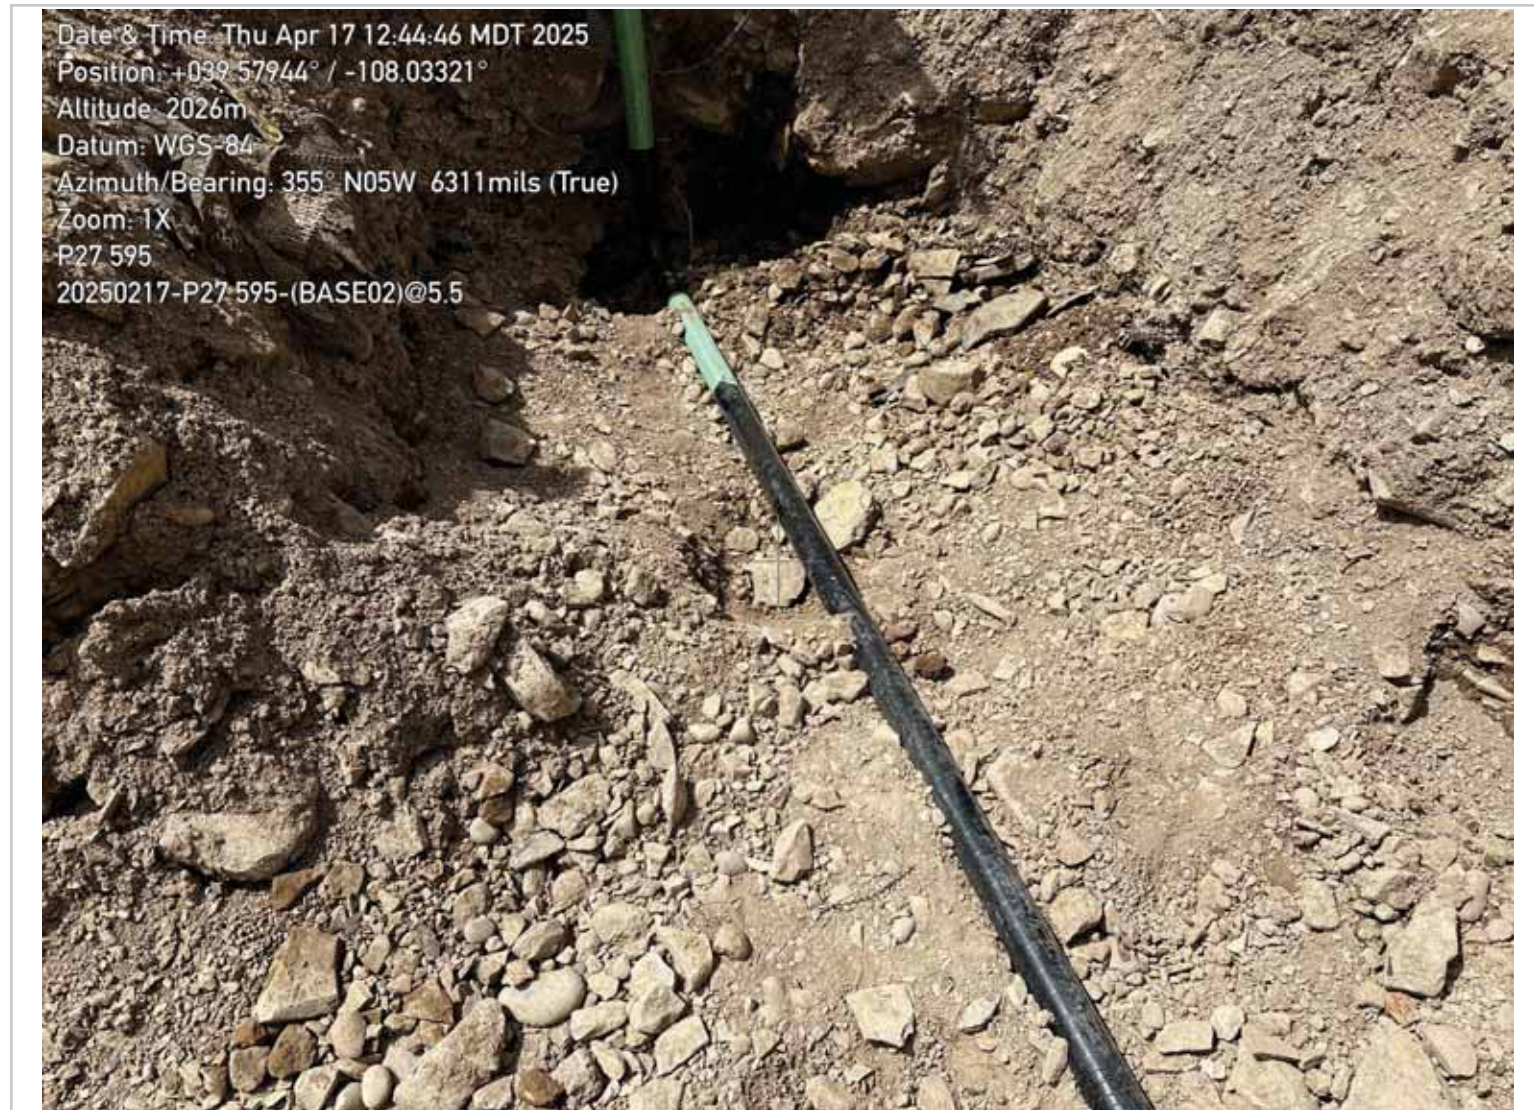
(BASE02)@5.5 Sample Location

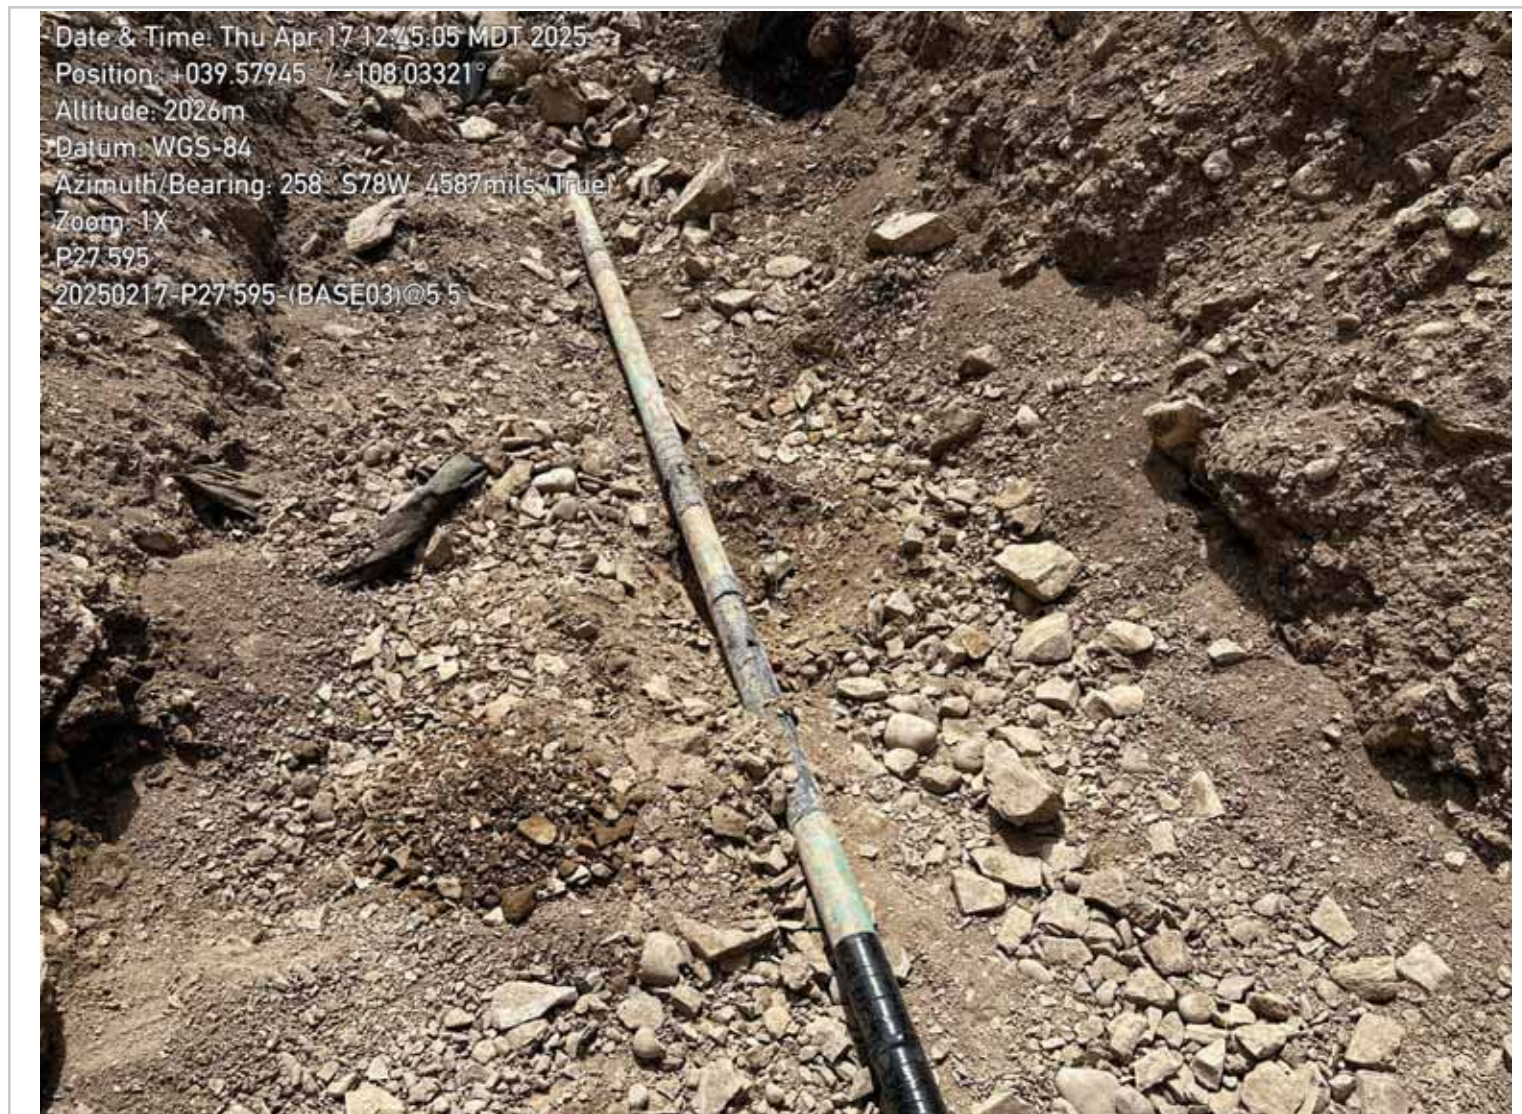
(BASE03)@5.5 Sample Location

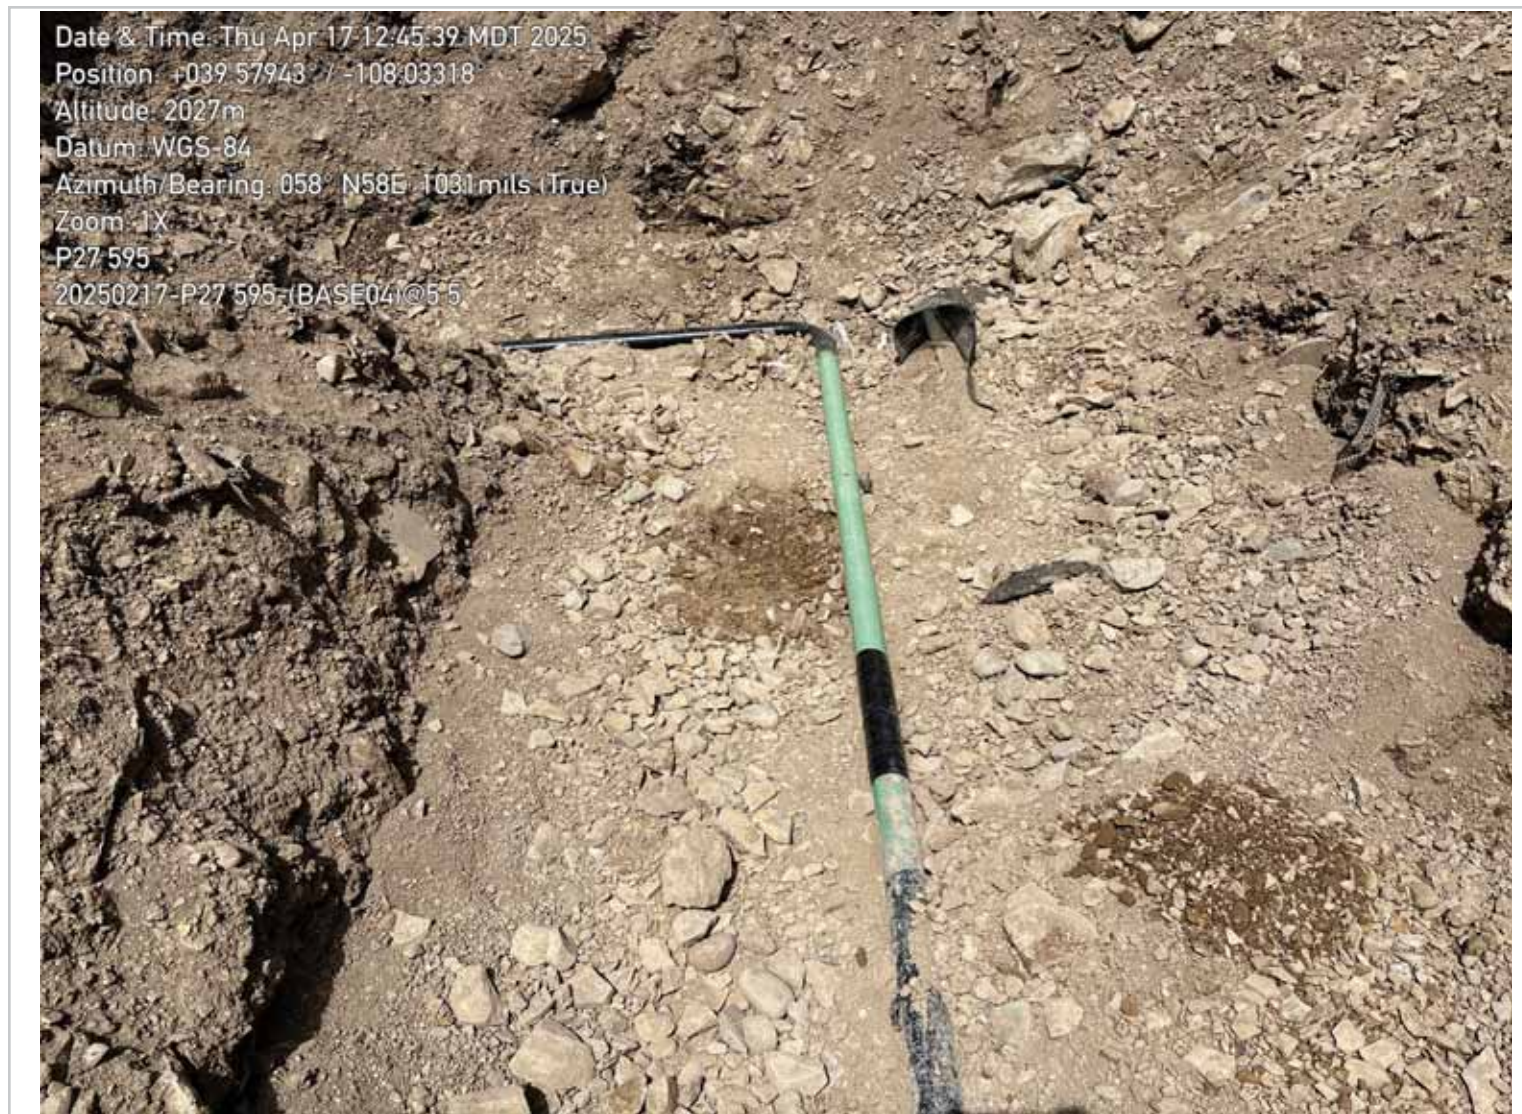
(BASE04)@5.5 Sample Location

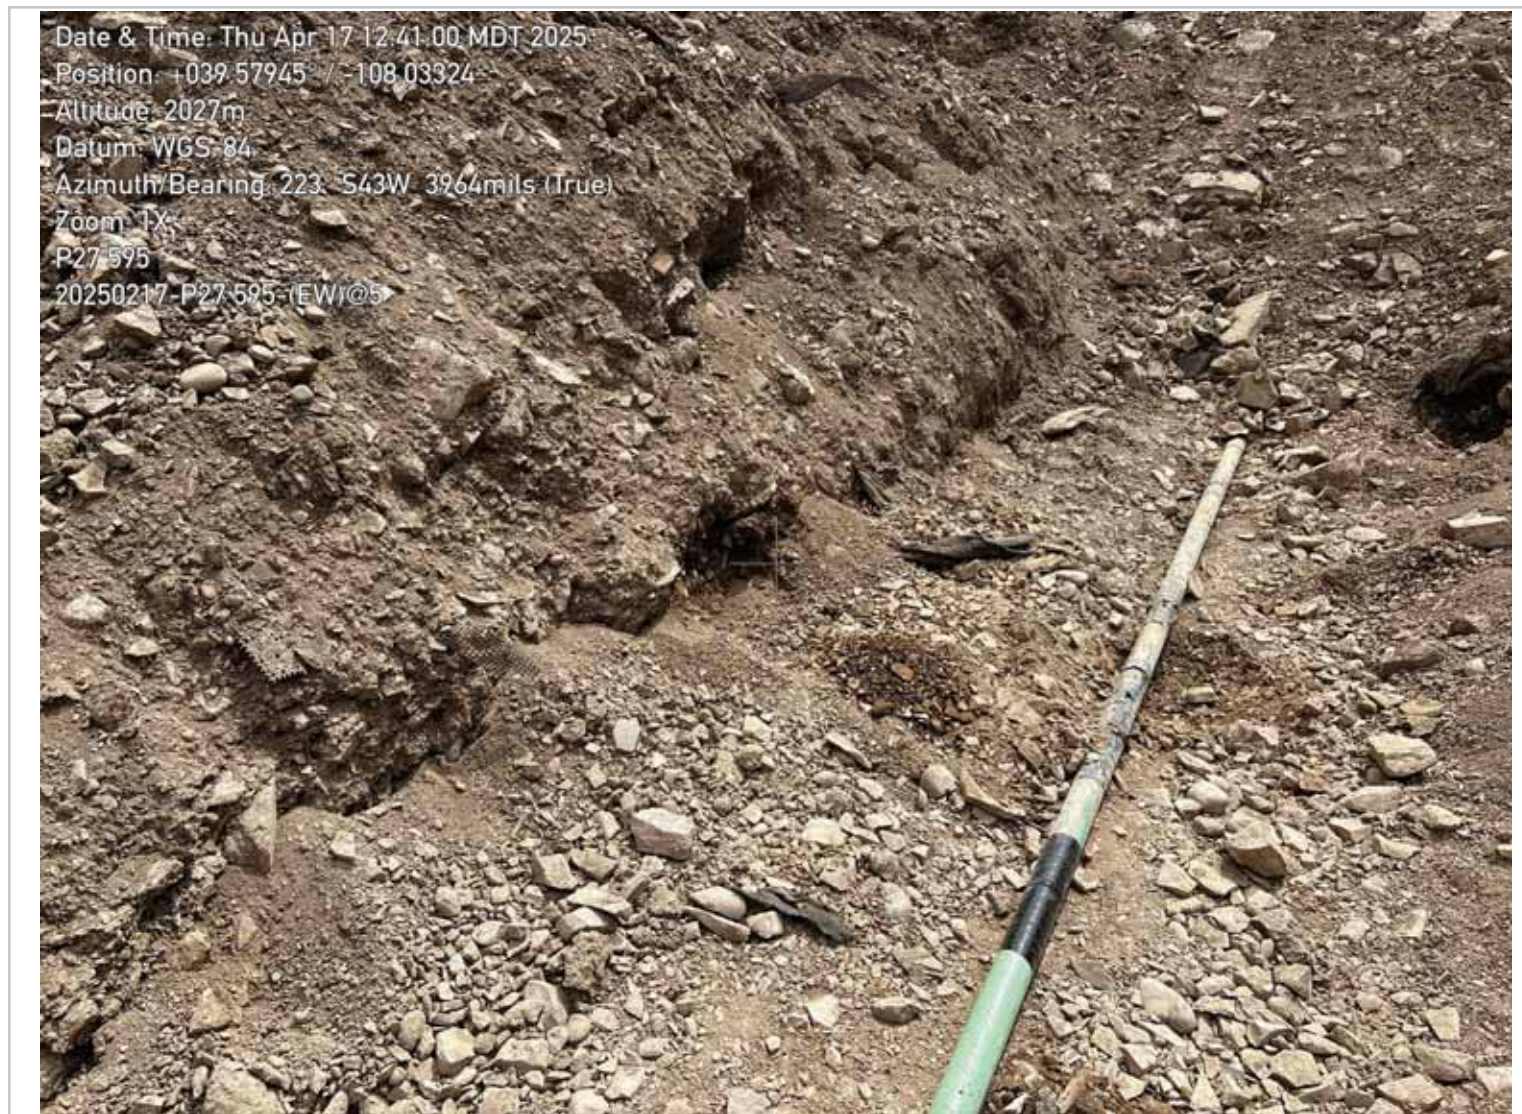
(EW)@5 Sample Location

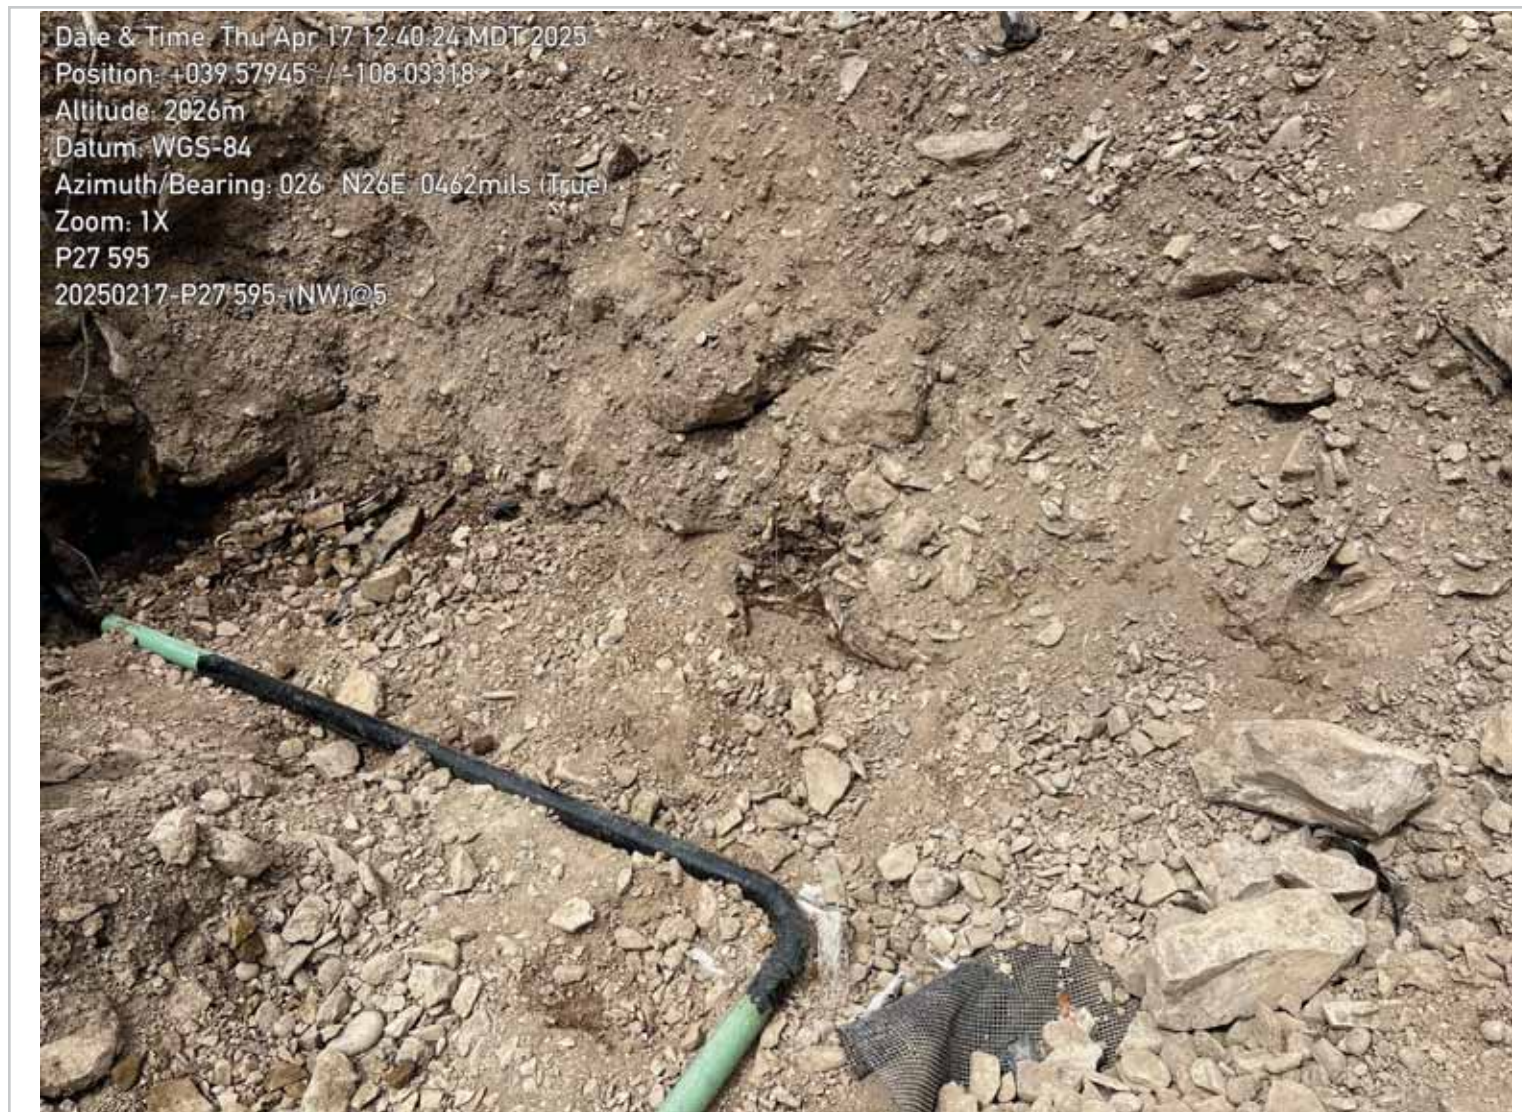
(NW)@5 Sample Location

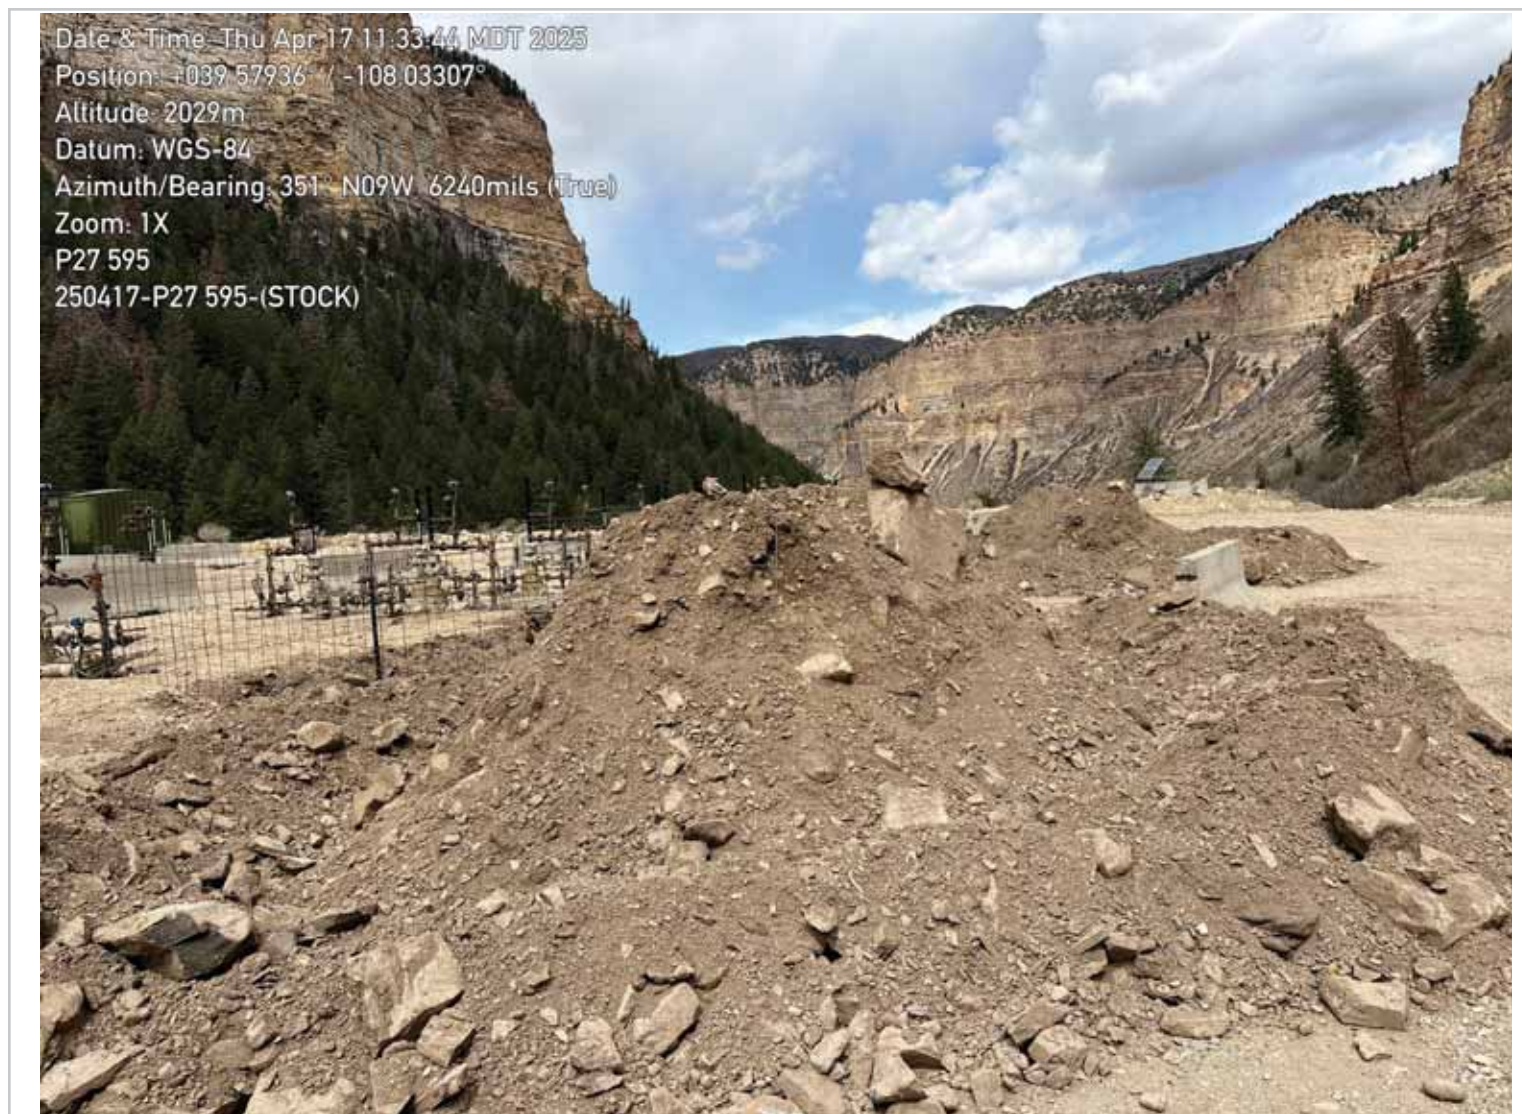
Field screening indicated a PID measurement of 4.3 ppm. Analytical results from the sample indicate compliance with PGSSL for all organic constituents, with the exception of 1,3,5-trimethylbenzene (0.014 mg/kg).

Analytical results of metals also exceeded PGSSL, including arsenic (21.26 mg/kg), barium (2,250.68 mg/kg), cadmium (0.48 mg/kg), and selenium (4.43 mg/kg). When compared to RSSL, the sample results meet allowable limits for all constituents except arsenic. Levels of pH exceeded the SSR standard with a value of 8.48.

Soil Stockpiles: View Northwest

Assuming the proposed screening levels, alternative allowable limit, and operator knowledge are approved, all constituents of concern are within Table 915-1 or proposed alternative allowable limits, including the stockpiled material. Based on this information, Confluence recommends that QB request closure of Spill/Release Point ID 489807 with a no further action (NFA) determination and request to utilize the compliant material as excavation backfill.
