# Final Reclamation and Stormwater Inspection

Location ID: 320334

Well Name: EDSTROM 24-8 #1

Inspection Document #: 718600643

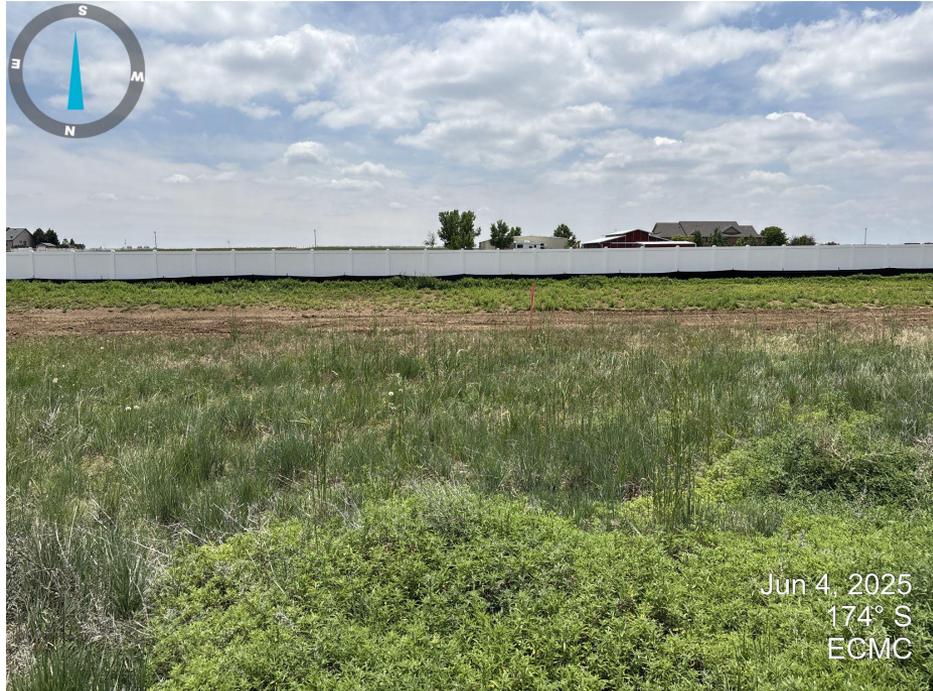
**Photo 1.** Looking south across the wellbore. Some desirable vegetation is present around the wellbore and appears to be progressing towards 80% of the reference area.

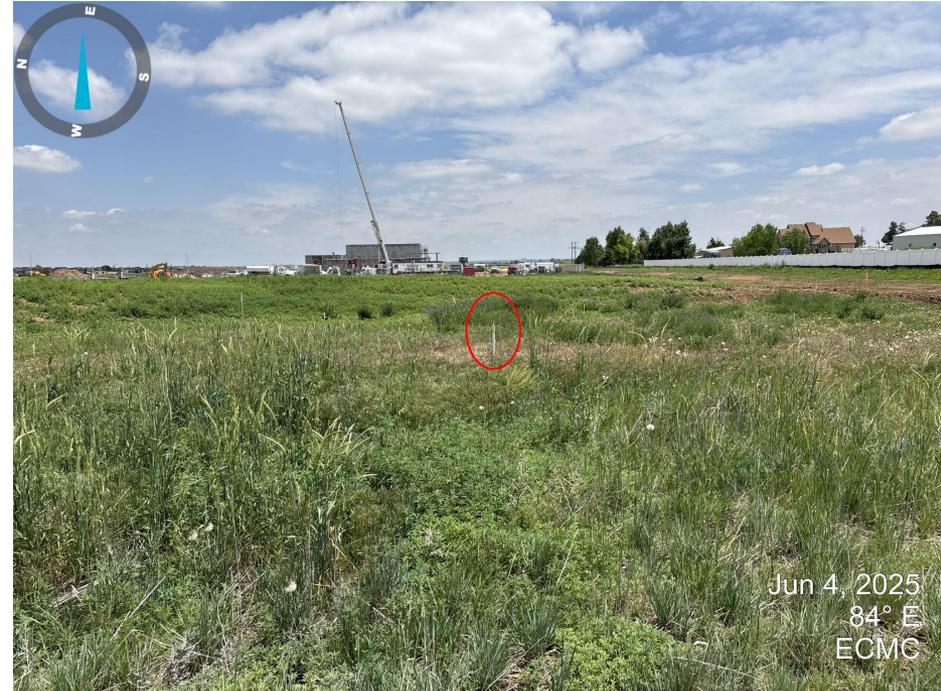
**Photo 2.** Looking east from the wellbore. A monitoring well is present approximately 50 ft east of the wellbore (red circle) and does not appear to be associated with the previous remediation project.

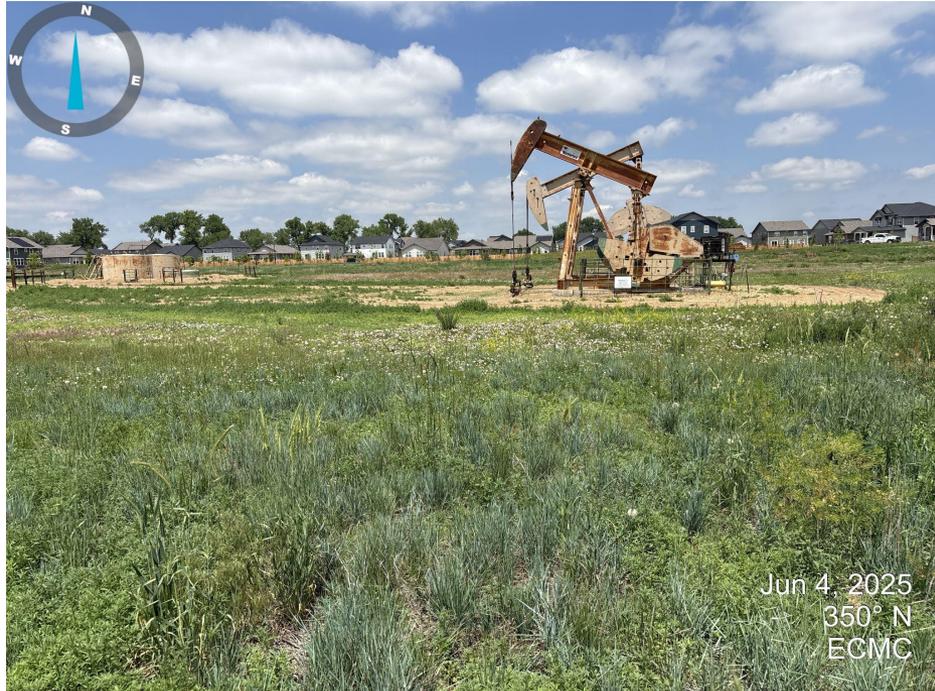
**Photo 3.** Looking north from the wellbore. This PA location is adjacent to active location ID 427862.

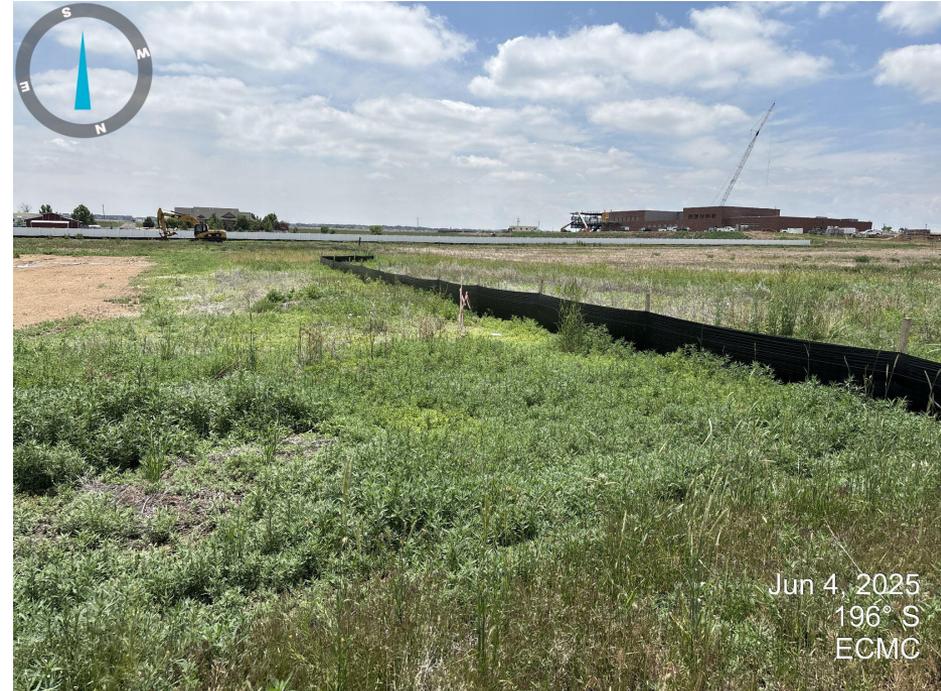
**Photo 4.** Looking south across the former tank battery location. Vegetation is primarily undesirable weeds such as Kochia with very little desirable vegetation establishment. . A black silt fence runs through the former tank battery area.

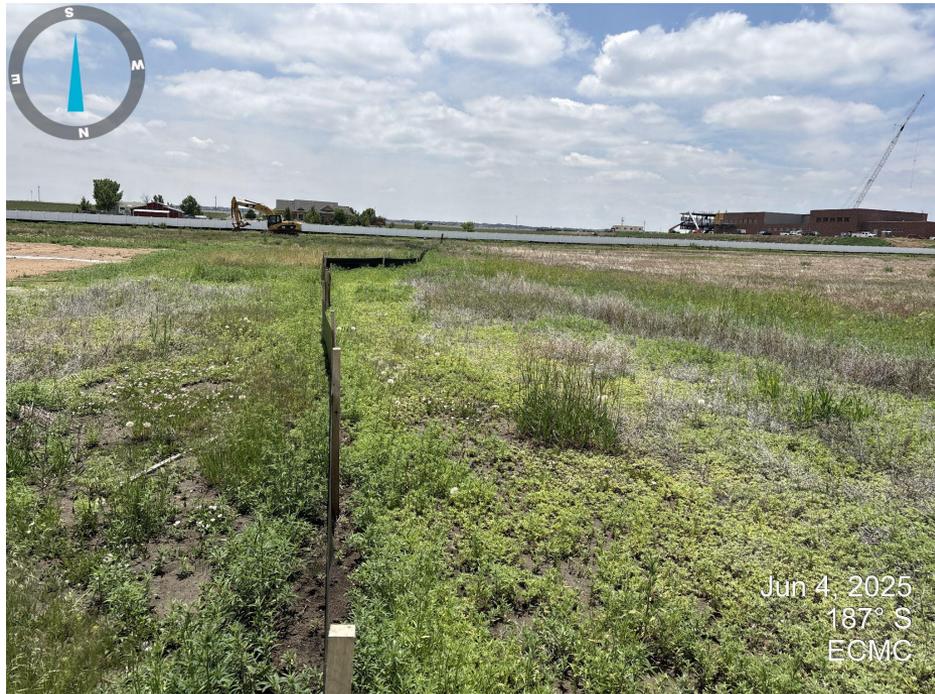
**Photo 5.** Looking south across the tank battery. See photo 5 comments.

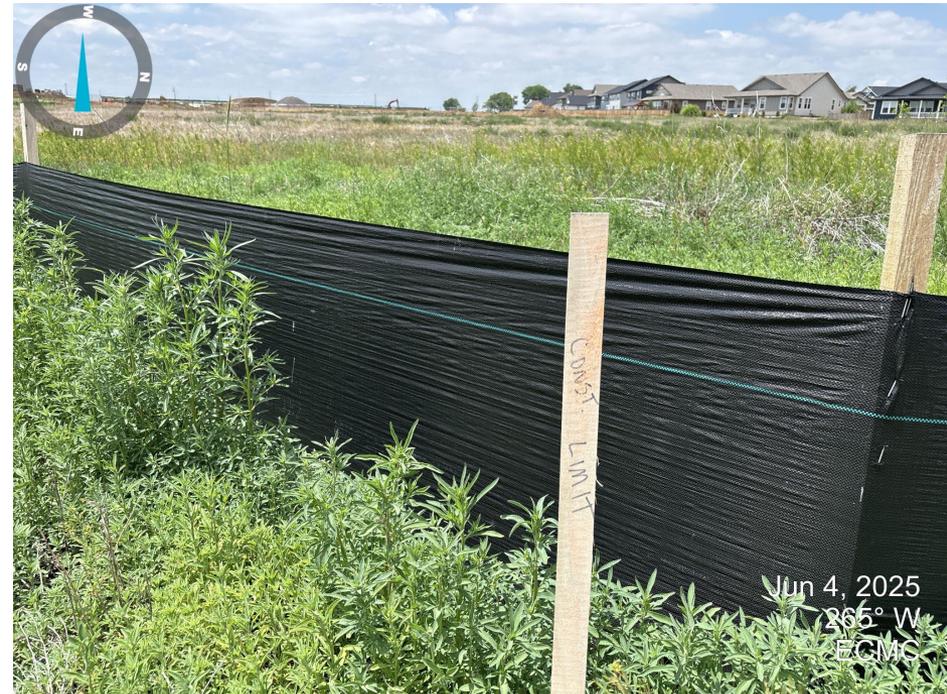
**Photo 6.** Near the silt fence on the tank battery, a marker labeled “const limit” is present.

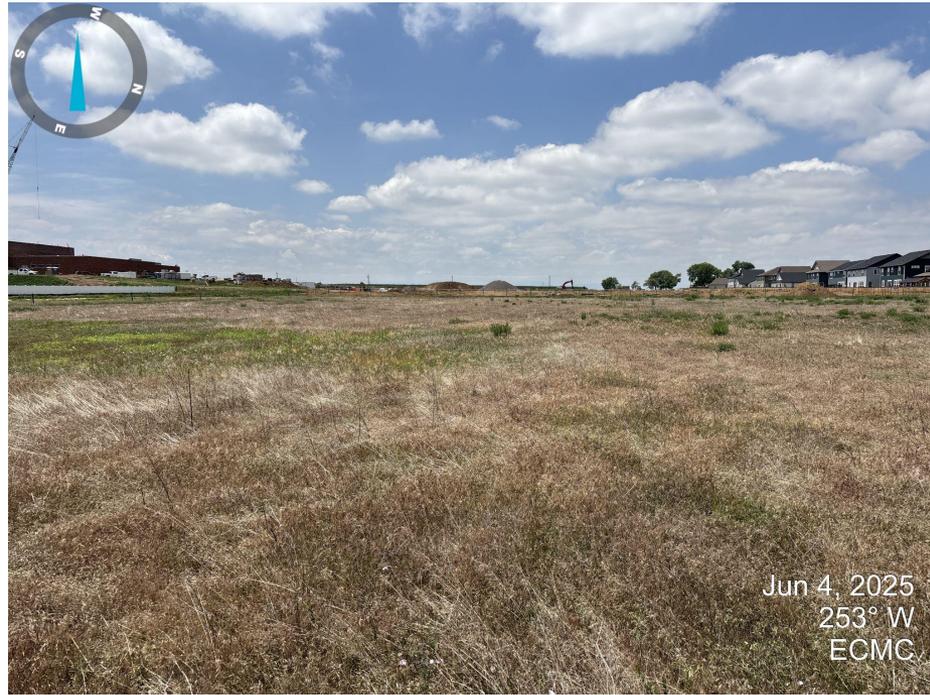
**Photo 7.** Reference vegetation to the west of the location.

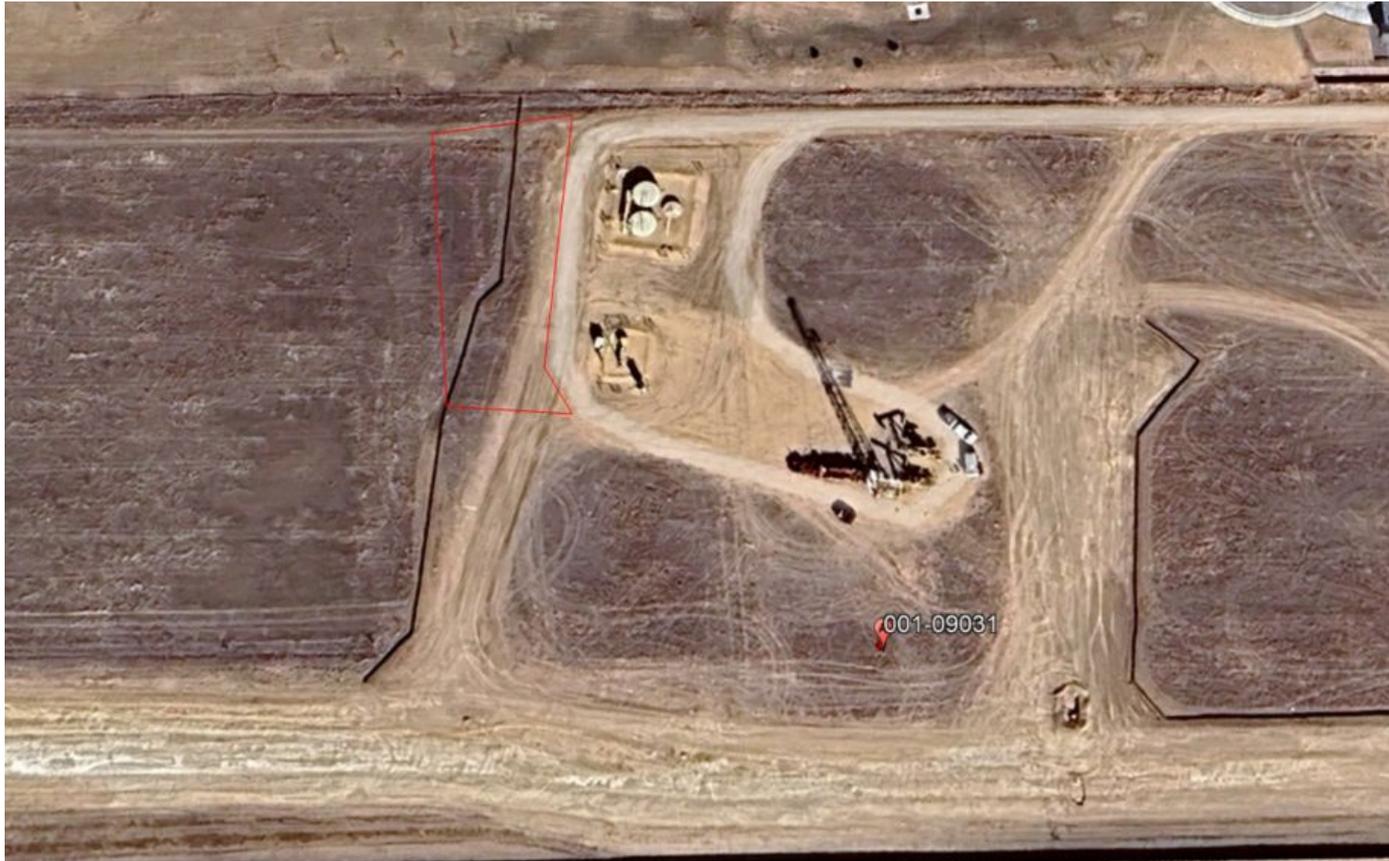
**Photo 8.** Google earth aerial imagery taken 03/2025. Silt fence with marker labeled “const limit” is present on former tank battery (red circle).
