Final Reclamation and Stormwater Inspection

Location Name: MCELWAIN #12-17

Inspection Document #: 718600651

Adams County, CO

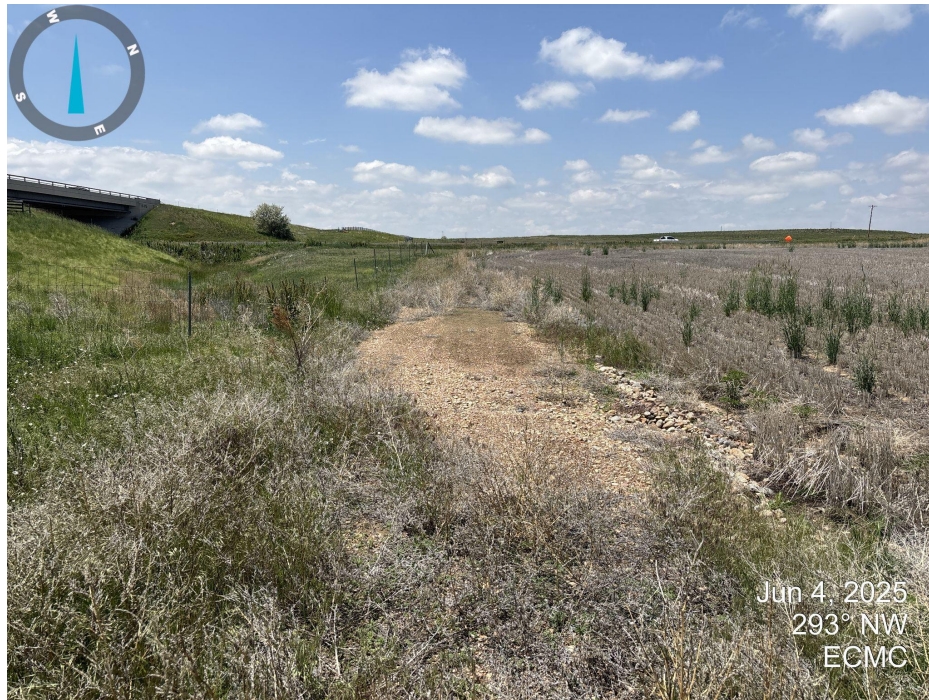
Photo 1. Looking west at the mid point of the access road where it crosses a low point in the field. A portion of the access road remains. Large cobble and gravel are present.

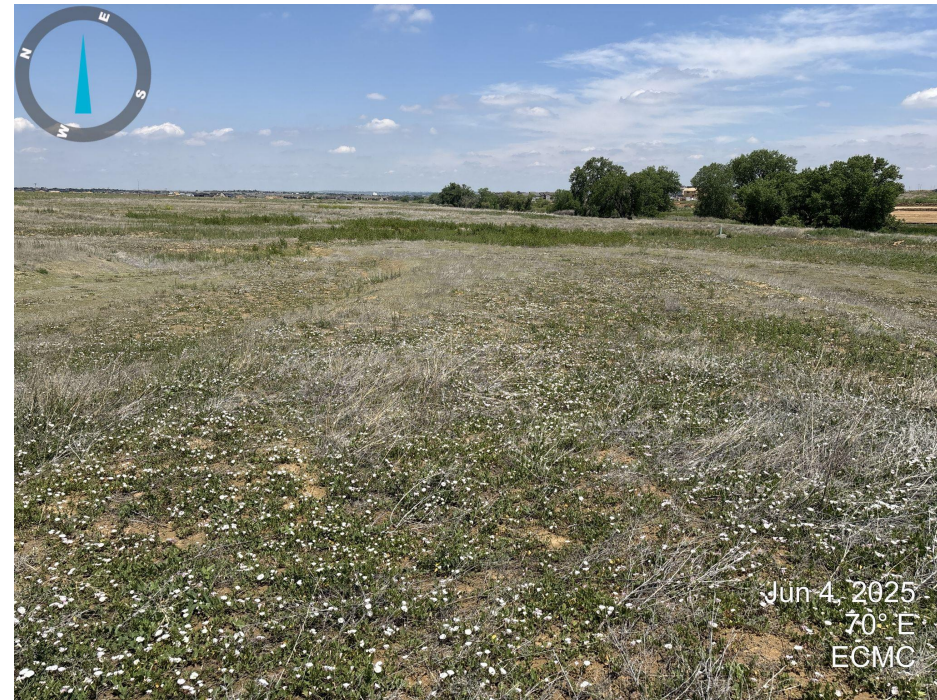
Photo 2. Looking east across the cogis location. GPS coordinates appear to be 50 ft offset from actual location.

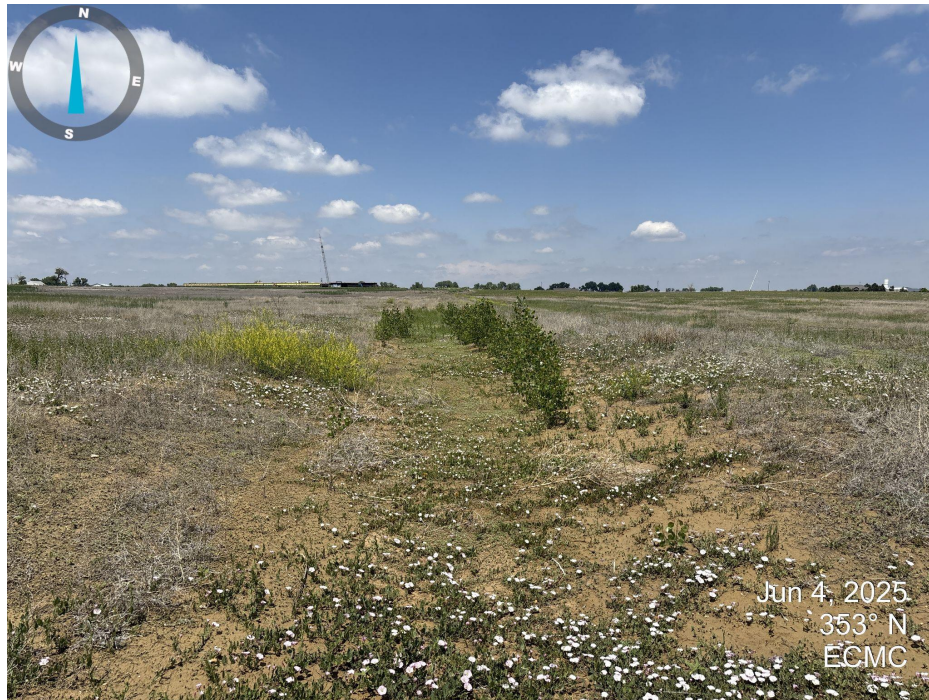
Photo 3. Looking north from wellbore according to imagery. Location appears to be within land use change involving significant earthworks. No oil and gas equipment remains.

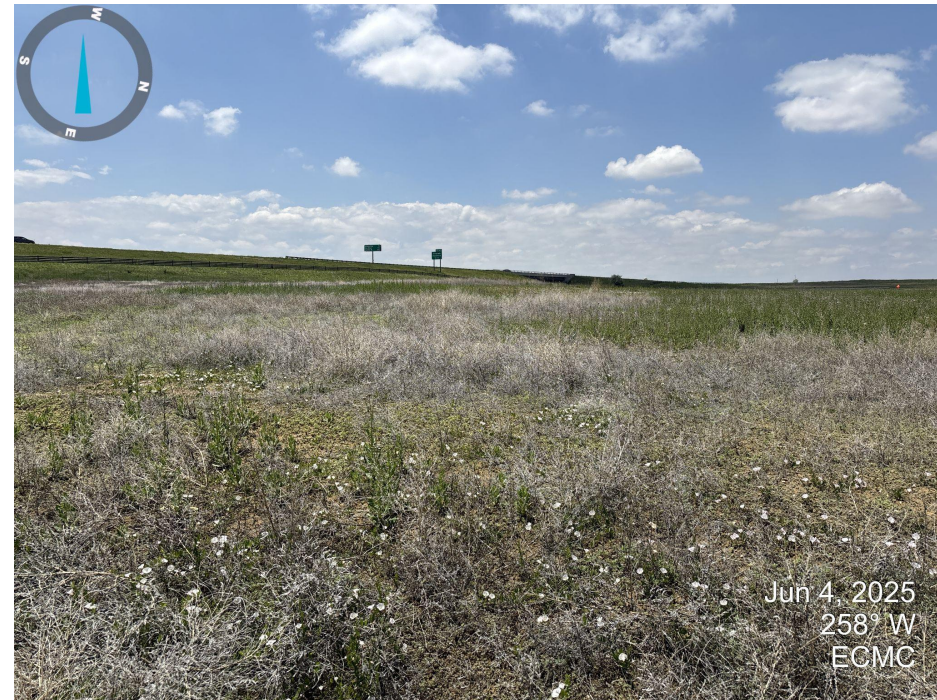
Photo 4. Looking west from the wellbore. See photo 3 comments.

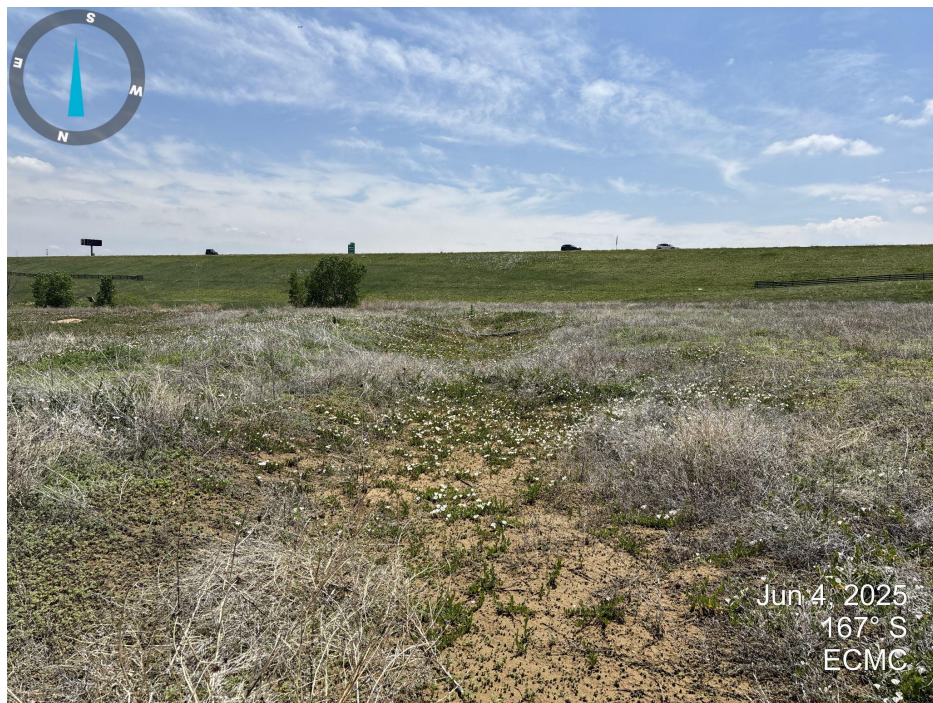
Photo 3. Looking south from the wellbore. See photo 3 comments.

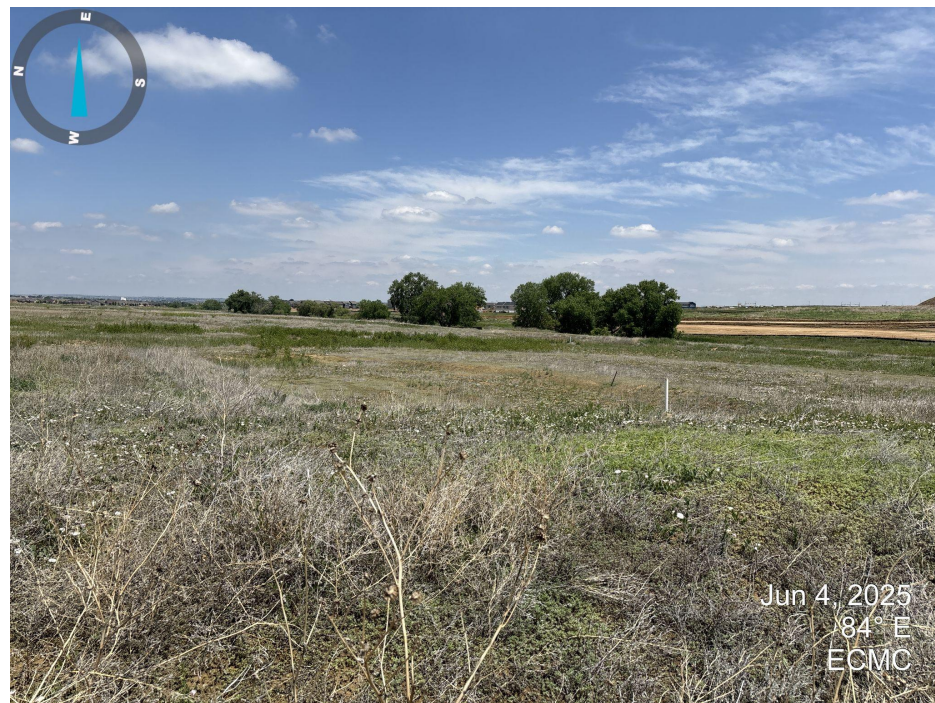
Photo 4. Looking east from the wellbore. See photo 3 comments.

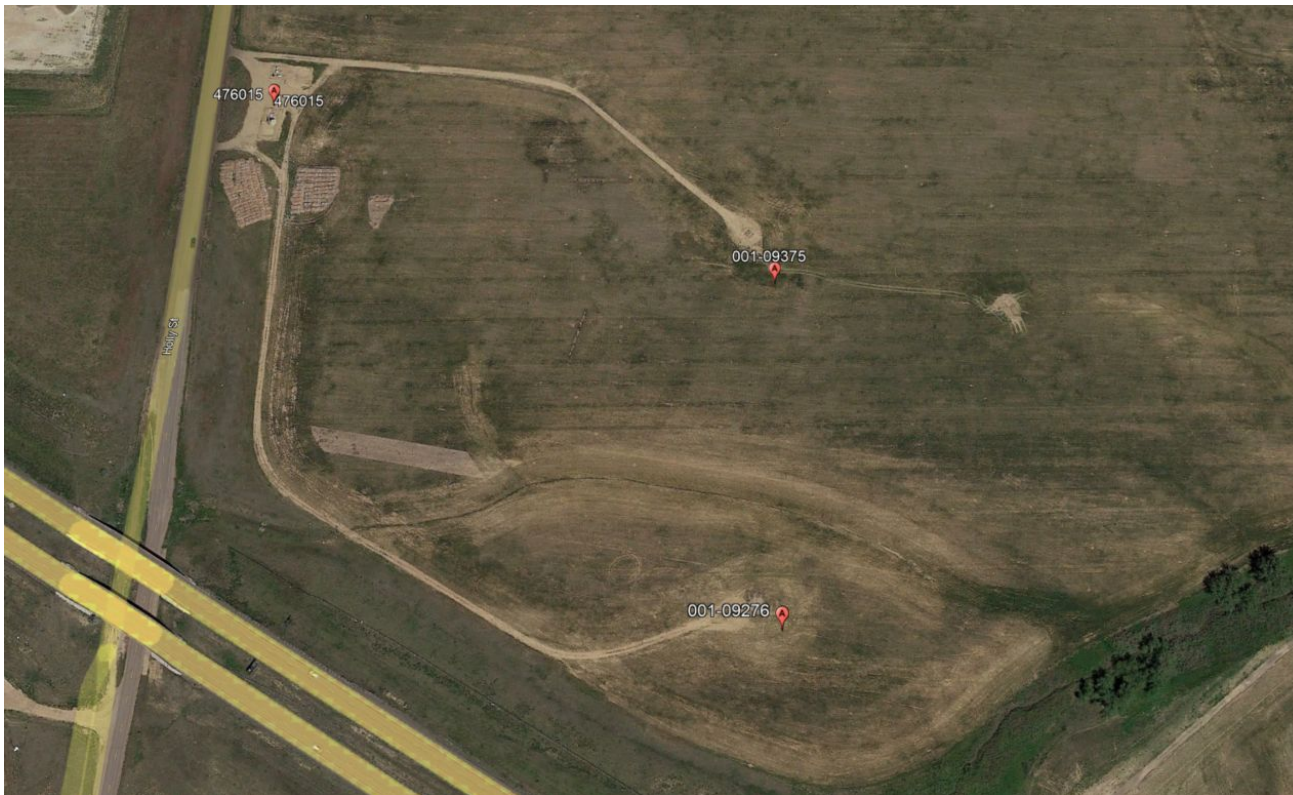
Photo 5. Google earth aerial photo taken 06/2017. Access road and well location are in cropland. GPS data of wellbore location appears to be approximately 50 ft off from imagery.

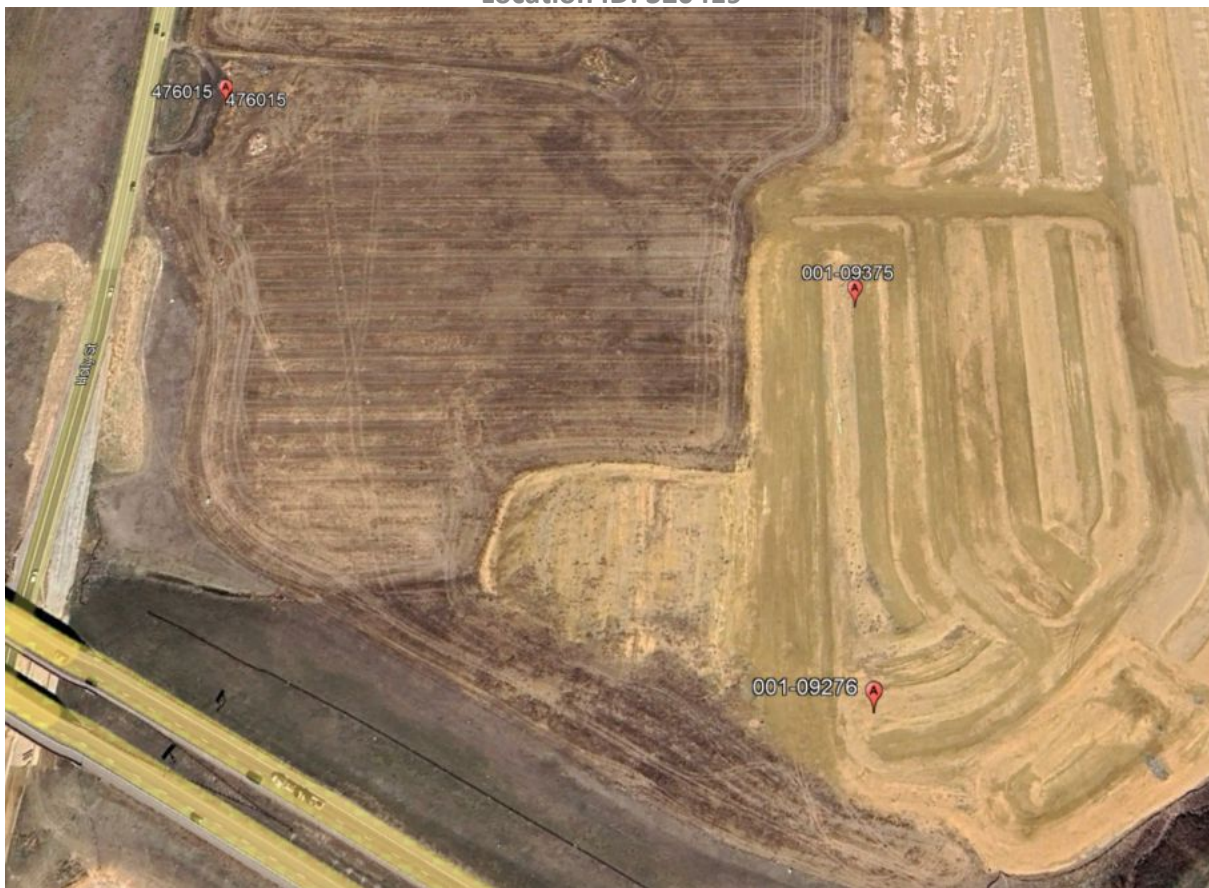
Photo 6. Google earth aerial photo taken 03/2025. Location appears to be located in land use change with significant earthworks conducted. Access road is present in cropland.
