Inspection Photos

API: 009-06567

Operator: WEST TEXAS OPERATING
CO LLC DBA XTREME ENERGYCO

Inspection Date: 6/16/2025

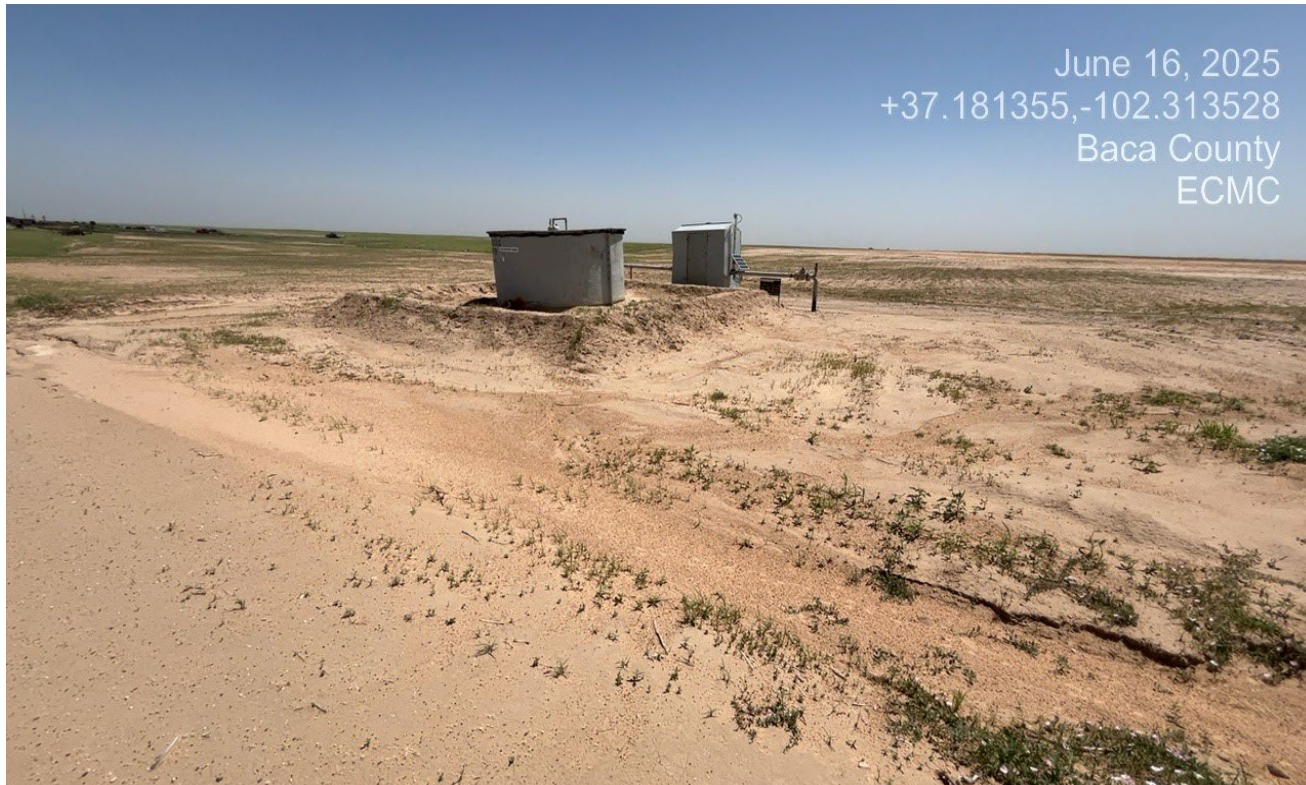
Photo 1. Facing north toward the offsite tank battery. The tank berm has been rebuilt for sufficient secondary containment.

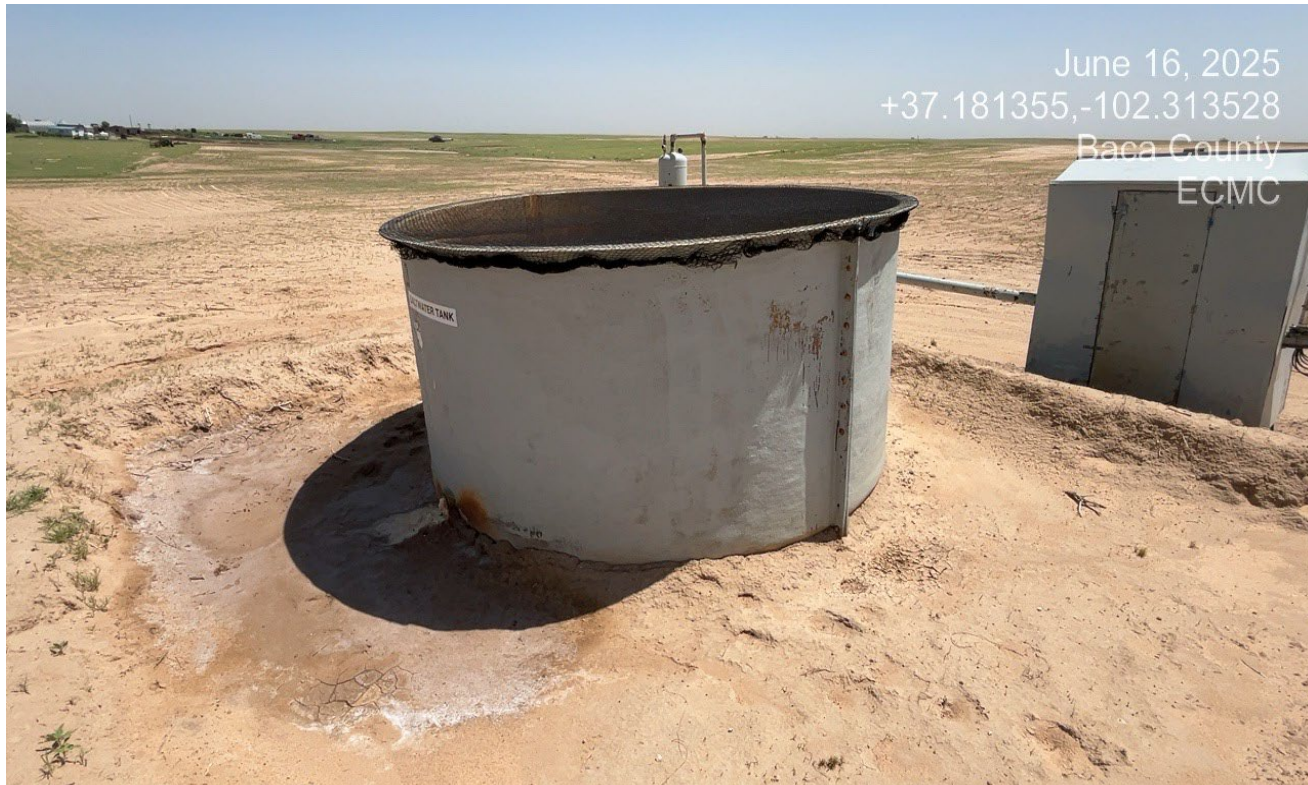
Photo 2. The netting on the tank has been repaired and maintained. There is a leak that occurred which was contained in the secondary containment.

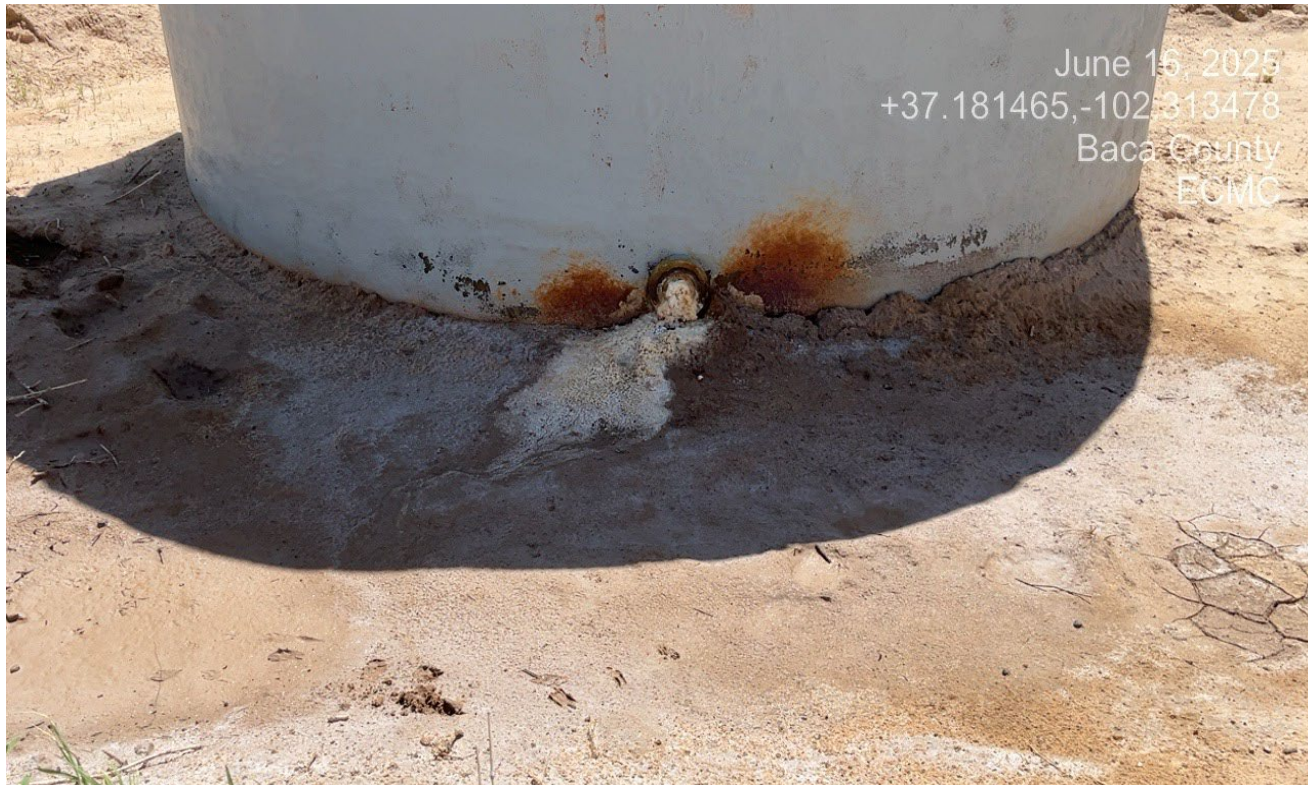
Photo 2. There is a leak at the tank which needs to be repaired. New tank may be needed.
