Inspection Photos

API: 009-06577

Operator: WEST TEXAS OPERATING
CO LLC DBA XTREME ENERGYCO

Inspection Date: 6/16/2025

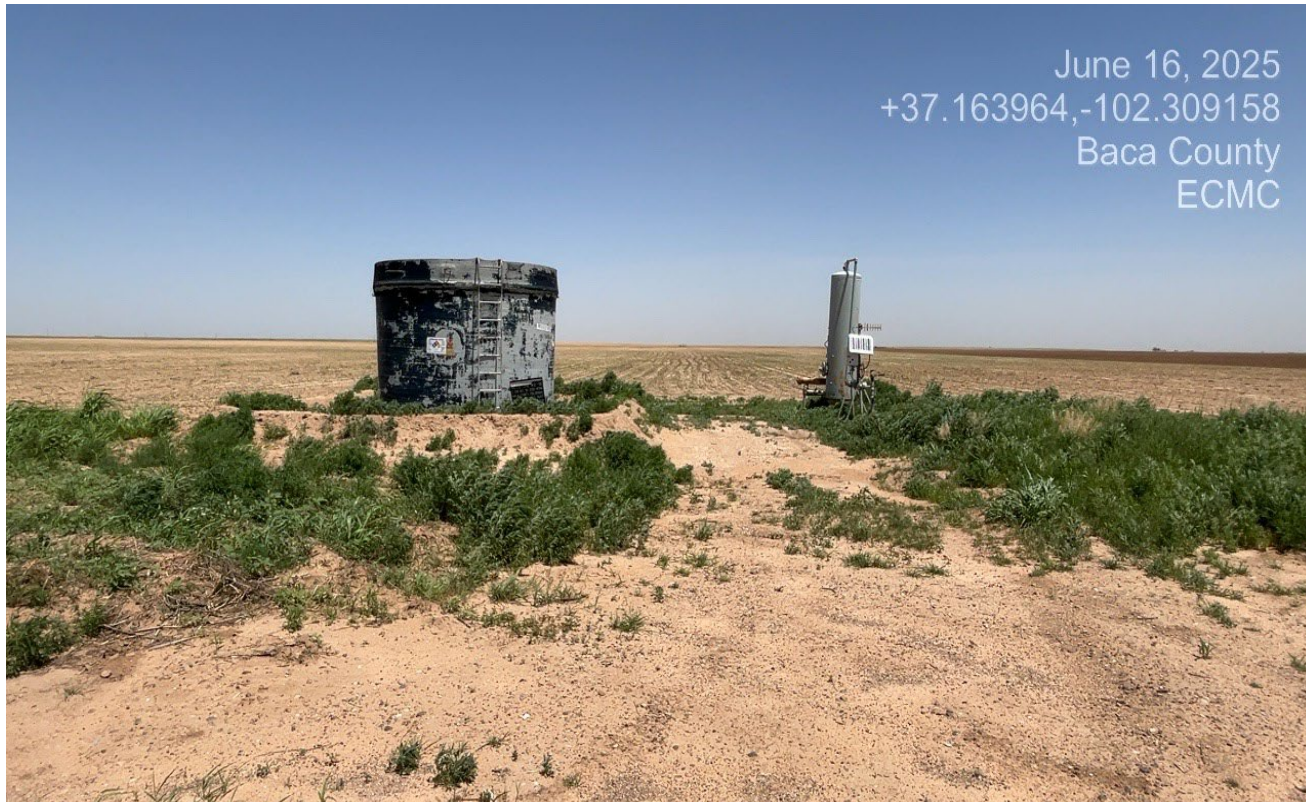
Photo 1. Facing north toward the offsite tank battery. The tank berm has been rebuilt for sufficient secondary containment. The netting on the tank has been repaired and maintained. Sign and labels appear to be updated. There are weeds around the equipment that need to be controlled.
