Final Reclamation and Stormwater Inspection

Operator: KERR MCGEE OIL & GAS ONSHORE LP -
47120

Location ID: 302901

Inspection Photos
Location Name: Pavistma 4-22
Location ID: 302901

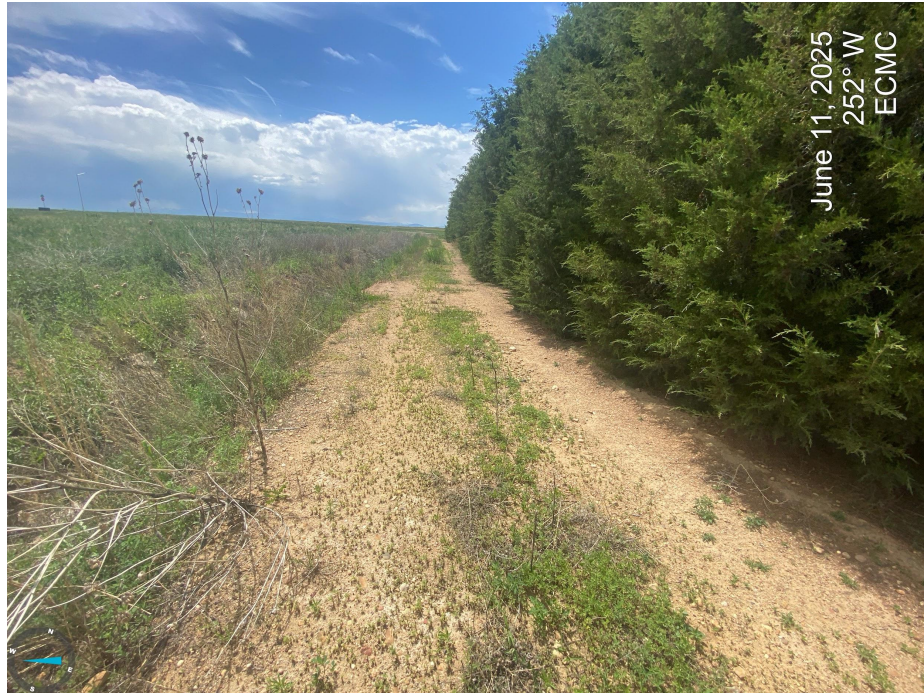
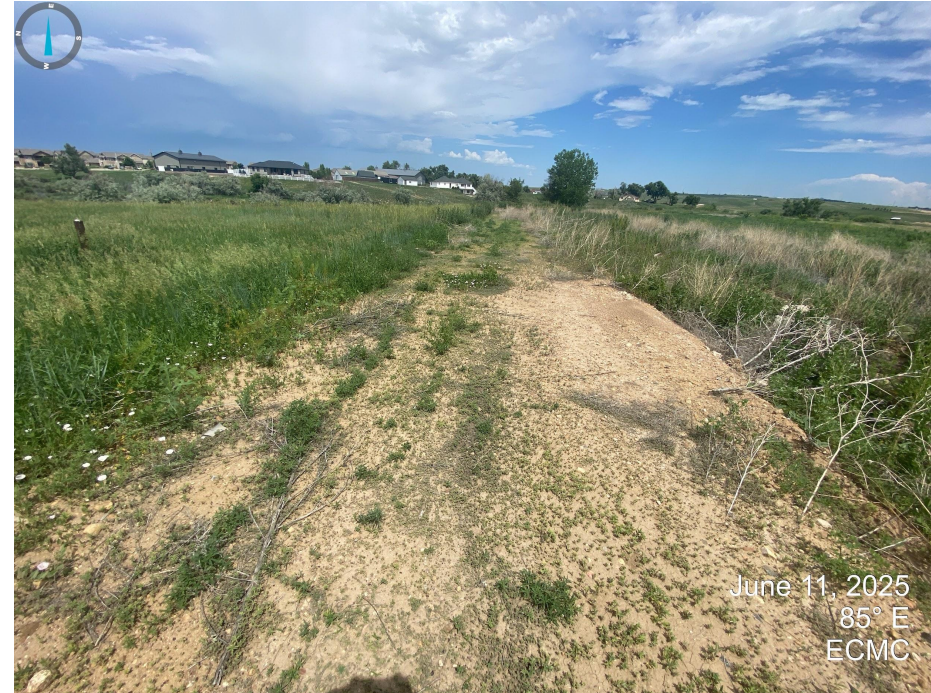
Photos 1 & 2. Taken along the access road, facing west (Photo 1; left) and east (Photo 2; right). Road base material remains throughout and will need to be removed.

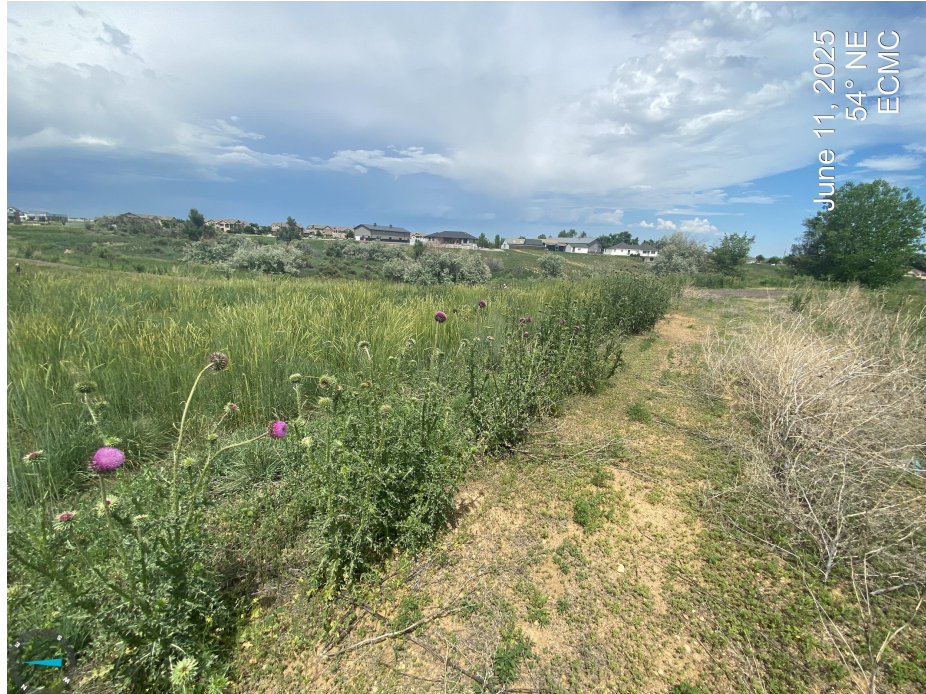
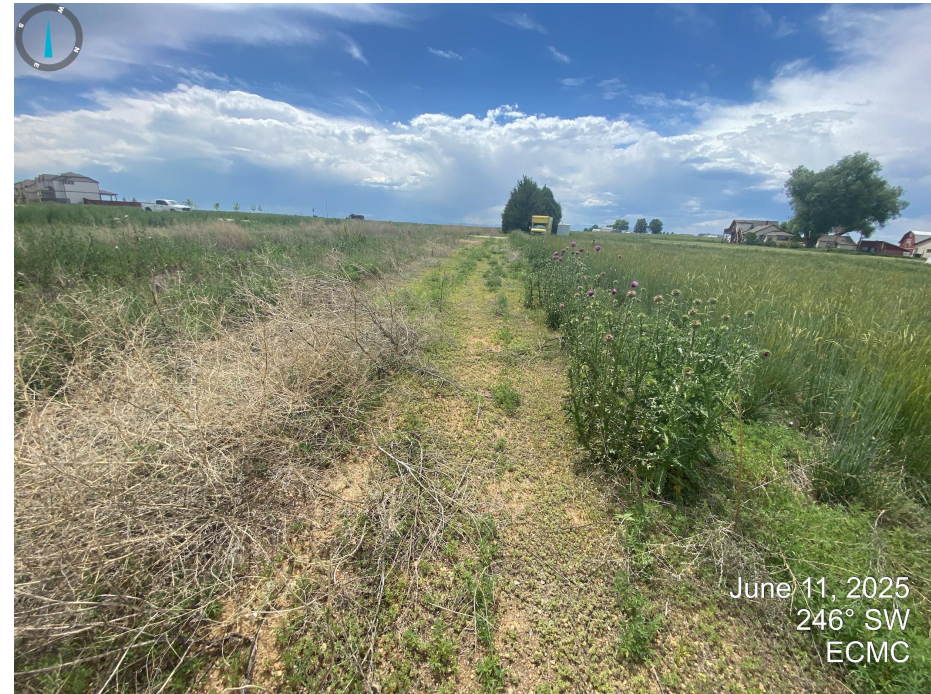
Photos 3 & 4. Taken along the former access road, south of the well location. Photo illustrates the presence of a CO List B Noxious Weed (Musk Thistle) that will need to be managed for.

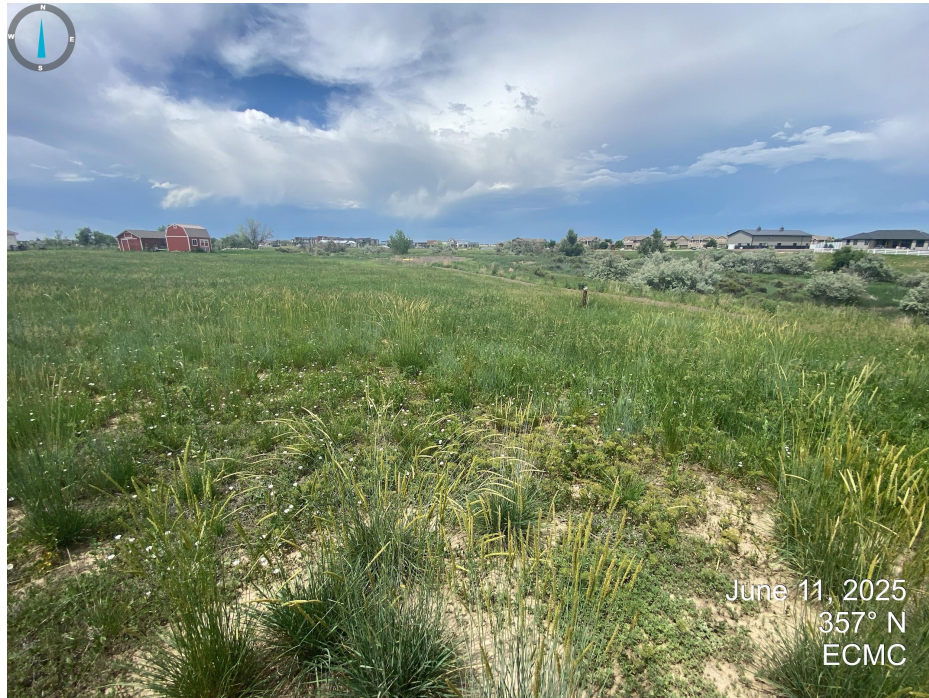
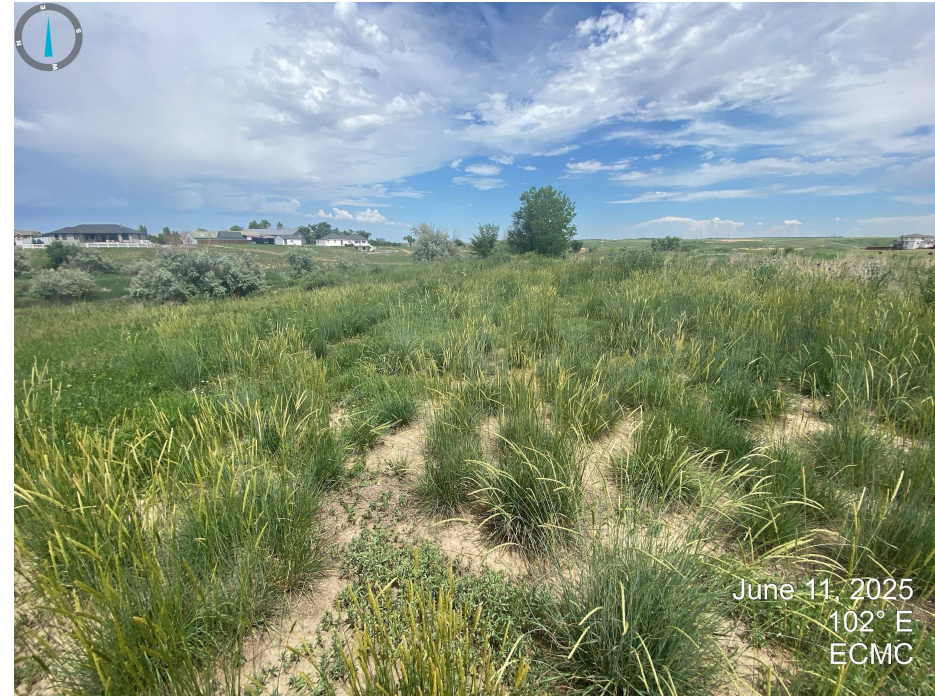
Photos 5 & 6. Taken from the well location facing north (Photo 5; left) and east (Photo 6; right). The well location appears to be progressing towards reclamation standards with vegetation reflective of the reference areas. Operator shall continue to monitor and manage the location for stormwater and undesirable vegetation until the location meets Rule 1004 standards and regulations.

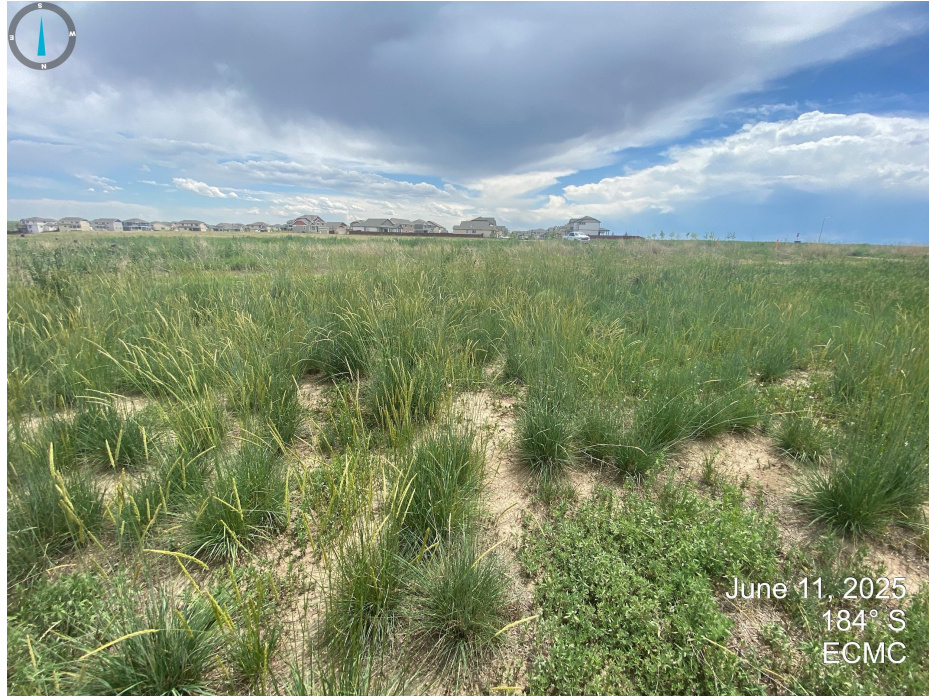
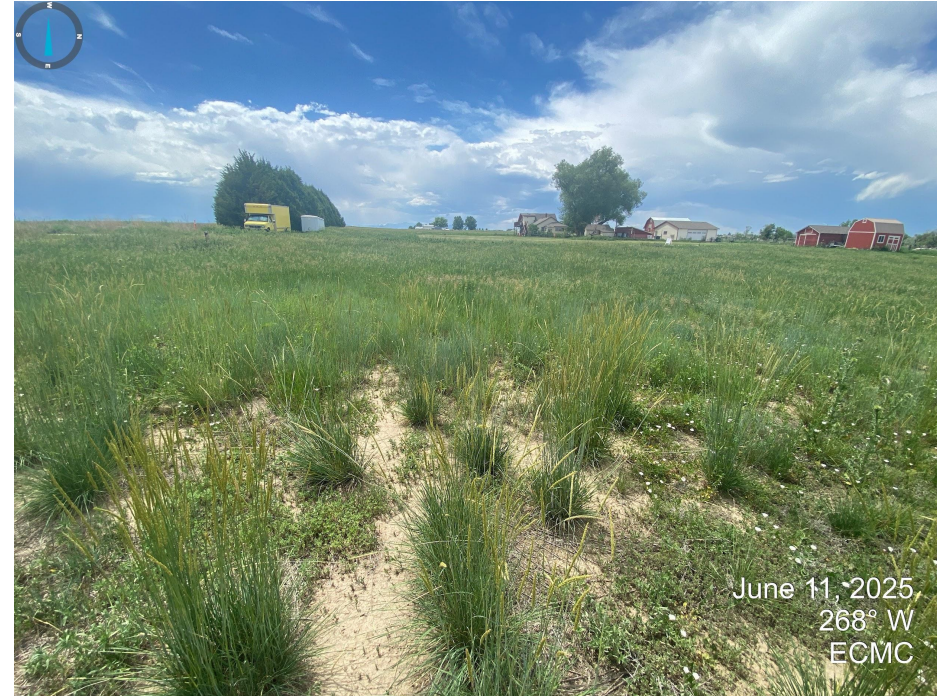
Photos 7 & 8. Taken from the well location facing south (Photo 7; left) and west (Photo 8; right). See comments in Photos 5 & 6 for additional information.

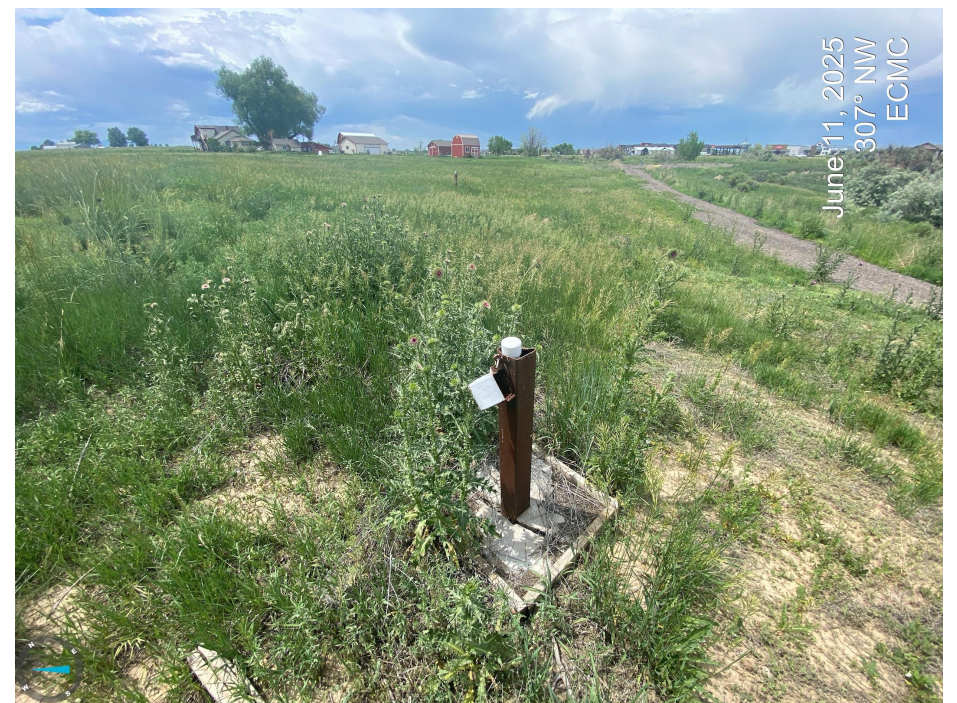
Photos 9 & 10. Groundwater monitoring wells remain around the former well location and will need to be removed.

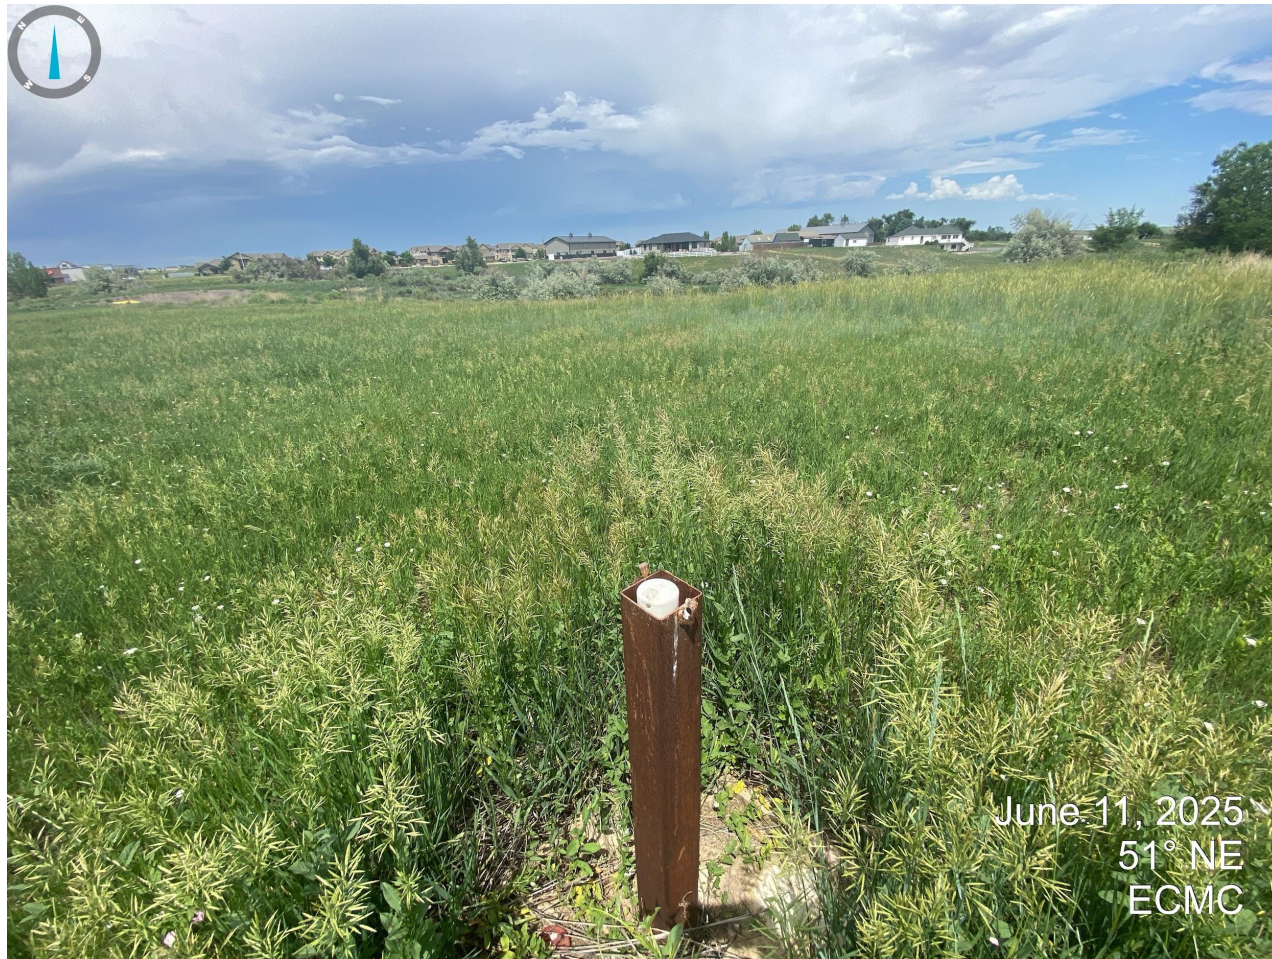
Photo 11. Continued from Photos 9 & 10. Groundwater monitoring wells remain around the former well location and will need to be removed.
