# Inspection Photos

**Operator:** LARAMIE ENERGY LLC - 10433

**Location ID:** 324292

**Inspection Doc:** 718100607

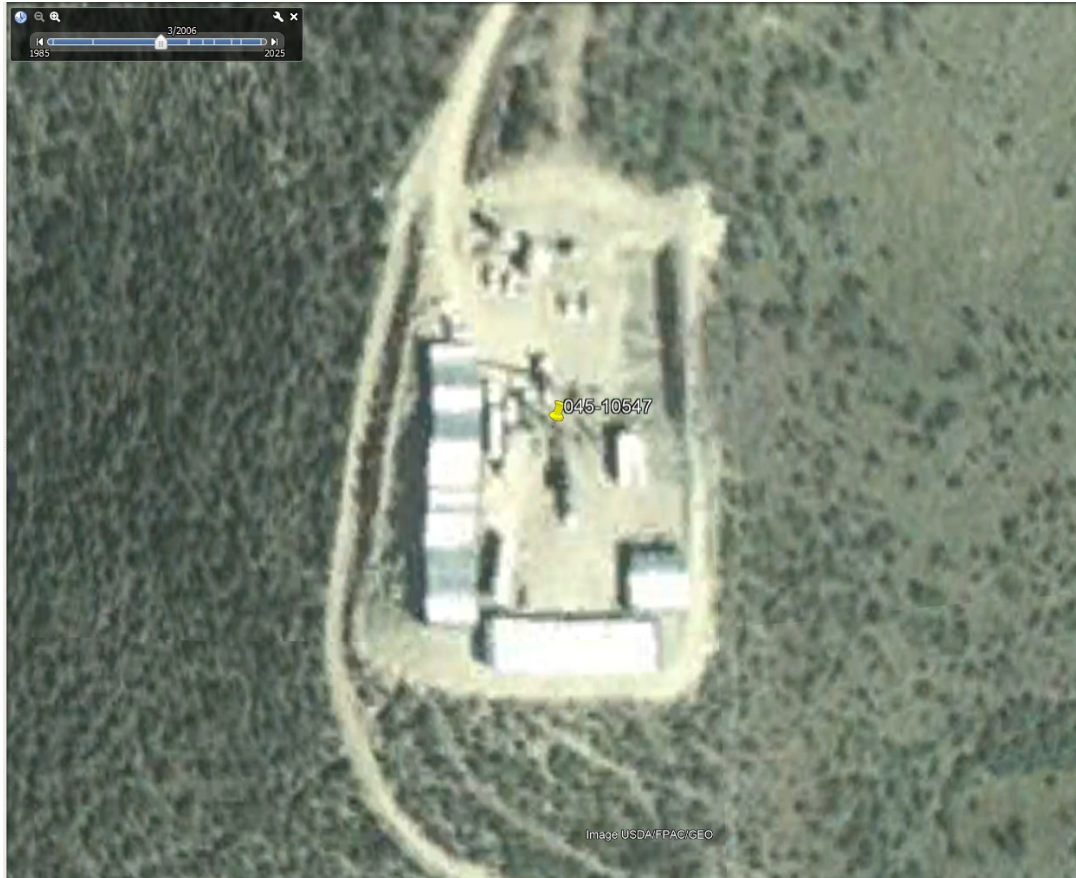
**Photo 1:** 2006 Google Earth aerial image of the Location. Photo shows Location during what appears to be drilling operations of the well.

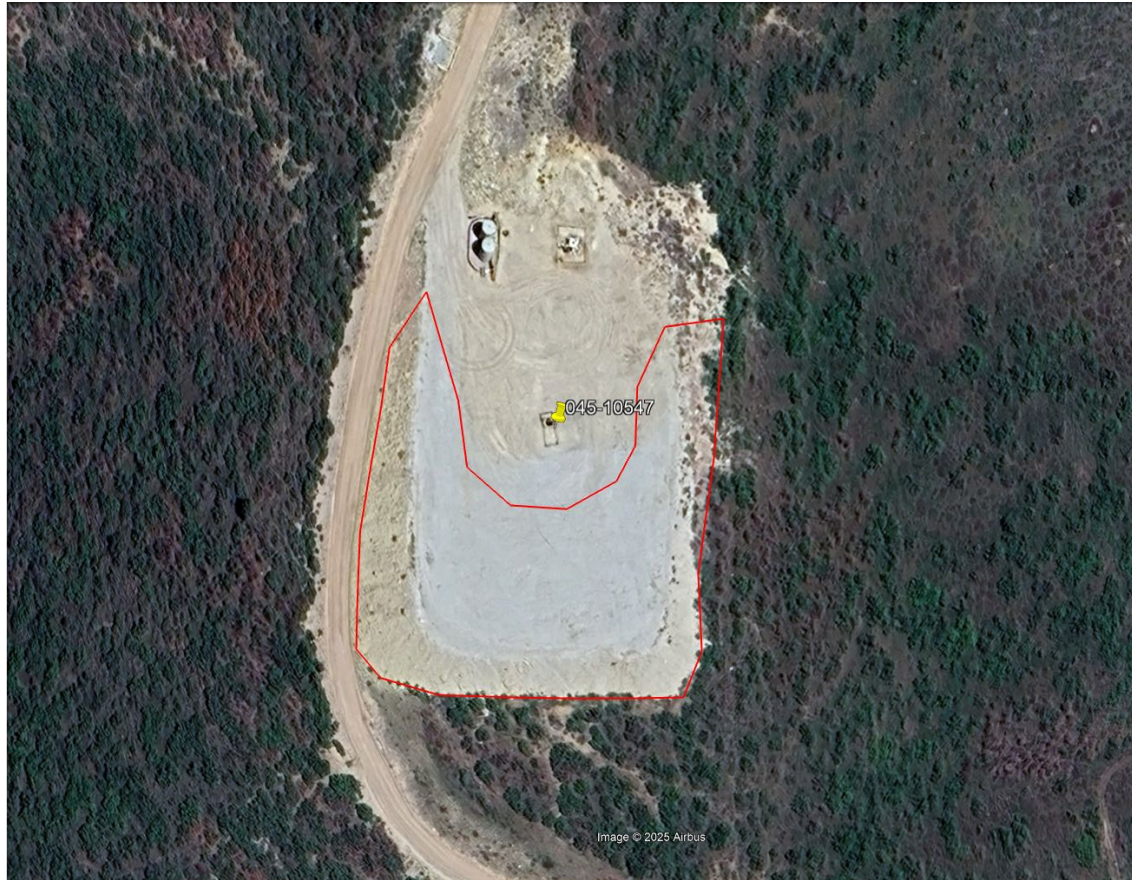
**Photo 2:** Most current (5/2025) google earth aerial imagery. Photo shows that the Location remains unchanged since site construction and drilling operations. Interim reclamation pursuant to 1003 requirements has not been performed. Red polygon represents approximate areas of the Location not necessary for production.

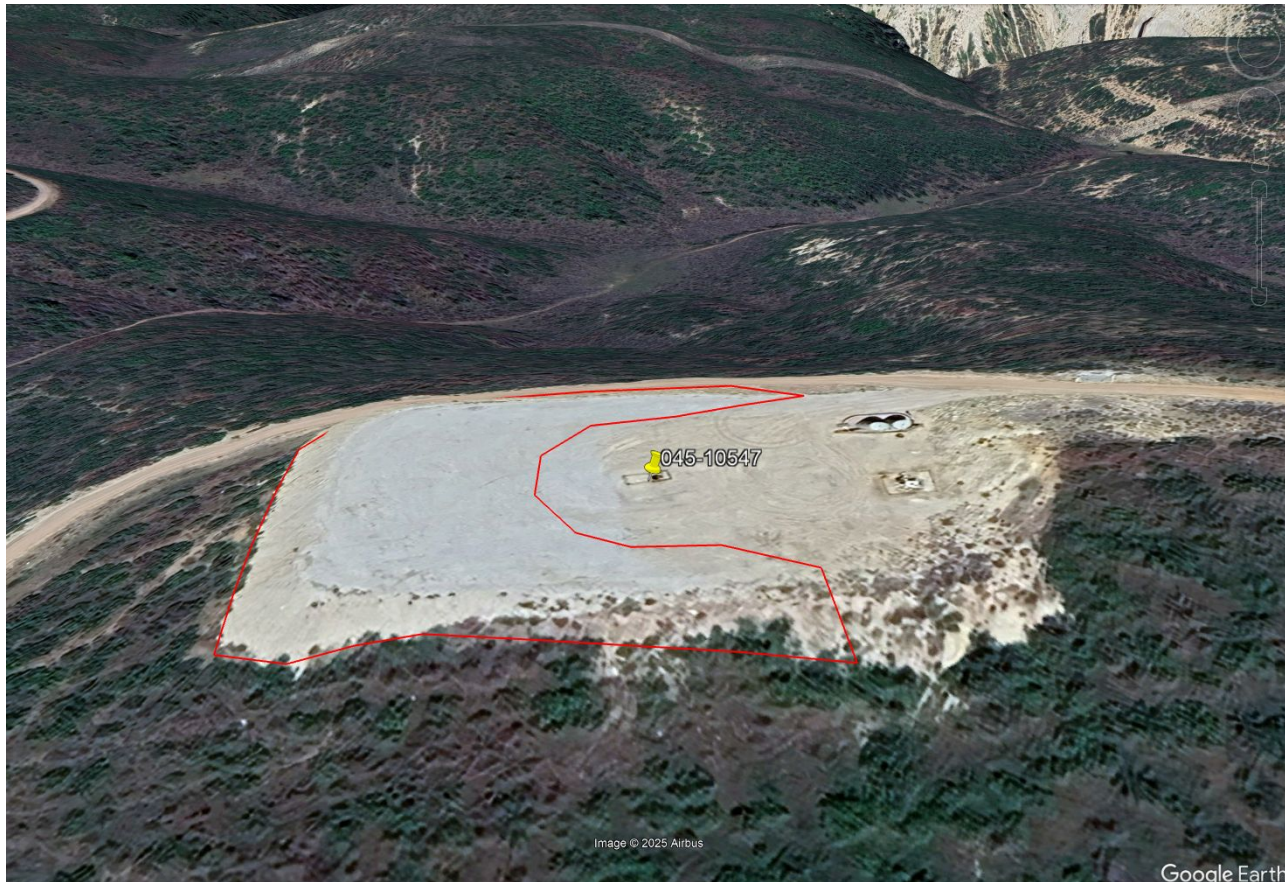
**Photo 3:** See comments under photo 2.

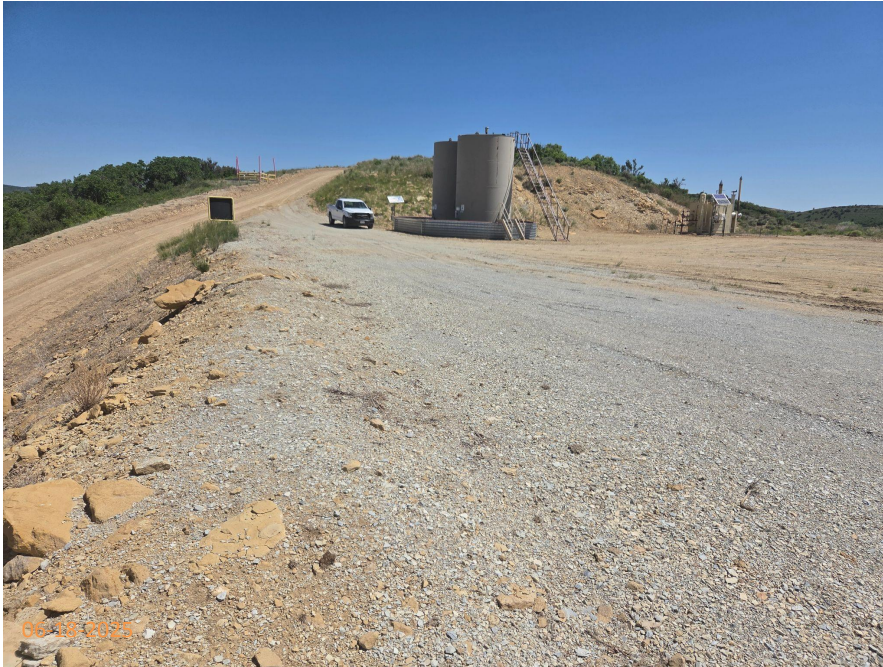
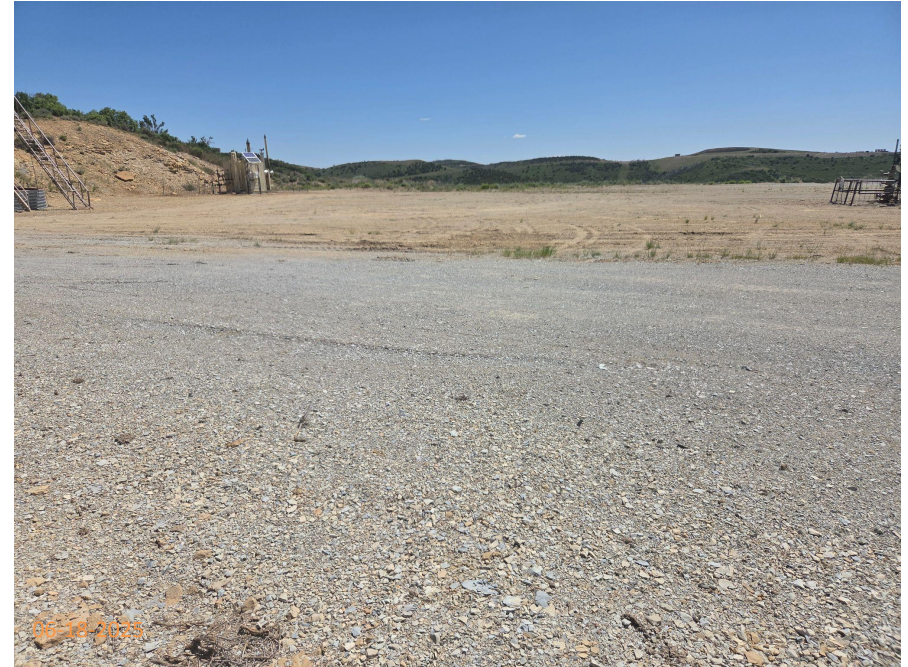
**Photo 4:** Photos 1-2 taken from the west end of the Location. Photos provide an overview of the Location from north, northeast, southeast to south. Photos examples showing interim reclamation pursuant to 1003 requirements has not been performed on the Location. Additionally, Reclamation Specialist was unable to locate any topsoil stored on the Location for future reclamation efforts.

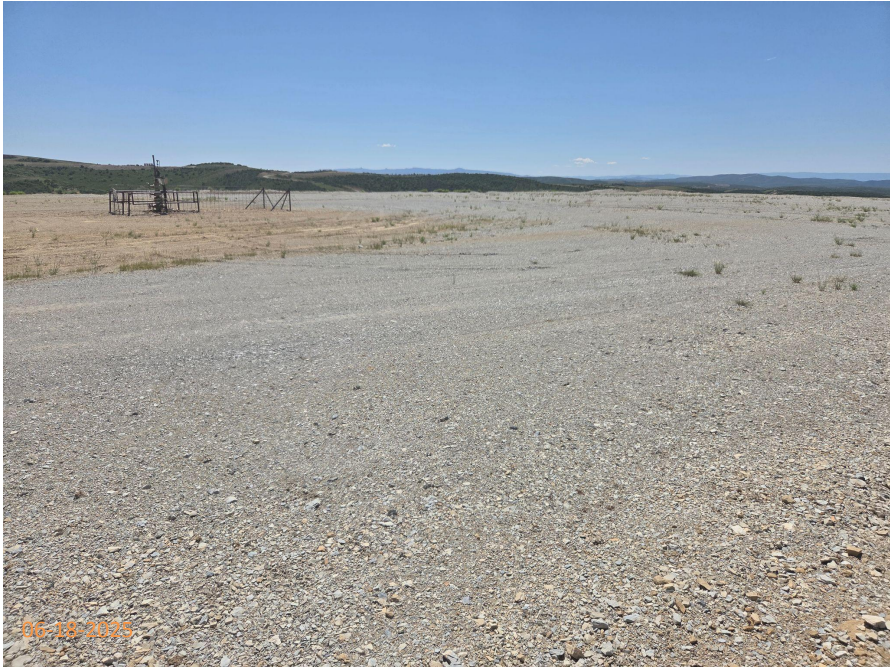
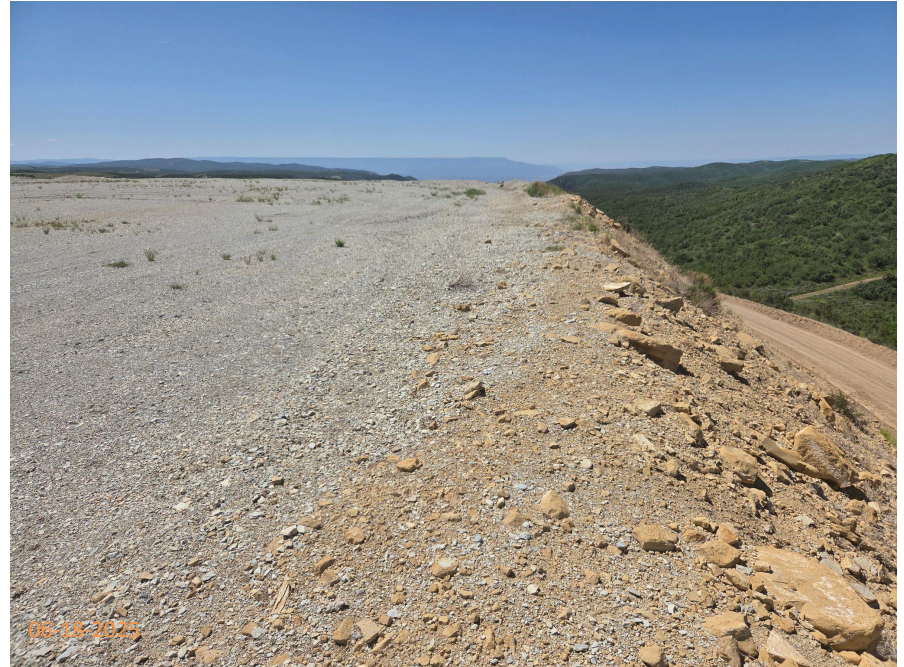
**Photo 5:** See comments under photo 4.

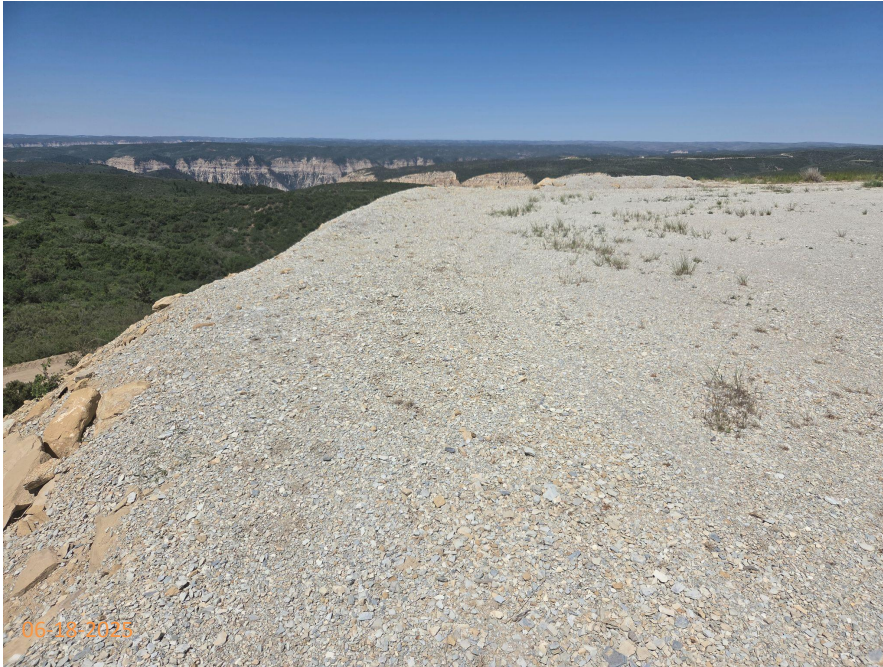
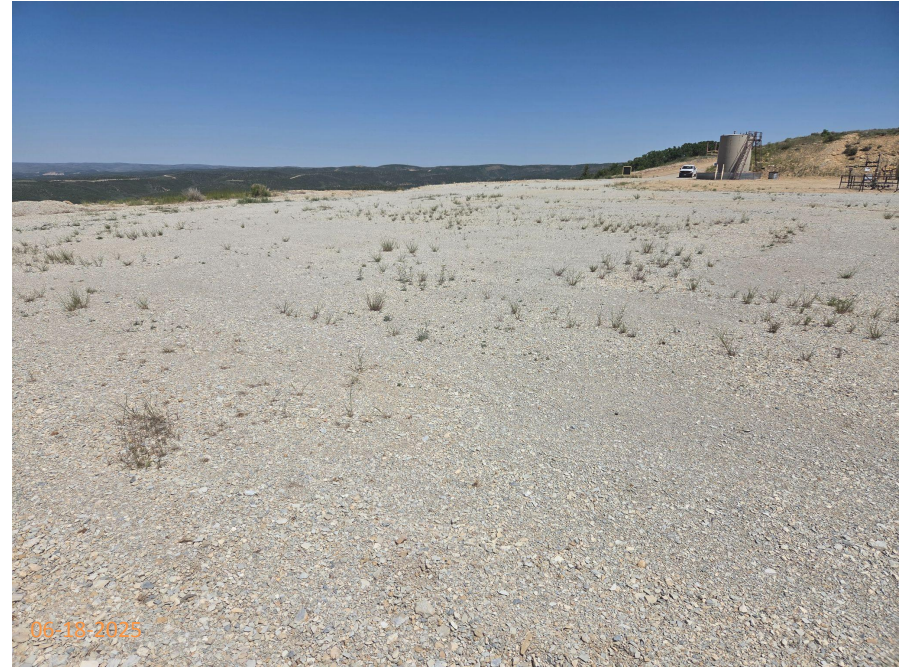
**Photo 6:** Photos 6-7 taken from the south end of the Location. Photos provide an overview of the Location from west, northwest, northeast to east. See comments under photo 4.

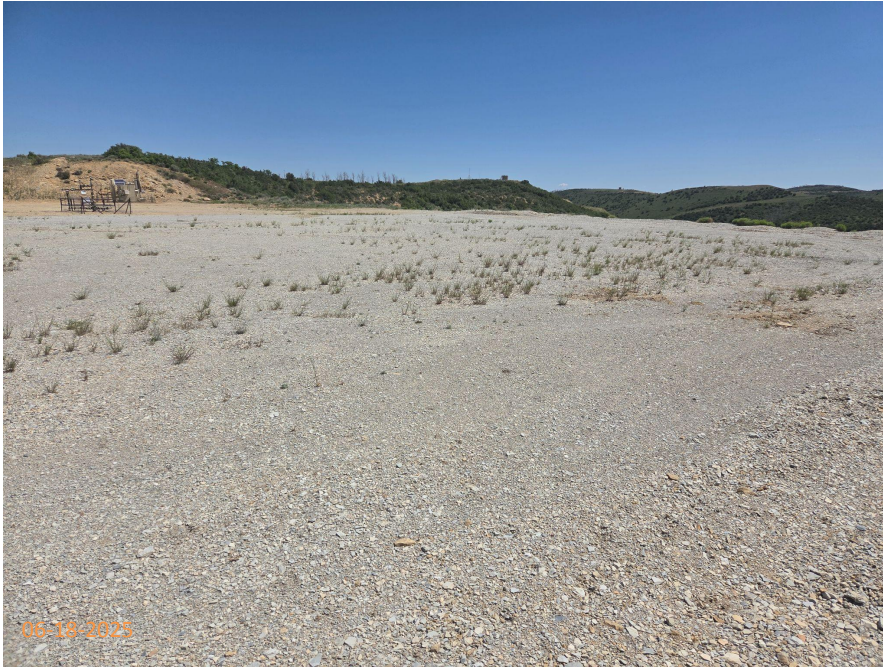
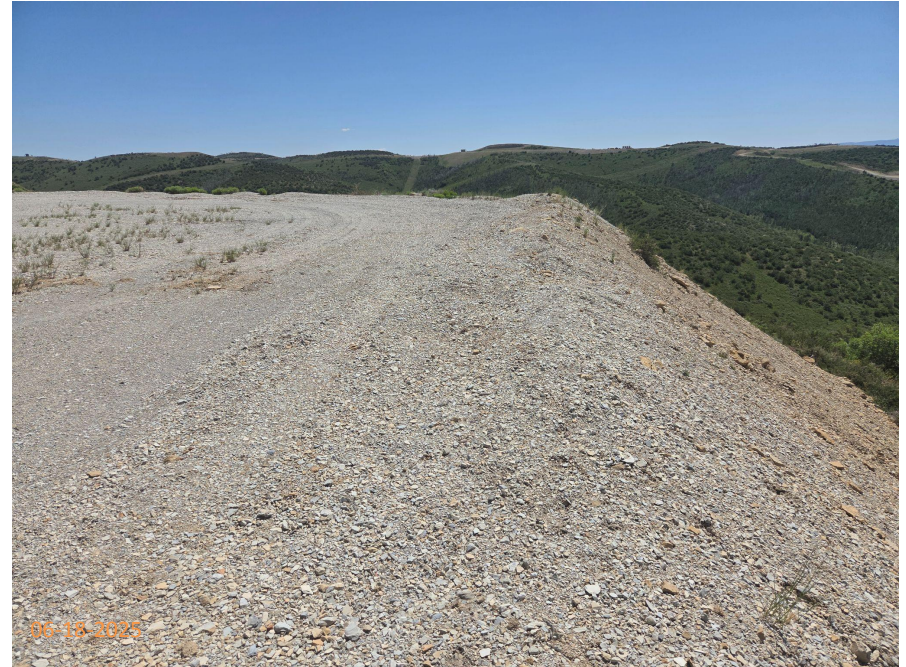
**Photo 7:** See comments under photo 1.

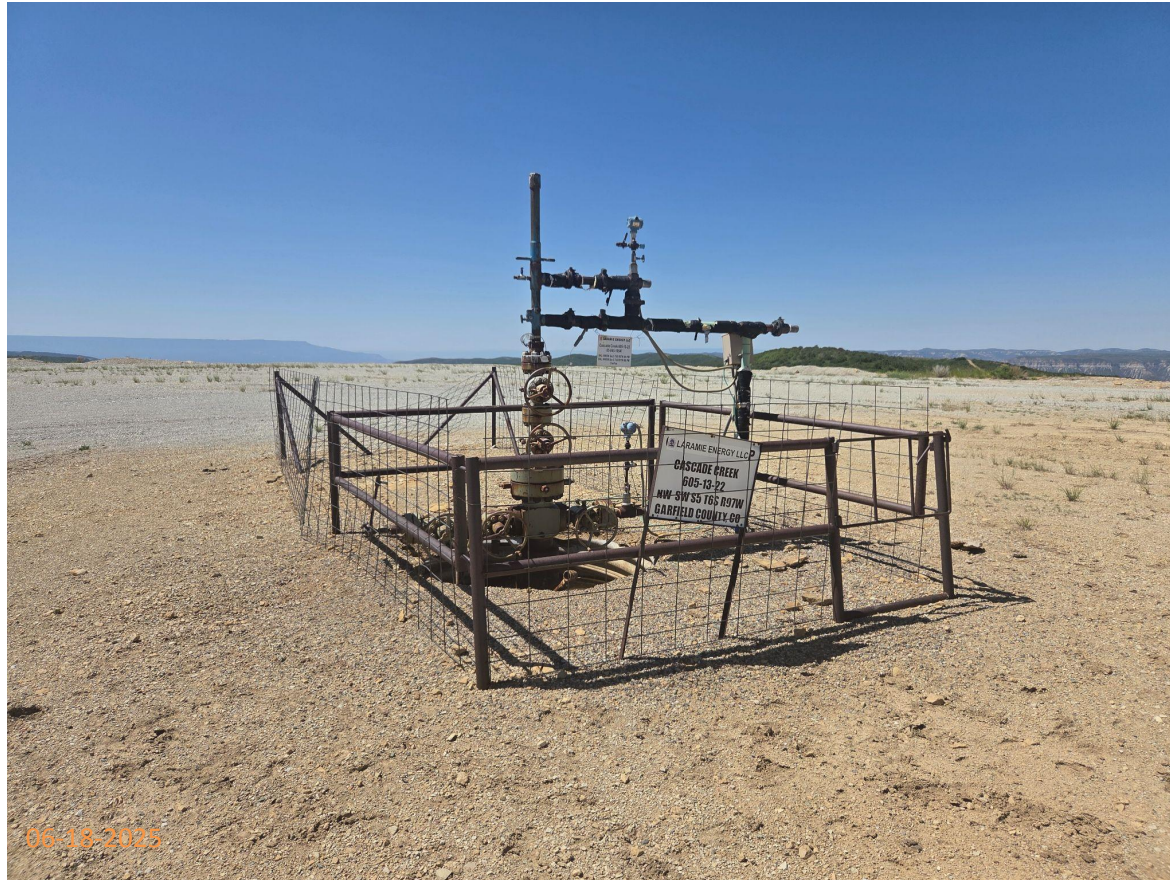
**Photo 8:** Photo shows well on Location. Cellar at the well has not been covered or backfilled.

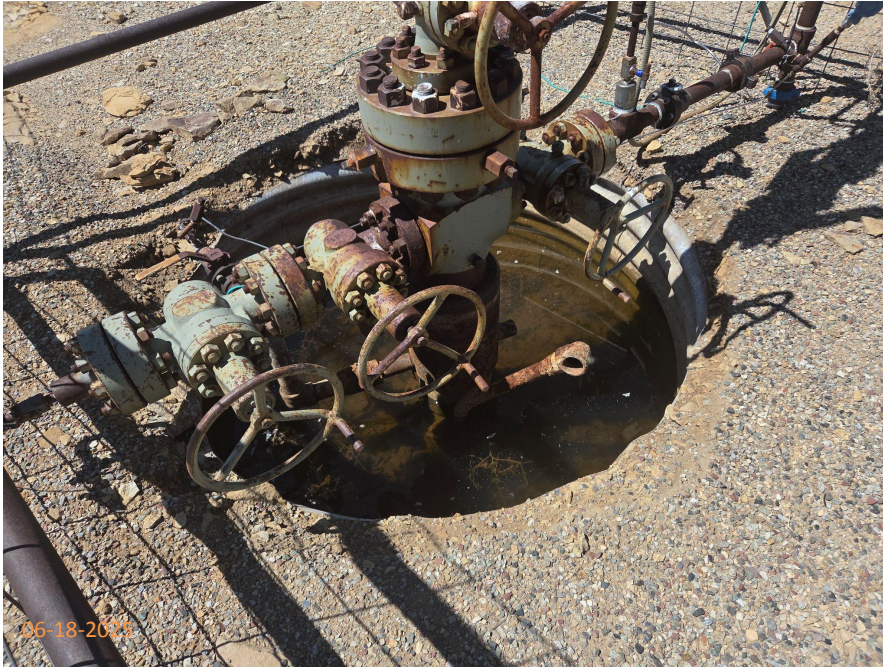
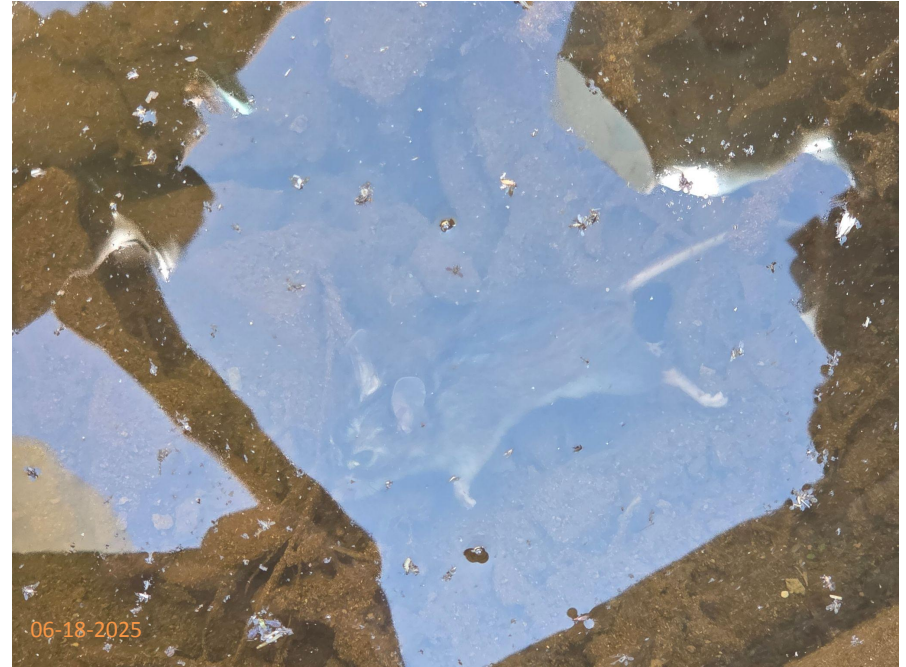
**Photo 9:** Continued from photo 8. Photo shows cellar has neither been backfilled, or properly covered. Cellar has filled with fluids. Wildlife mortality observed.
