# **Sampling Photographic Log**

Citation MPU Pressure Maintenance and  
Injection Facility

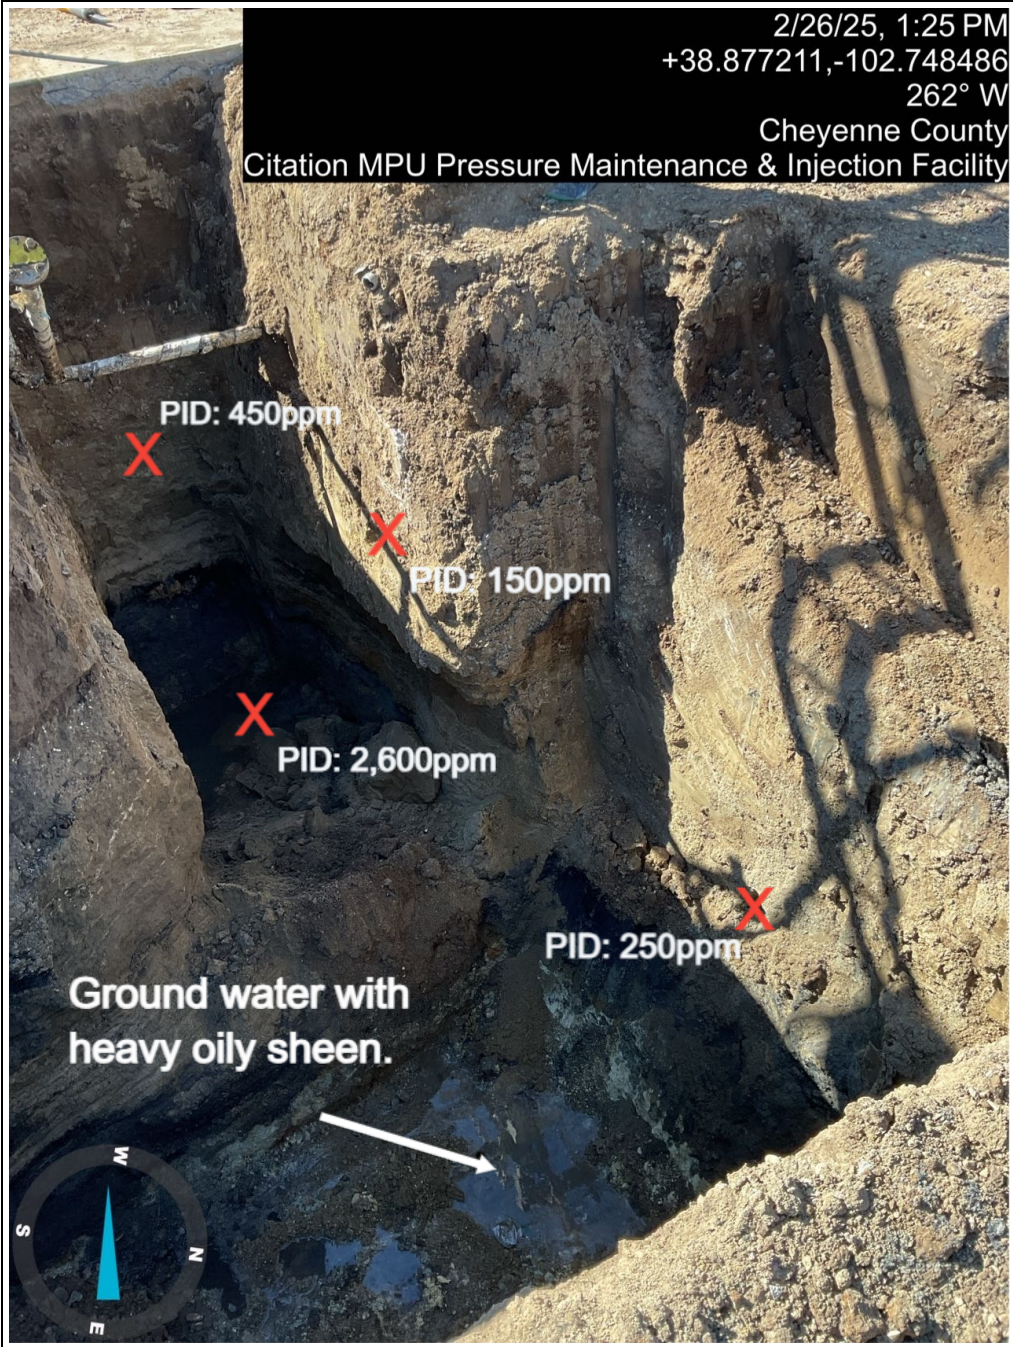
2/26/25, 1:25 PM  
+38.877211,-102.748486  
262° W  
Cheyenne County  
Citation MPU Pressure Maintenance & Injection Facility

W view into pit.

Failed PIDs on walls  
and base between  
150ppm-2,600ppm

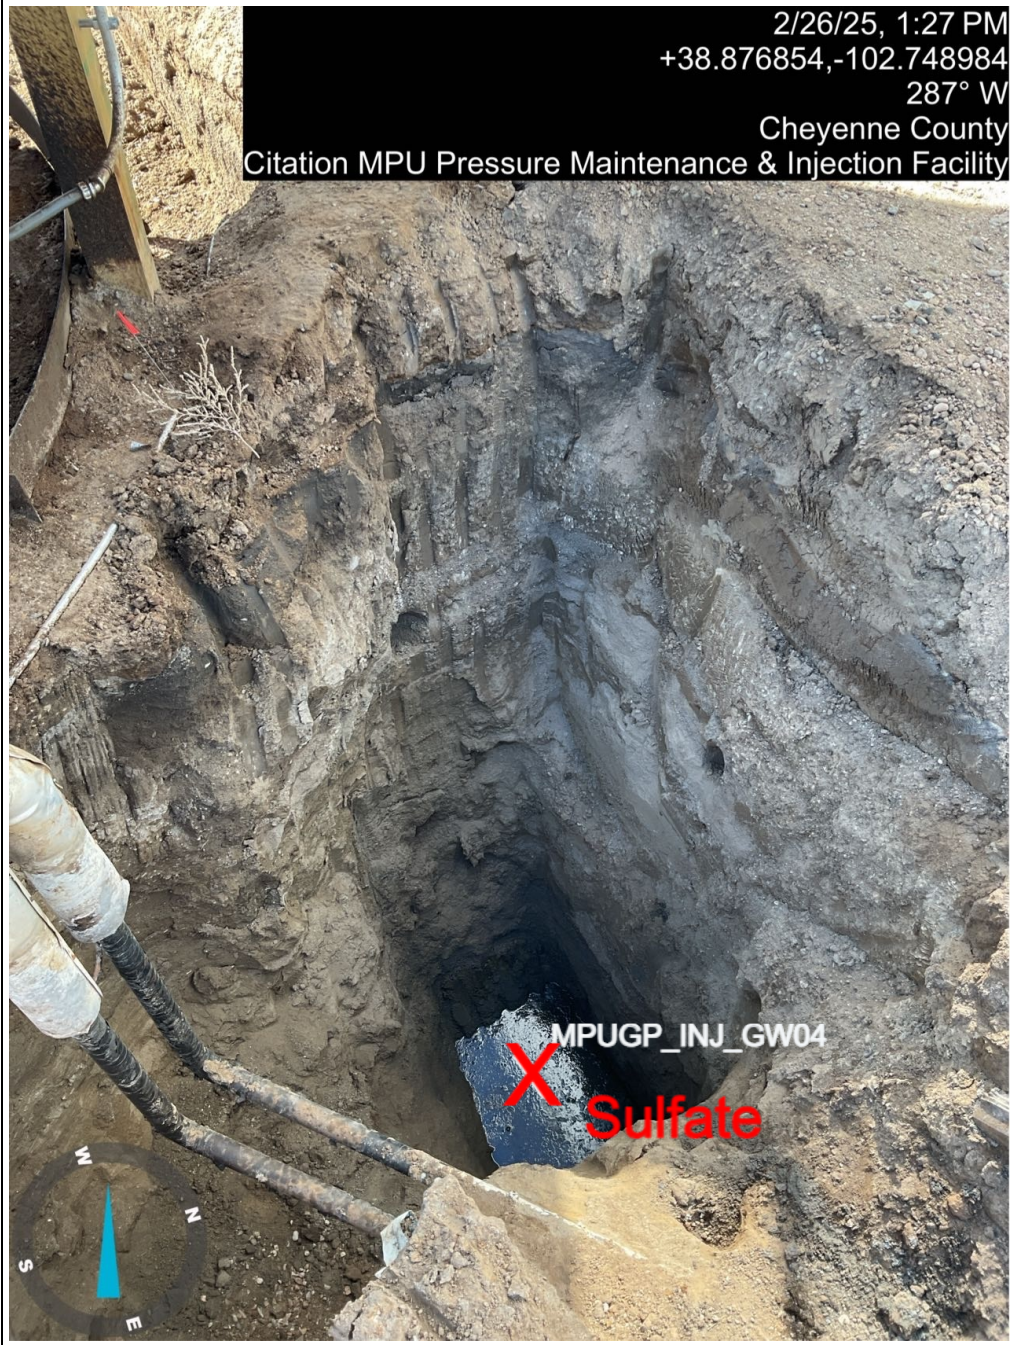
2/26/25, 1:27 PM  
+38.876854,-102.748984  
287° W  
Cheyenne County  
Citation MPU Pressure Maintenance & Injection Facility

**Description:**  
MPUGP\_INJ\_GW04  
Sulfate exceedance 467

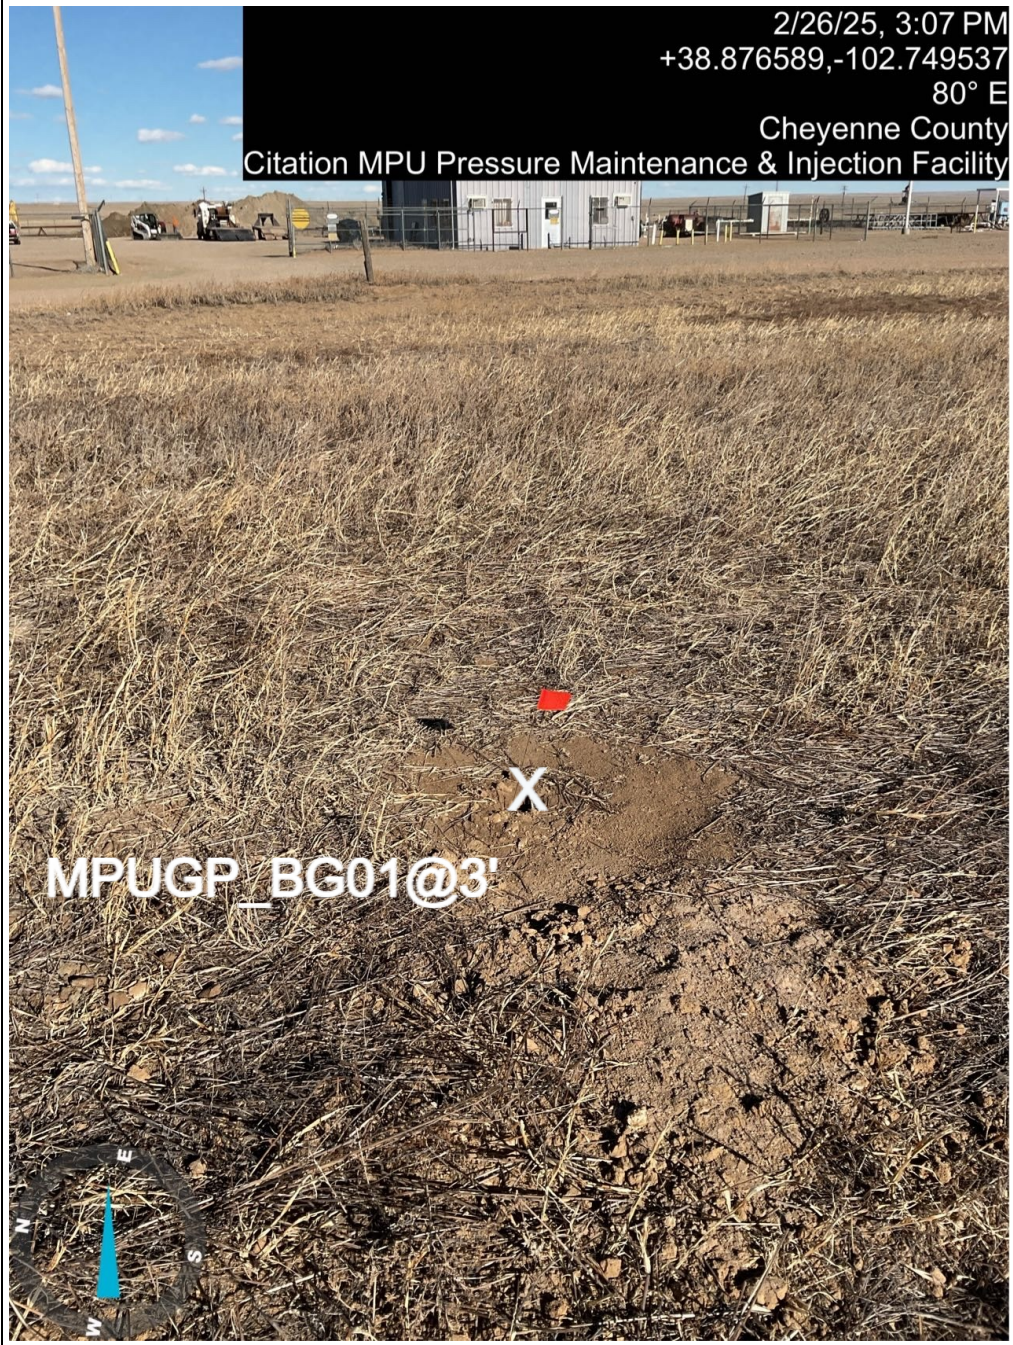
2/26/25, 3:07 PM  
+38.876589,-102.749537  
80° E  
Cheyenne County  
Citation MPU Pressure Maintenance & Injection Facility

MPUGP\_BG01@  
3',6',9',12' - taken on  
2/6/25 (Not pictured due  
to darkness at time of  
sampling)

MPUGP\_BG01@3'  
retaken by CH on  
2/26/25 (Pictured)

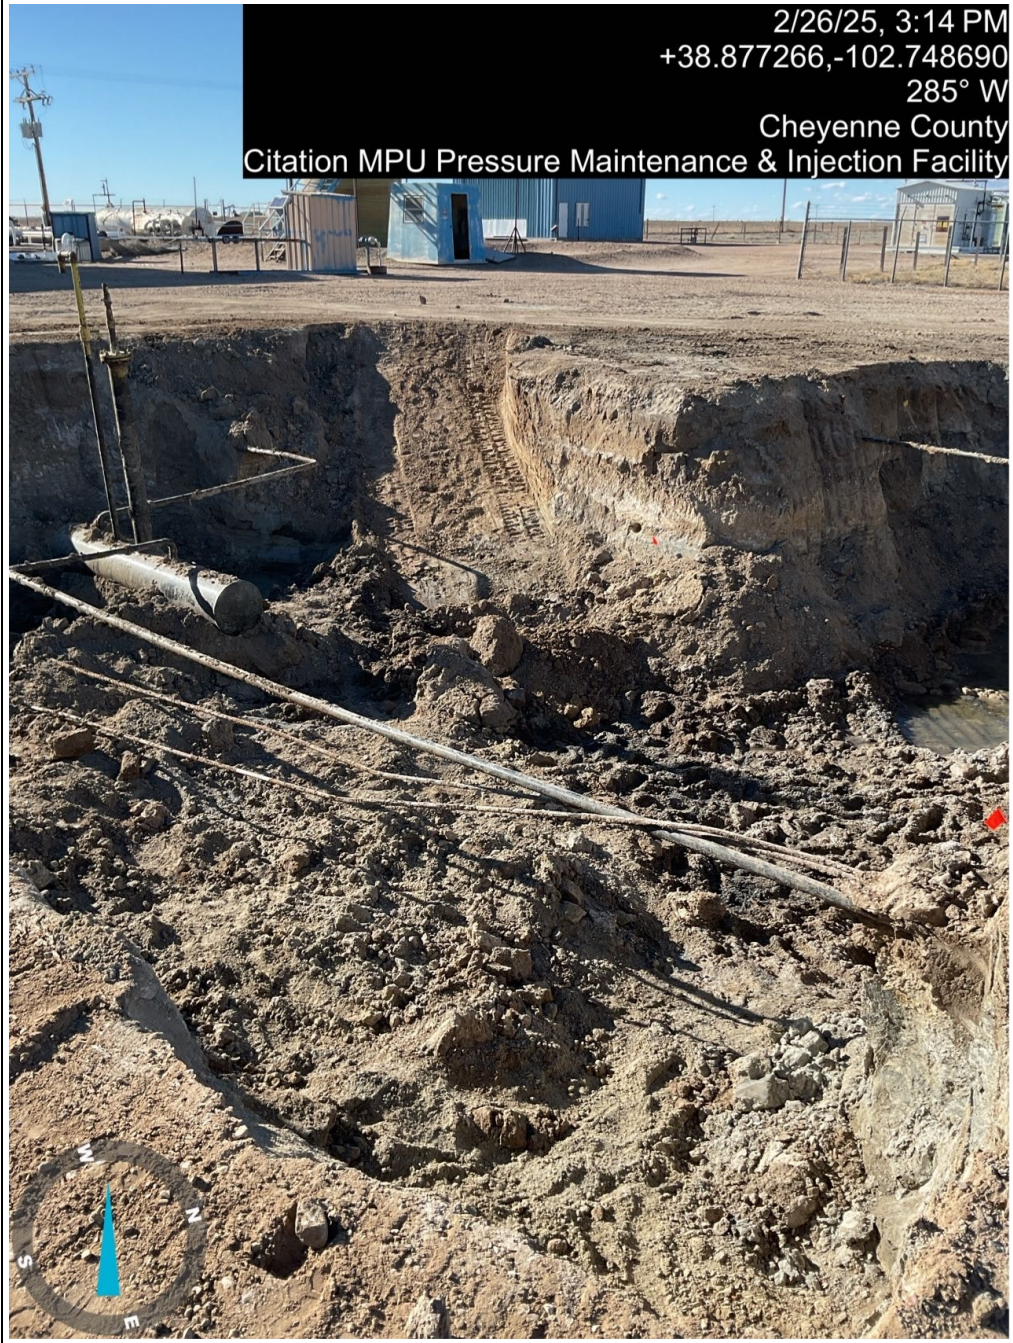
2/26/25, 3:14 PM  
+38.877266,-102.748690  
285° W

NW view of ramp  
for skid steer access.

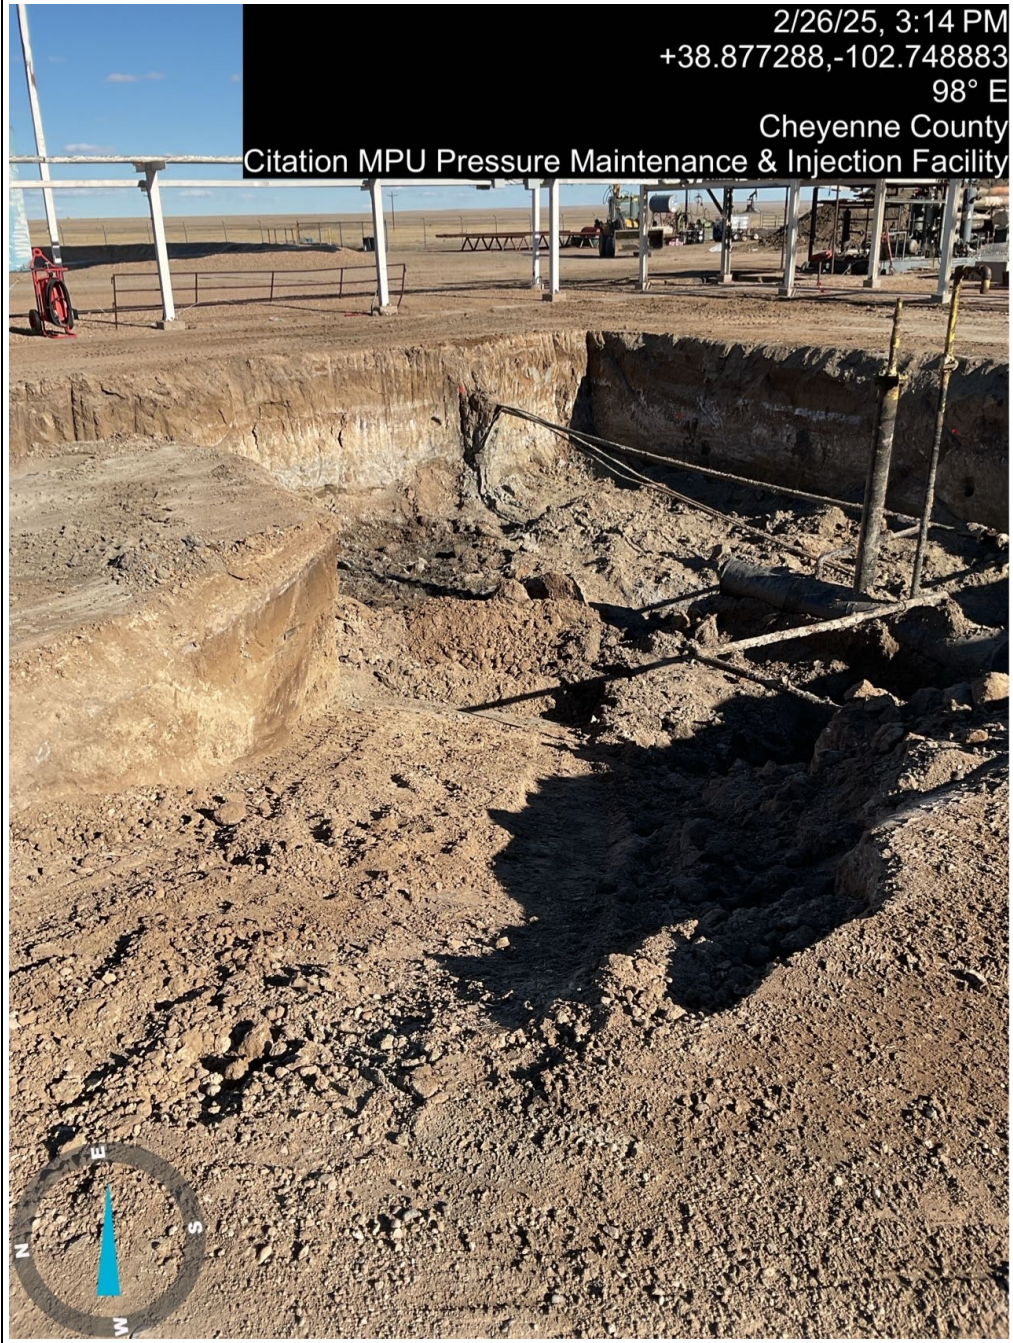
2/26/25, 3:14 PM  
+38.877288,-102.748883  
98° E

SE view of ramp  
for skid steer access.

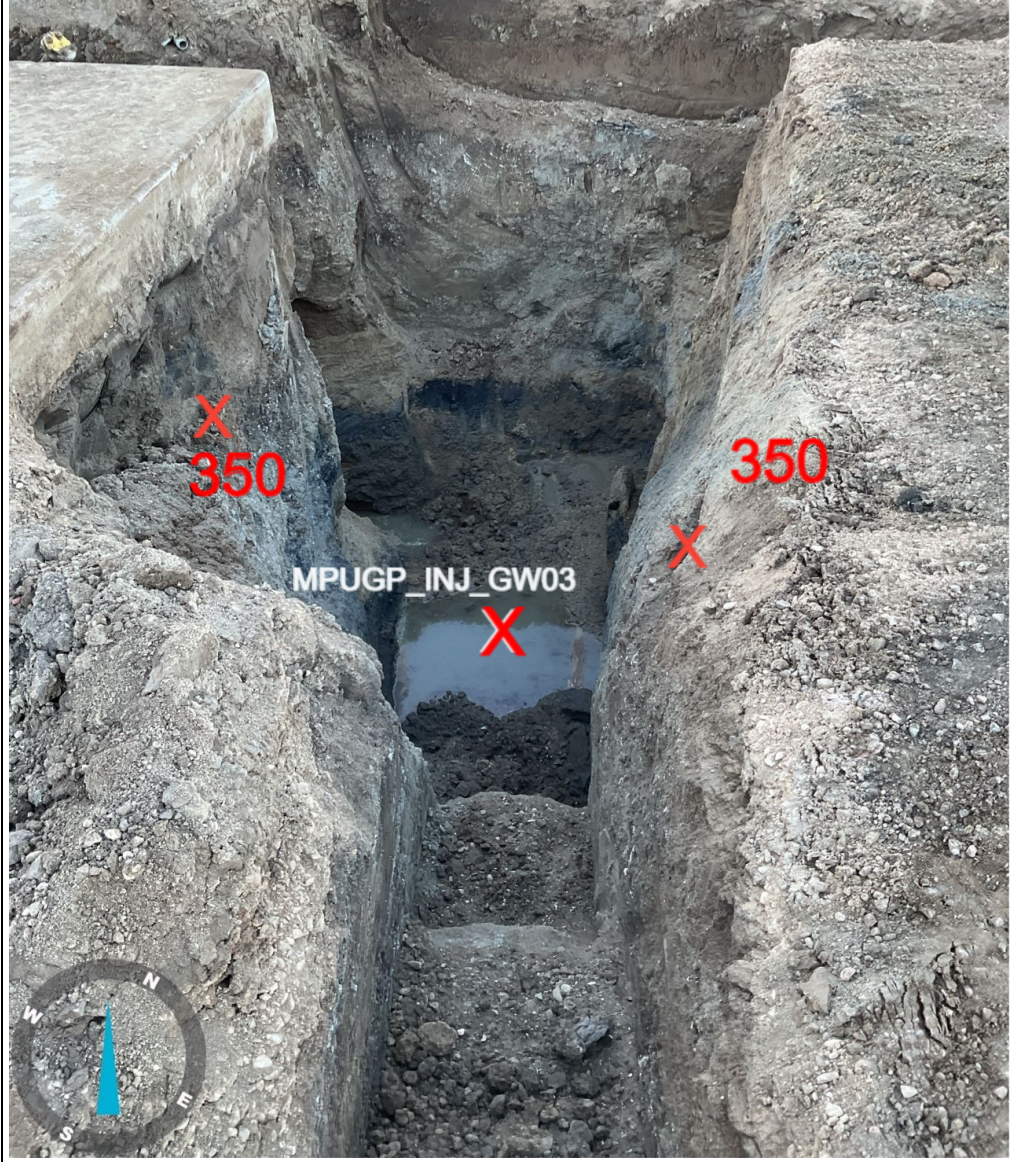
2/26/25, 4:57 PM  
+38.877093,-102.748390  
331° NW  
Cheyenne County  
Citation MPU Pressure Maintenance & Injection Facility

MPUGP\_INJ\_GW03

Failed PID readings  
at ~350ppm 2' deep  
into side walls.

N view into pit.

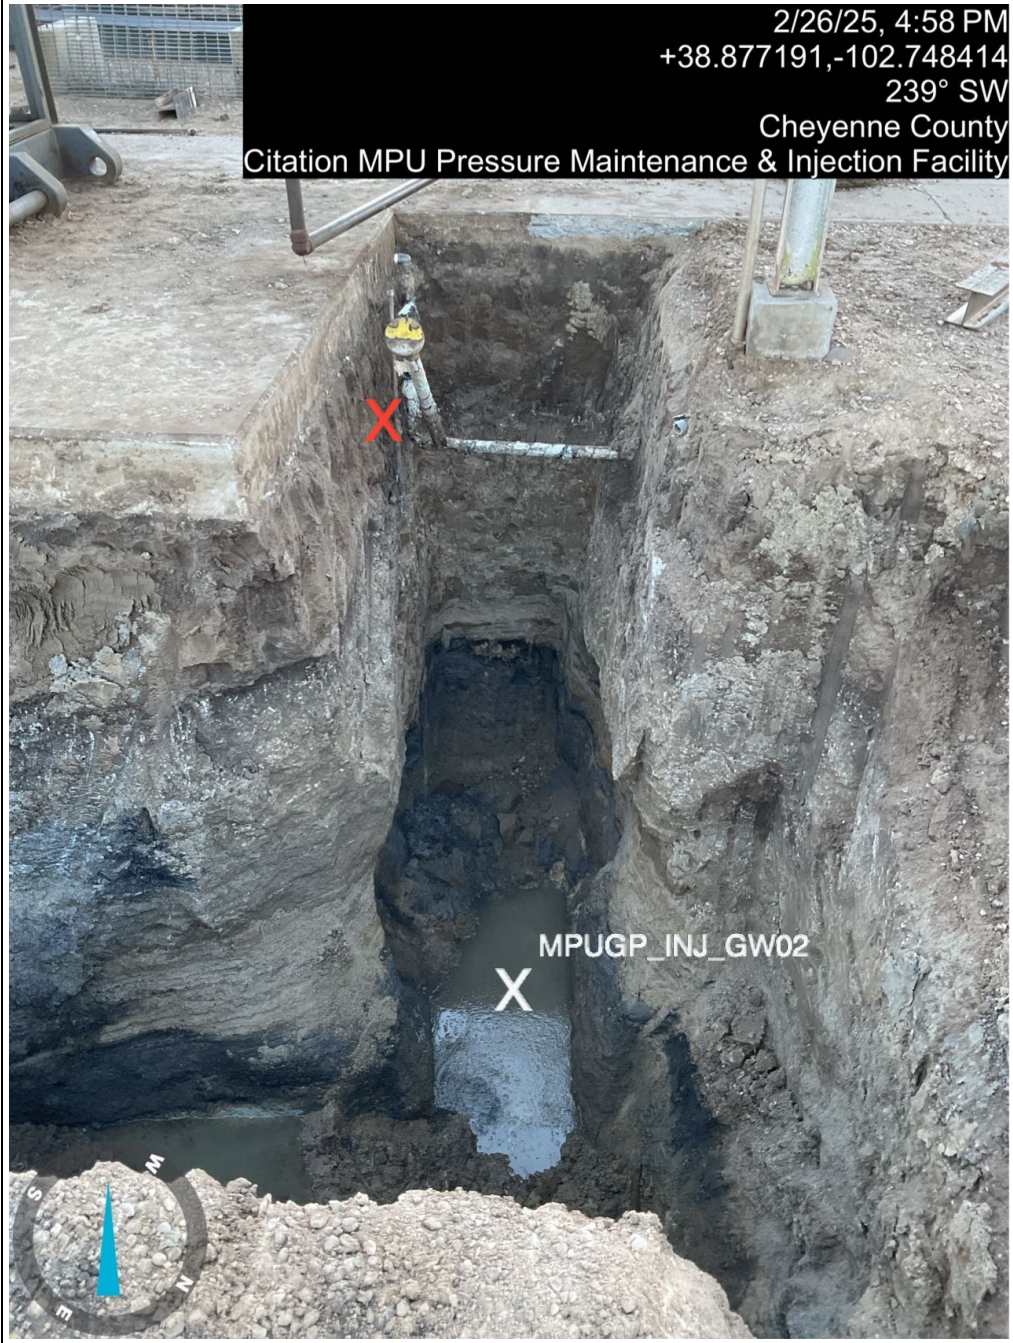
2/26/25, 4:58 PM  
+38.877191,-102.748414  
239° SW  
Cheyenne County  
Citation MPU Pressure Maintenance & Injection Facility

MPUGP\_INJ\_GW02

Failed PID at 4' horizon:

Read at 700ppm

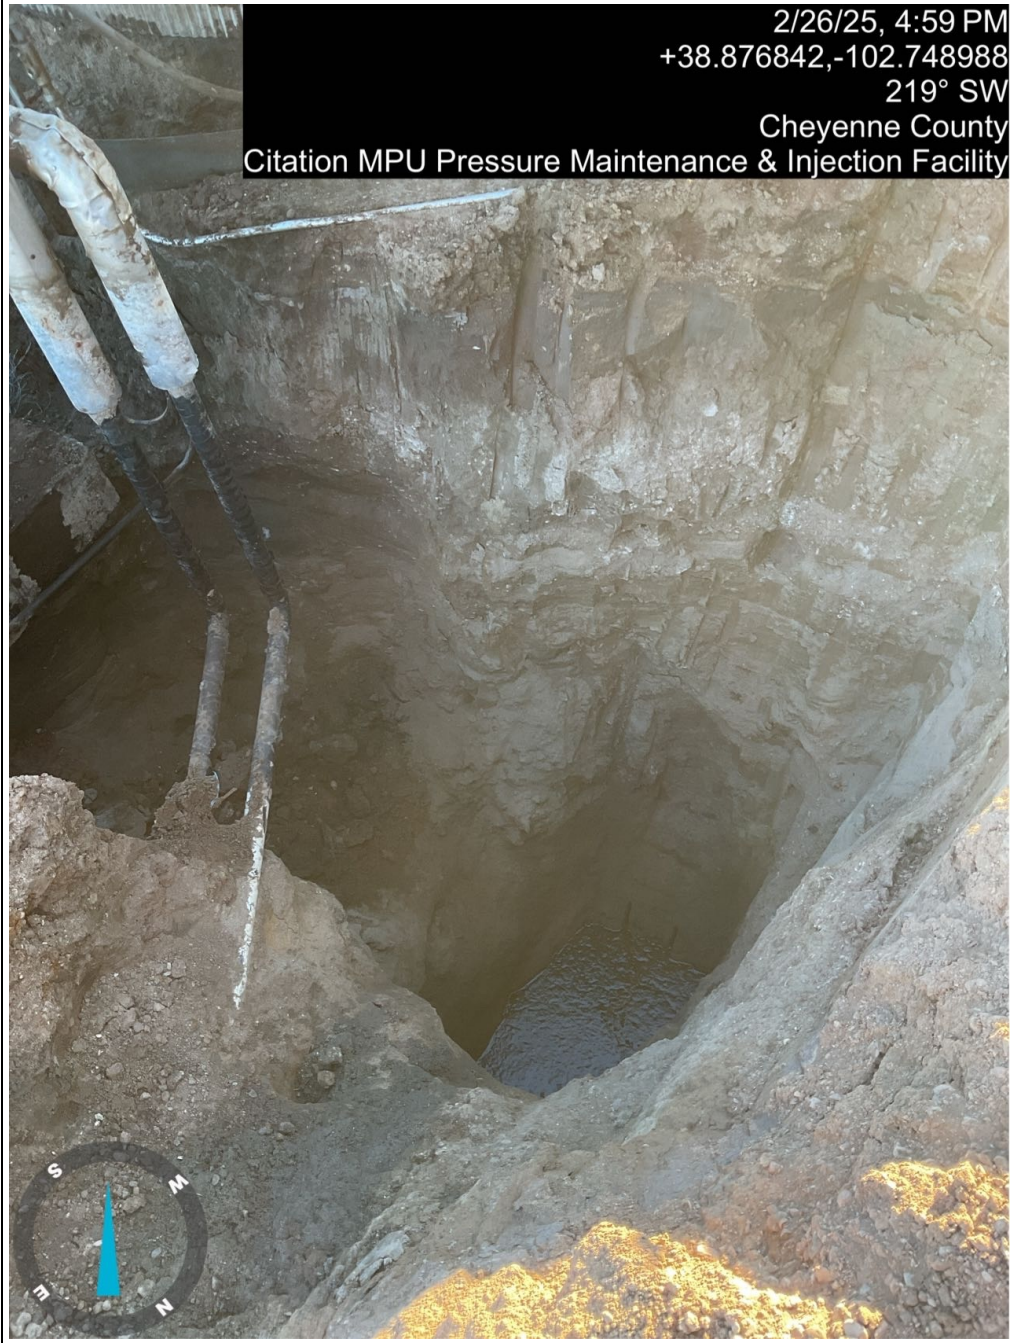
2/26/25, 4:59 PM  
+38.876842,-102.748988  
219° SW  
Cheyenne County  
Citation MPU Pressure Maintenance & Injection Facility

Walls of pit composed of sand at lower depths collapses into hole preventing backhoe from digging deeper.

SW view of pit.

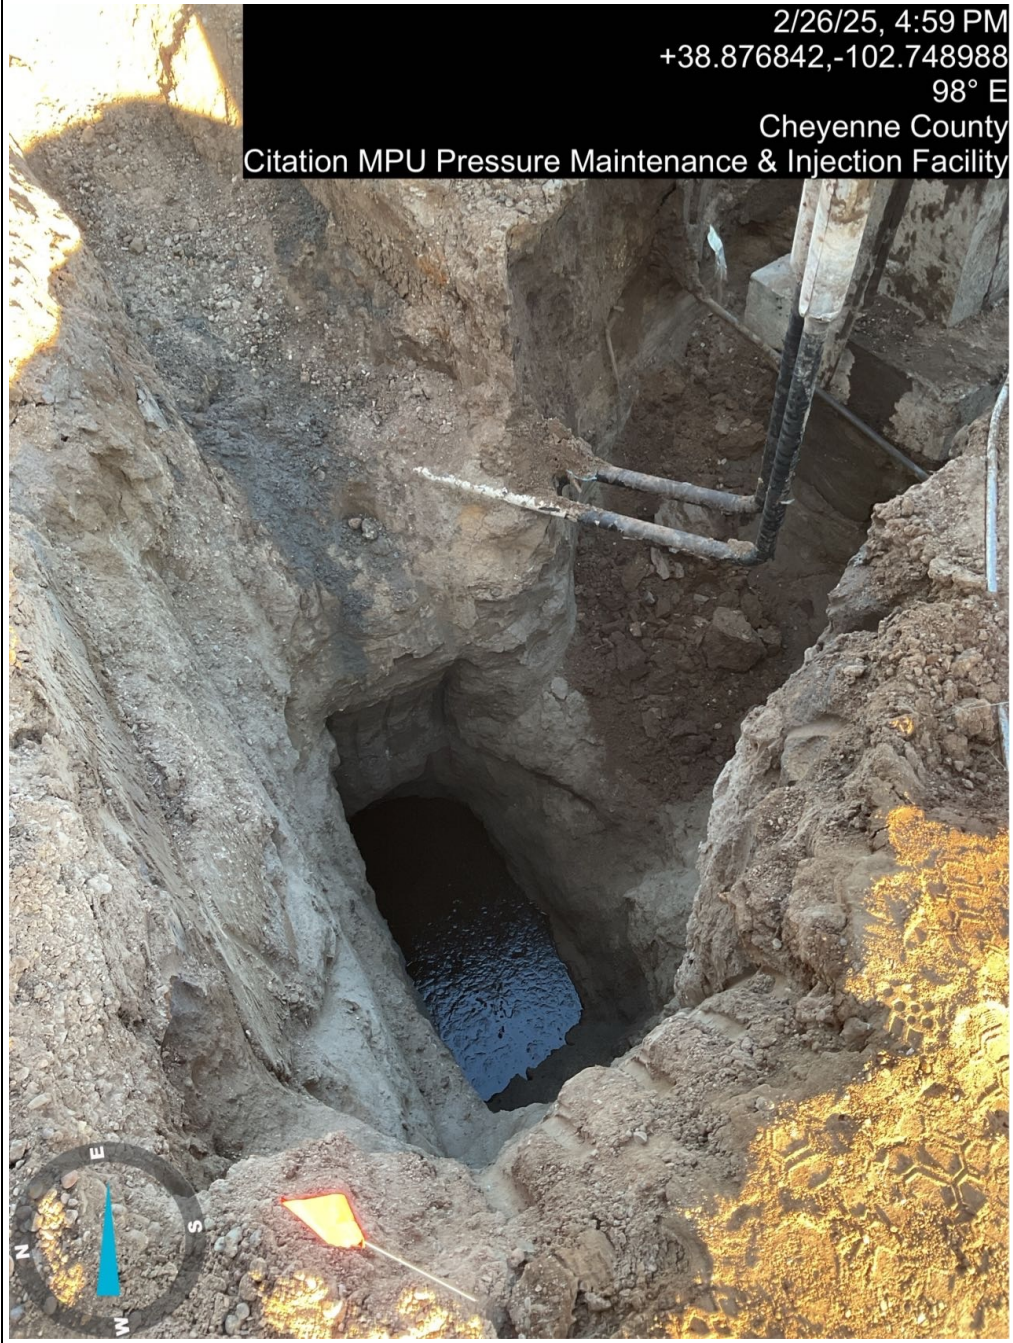
2/26/25, 4:59 PM  
+38.876842,-102.748988  
98° E  
Cheyenne County  
Citation MPU Pressure Maintenance & Injection Facility

**Description:**  
SE view of pit.

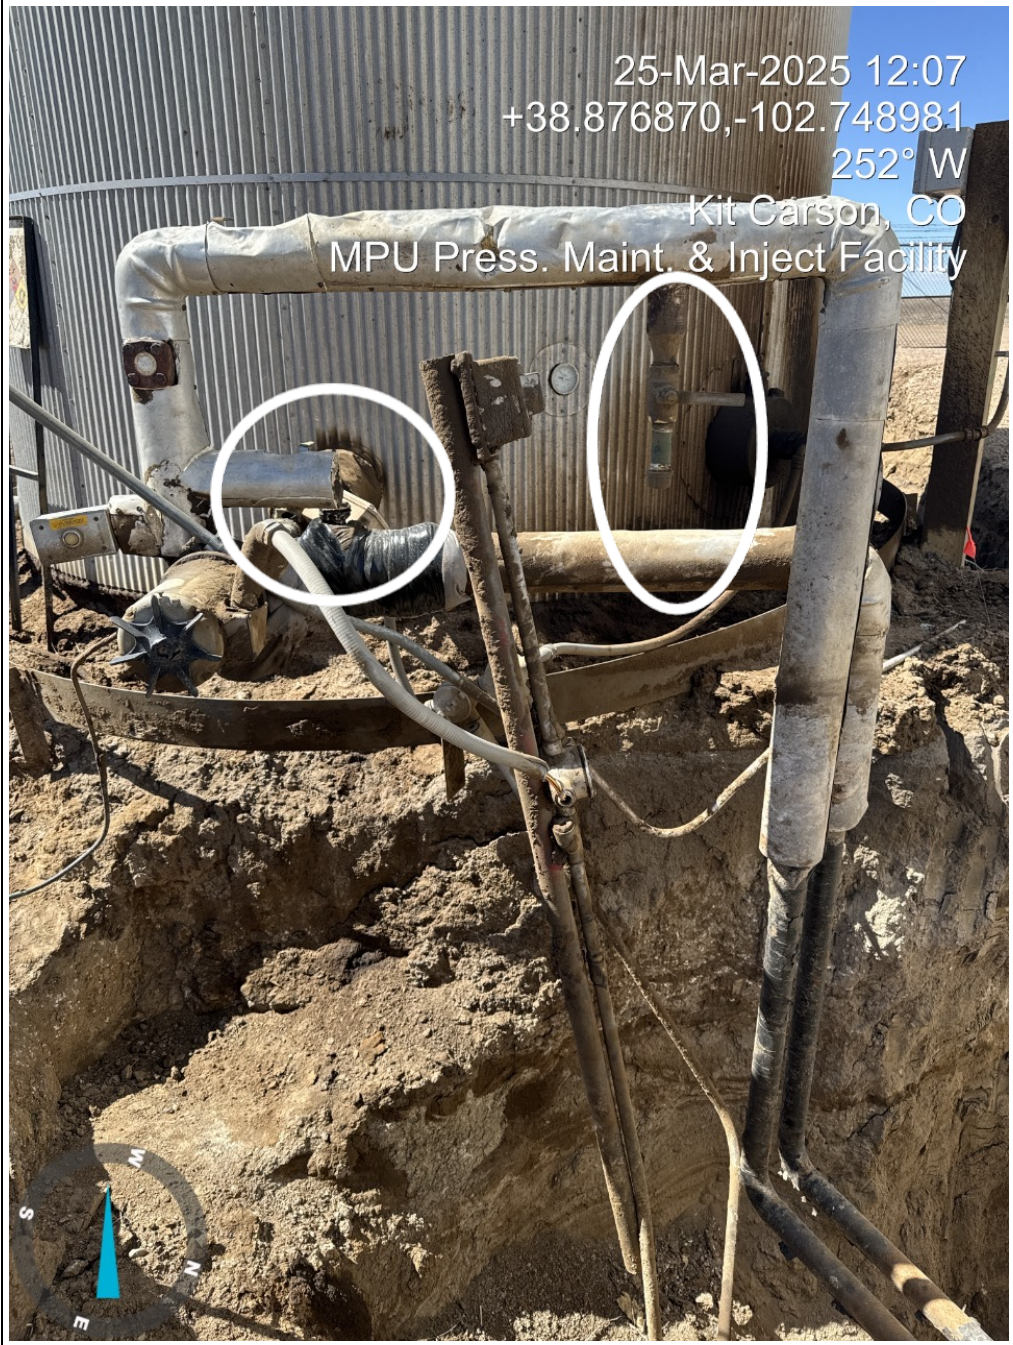
25-Mar-2025 12:07  
+38.876870,-102.748981

Pipes have been turned off and cleared with some being cut and closed.

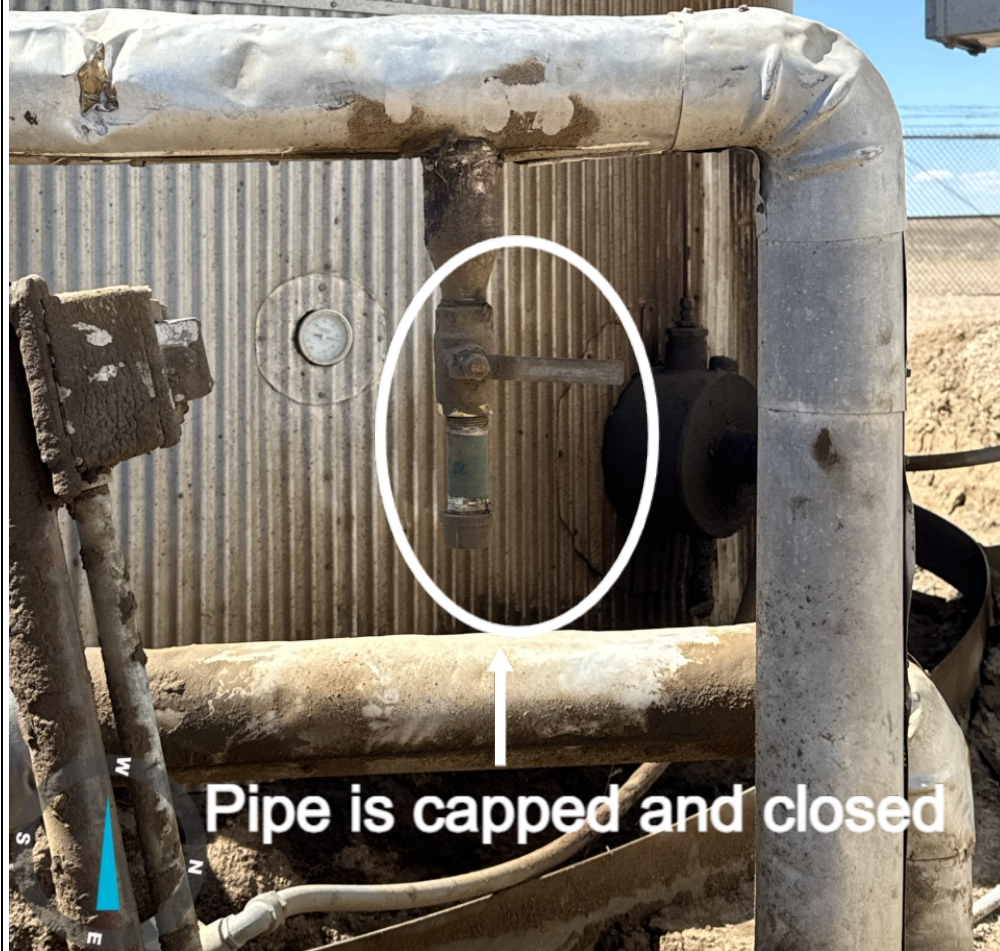
25-Mar-2025 12:07  
+38.876870,-102.748981  
261° W  
Kit Carson, CO  
MPU Press. Maint. & Inject Facility

Pipe is capped and closed

Flow pipe from diversion has been capped and closed.

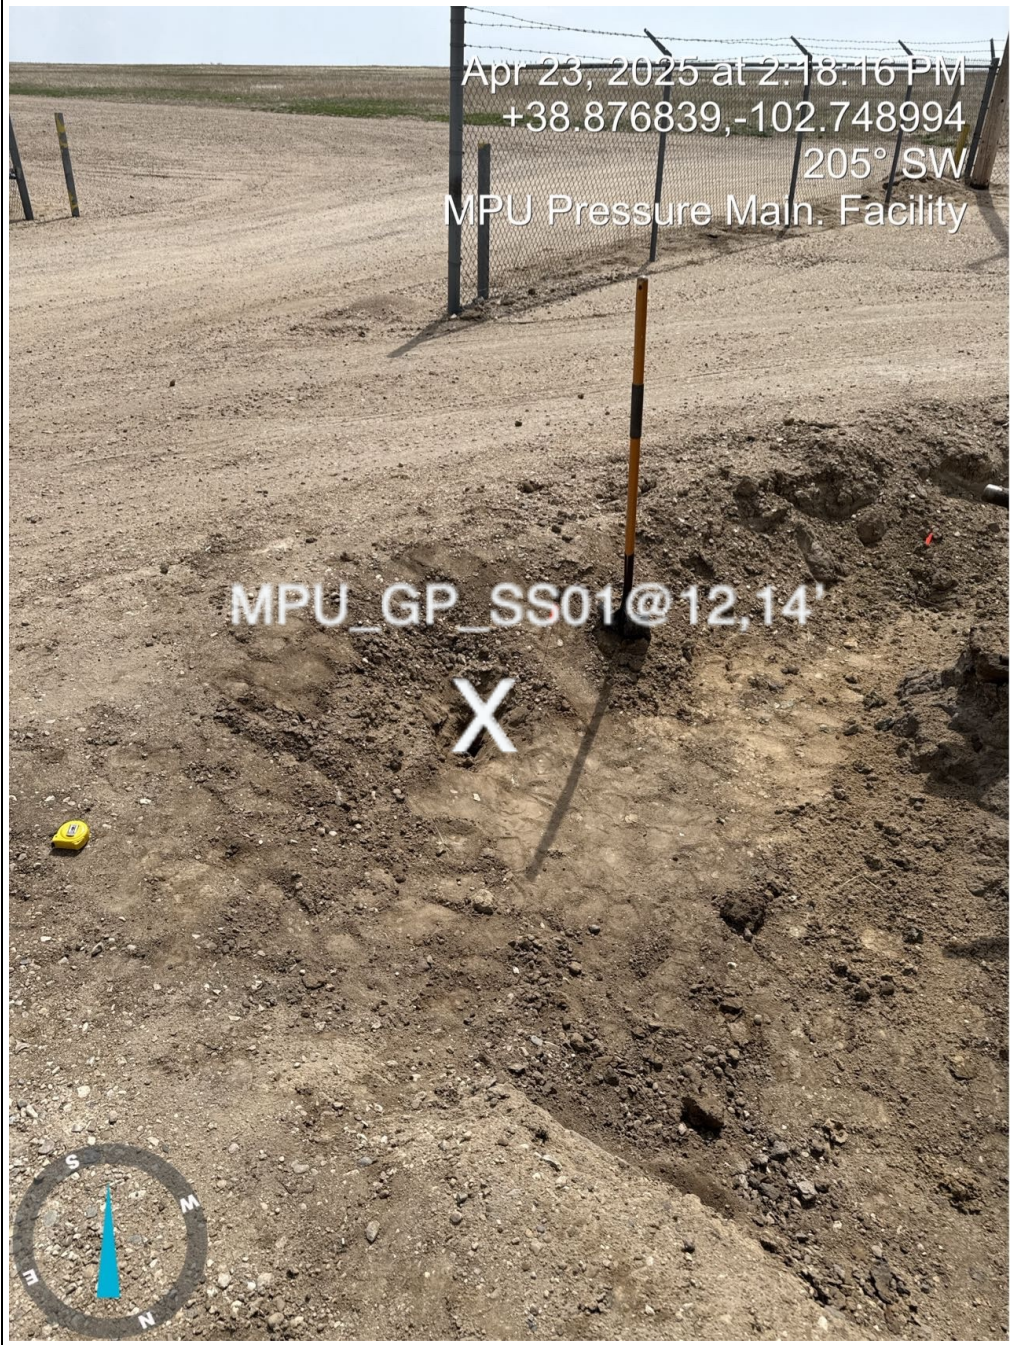
Apr 23, 2025 at 2:18:16 PM  
+38.876839,-102.748994  
205° SW  
MPU Pressure Main. Facility

MPU\_GP\_SS01@12,14'

MPU\_GP\_SS01@12',14  
Ppm 0.7

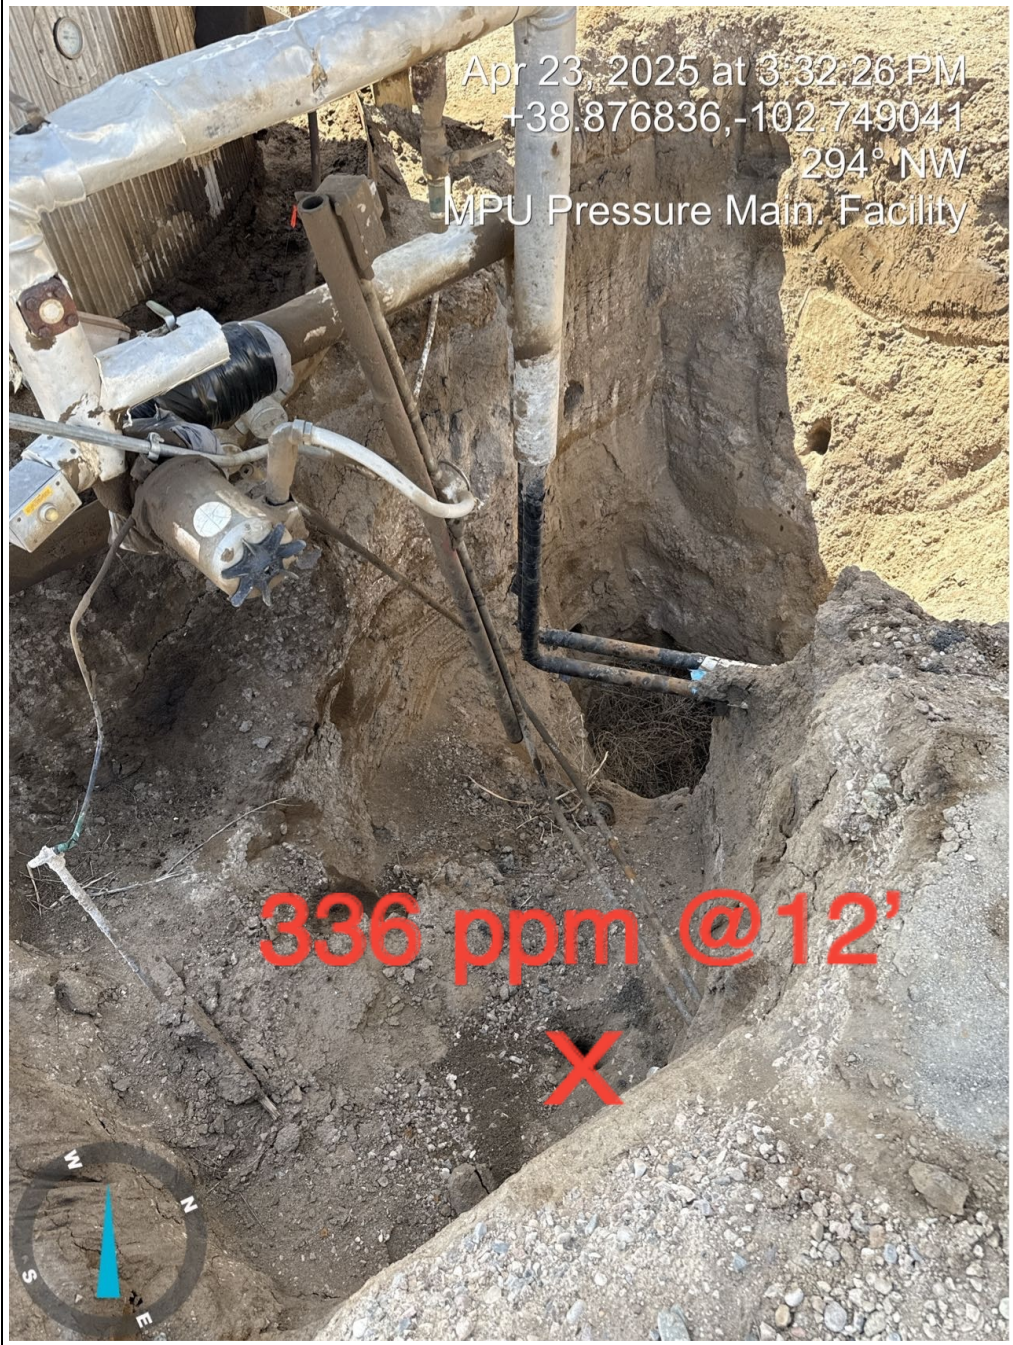
Apr 23, 2025 at 3:32:26 PM  
+38.876836,-102.749041  
294° NW  
MPU Pressure Main Facility

MPU\_PRESS\_TANK  
B01@8' hole

Went to take 10' and 12'  
samples and ppm was  
over.

Soil was sand, grey  
wet and smelled like PW

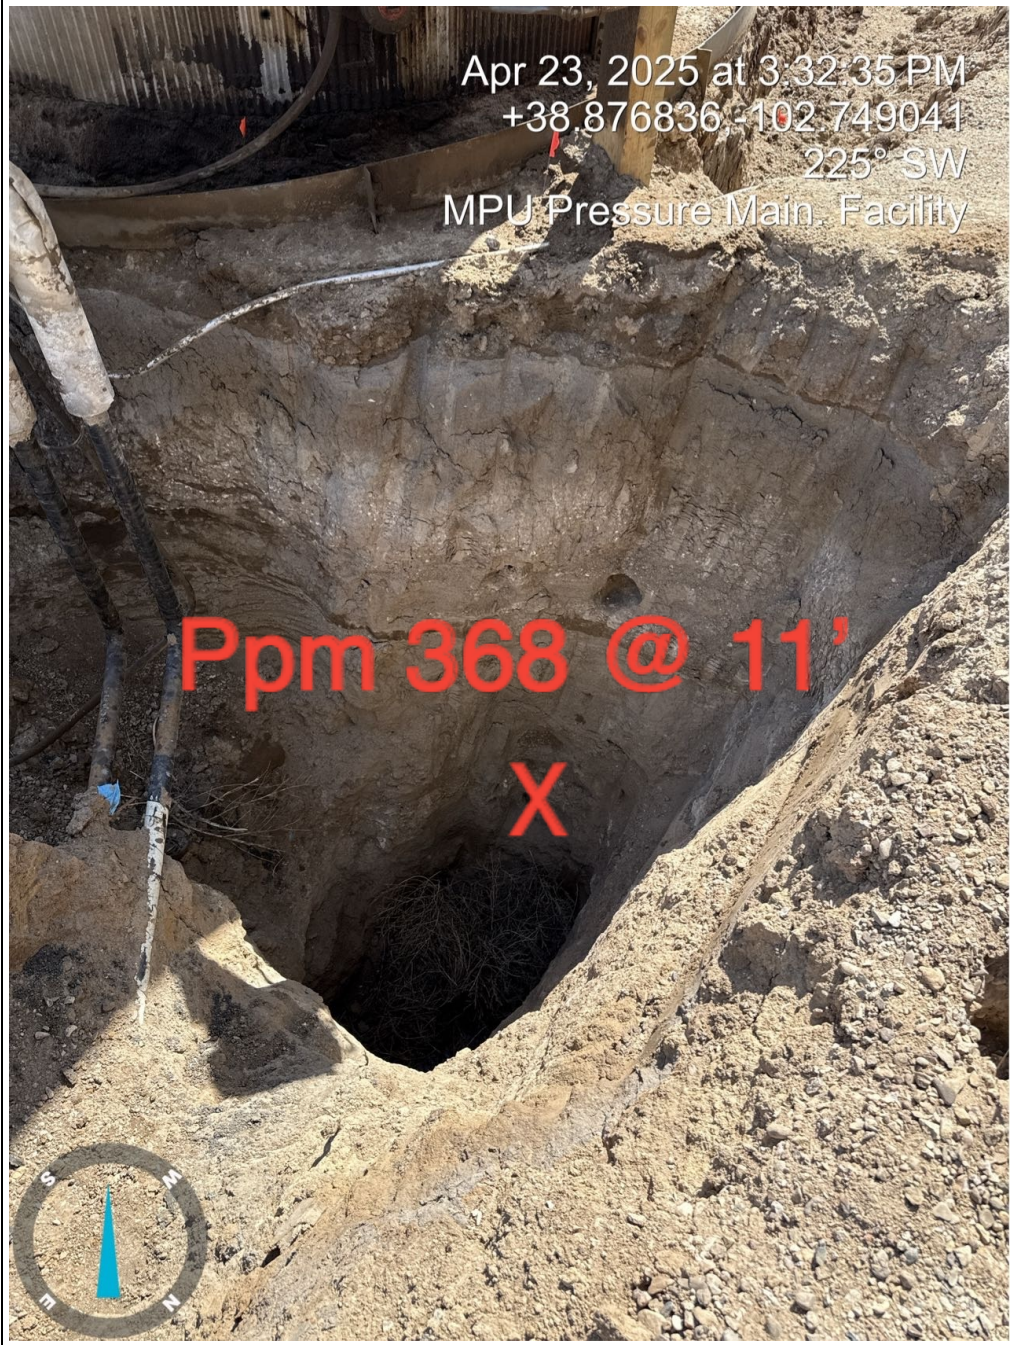
Apr 23, 2025 at 3:32:35 PM  
+38.876836, -102.749041  
225° SW  
MPU Pressure Main Facility

Ppm 368 @ 11'

high ppm in pit wall

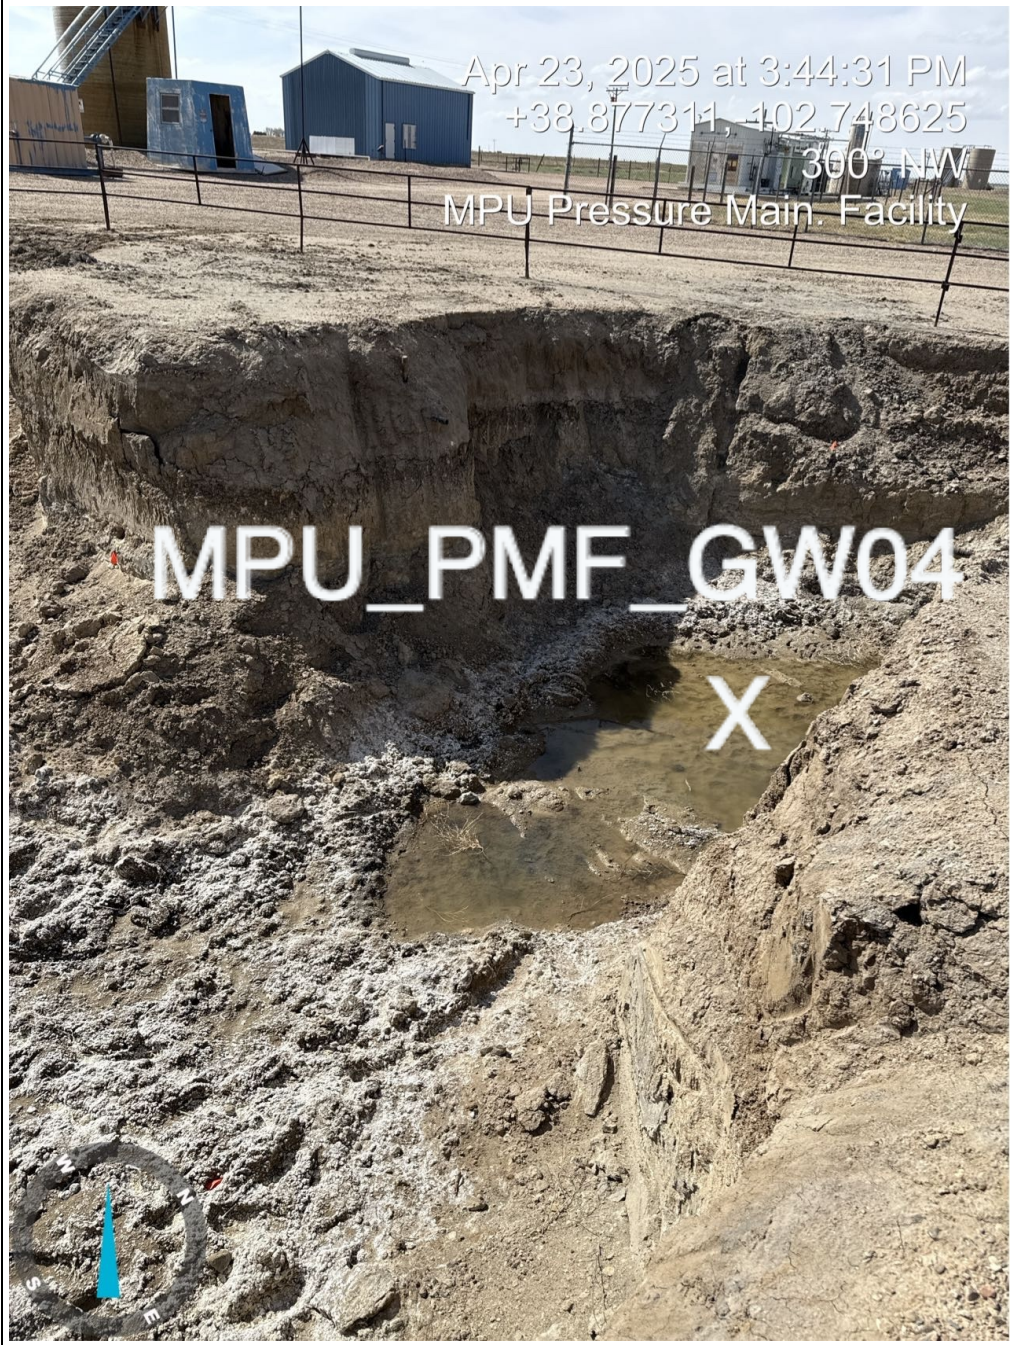
MPU\_PMF\_GW04  
sample location
