Inspection Photos

Operator: QB ENERGY OPERATING LLC

Location ID: 324226

Inspection Doc: 719200010

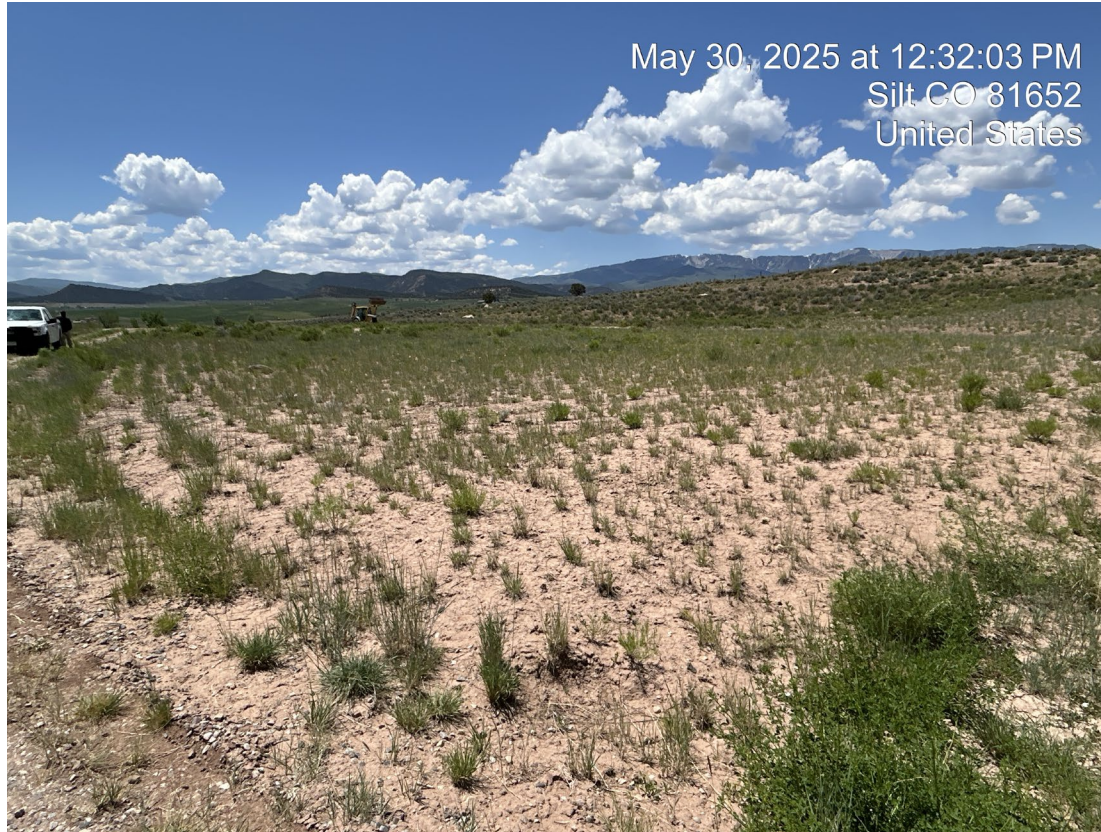
Photo 1: Photo is taken from the northeast portion of the Location and provides an overview looking southwest. Desirable, uniform and perennial vegetation establishment is apparent. 1004 final reclamation requirements have been met.

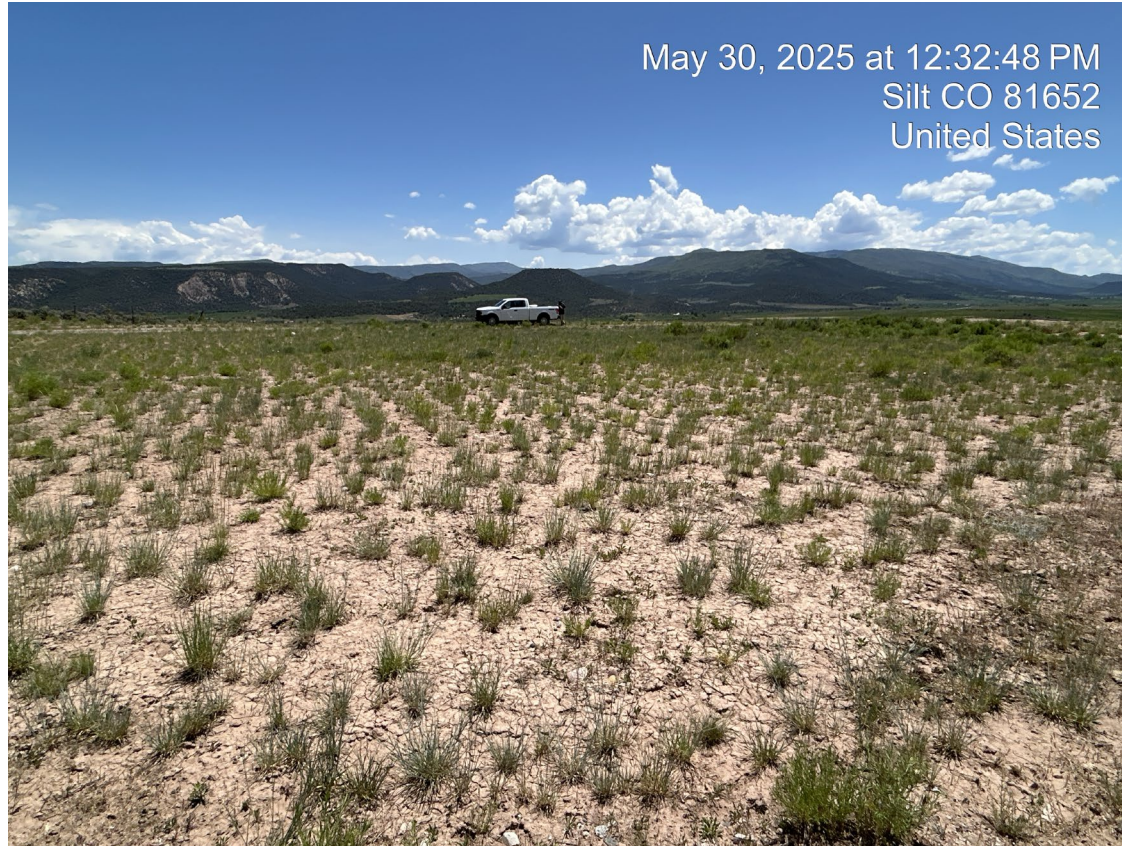
Photo 2: Photo is taken from the western portion of the Location looking east. 1004 final reclamation requirements have been met.

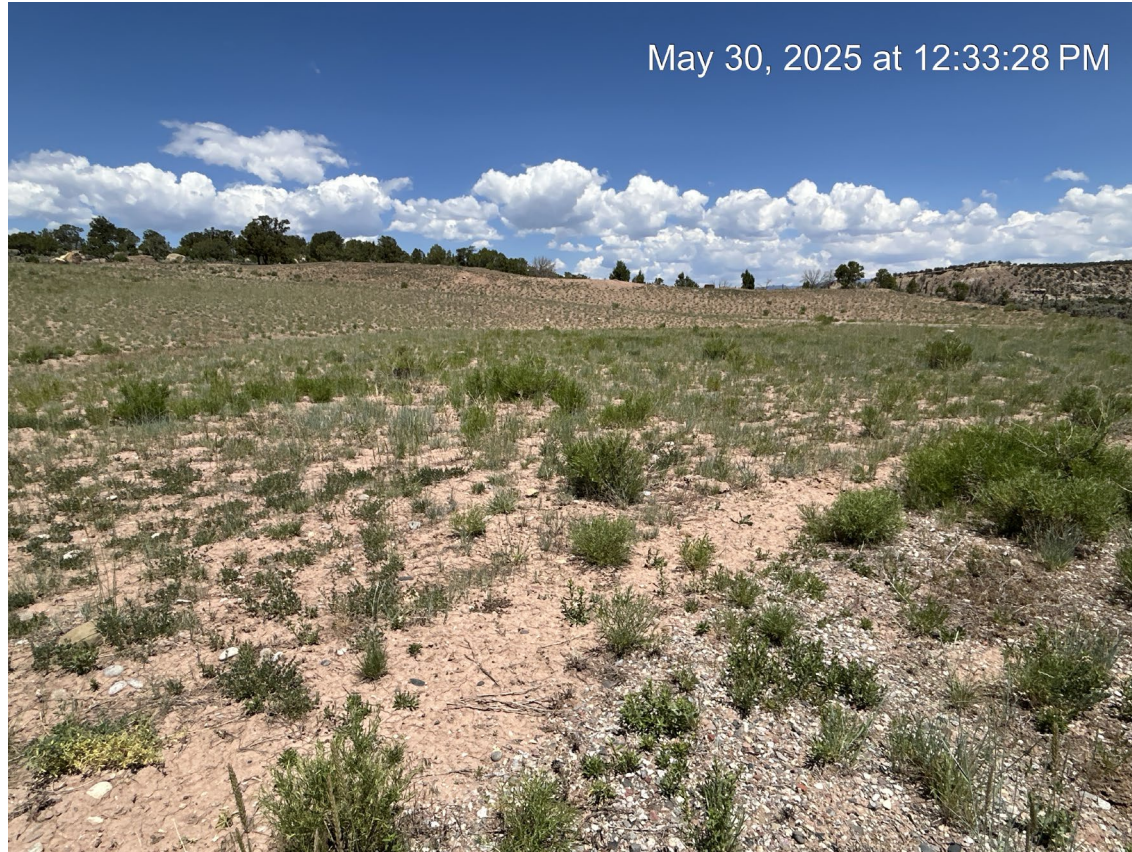
Photo 3: Photo taken from the southeast portion of the location looking northwest. Vegetation meets 1004 final reclamation requirements.
