FLOWLINE ABANDONMENT FORM

SITE NAME: UNI UPR C25-03							DATE: 7/5/2023	REM. PROJECT #: 22188	WEATHER: High 60s, cloudy		
SITE DIRECTIONS: CR40 & 57 proceed to booth hay yard, NE around edge of center pivot, NE 0.5, N 200ft thru gate							CLIENT: Noble				
LEGALS AND LAT/LONG: 40.290085 / -104.50388							TASMAN PERSONNEL: Elyse Hossink				
SOIL TYPES: Well Graded Sand - SW							SURFACE GRADIENT: Southeast				
SOIL SAMPLING							FACILITY INFRASTRUCTURE				
Date/Time	Soil Sample ID	PID (ppm)	Visual	Olfactory	Photo?	Grab or Lab Sample?	EQUIPMENT		Quantity		
							Above Ground Storage Tank (AST)				
7/5/2023 13:55	FL01-A@2.5	9.1	HC Staining	No Odor	Yes	Lab	Buried or Partially Buried Vessel				
7/5/2023 15:15	FL01-B@3.5'	0.6	No Staining	No Odor	Yes	Lab	Separator				
							Emission Control Device (ECD)				
							Dump Line				
							Wellhead				
							Flowline		1		
							Other:				
							Soil Loads Removed				
							IMPACTED SOIL IDENTIFIED?

Flowline Closure Checklist

Flowline Closure & Soil
 Analytical Results Map
 (07/05/2023, 02/12/2024, &
 02/13/2024)

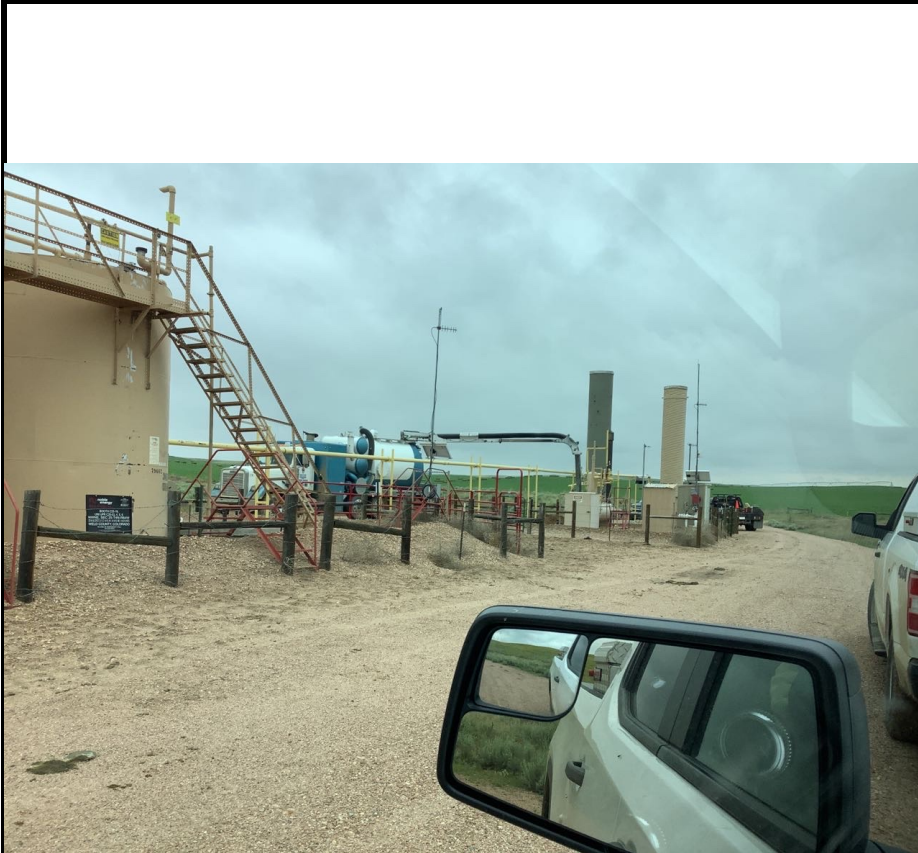
Equipment ID:		Equipment Type:	
Material:	Volume:	Contents:	
Notes/Conditions: Site photo of Facility

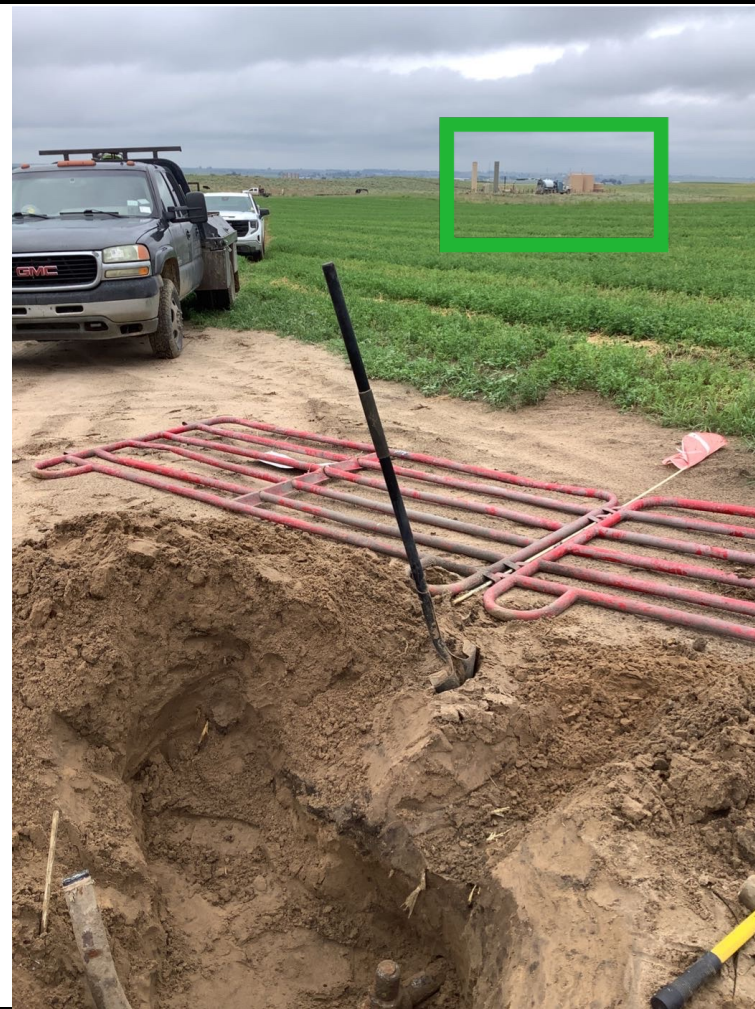
Equipment ID:		Equipment Type:	
Material:	Volume:	Contents:	
Notes/Conditions: Site photo - from wellhead, facility in green rectangle

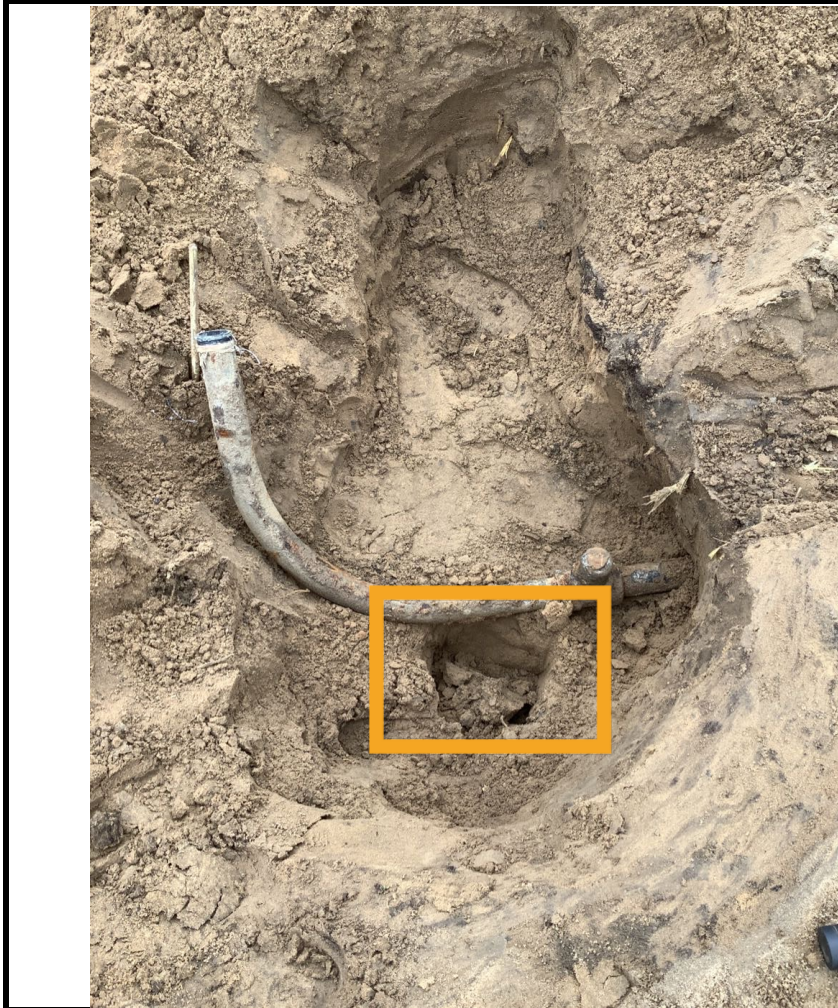
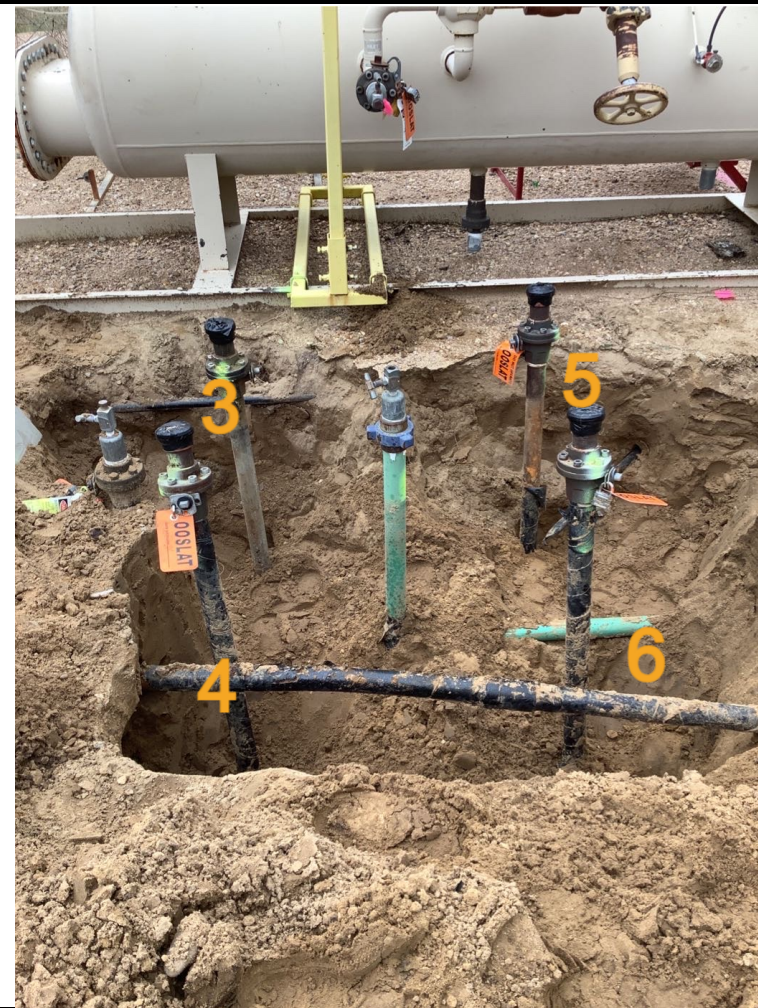
Other observations regarding on location flowlines:
Samples were taken at the wellhead (FL01-A@2.5') and at the separator (FL01-B@3.5'). Both samples were submitted to the lab for analysis.
Flowline was ABIP to be pulled at a later date

Equipment ID: FL01-A@2.5'		Equipment Type: Flowline		Equipment ID:		Equipment Type:	
Material: Steel	Volume:	Contents: Oil/Gas/Water		Material:	Volume:	Contents:	
Notes/Conditions:				Notes/Conditions: location of UNI UPR C25-03, UNI UPR C25-04, UNI UPR 25-05 and UNI UPR C25-06 flowlines at common separator labeled 3-6 respectively.

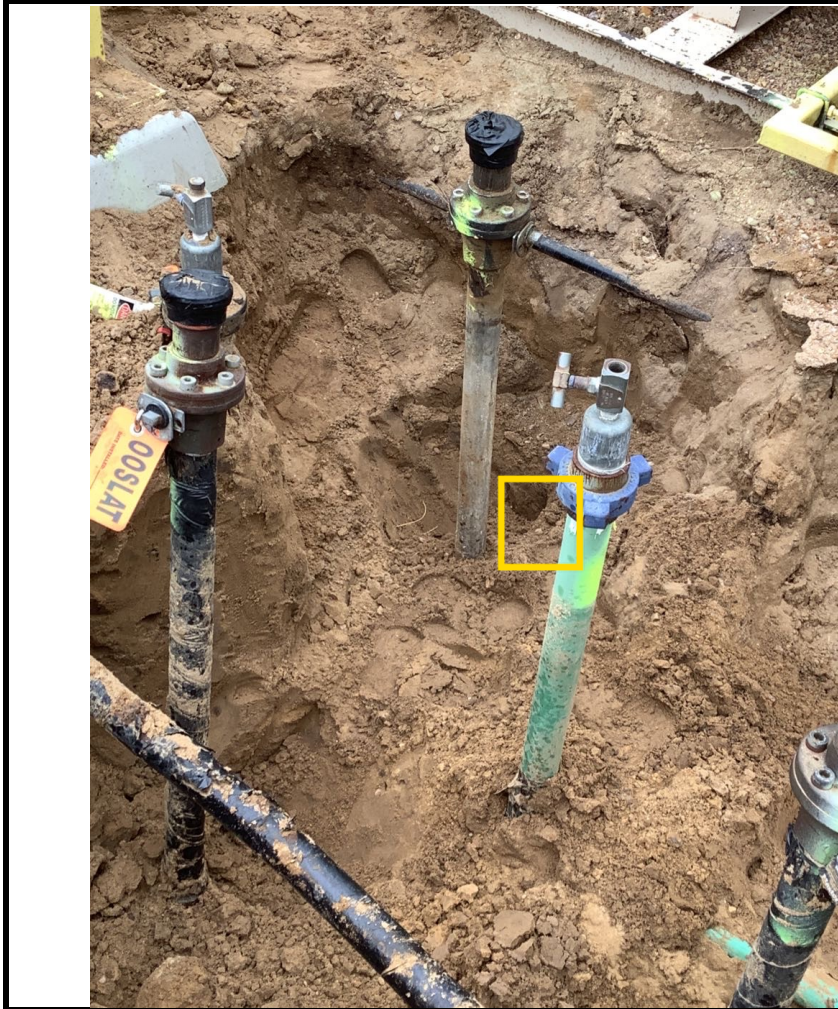
Equipment ID: FL01-B@3.5'		Equipment Type:		Equipment ID:		Equipment Type:	
Material:	Volume:	Contents:		Material:	Volume:	Contents:	
Notes/Conditions:				Notes/Conditions:

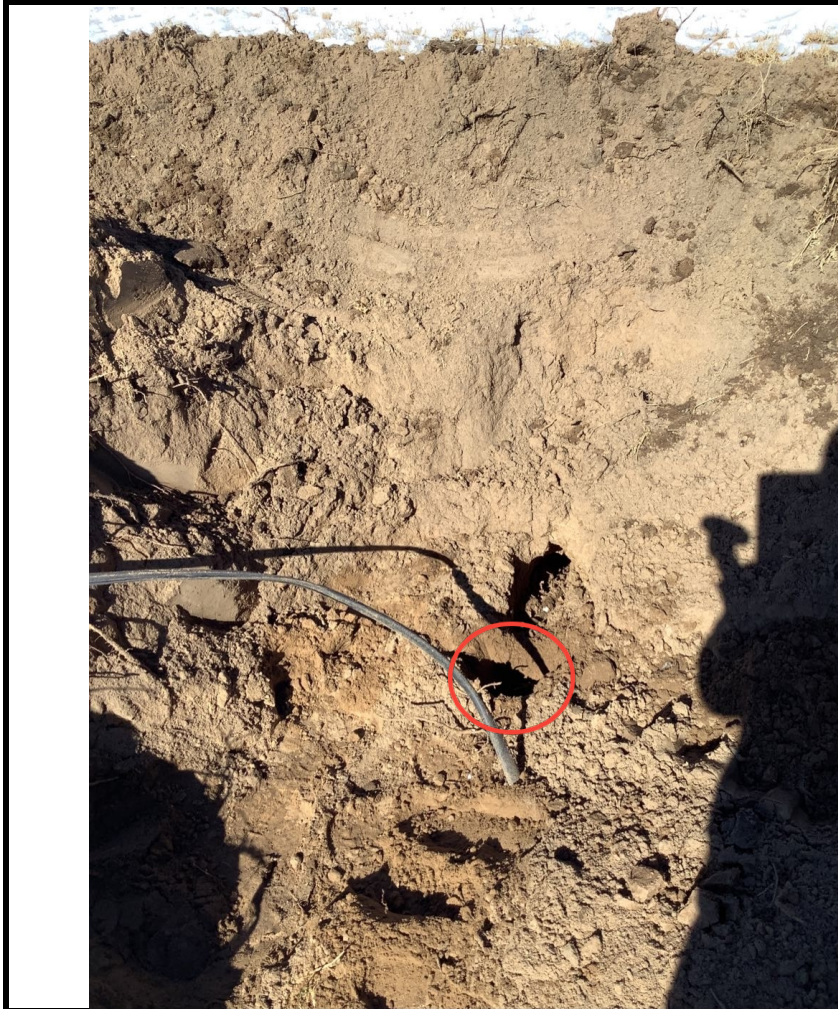
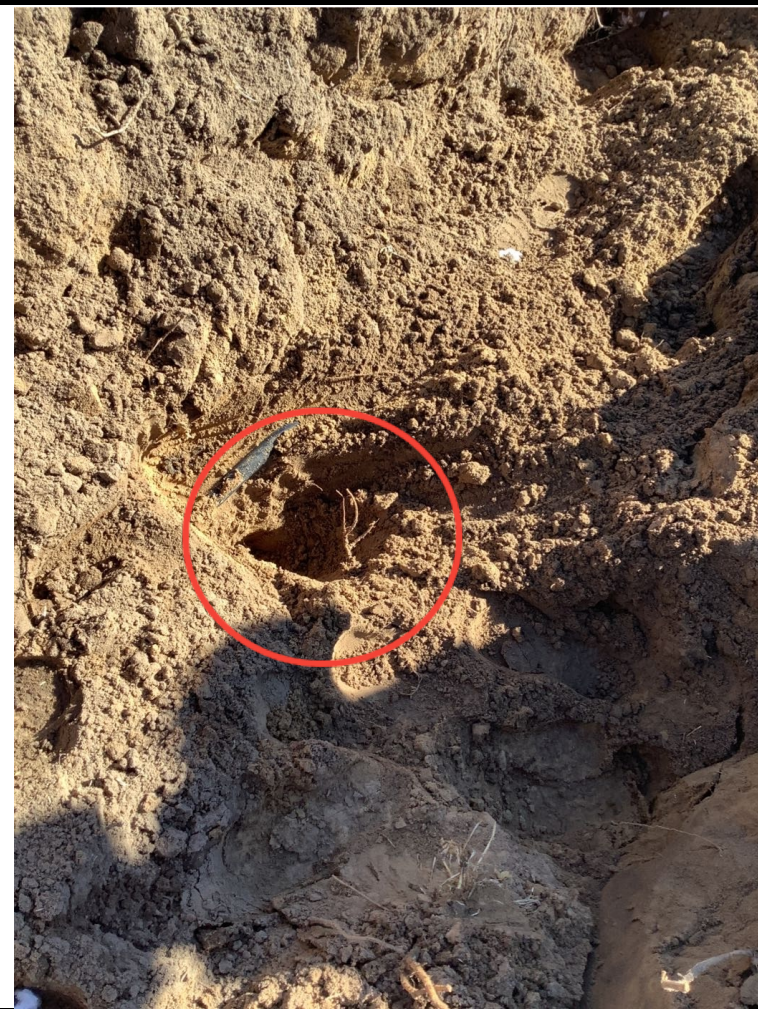
Equipment ID: FL01-C @ 3'		Equipment Type:		Equipment ID: FL01-D @ 3'		Equipment Type:	
Material:	Volume:	Contents:		Material:	Volume:	Contents:	
Notes/Conditions:				Notes/Conditions:

Flowline type				
Depth	3			
Age				
Length	1,410 ft			
Construction Material	Steel			
Were flowlines pulled?	Yes			
Visual Integrity of lines	Good			
Visual impacts if trenched	None			
PID Readings if trenched	0.2			
Sample taken? Location/Sample ID#	FL01-C-FL01-I			
Photo Number(s)
